# National Transportation Safety Board

CEN22LA377

## **AIRCRAFT EXAMINATION SUMMARY**

Location: Vernon Hills, IL  
Date: August 5, 2022  
Time: 2200 cdt  
Airplane: N6460R

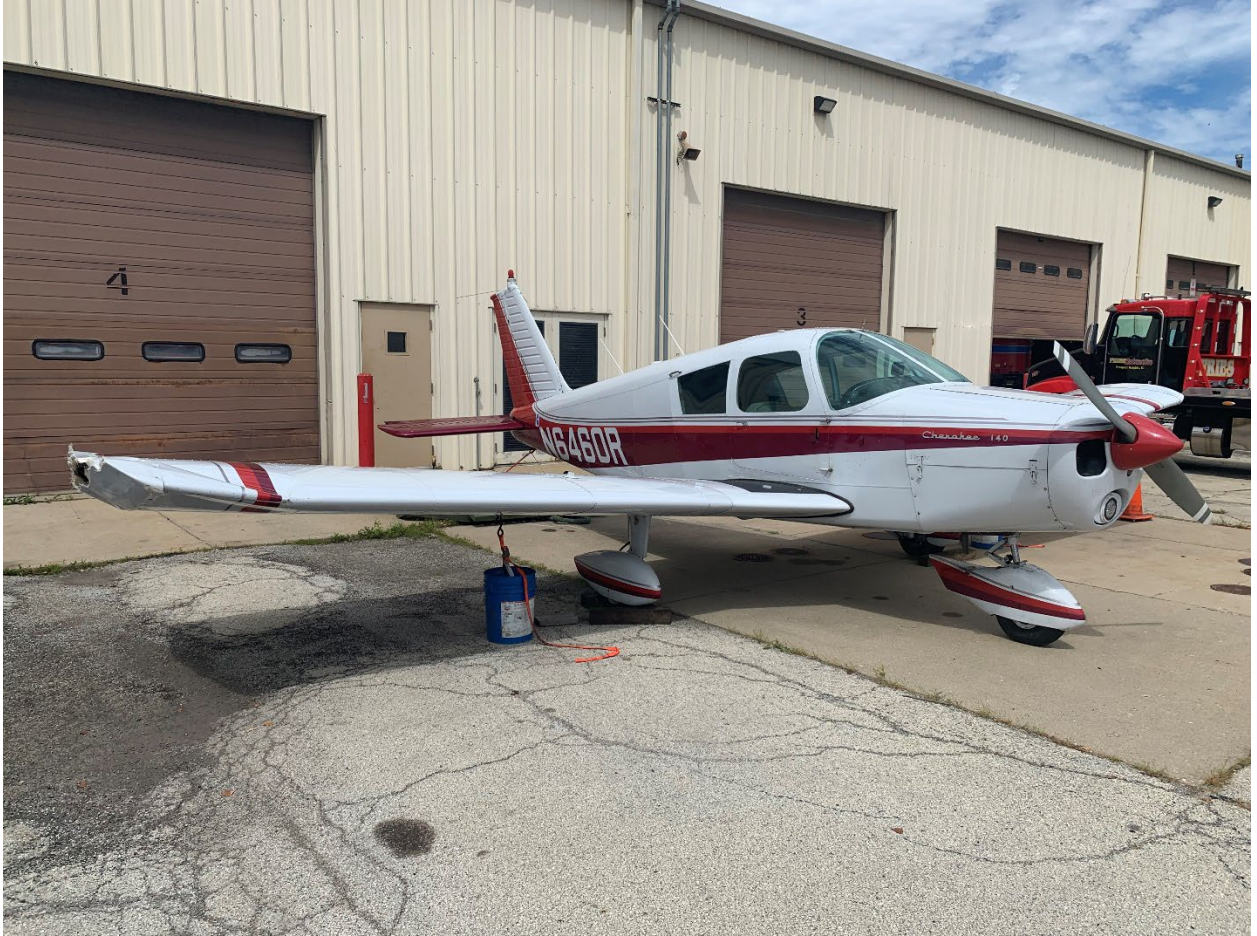
The airframe was intake with no missing pieces. There was a nick in one propeller blade and the right wing was bent upward at the tip. The damage to the right wing constituted substantial damage.

Figure 1: Airplane during postaccident examination.

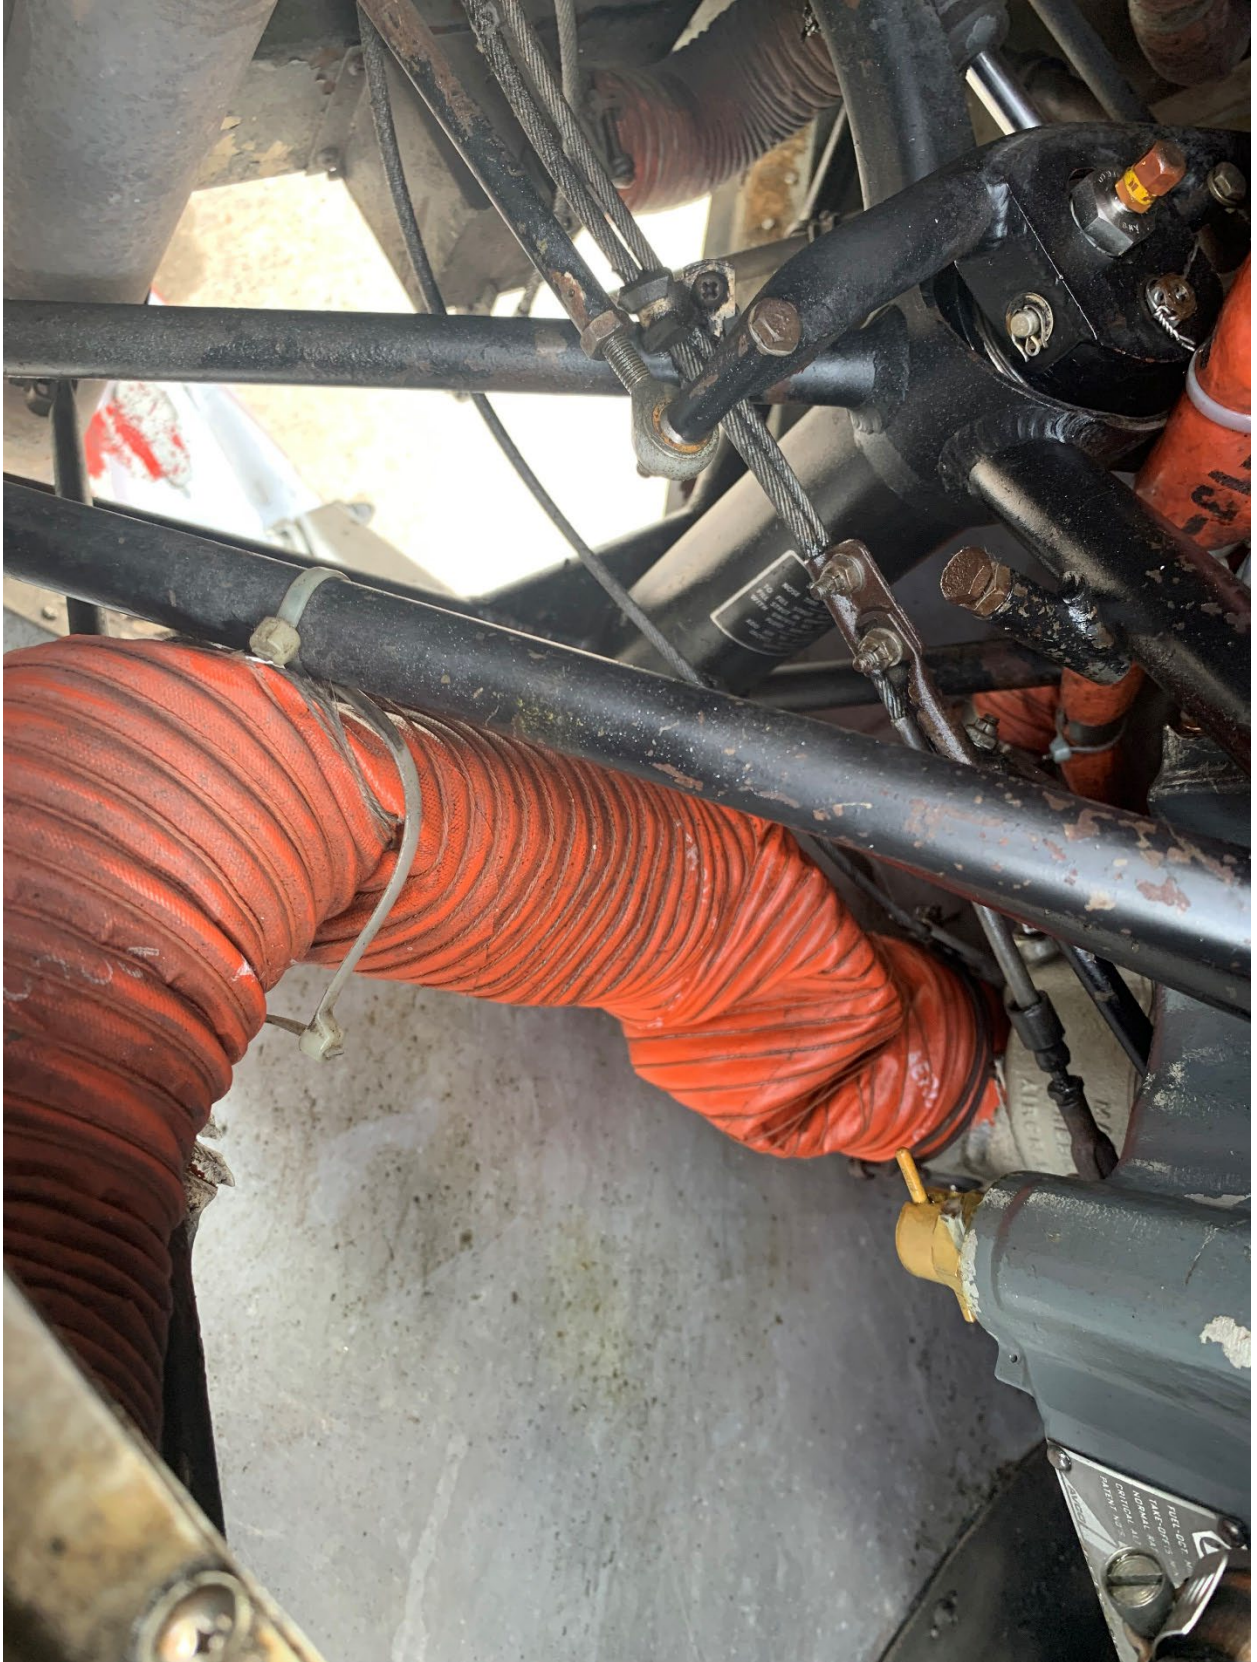
Examination of the engine revealed that the flexible tube from the heat shroud to the carburetor heat box was partially collapsed. The damage to the tube did not appear to be impact related. Several of the engine spark plug ignition leads were loose. The engine could be freely rotated, and compression was felt on all cylinders. It was decided to perform an engine run and the spark plugs were replaced as-found. The engine was started normally and ran smoothly. The engine rpm was increased to

2000 rpm, and a magneto check performed with normal rpm drop. When the carburetor heat check was performed, the engine rpm reduced by 700 rpm, but restored when the carburetor heat was turned off. The induction tube could not be seen from the cockpit during the engine run test. Subsequent disconnection of the induction hose and examination revealed no further anomalies with the carburetor heat system. No other anomalies were detected during the engine test run.

Figure 2: View of collapsed induction tube.
