# National Transportation Safety Board

CEN22LA378

## **MATERIALS LABORATORY**

Factual Report 23-016

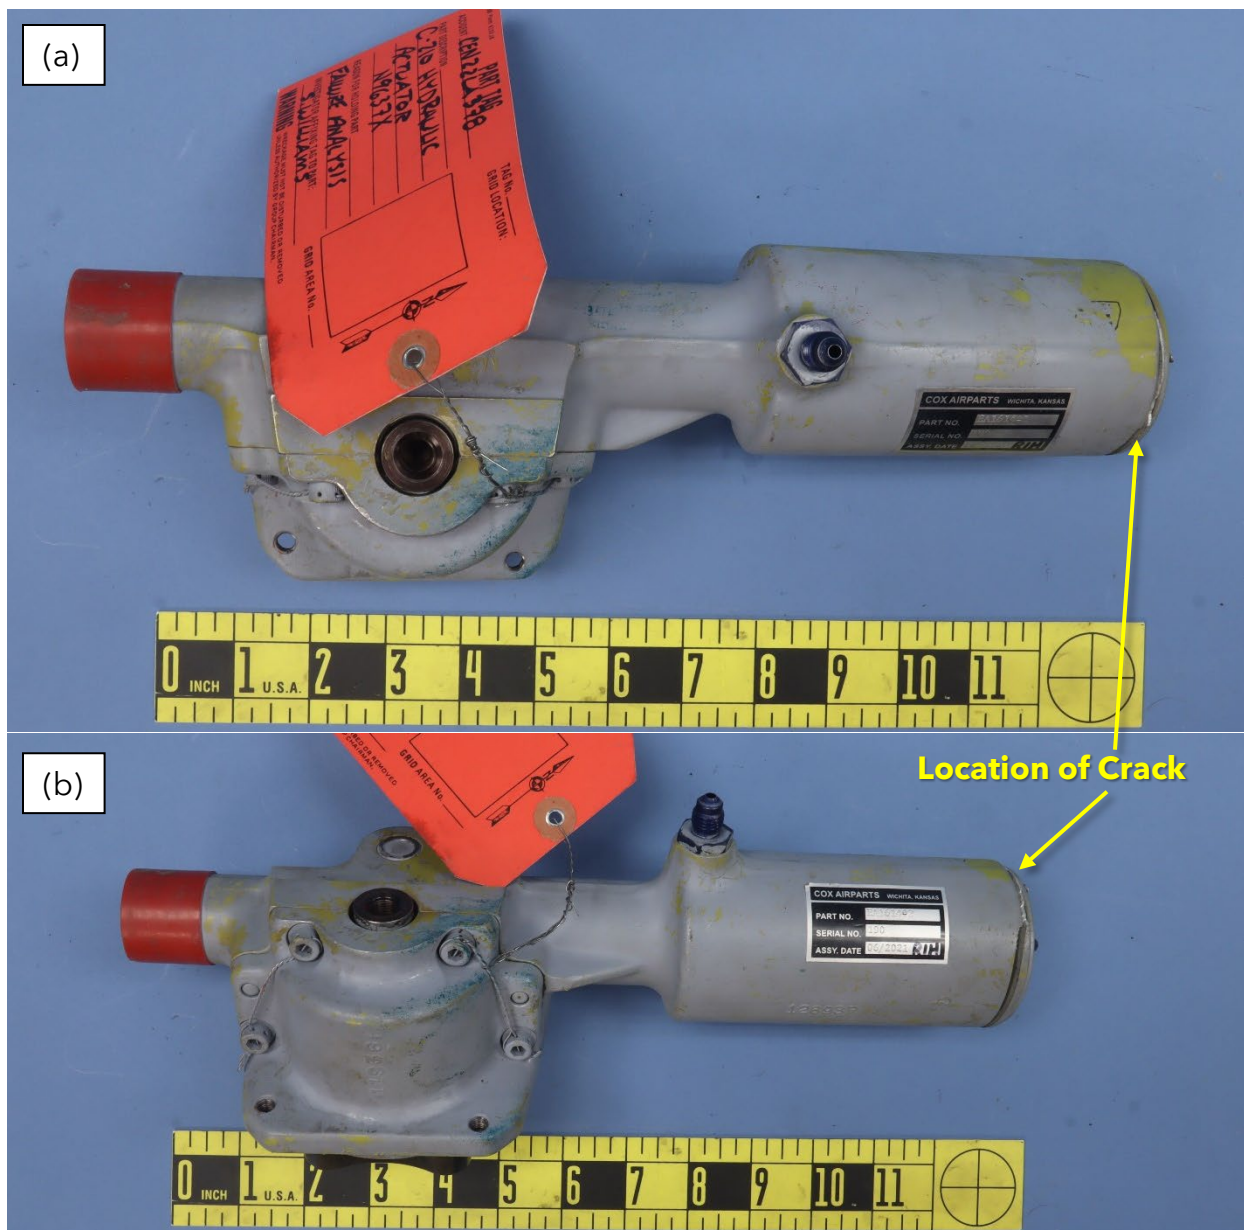
The cracked hydraulic actuator is illustrated in Figure 1 and Figure 2, as received from different sides. The part had cracked around the barrel, with circumferential components. Figure 3 shows the identification plate and embossed markings for the actuator. The embossed markings on the barrel stated:

**Figure 1.** The hydraulic actuator, as received.

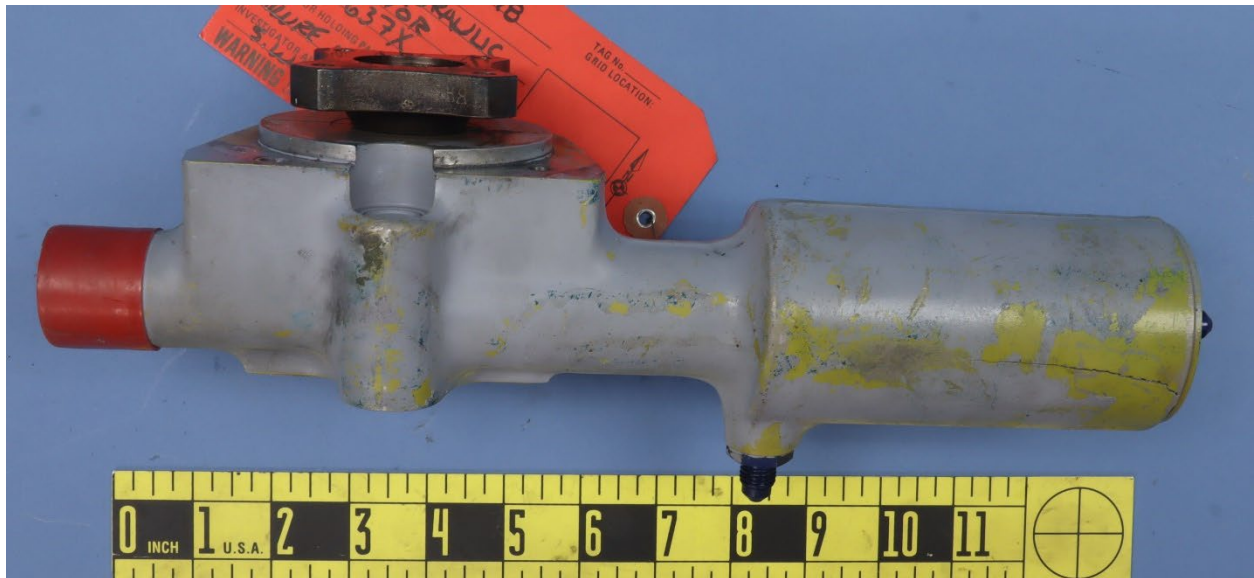
**Figure 2.** View of the hydraulic actuator, viewed opposite that in Figure 1b. This shows the longitudinal crack on the housing barrel.

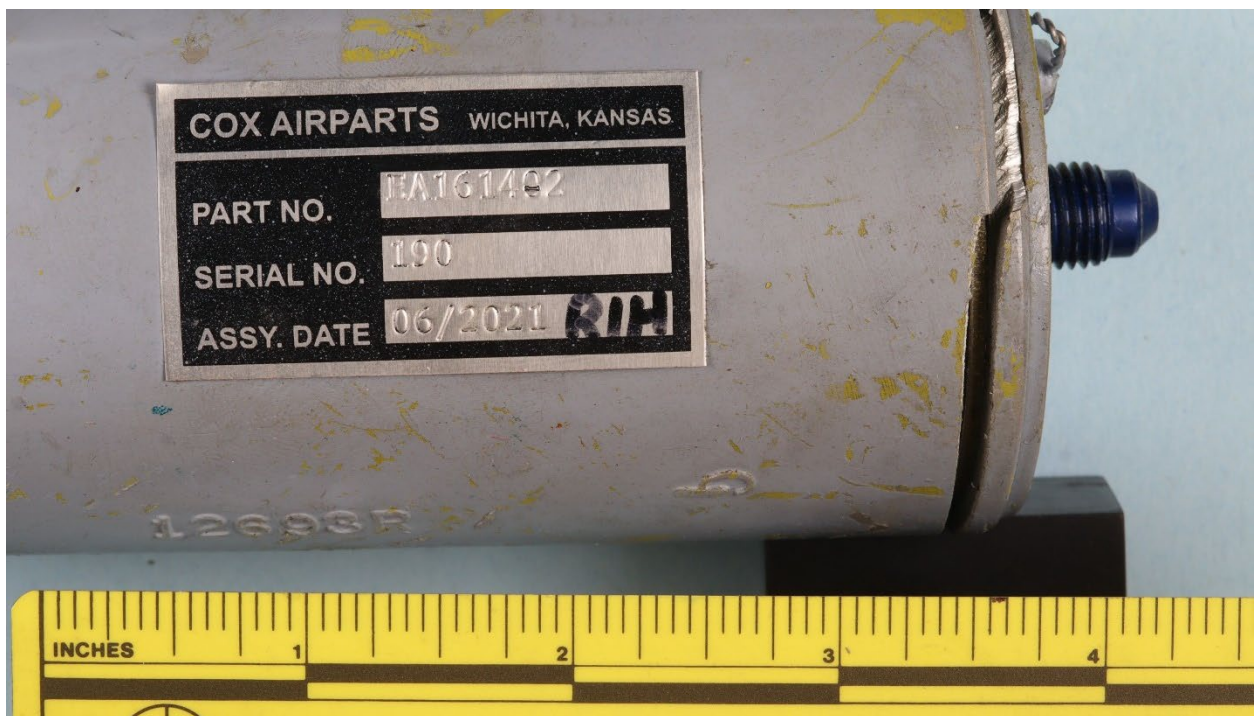
**Figure 3.** View of the markings on the housing barrel of the actuator, with the circumferential crack on the right.

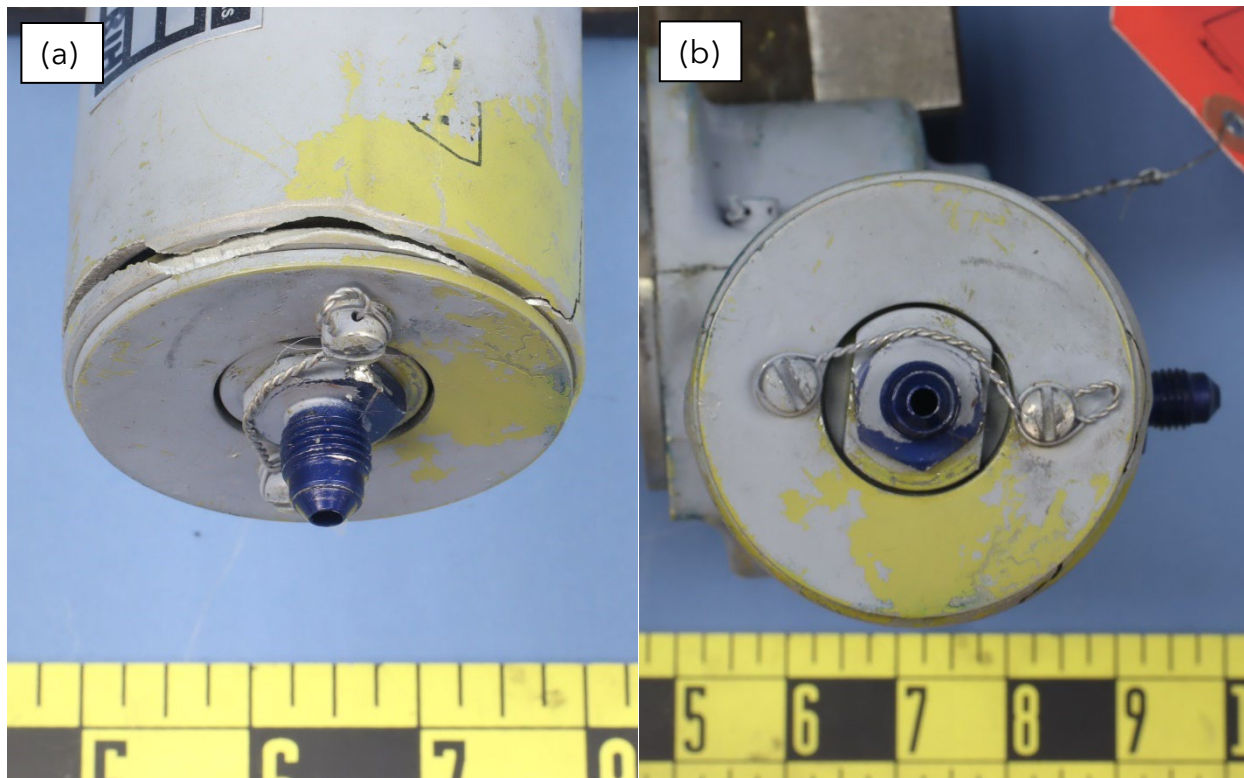
The part was cracked about the barrel section adjacent to the endcap, as illustrated in Figure 4. The circumferential portion of the crack was 5.75 in long (in circumference). Figure 5 shows the transition to a longitudinal crack along the housing barrel (Figure 6)—the longitudinal section of the crack extended for 2.60 inches.

**Figure 4.** The end of the hydraulic actuator, showing the circumferential portion of the crack.

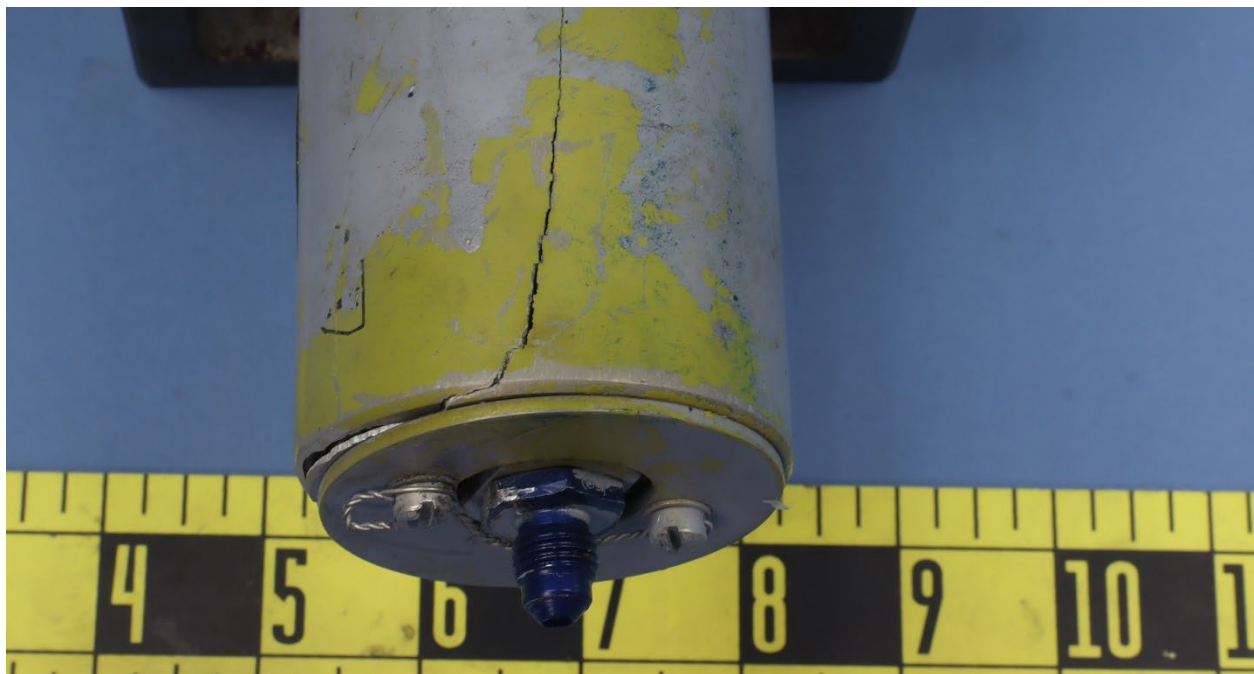
**Figure 5.** The longitudinal crack on the actuator housing, emanating from the circumferential crack (opposite the view in Figure 4a).

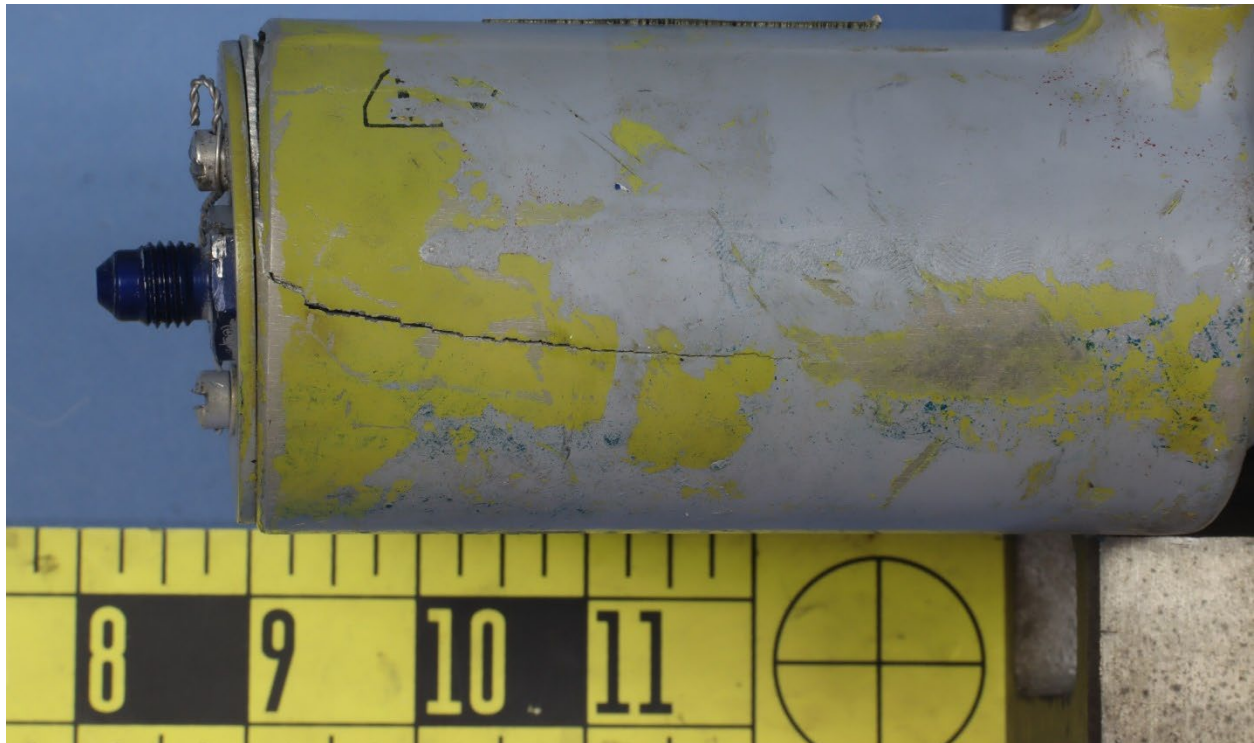
**Figure 6.** The longitudinal crack along the actuator housing barrel.

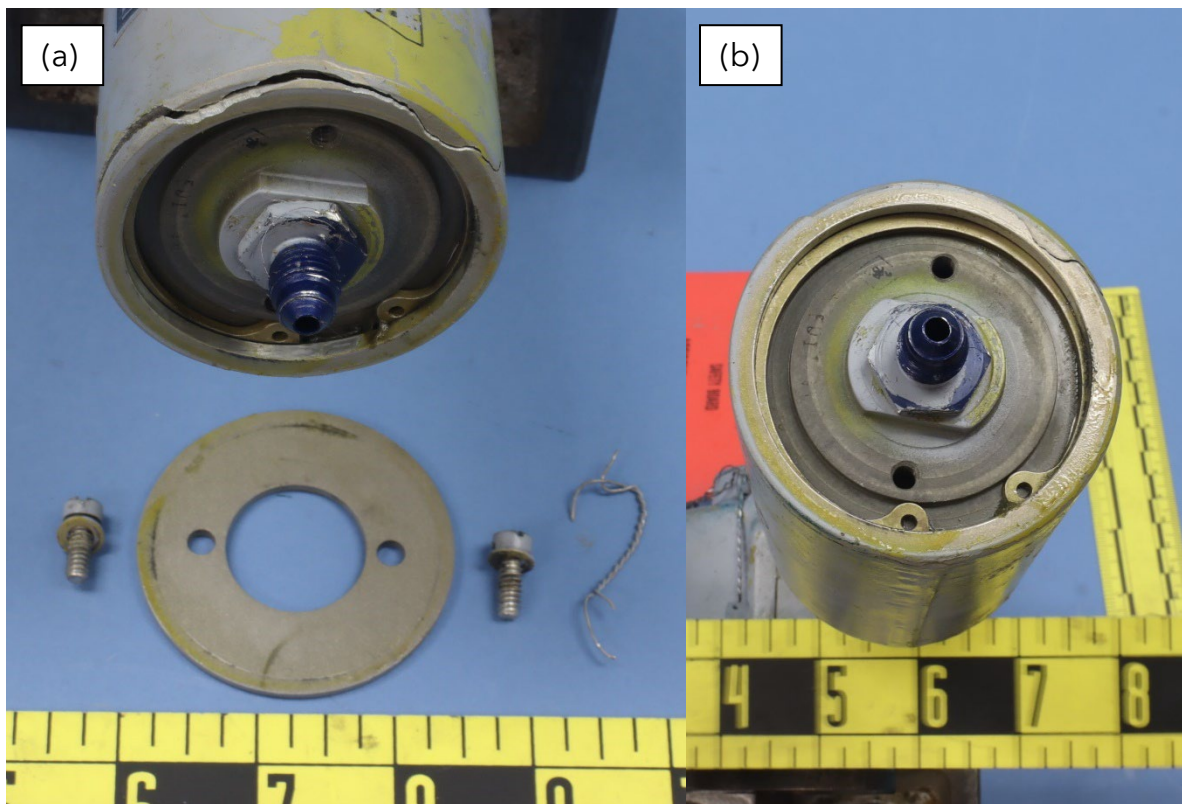
The end cap of the actuator was separated by sectioning the safety wire and removing the retaining screws. Once the endcap was removed, the extent of the circumferential cracking was revealed (Figure 7). Though cracked, the end flange was still attached by a small filament near the transition with the longitudinal crack.

**Figure 7.** The cracked end of the actuator pictured in Figure 4, after removal of the screws and the end cap.

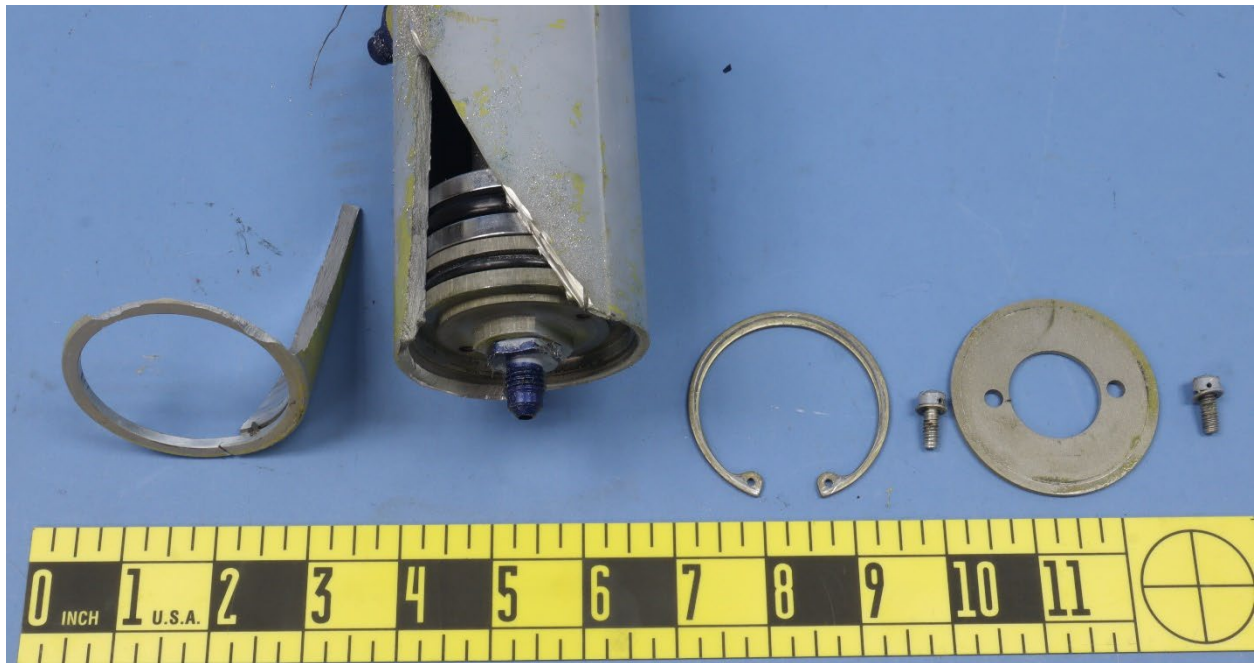
The barrel of the housing was sectioned at a 45° angle to separate the cracked area from the rest of the assembly. Figure 8 illustrates the sectioned cracked area positioned next to the actuator body, with the retaining ring and endcap towards the right.

**Figure 8.** The cracked end of the actuator pictured in Figure 7a, after sectioning and removal of the cracked regions of the housing barrel.

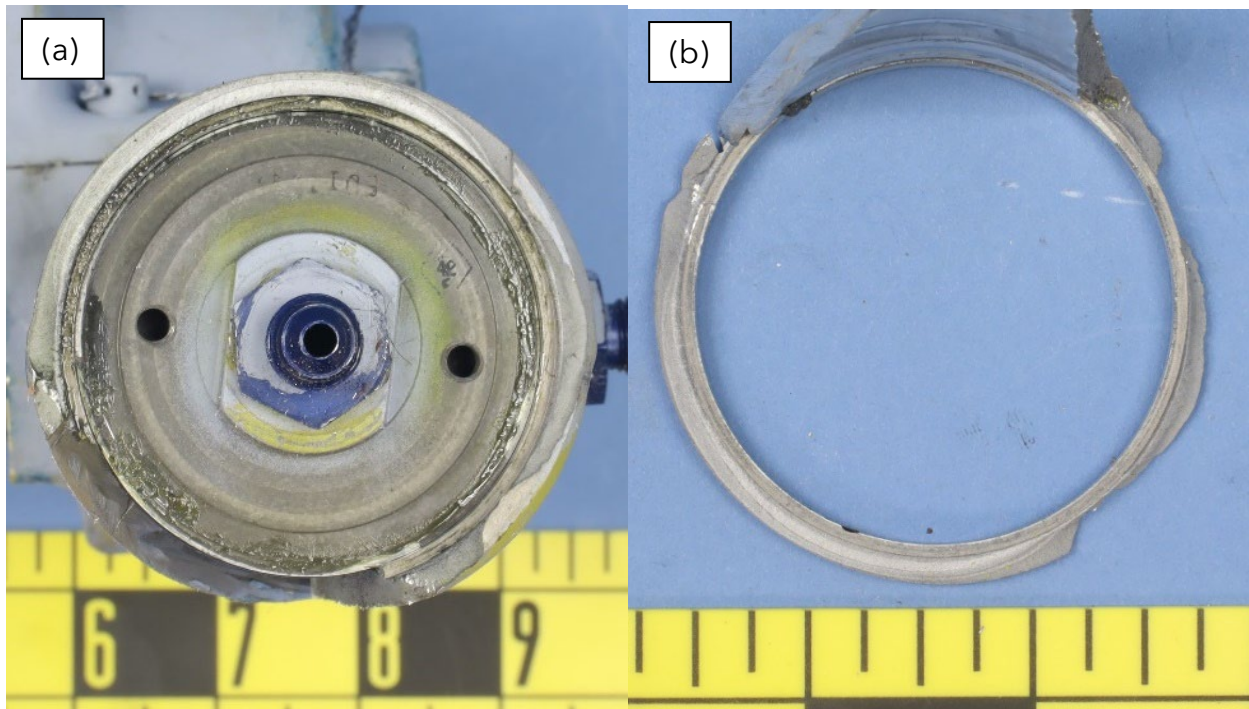
The mating fracture surfaces of the opened circumferential crack are shown in Figure 9. This fracture surface exhibited one thumbnail-shaped crack. In contrast, the longitudinal crack exhibited a rough surface texture and a dull luster. The surface revealed V-shaped chevron marks pointing toward the circumferential crack at the endcap, consistent with fracture from that location. The mating sides of the longitudinal crack portion are depicted in Figure 10.

**Figure 9.** The mating faces of the fractured end of the actuator, after sectioning and disassembly.

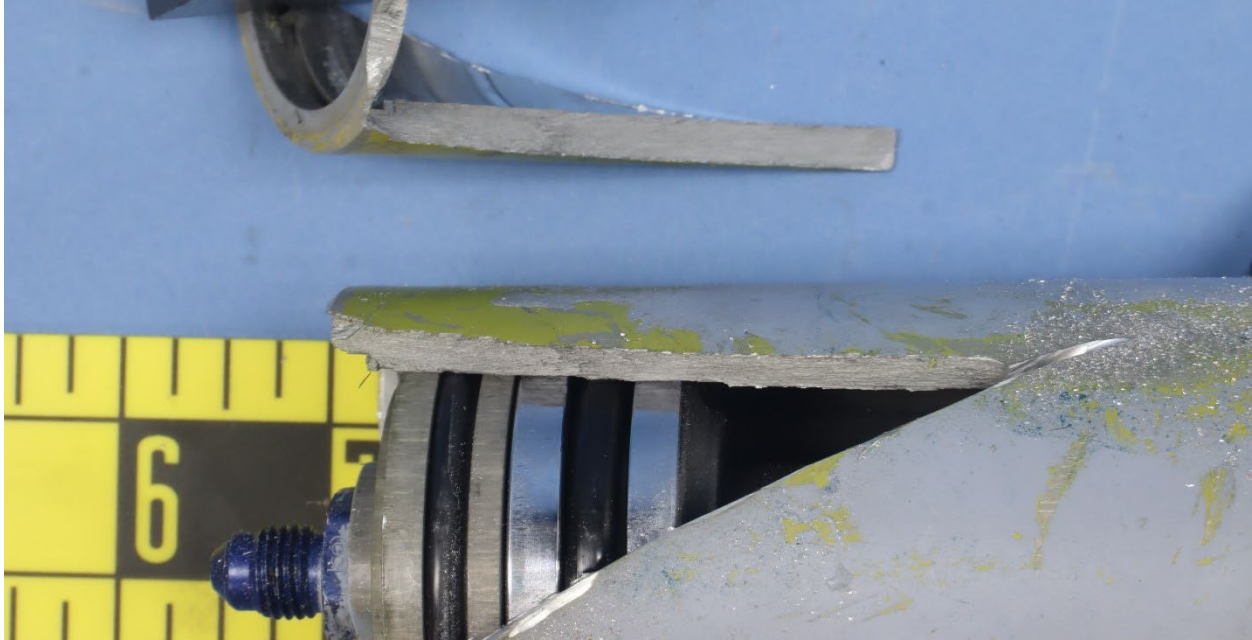
**Figure 10.** Mating faces of the longitudinal crack, after sectioning to open the crack faces.

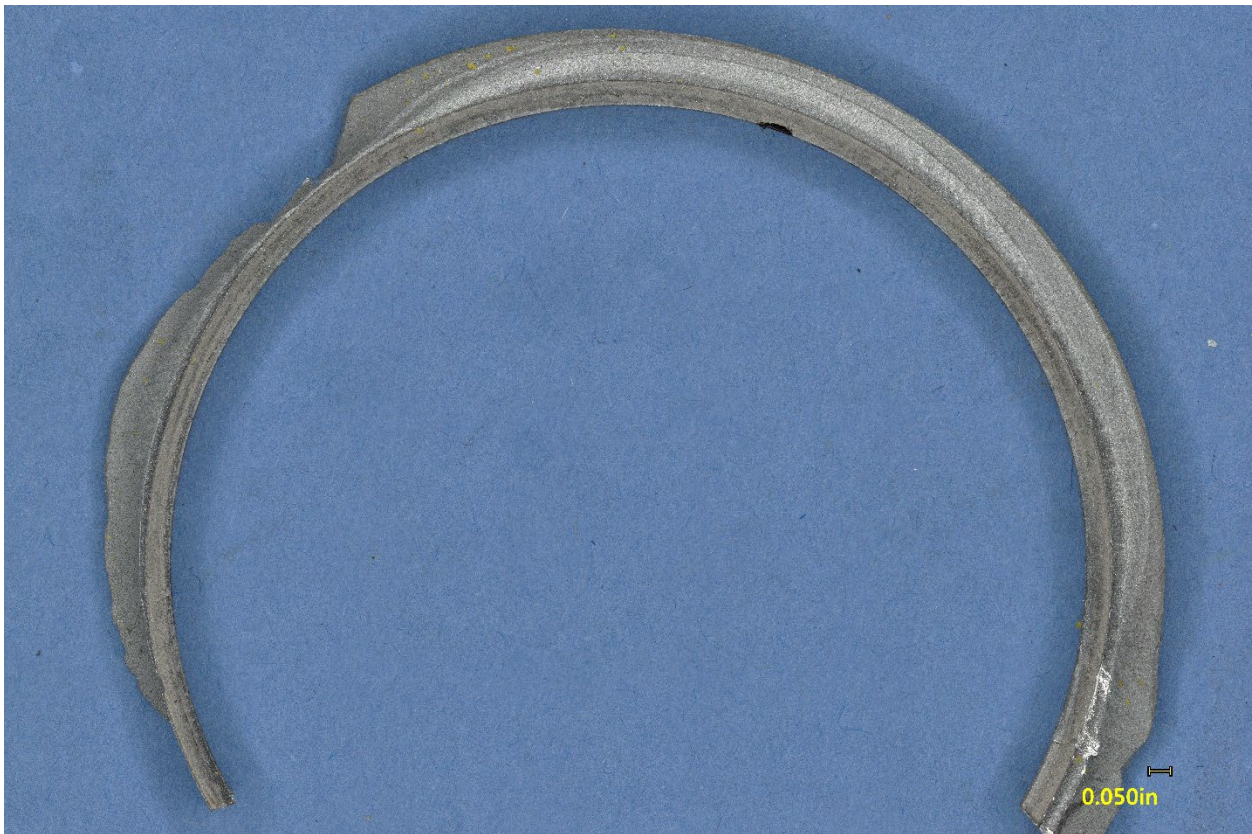
**Figure 11.** Montage of magnified images of the crack face of the circumferential crack, showing indications of progressive cracking.

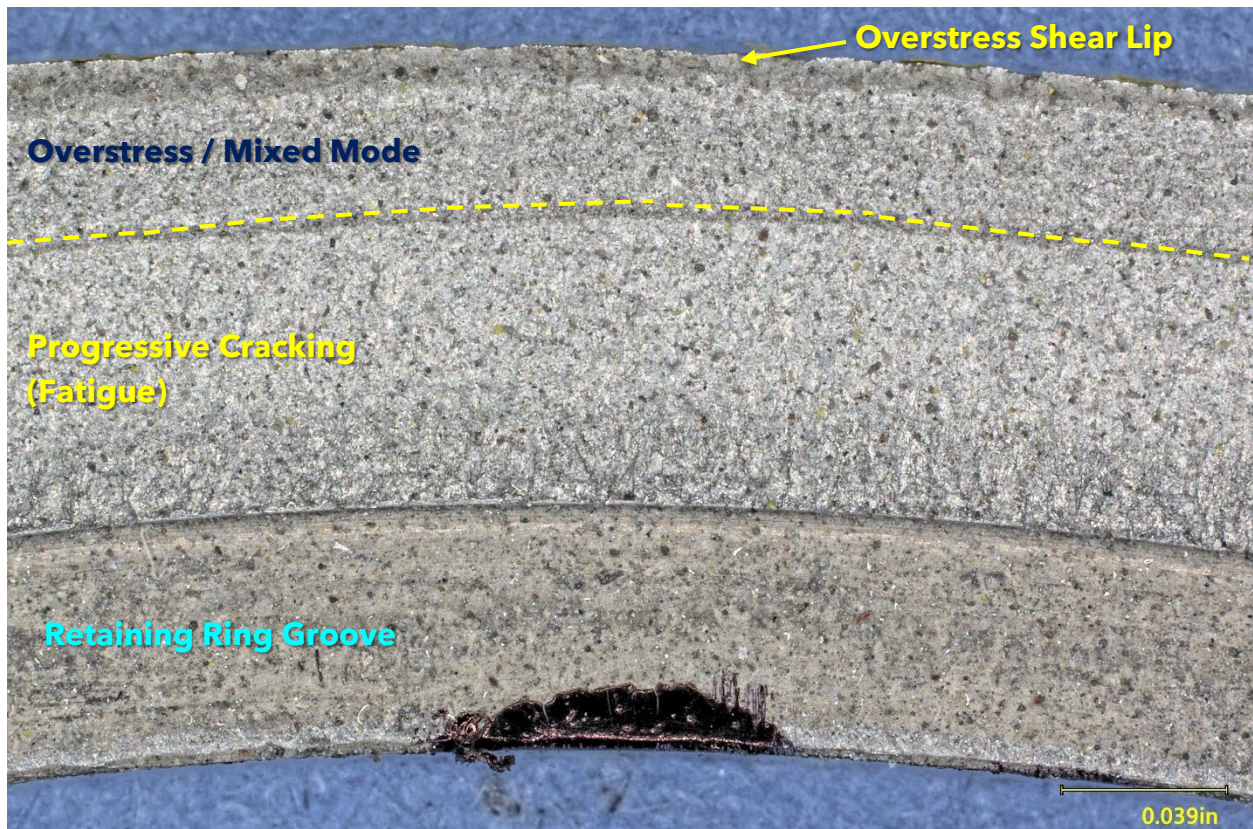
Figure 12 shows a closer view of the deepest area of the thumbnail crack on the outer circumferential fracture face. The middle part of this fracture surface exhibited crack arrest marks, consistent with progressive cracking, later determined to be fatigue. The fatigue cracks originated from the retaining ring groove, progressing through more than half of the actuator barrel thickness at the largest portion (see Figure 12).

The length of the fatigue portion of the crack was 2.64 inches or 131° of the part circumference. The depth was 1.7 inches from the retaining ring at its maximum, with the remaining 1.03 being subsequent fracture features. The thumbnail crack initiated at a corner in the retainer clip groove. Figure 13 shows a closer view of the groove, with multiple initiation sites identified by yellow arrows. The crack propagation direction is annotated with dashed white arrows.

**Figure 12.** The progressive crack in Figure 11, showing the area of crack initiation.

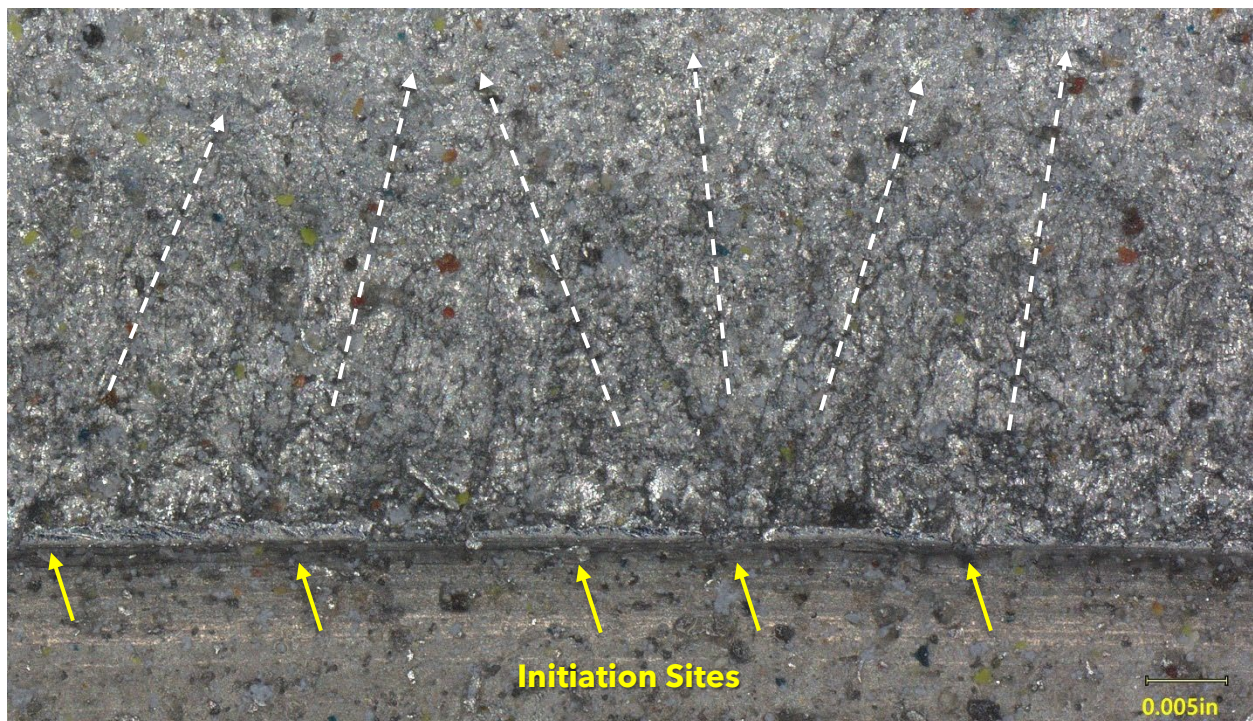
**Figure 13.** Closer view of the crack initiation area, with some initiation sites identified (yellow arrows) and the local crack growth directions annotated (white arrows).

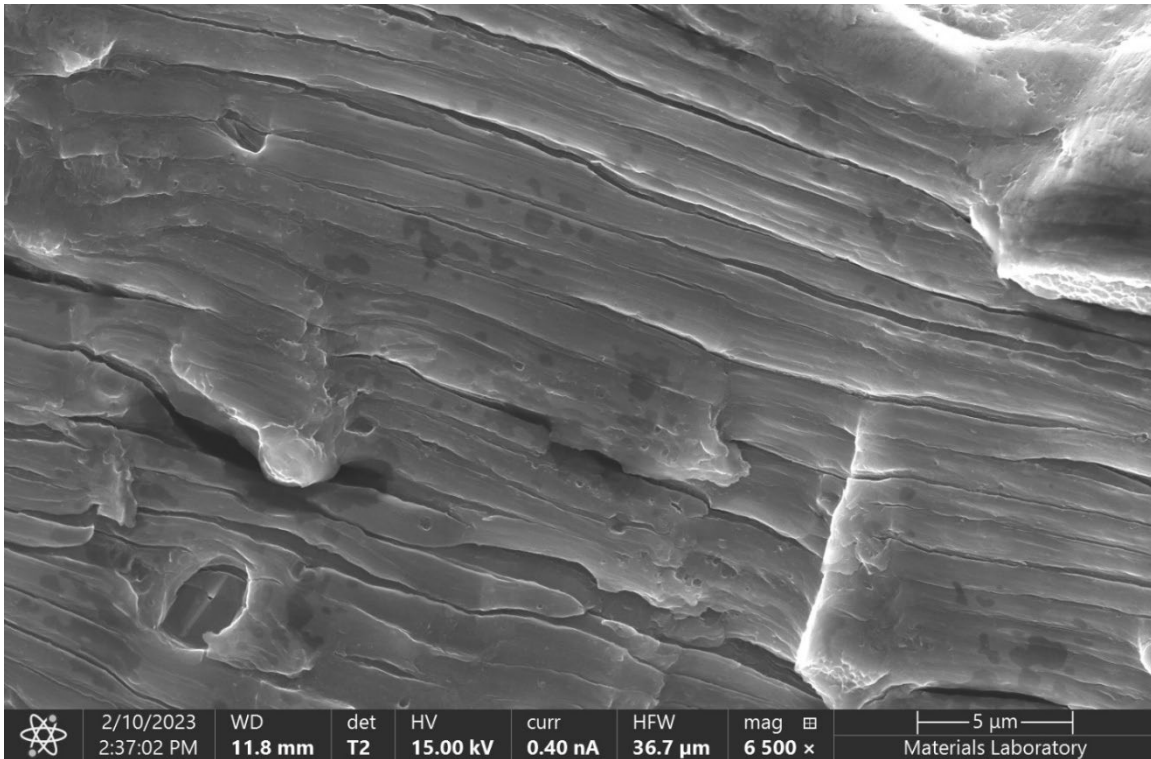
This fracture surface was examined using a scanning electron microscope (SEM). Figure 14 shows a typical area of the thumbnail region, displaying striations consistent with fatigue crack propagation. Portions of the fracture surface outside the fatigue crack revealed mostly dimple rupture, consistent with subsequent overstress fracture (Figure 15). However, there were also isolated fatigue striations, indicating an area of mixed-mode fracture. One such region was typified in the location shown in the backscattered micrograph of Figure 16.

**Figure 14.** Secondary electron (SE) micrograph showing fatigue striations in the progressive cracking portion of the fracture surface.

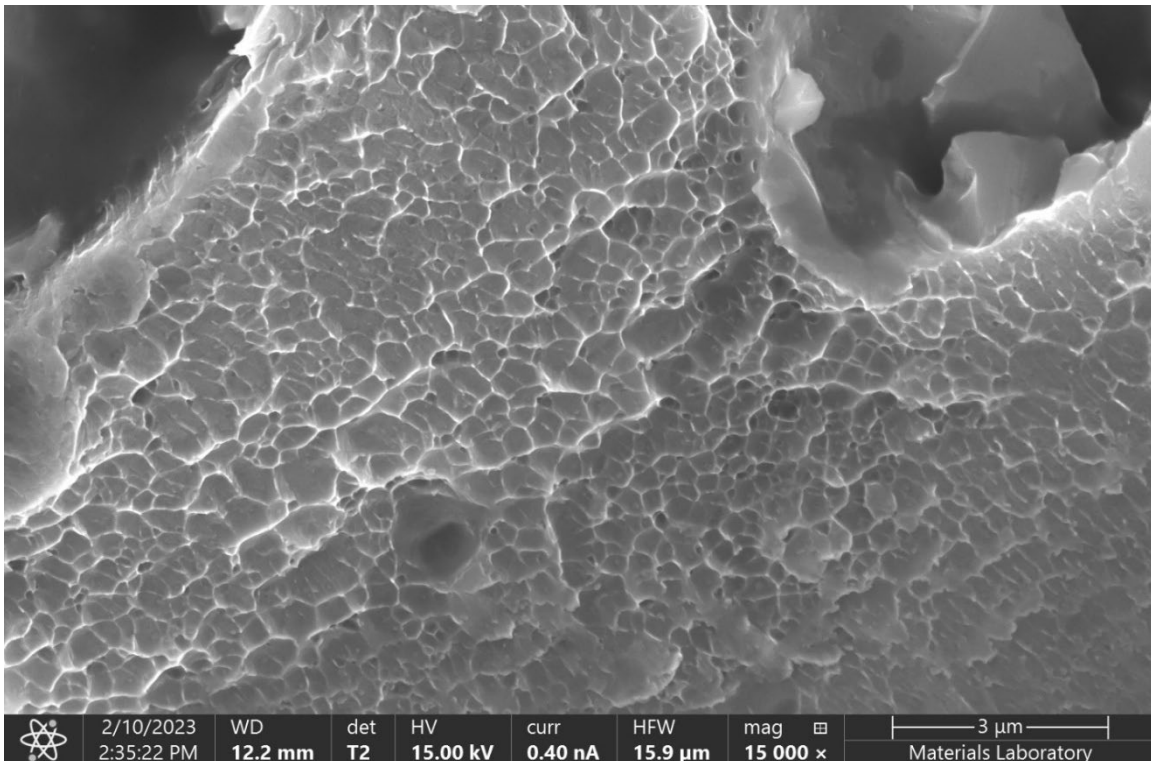
**Figure 15.** SE micrograph of dimpled rupture in the area outside the primary fatigue crack.

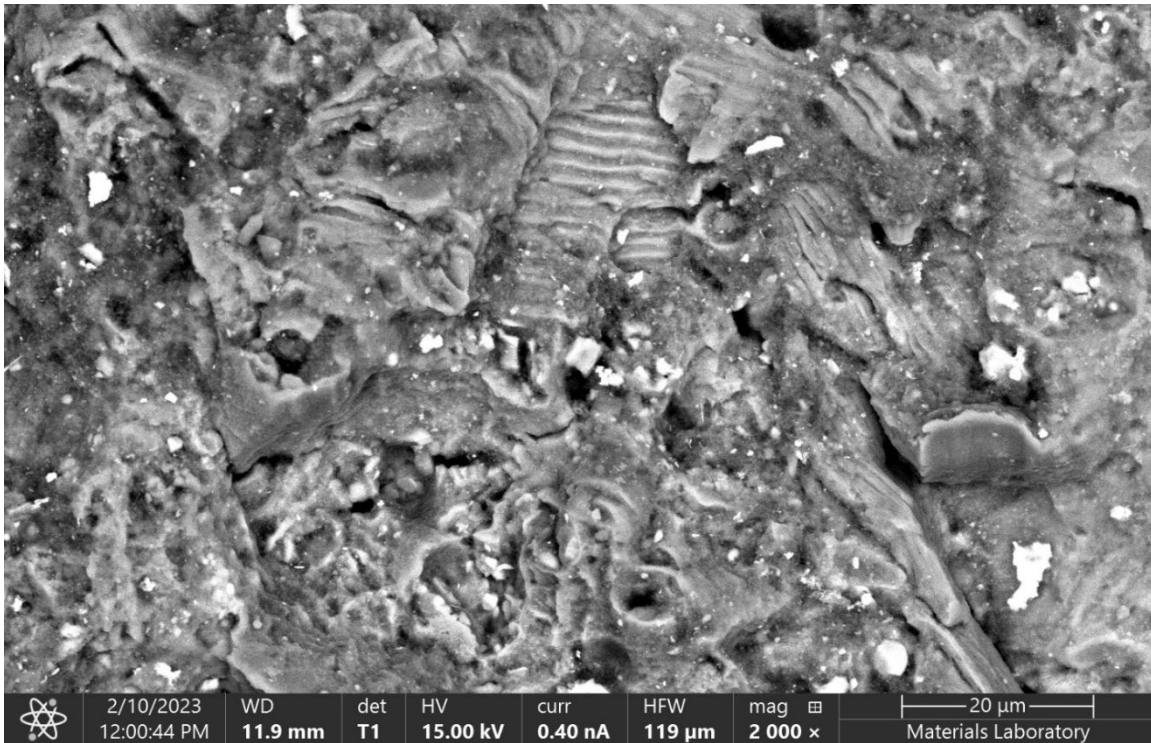
**Figure 16.** Backscattered electron (BE) micrograph of the mixed mode area outside of the primary fatigue crack, showing dimpled rupture and striations.

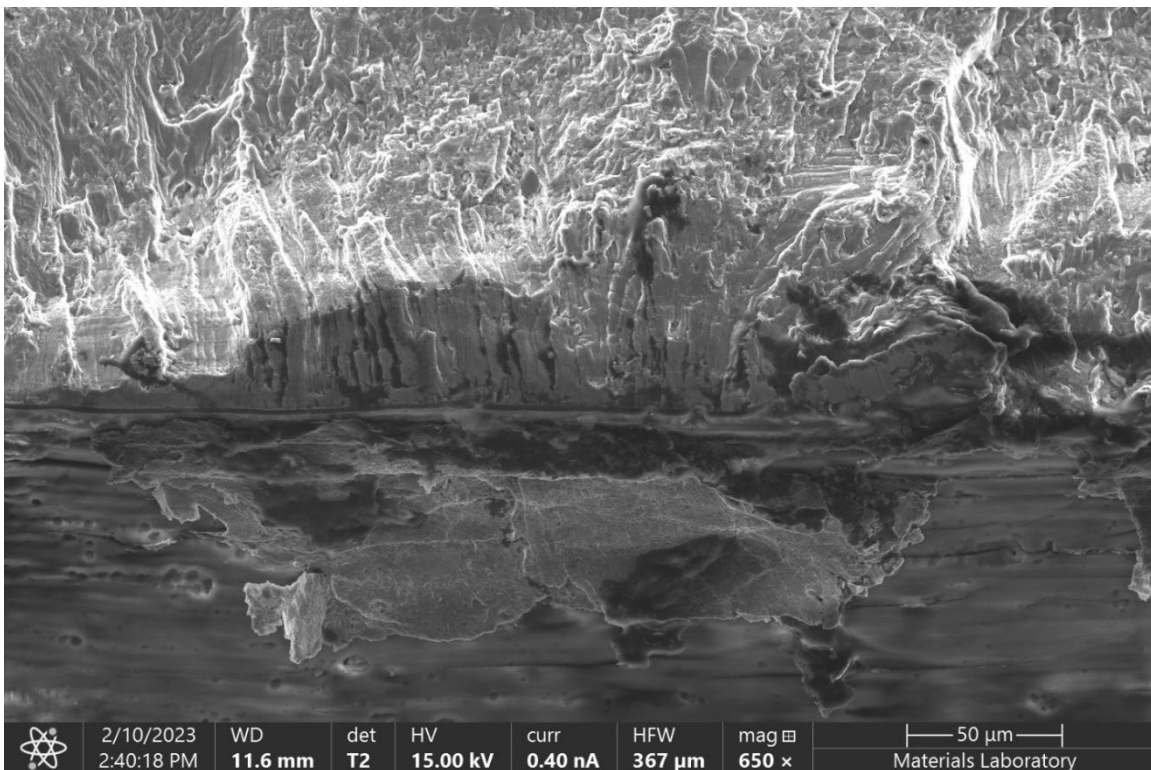
The thumbnail-shaped fatigue cracks exhibited ratchet marks, consistent with multiple fatigue crack initiation. One such crack initiation site is illustrated in Figure 17. Along this initiation site, fine striations were observed (Figure 18). A backscattered examination of this site revealed an area of high atomic number contrast along the retaining ring groove surface at the site (white area in Figure 19).<sup>1</sup> Examination of the material using energy dispersive x-ray spectroscopy (EDS) found it to be consistent with cadmium, consistent with remnants from a cadmium coating. Similar cadmium material was found at other crack initiation sites along the groove, such as in Figure 20.

**Figure 17.** SE micrograph of one of the fatigue crack initiation sites on the cylinder groove.

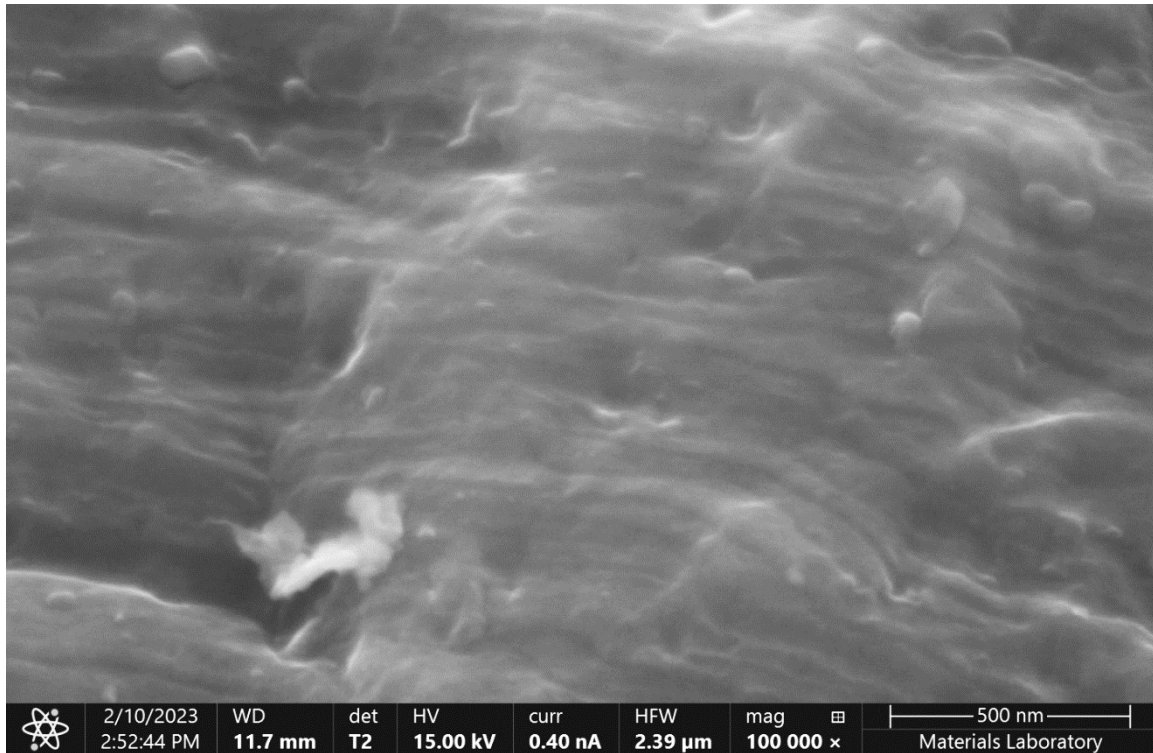
**Figure 18.** SE micrograph of fine striations near the initiation site in **Figure 17**.

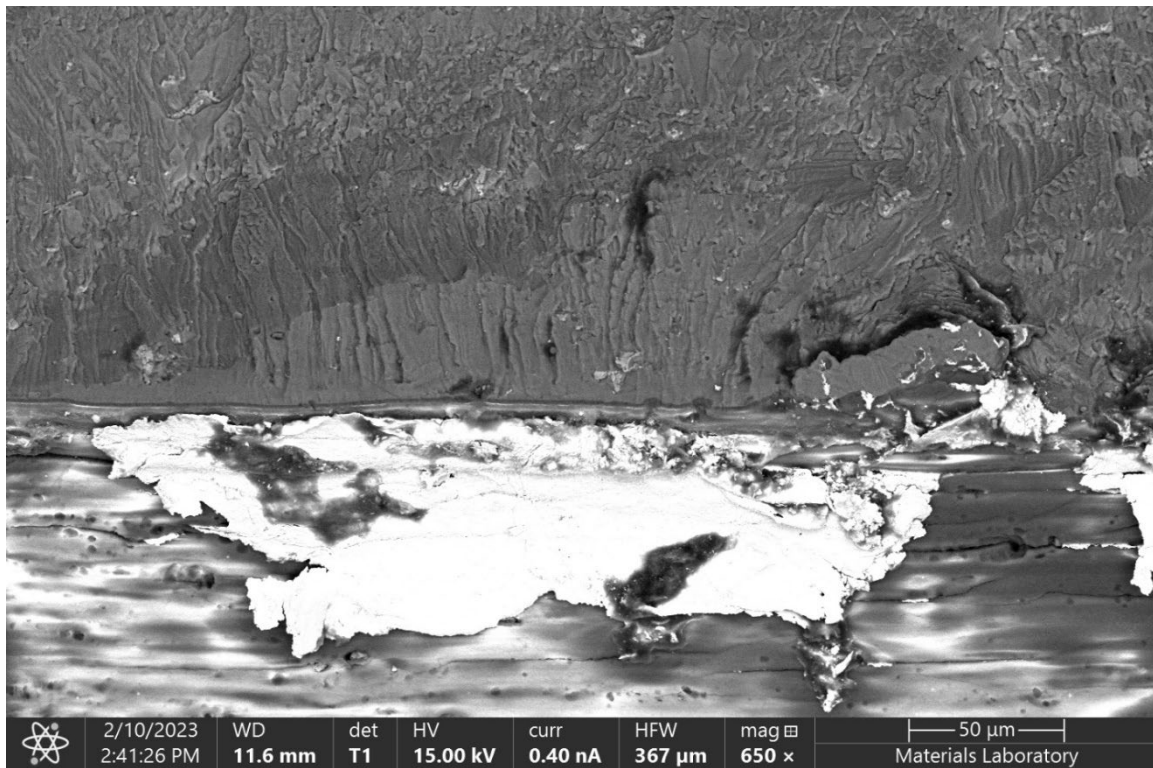
**Figure 19.** BE micrograph of the initiation site in **Figure 17**, showing a large cadmium-rich (white-colored) area adjacent to the initiation site.

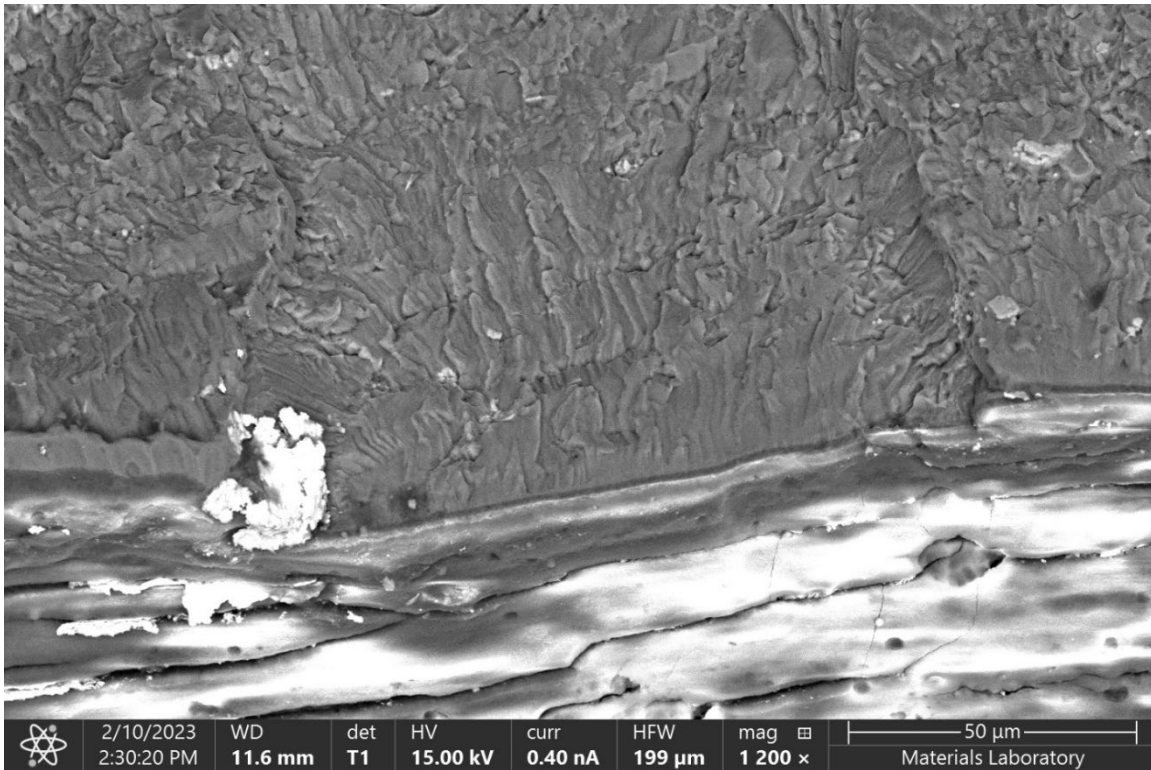
Figure 20 also demonstrates the layer of nonconductive material present along the groove, manifesting as brighter contrast charging areas. A closer view at the crack initiation sites revealed a darker contrast surface layer with a small pit-like valley (Figure 21). EDS examination of this layer found it to be consistent with aluminum oxide. This surface layer of oxide and inward depressions were typical of the other fatigue crack initiation sites along the retaining ring groove.

**Figure 20.** BE micrograph of a second crack initiation site, showing charging (nonconductive) compounds along the groove.

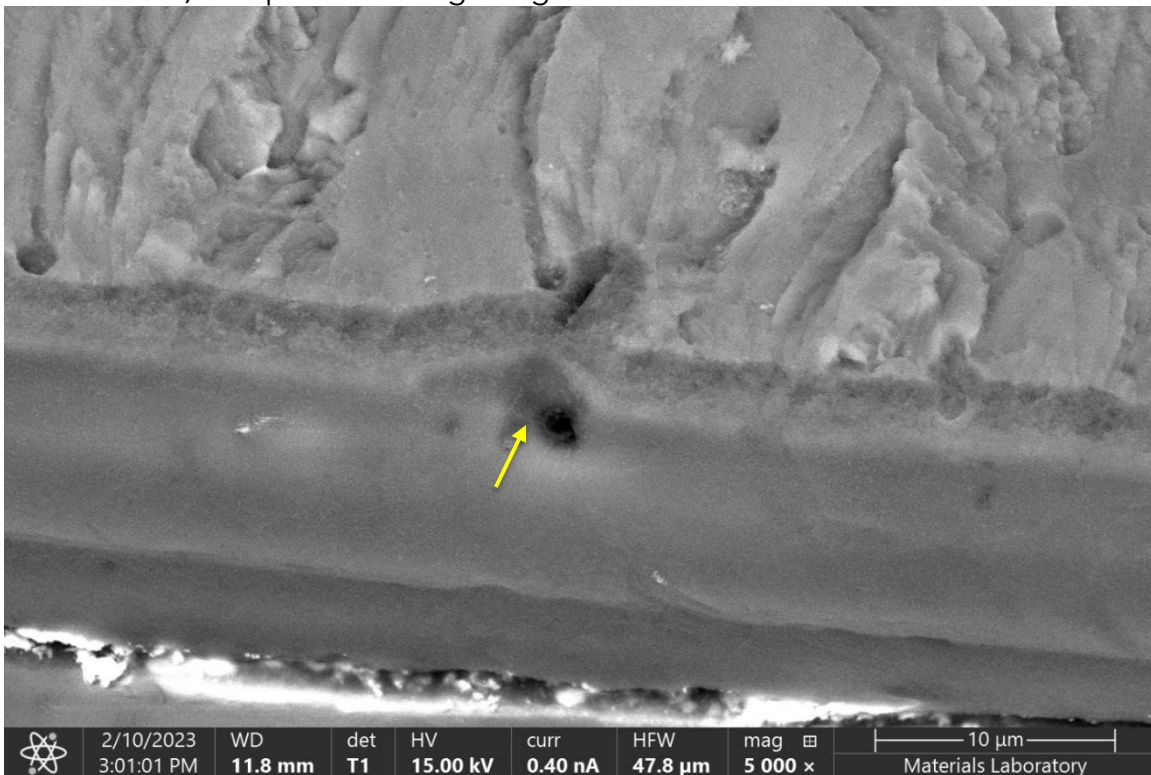
**Figure 21.** BE micrograph of the initiation site edge, showing a small groove with lower Z-contrast (arrow).

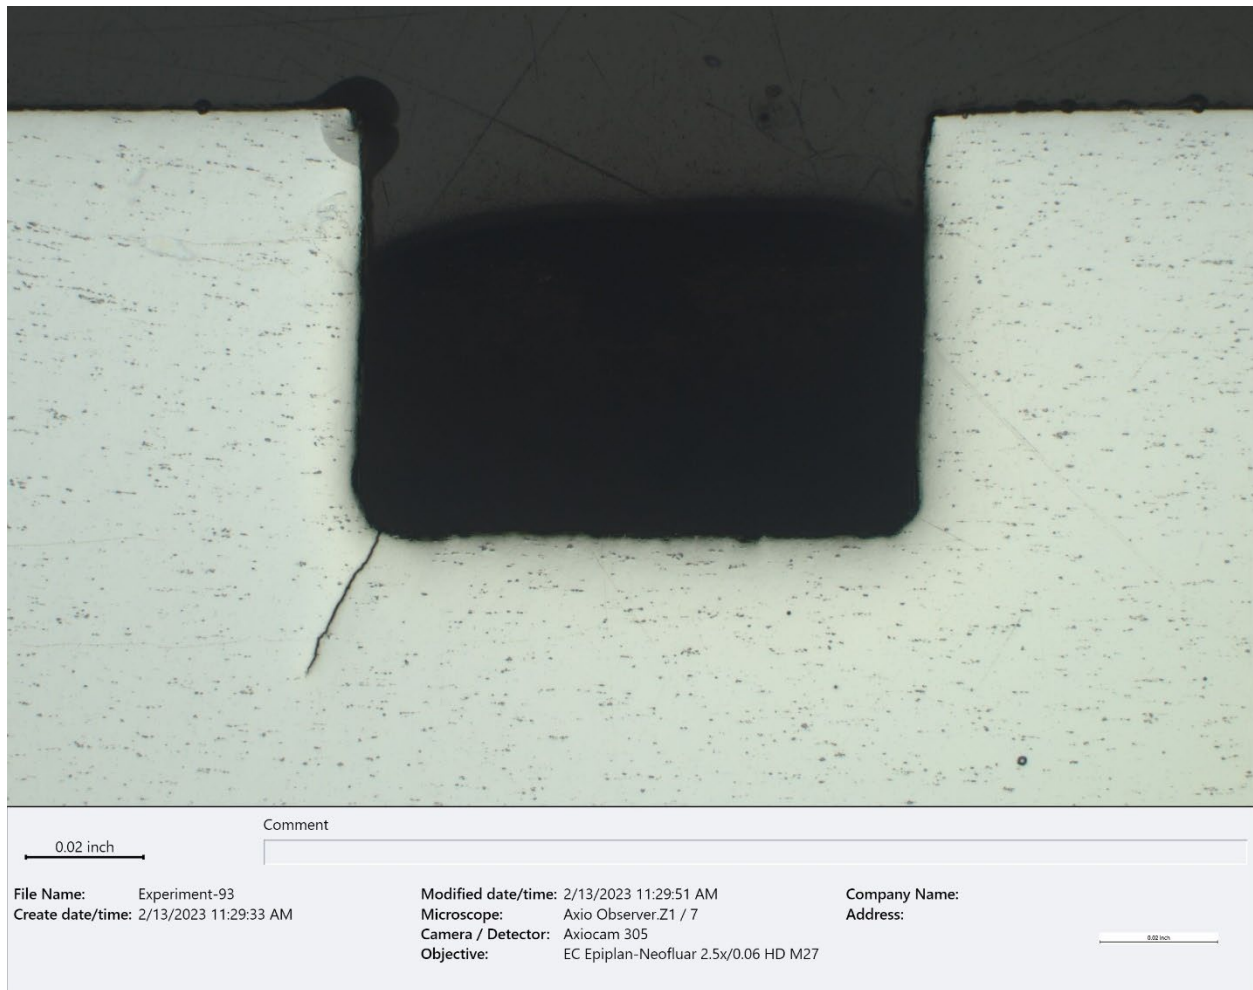
A portion of the actuator housing was cross-sectioned through the retaining ring for metallographic examination. Figure 22 shows this cross-section after mounting and polishing. Overall, the microstructure exhibited grain flow consistent with wrought material processing. As shown in Figure 22, an angled crack approximately 0.02 inches long had propagated out of an upward-facing corner of the retaining ring groove (lower left in the figure). Figures 23 and 24 show closer views of this crack at the groove corner, revealing additional smaller cracks. One of these smaller cracks exhibited a corrosion pit present along the surface of the retaining ring groove (see Figure 19).

These features were consistent with fatigue cracking having initiated along the retaining ring groove of the actuator. Propagating outward in a circumferential direction, once the fatigue crack grew to its terminal size, the remainder of the cross-section fractured from mixed overstress and fatigue. This cracking led to part of the housing barrel fracturing in overstress, allowing the release of the internal pressurized hydraulic fluid.

**Figure 22.** Bright-field (BF) optical metallograph cross-section of the actuator retaining ring showing an angled crack propagating from the left groove radius (~25X, as polished).
