# National Transportation Safety Board

CEN22LA378

## **MATERIALS LABORATORY**

Factual Report 23-016

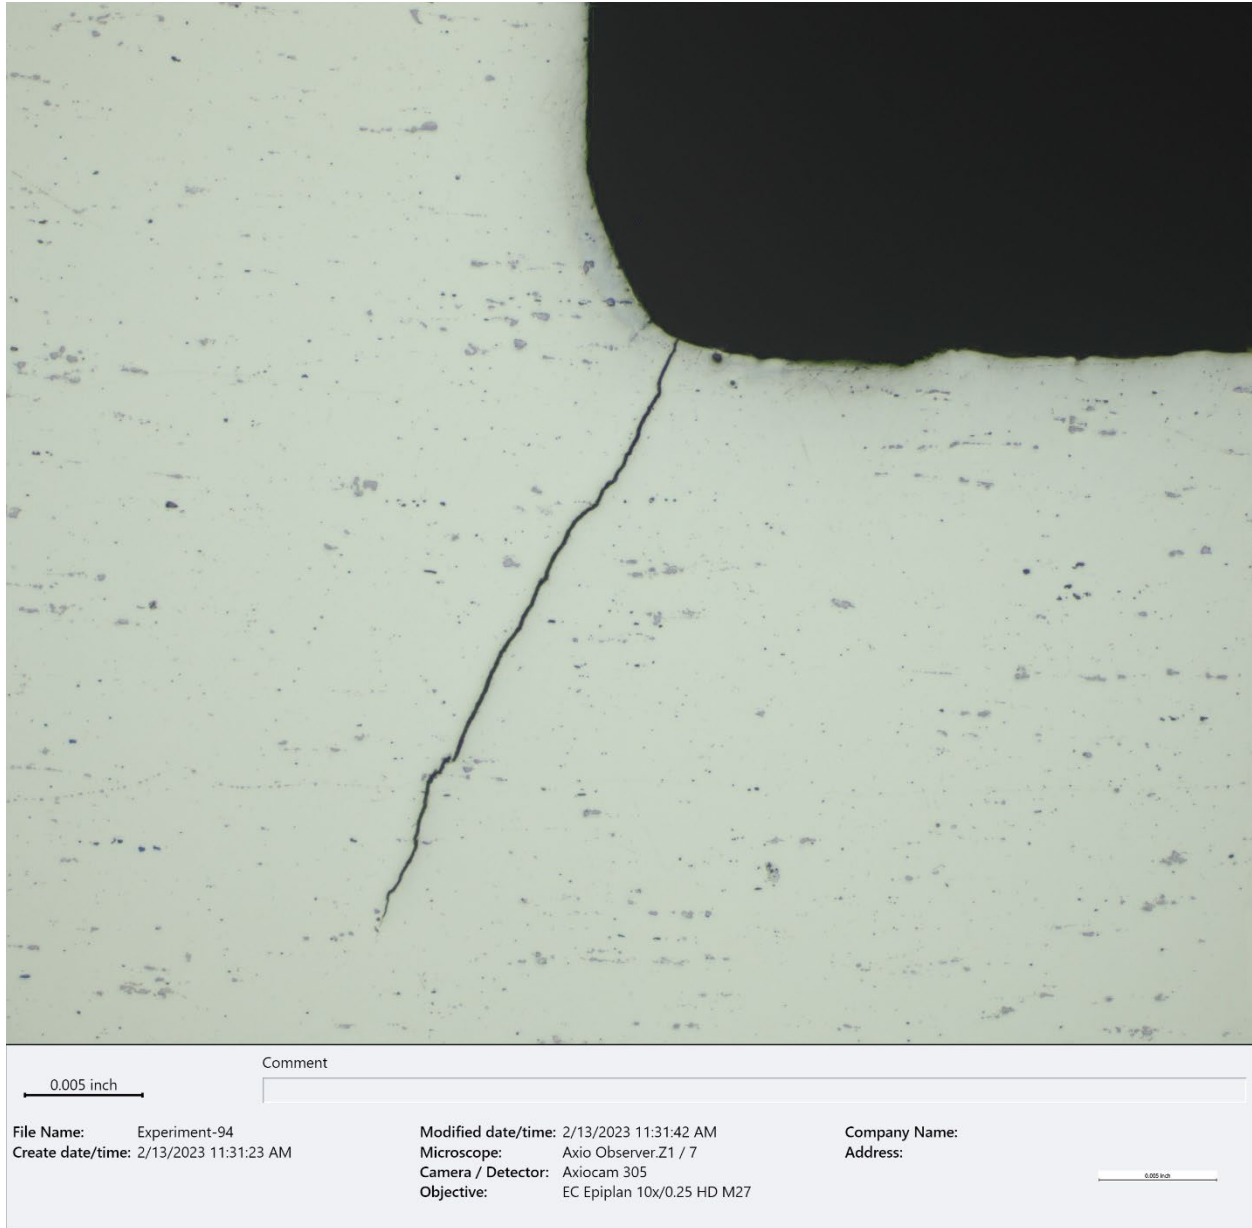
**Figure 23.** BF optical metallograph showing a closer view of the left corner crack from **Figure 22** (~100X, as polished).

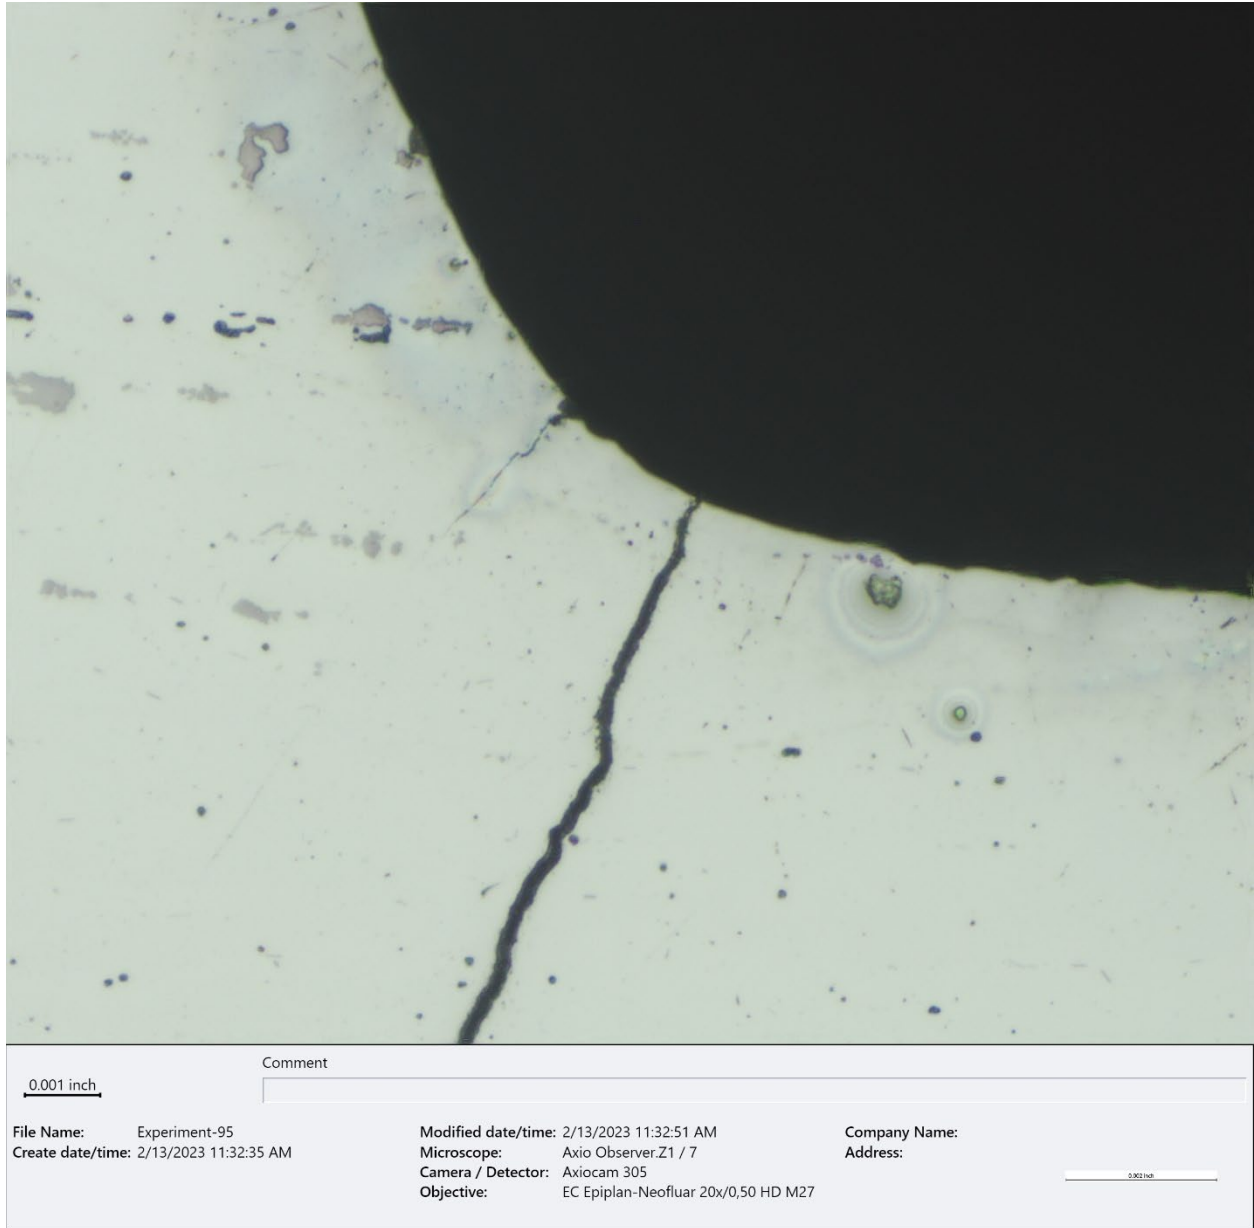
**Figure 24.** BF optical metallograph showing a closer view of the left corner crack from **Figure 22** (~320X, as polished).
