### NATIONAL TRANSPORTATION SAFETY BOARD Office of Aviation Safety Washington, DC 20594

#### SUMMARY OF AIRCRAFT EXAMINATIONS

-- CEN22LA412 --

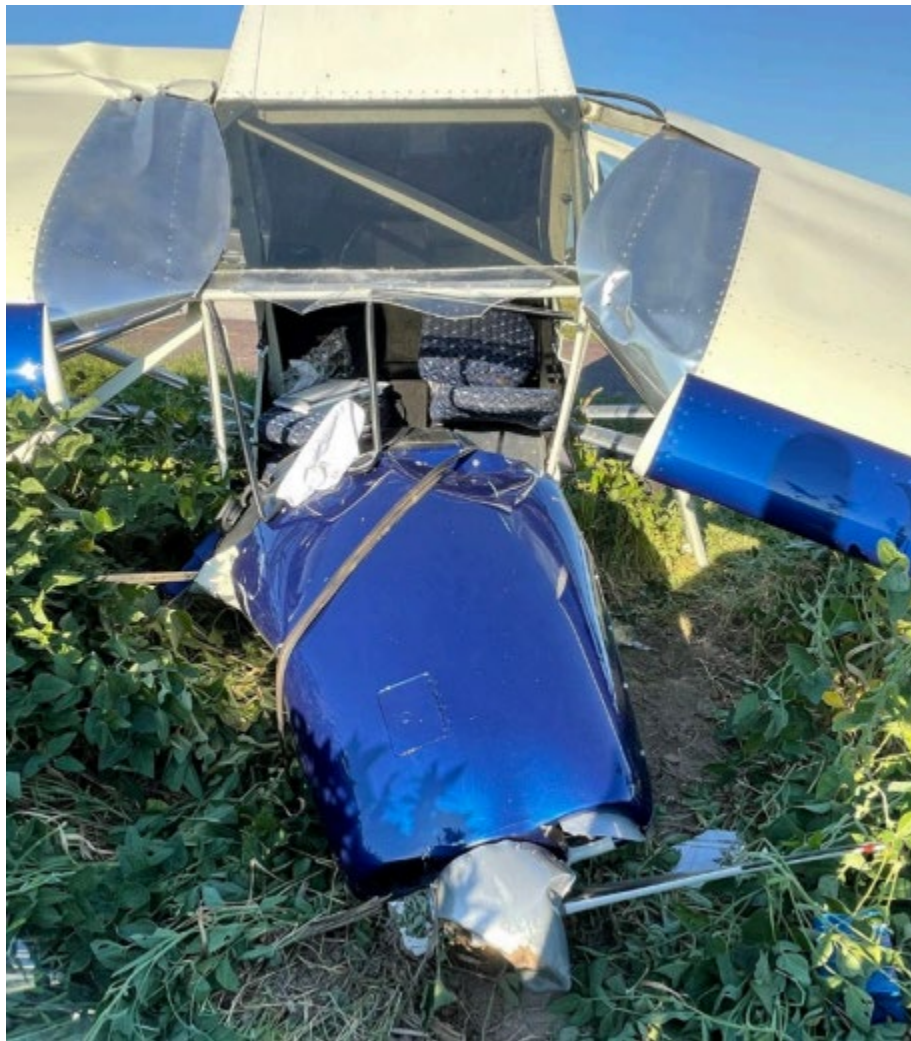
On September 7, 2022, about 1520 central daylight time, a Zenith 750, N1949H, was substantially damaged when it was involved in an accident at Herrmann-Faulk Airfield (54MO), Silex, Missouri. The pilot sustained minor injuries and the pilot-rated passenger sustained serious injuries. The airplane was operated as a Title 14 *Code of Federal Regulations* Part 91 flight.

Photo 1 – Airplane at Accident Site (Courtesy of FAA)
