# National Transportation Safety Board

CEN22LA413

## **ENGINE EXAMINATION**

Location: Bulverde, Texas  
Date: September 9, 2022  
Time: 0750 Local  
1215 UTC  
Airplane: Piper PA32-300T

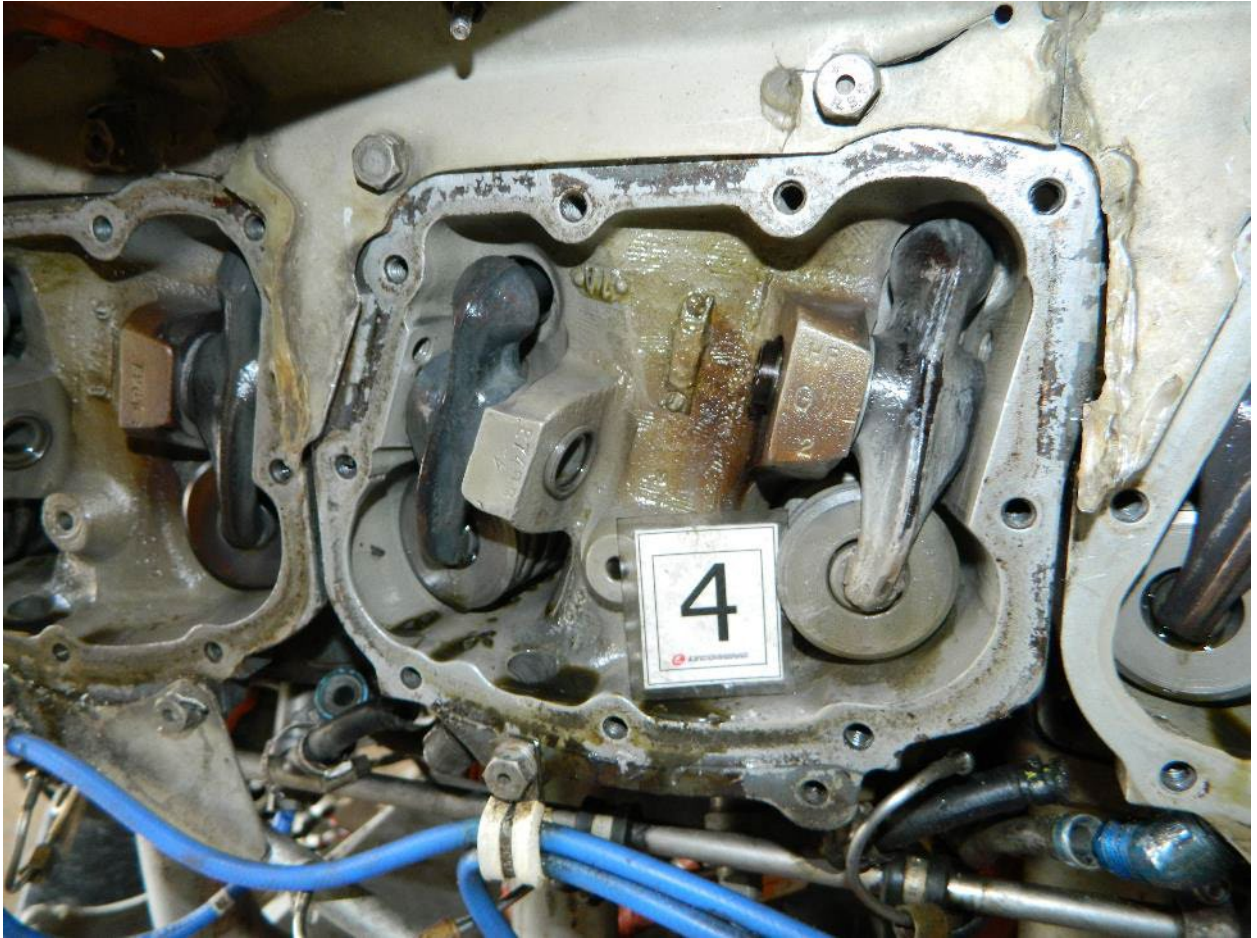
The rocker box covers were removed and abnormal discoloring around the #4 exhaust valve area.

**Figure 1 Cylinder No. 4 Rocker Arms**

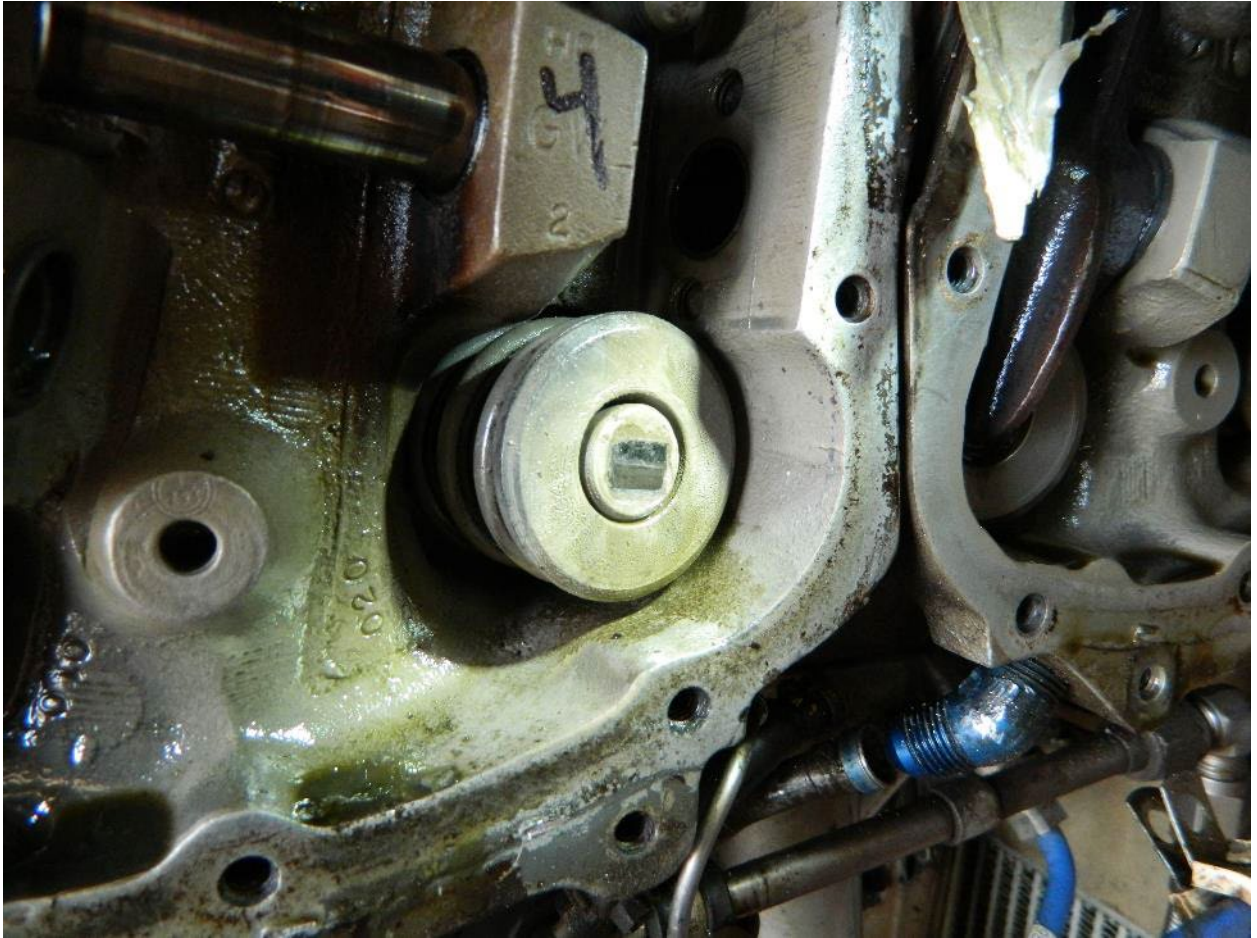
Further examination of the #4 exhaust arm showed a large amount of carbon build up on the rocker arm, rocker shaft, and valve springs. The rotator cap, rocker arm, and springs were removed. The rotator cap had carbon deposits and a wear pattern which suggested a lack of rotation of the cap.

**Figure 2 Rotator Cap With Wear**

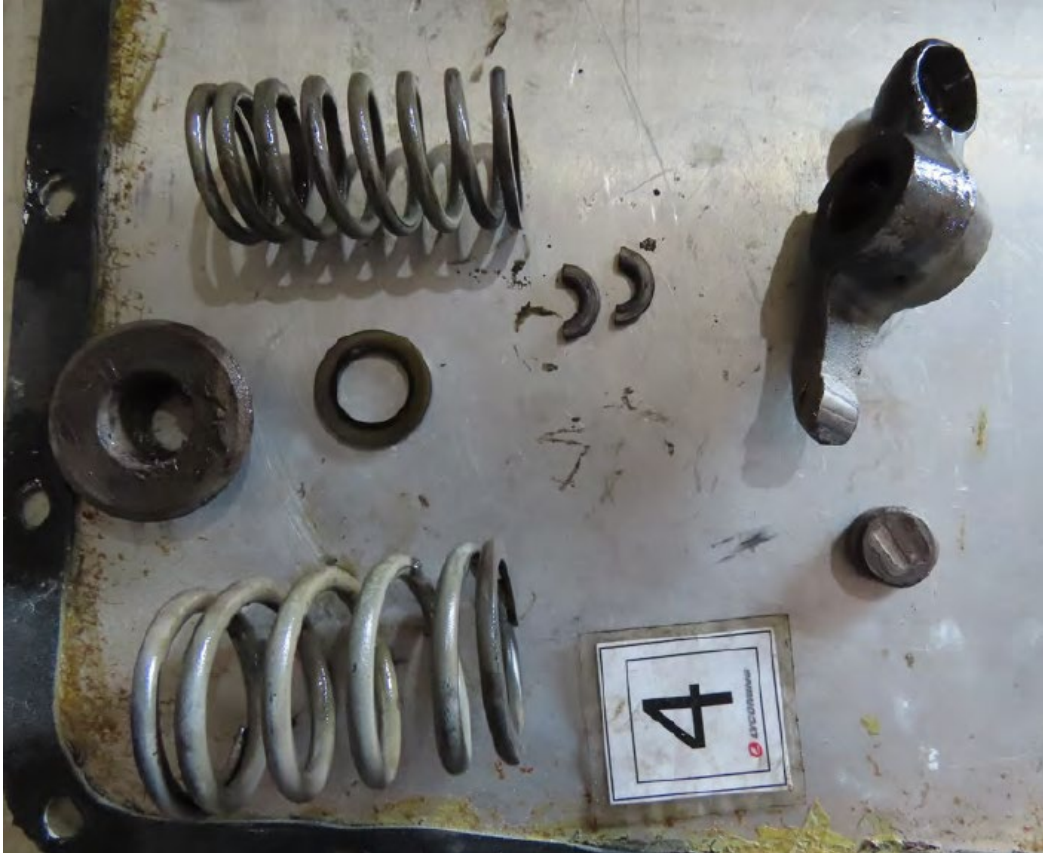
**Figure 3 Cylinder No. 4 Exhaust Cap, Rocker Arm, and Springs (Picture from Lycoming)**

When the exhaust valve was moved within the valve guide, it had excessive wobble and movement within the guide. The valve face had a dark coloration consistent with exposure to high heat.
