# National Transportation Safety Board

CEN22LA421

## **AIRPLANE EXAMINATION**

Location: Broomfield, Colorado  
Date: September 14, 2022  
Time: 1140 (Local)  
1740 UTC  
Airplane: Piper PA28R-180

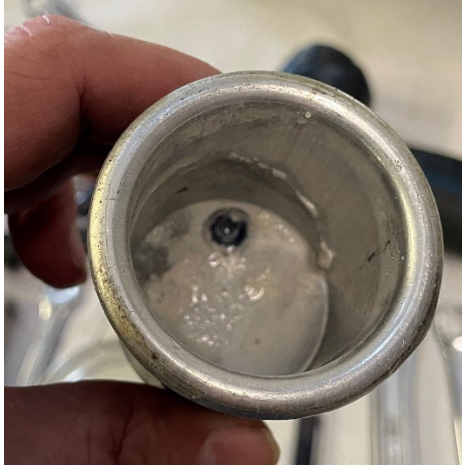
**Figure 1 Gascolator Bowl**

Examination of the gascolator did not detect any preimpact anomalies. A small amount of fuel and water was found in the gascolator bowl along with some white sediment.

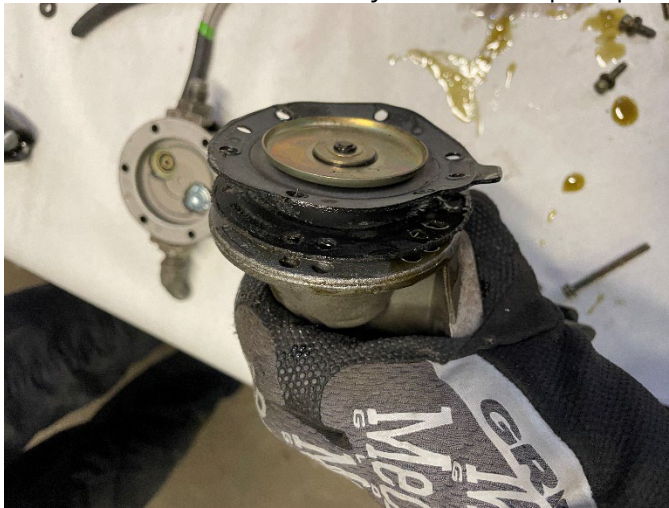
**Figure 2 Engine-Driven Fuel Pump**

The fuel line towards the engine driven fuel pump was unobstructed. The fuel engine driven fuel pump was removed and manually actuated. Suction and expulsion could be felt. Disassembly of the fuel pump did not find any anomalies.

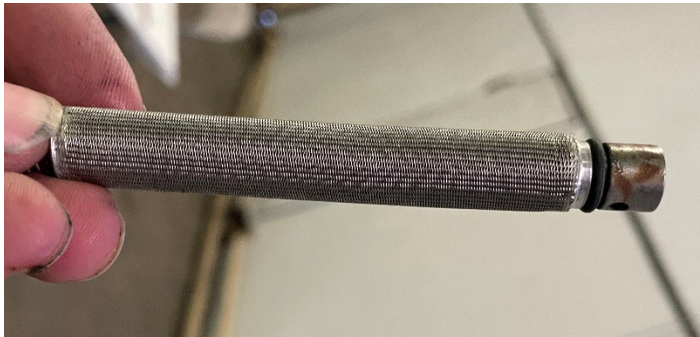
**Figure 5 Fuel Screen**

The engine was visually examined to ensure all lines and hoses remained properly attached. The engine mounts were not damaged. All engine accessories remained attached to the engine. Engine control continuity was established from the cockpit controls to the throttle body where they appeared to move full travel. The fuel screen was removed and was unobstructed.

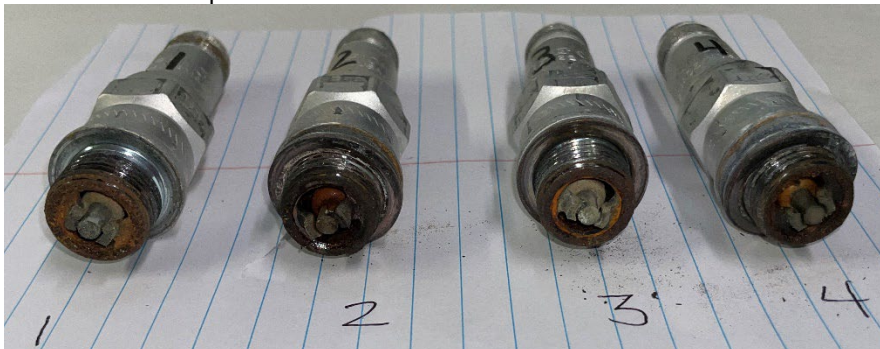
**Figure 6 Top Spark Plugs**

The upper ignition leads were removed, and top bank of spark plugs were removed and photo documented.

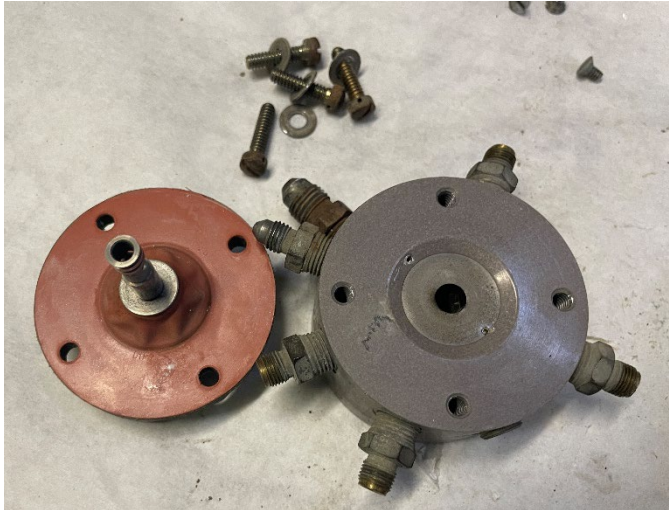
**Figure 7 Fuel Divider**

The fuel divider was disassembled with no anomalies noted.

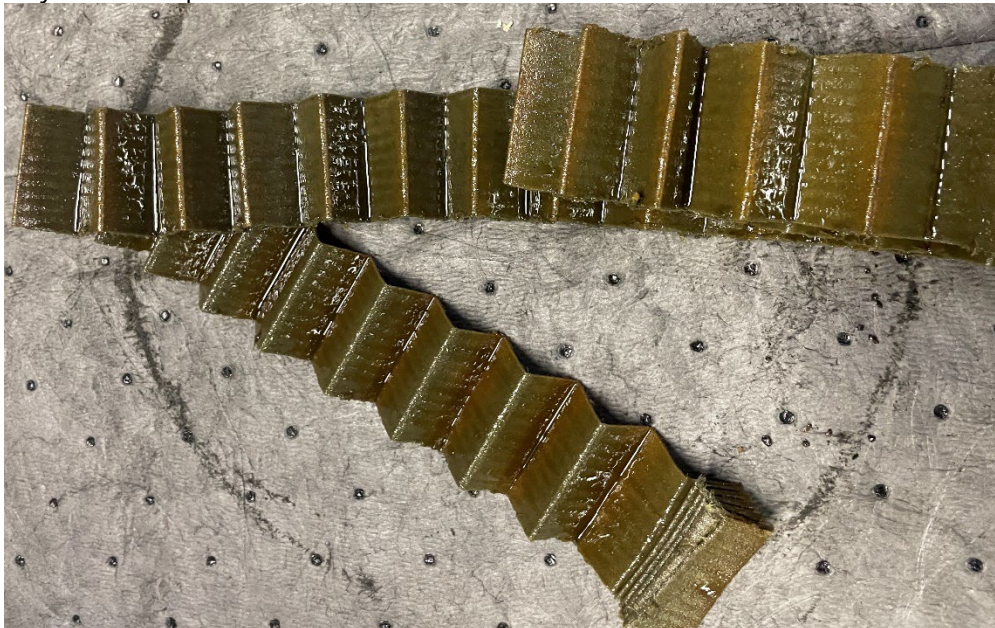
**Figure 8 Oil Filter**

The oil filter was opened and the paper filter removed. The filter was clear of any metallic particles.

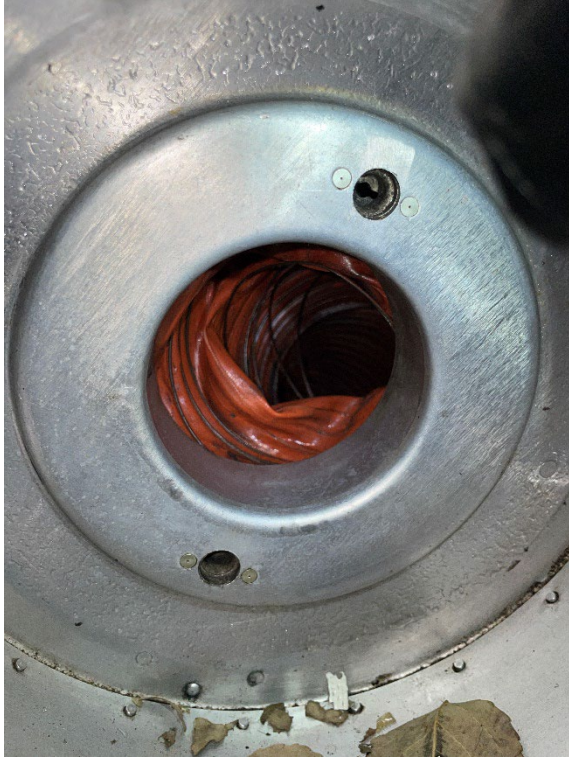
**Figure 9 Induction Hose**

The air filter was opened and found mostly clear of debris. There were a few leaves in the filter compartment but not enough to clog the filter. Removal of the filter found that the interior of the induction hose was partially collapsed inward. The exterior of the hose did not display obvious damage.
