CEN22LA421

## INVESTIGATION PHOTOGRAPHS

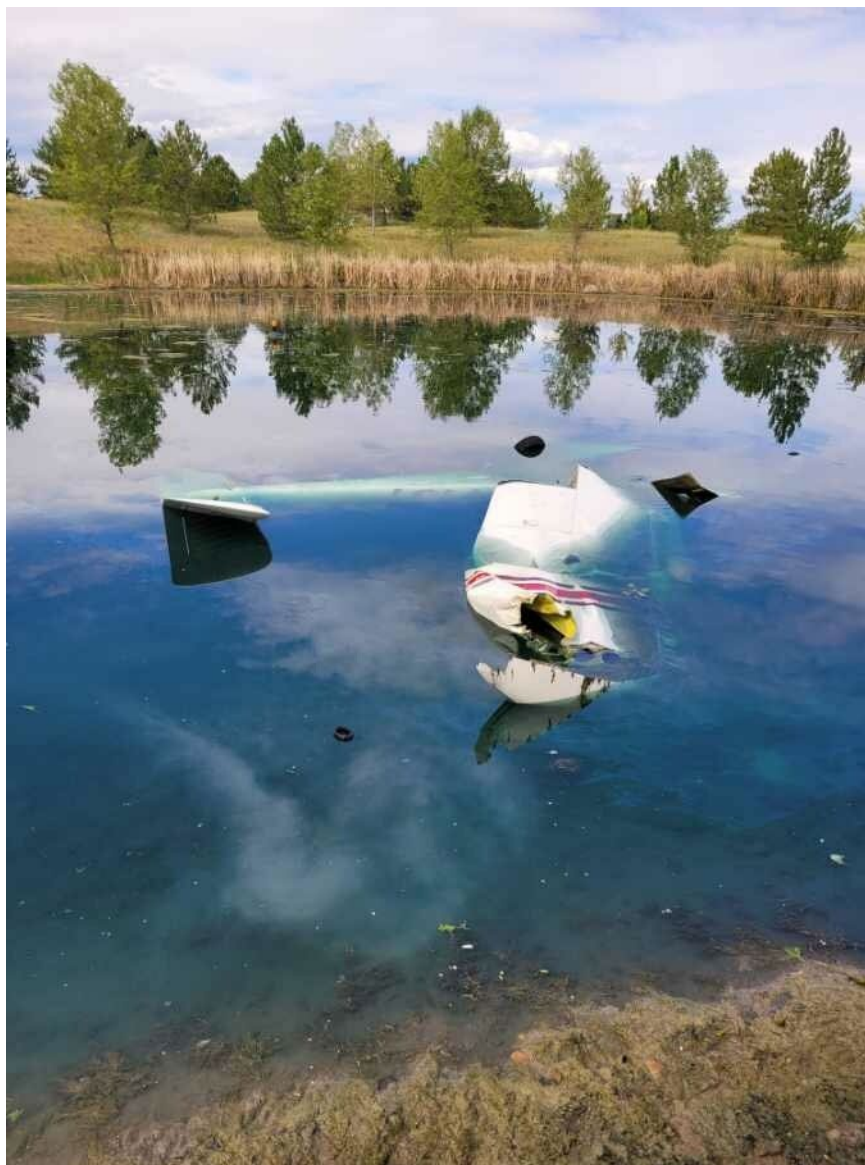
**Photograph 1 - Airplane at accident site(Courtesy of FAA)**

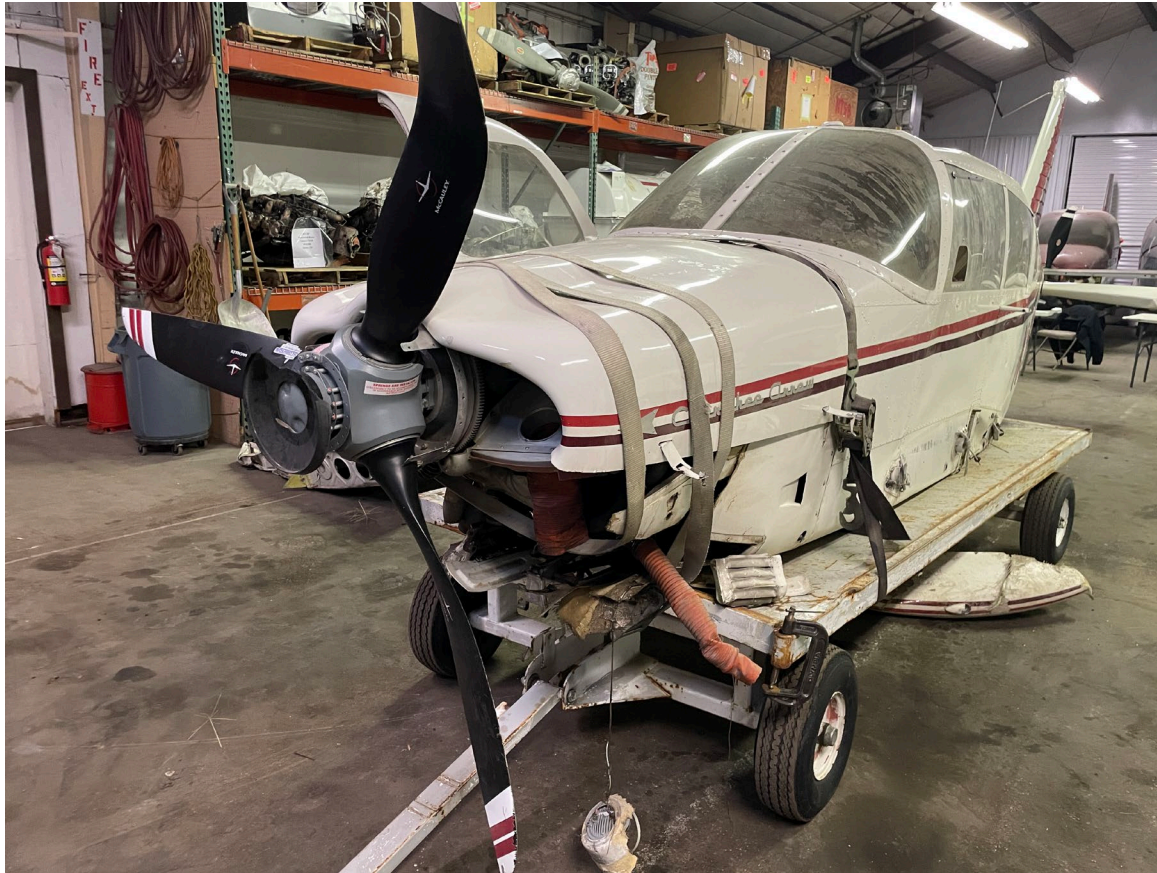
**Photograph 2 - Airplane during examination (NTSB Photo)**

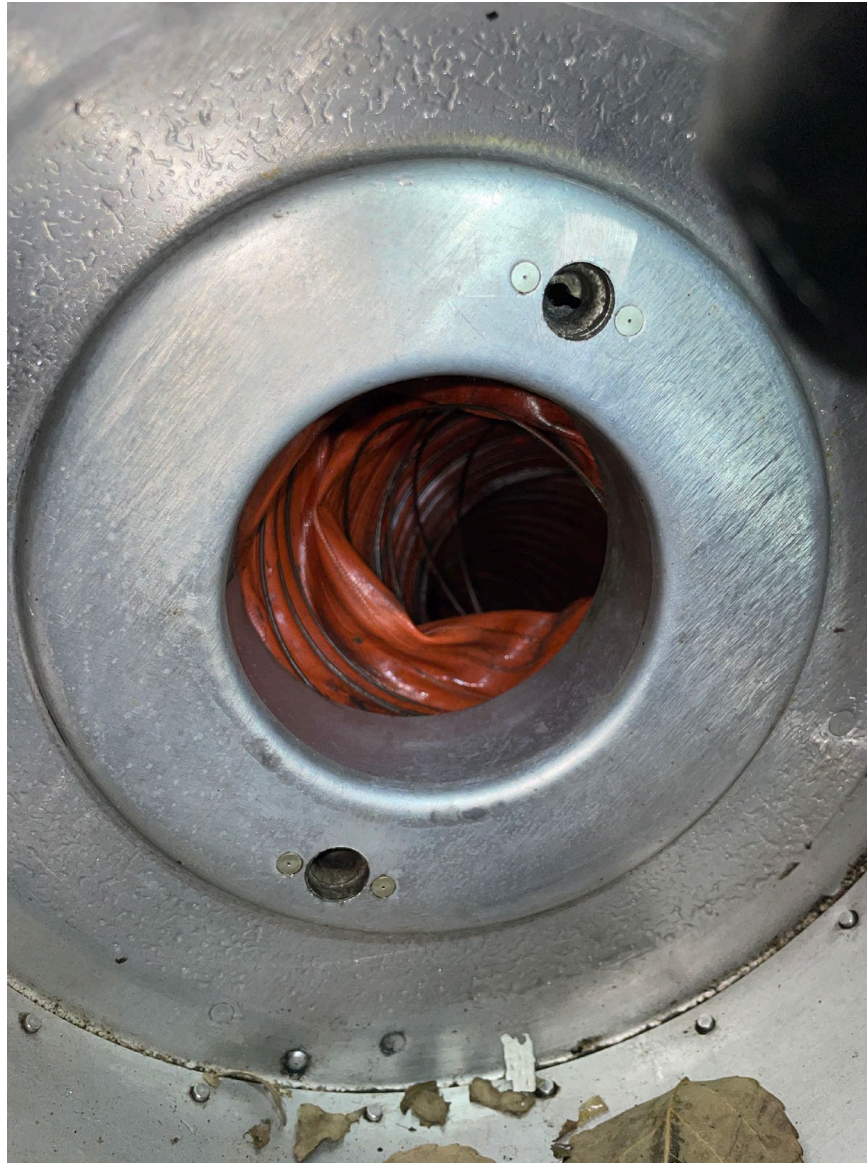
**Photograph 3 - Partially collapsed induction hose (NTSB Photo)**
