# National Transportation Safety Board

CEN22LA421

## **MAGNETO EXAMINATION SUMMARY**

Location: Broomfield, Colorado  
Date: 9/14/2022  
Time: 1140 mdt  
Airplane: Piper PA-28R-180, N3713T

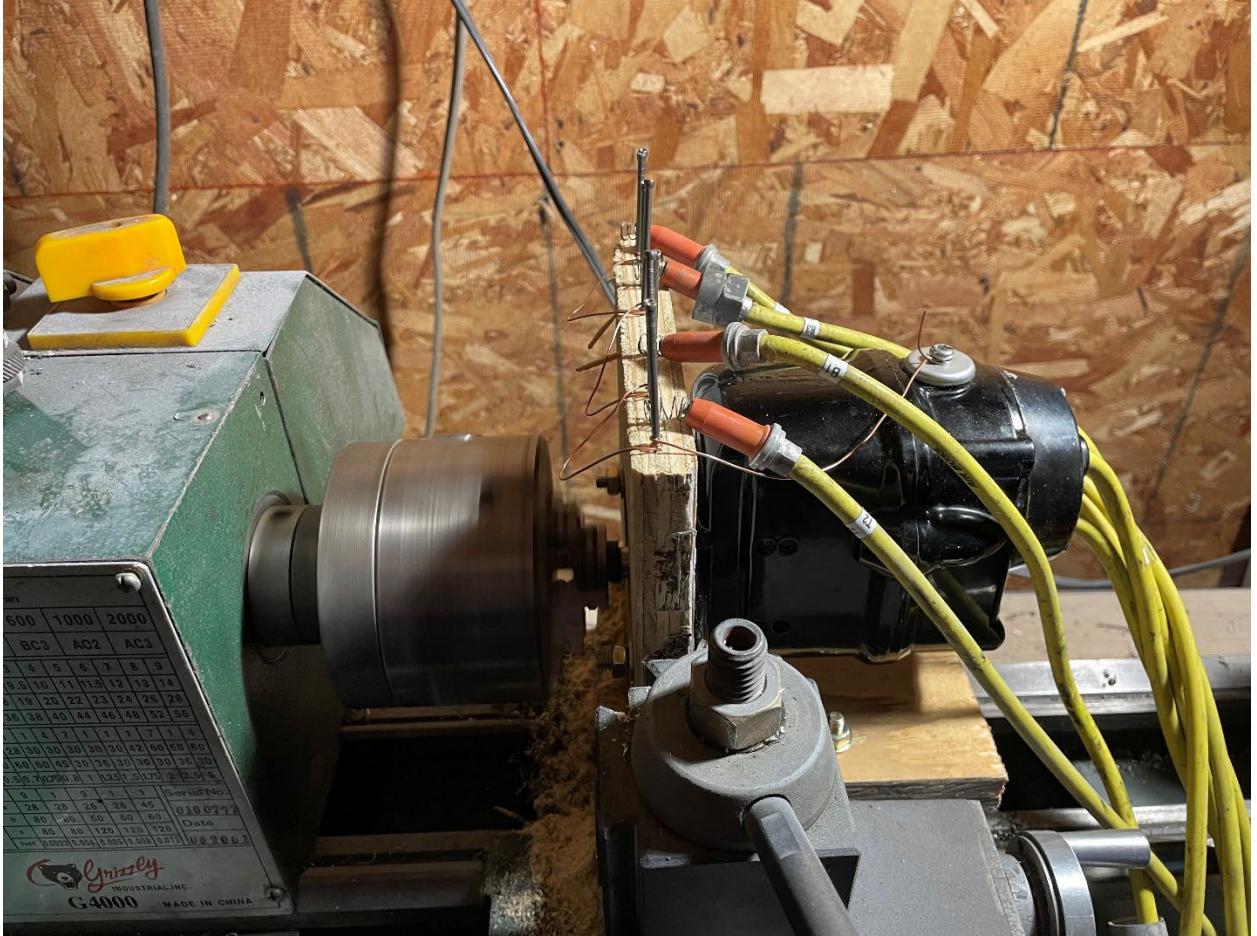
The aircraft magnetos were sent to the NTSB IIC for examination. The left magneto arrived with its impulse coupling removed from the unit and the ignition harness loose in the shipping box.

Figure 2: Left magneto installed on test fixture.

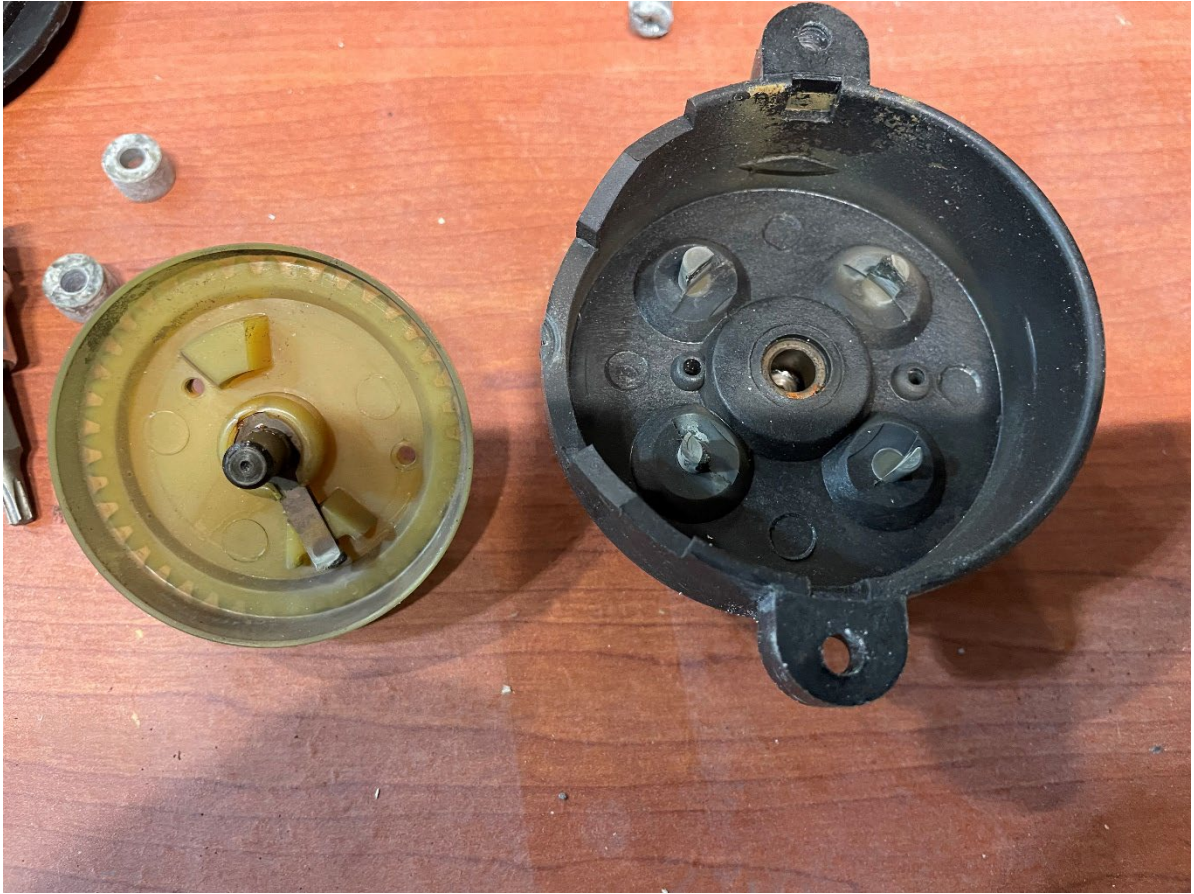
The magneto was then disassembled to check the internal components. Upon opening it was observed that the contact points were opening and closing on rotation of the input shaft. The contact point assembly was dirty and rusted. All internal wiring was still connected. Both plastic gears were intact, and the timing of the gears was checked and appeared to be correct. The distributor cap posts and the rotor tip both had extensive pitting. The carbon brush was stuck inside the rotor shaft. The tab on the coil that the carbon brush rides against was dirty and had carbon deposits.

Figure 3: Left magneto distributor cap and rotor.

The contact point tips were cleaned with fine sandpaper, the coil tab was cleaned with a Scotchbrite pad and the unit re-assembled. It was then placed back on the test fixture but no spark was still produced.

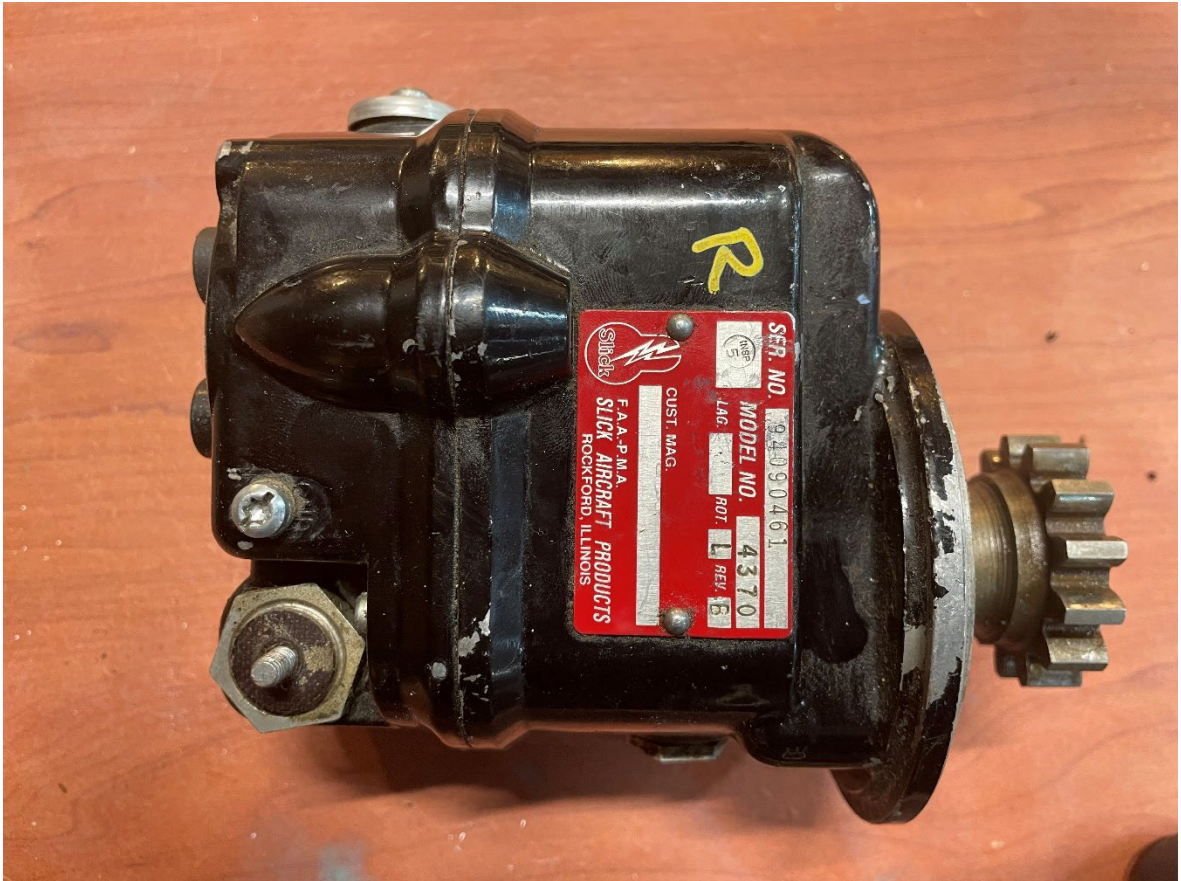
The right magneto arrived with the input gear installed. The ignition harness was loose in the box. This magneto was not equipped with an impulse coupling. The magneto was installed on the test fixture and run at 400 rpm but did not produce spark. The magneto was disassembled to check the internal components.

Figure 4: Right magneto.

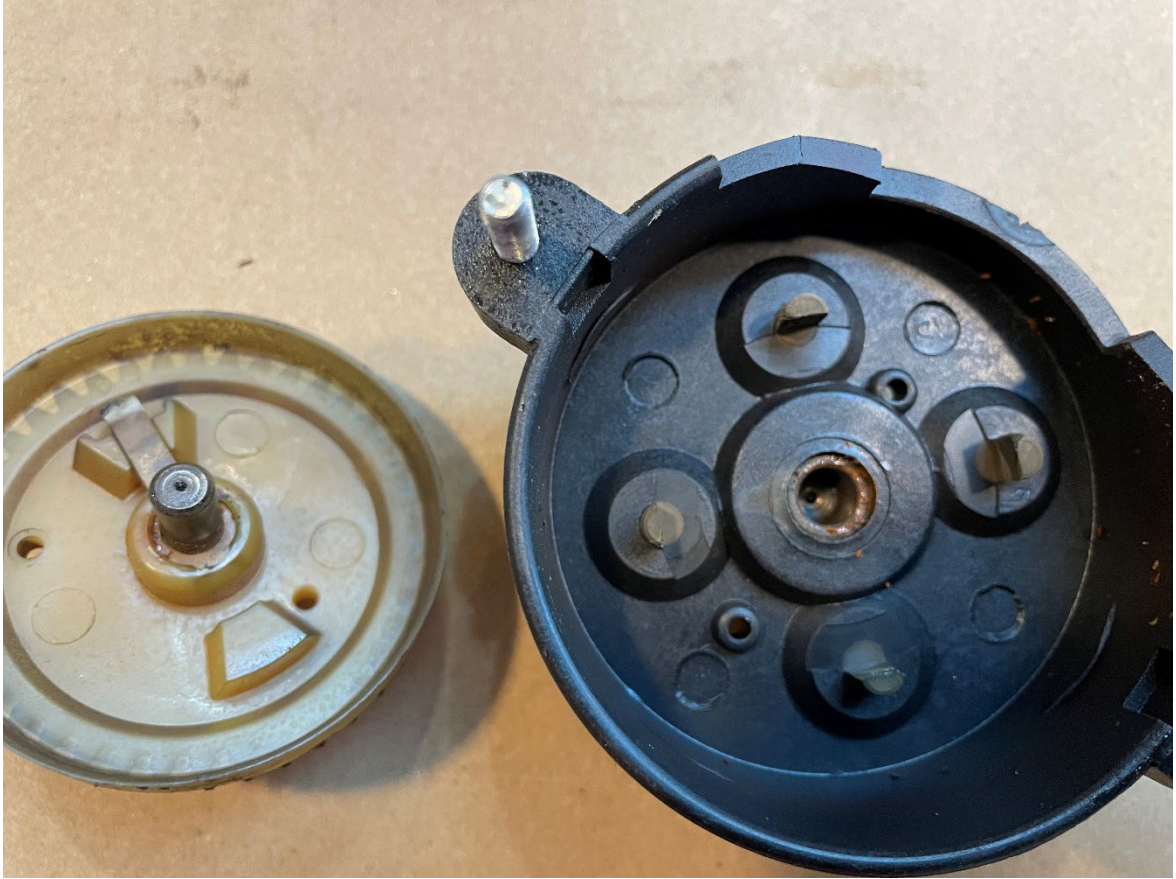
Upon opening it was observed that the contact points were opening and closing on rotation of the input shaft. The contact point assembly was dirty and rusted. All internal wiring was still connected. Both plastic gears were intact, and the timing of the gears was checked and appeared to be correct. The distributor cap posts and the rotor tip both had extensive pitting. The carbon brush was stuck inside the rotor shaft. The tab on the coil that the carbon brush rides against was dirty and had carbon deposits.

Figure 5: Right magneto distributor cap and rotor.

The contact point tips were cleaned with fine sandpaper, the coil tab was cleaned with a Scotchbrite pad and the unit re-assembled. It was then placed back on the test fixture but no spark was still produced.
