# National Transportation Safety Board

CEN22LA427

## **MATERIALS LABORATORY**

Factual Report 23-014

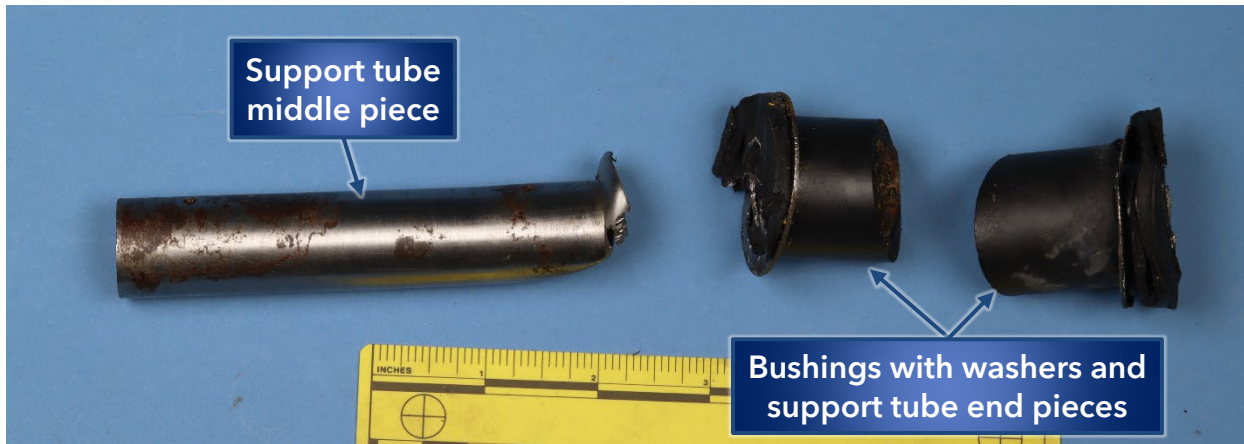
An overall view of the submitted components is shown in figure 1. The tube was received cut in two locations and had a polished appearance with circumferentially-oriented fine grinding marks on the exterior surface. Superficial-appearing orange and dark red oxides were also observed, mostly on the lower half of the tube exterior surface.

**Figure 1.** Support tube, washers, and bushings as received.

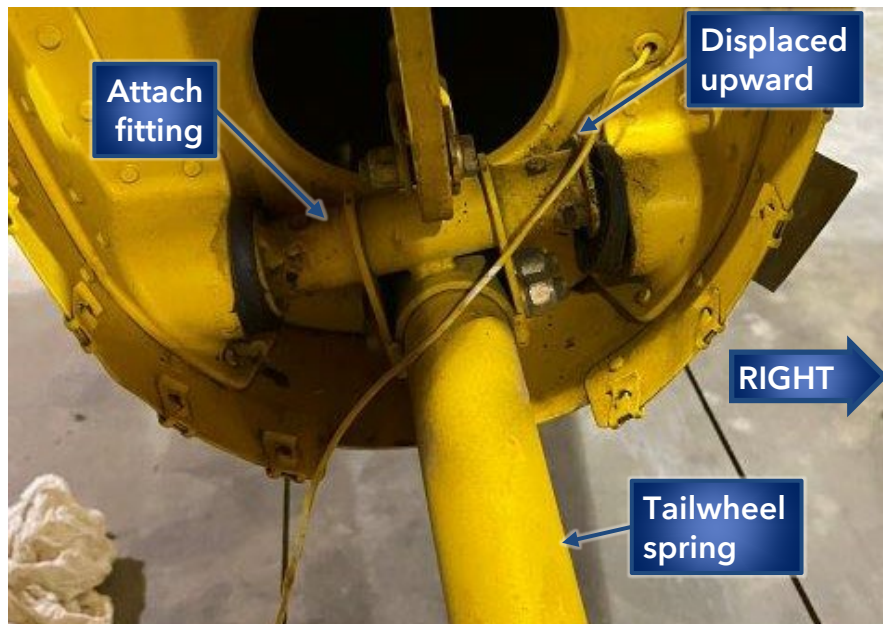
A view of the aft bulkhead on the accident airplane before the support tube was removed is shown in figure 2. No portion of the support tube is visible, but the right end of the attach fitting was displaced upward relative to the right attachment lug on the fuselage. The support tube was reportedly cut from the assembly using a handheld reciprocating saw, producing the pieces shown in figure 1.

**Figure 2.** Aft bulkhead on the accident airplane before the support tube was removed.

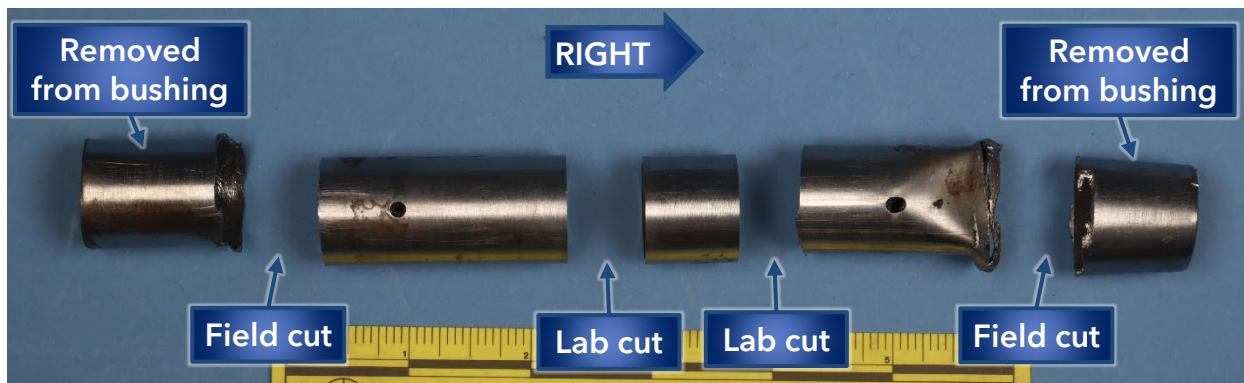
The locations of field cuts are shown in figure 3. The location of the field cuts corresponded to the joints between the attachment fitting and the fuselage lugs. In addition to

the transverse cut through the cross-section at each location, evidence of additional partial cuts adjacent to the through-section cut were observed. No evidence of any fracture features were observed at either of the cut locations on the tube. The tube wall at the location of the right joint was flattened and substantially deformed consistent with ductile overstress deformation of tube, and the deformation corresponded to the upward displacement of the attach fitting right end relative to the adjacent fuselage lug. The piece of the tube that had been retained within the lug was ovalized, also consistent with overstress deformation associated with the relative displacement. The left end of the support tube was slightly flattened but appeared to be intact aside from the field cut.

**Figure 3.** Support tube assembled in relative positions after end pieces were removed from the bushings and lab cuts were made in the middle piece.
