CEN23FA031

## INVESTIGATION PHOTOGRAPHS

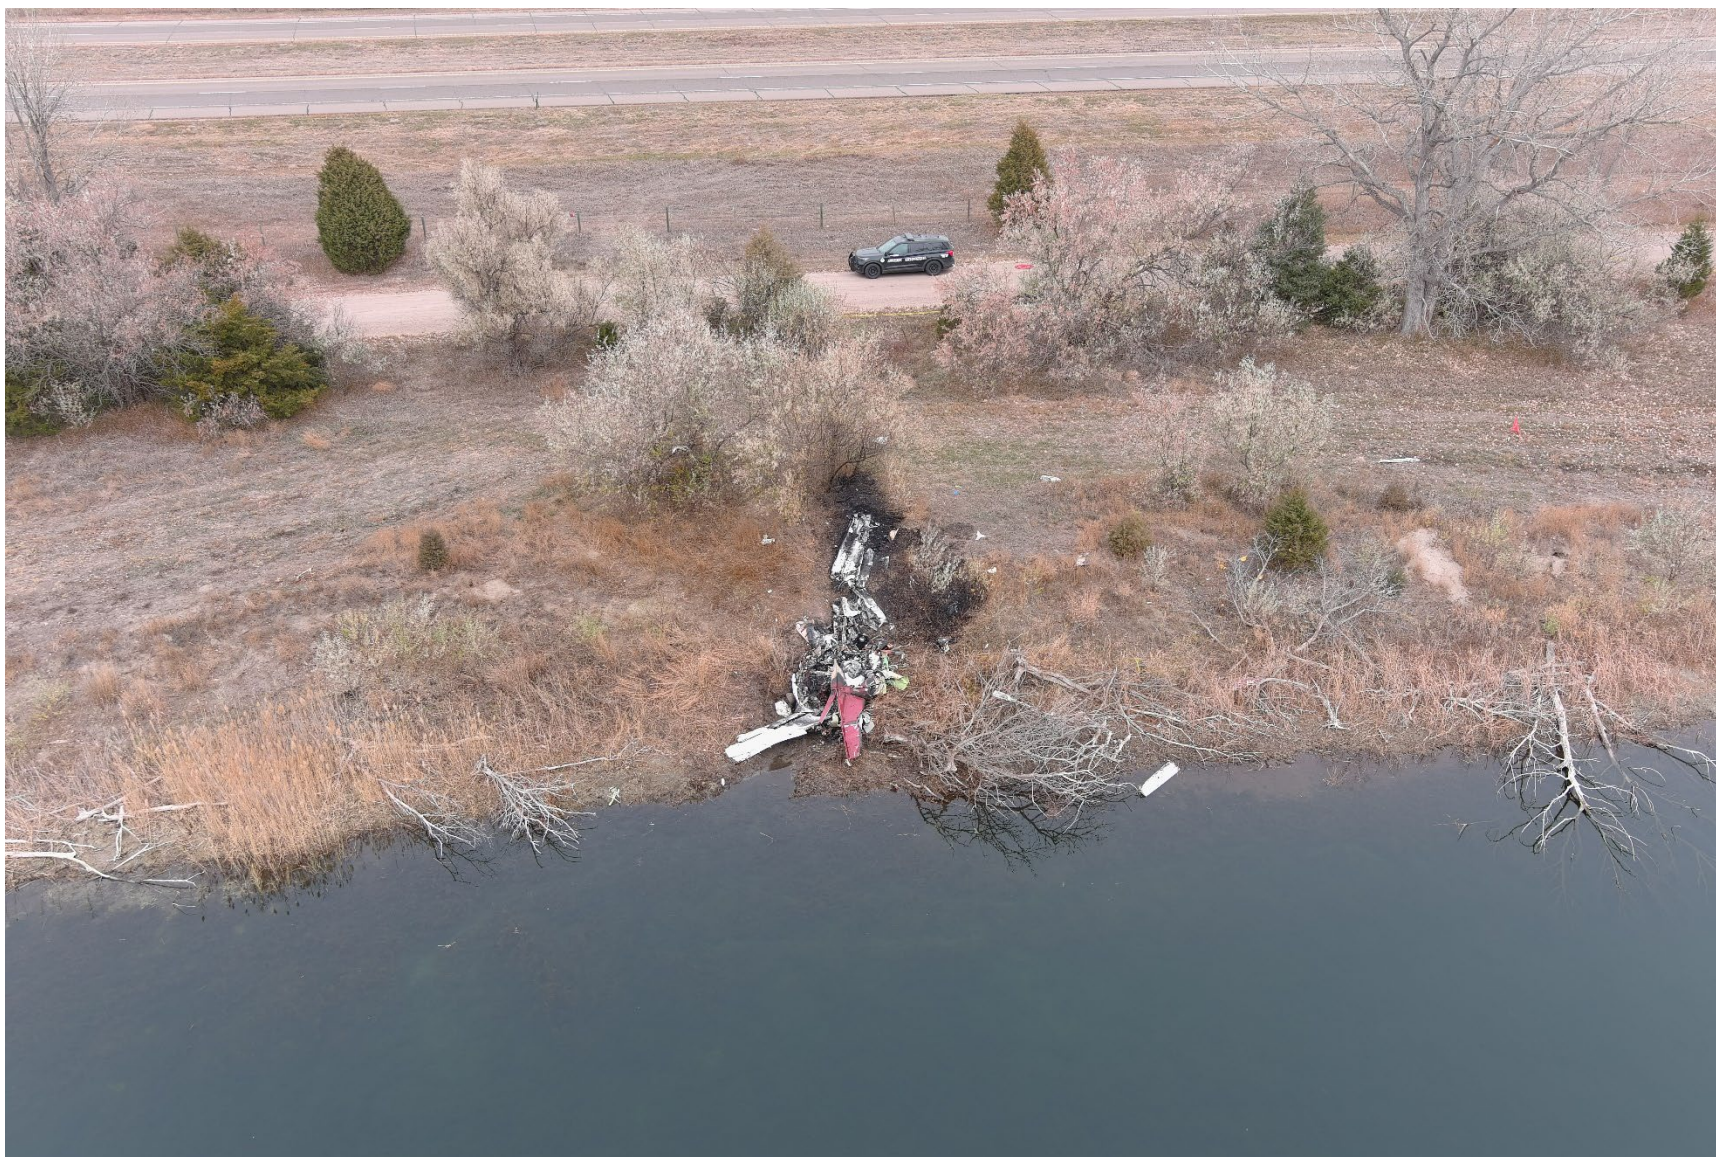
**Photograph 1 - Aerial view of accident site (Courtesy of Nebraska State Patrol)**

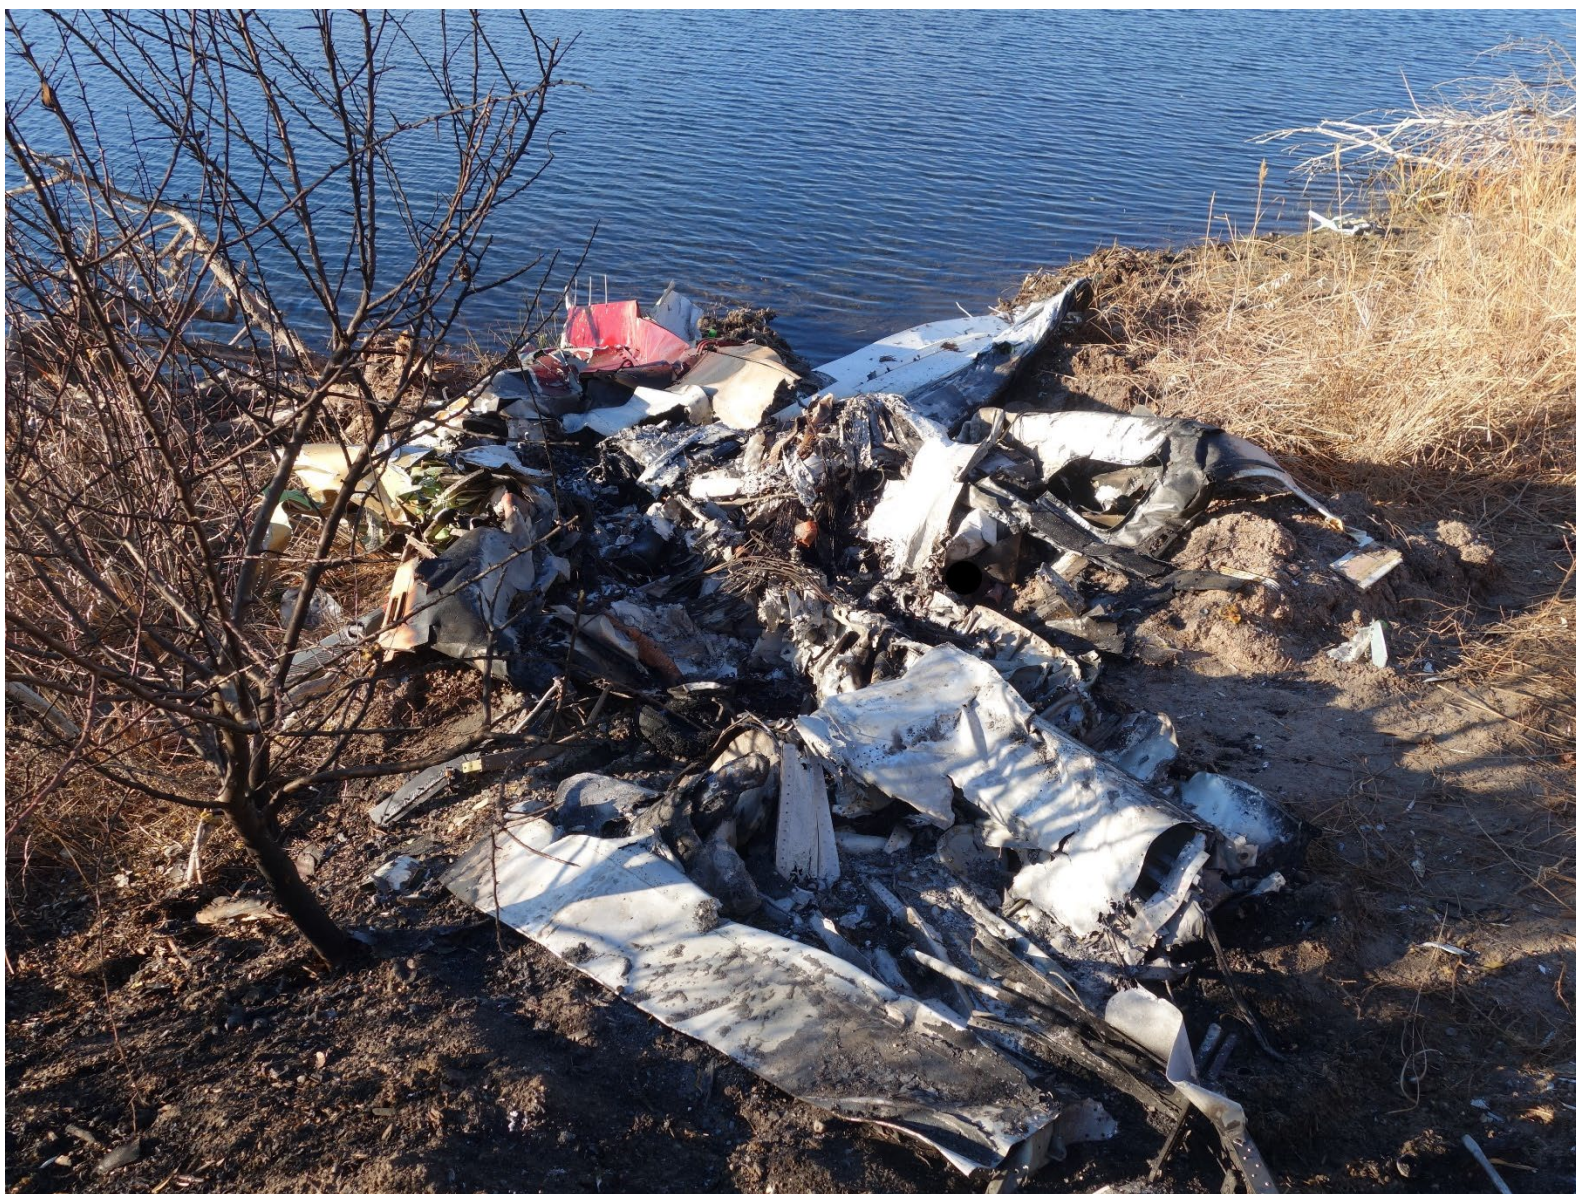
**Photograph 2 - Accident main wreckage (Courtesy of Piper Aircraft, Inc.)**

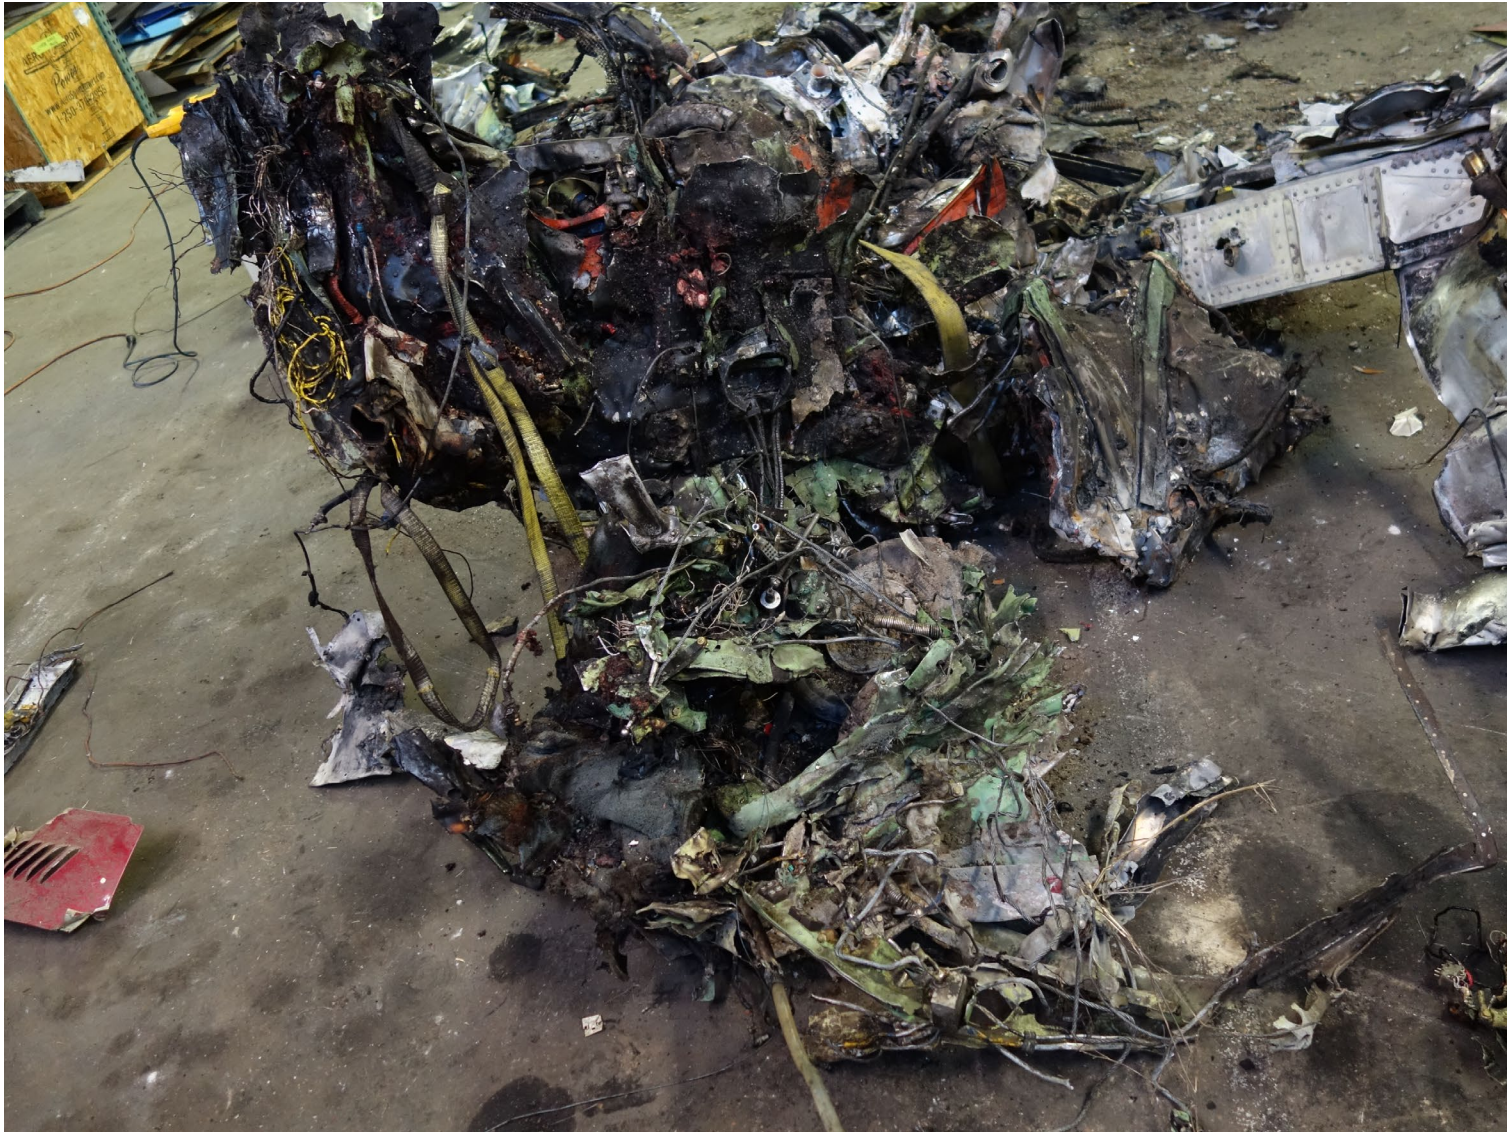
**Photograph 3 - Forward fuselage and cockpit (Courtesy of Piper Aircraft, Inc.)**

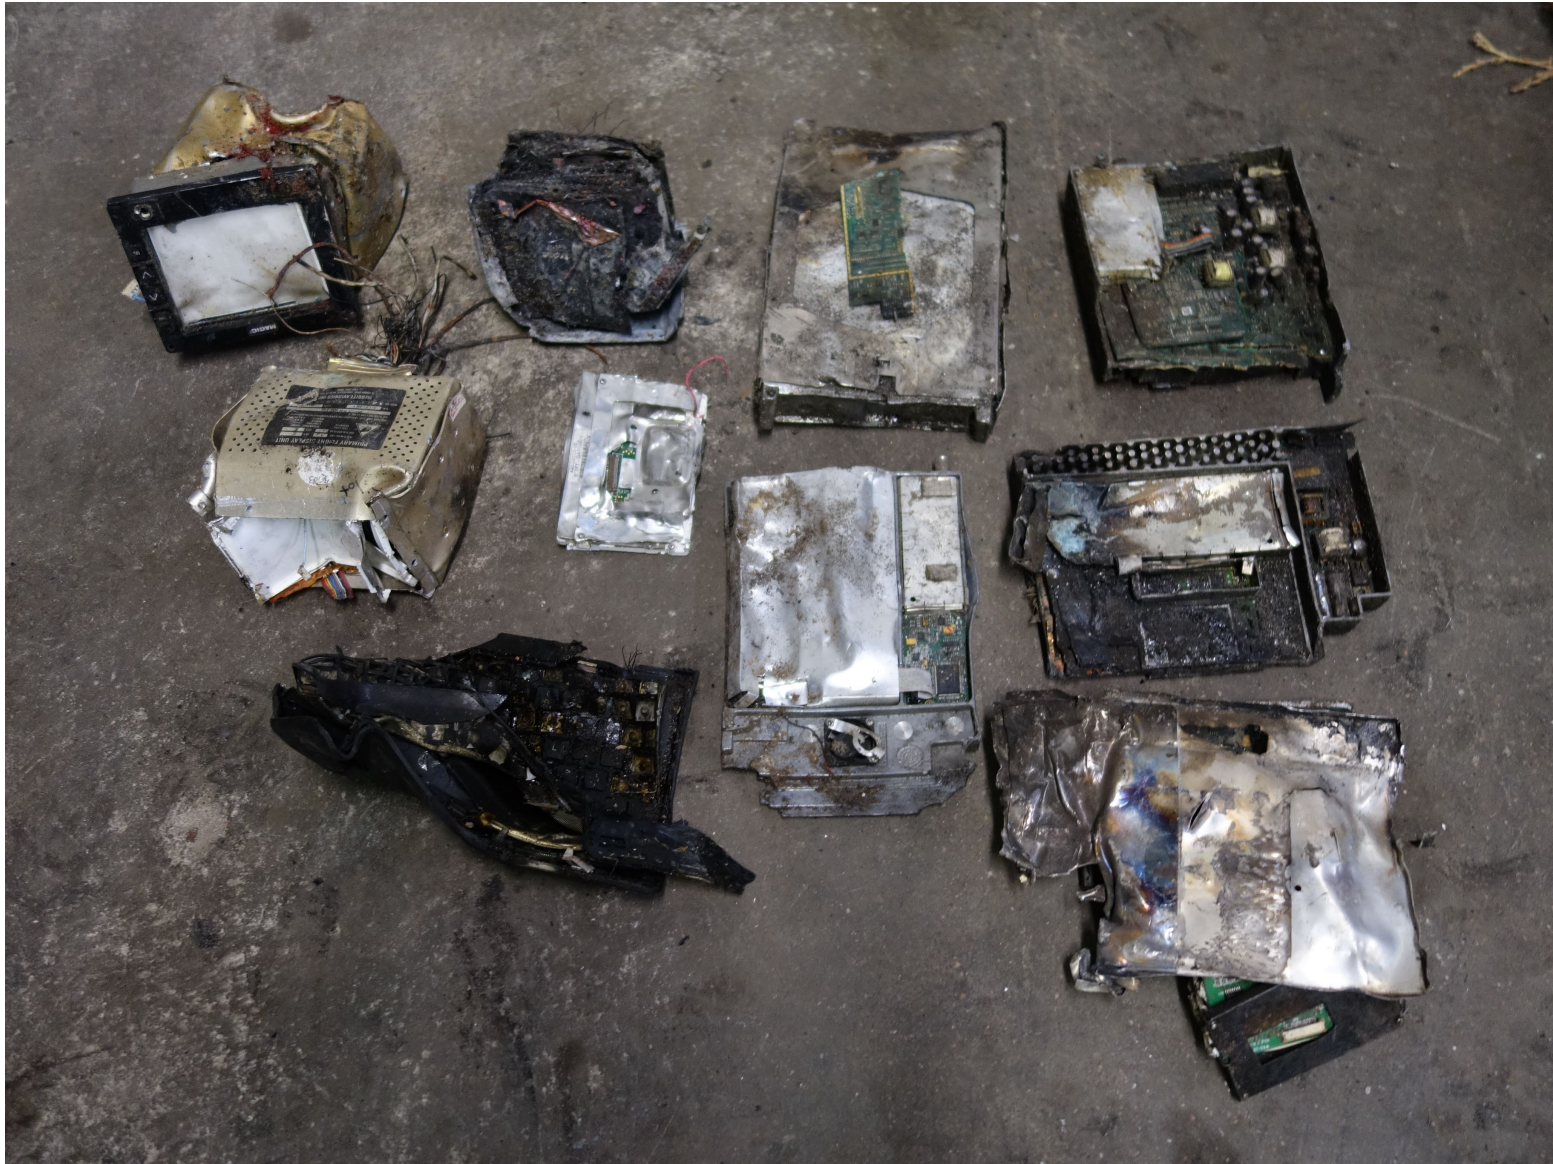
**Photograph 4 - Recovered cockpit avionics equipment (Courtesy of Piper Aircraft, Inc.)**

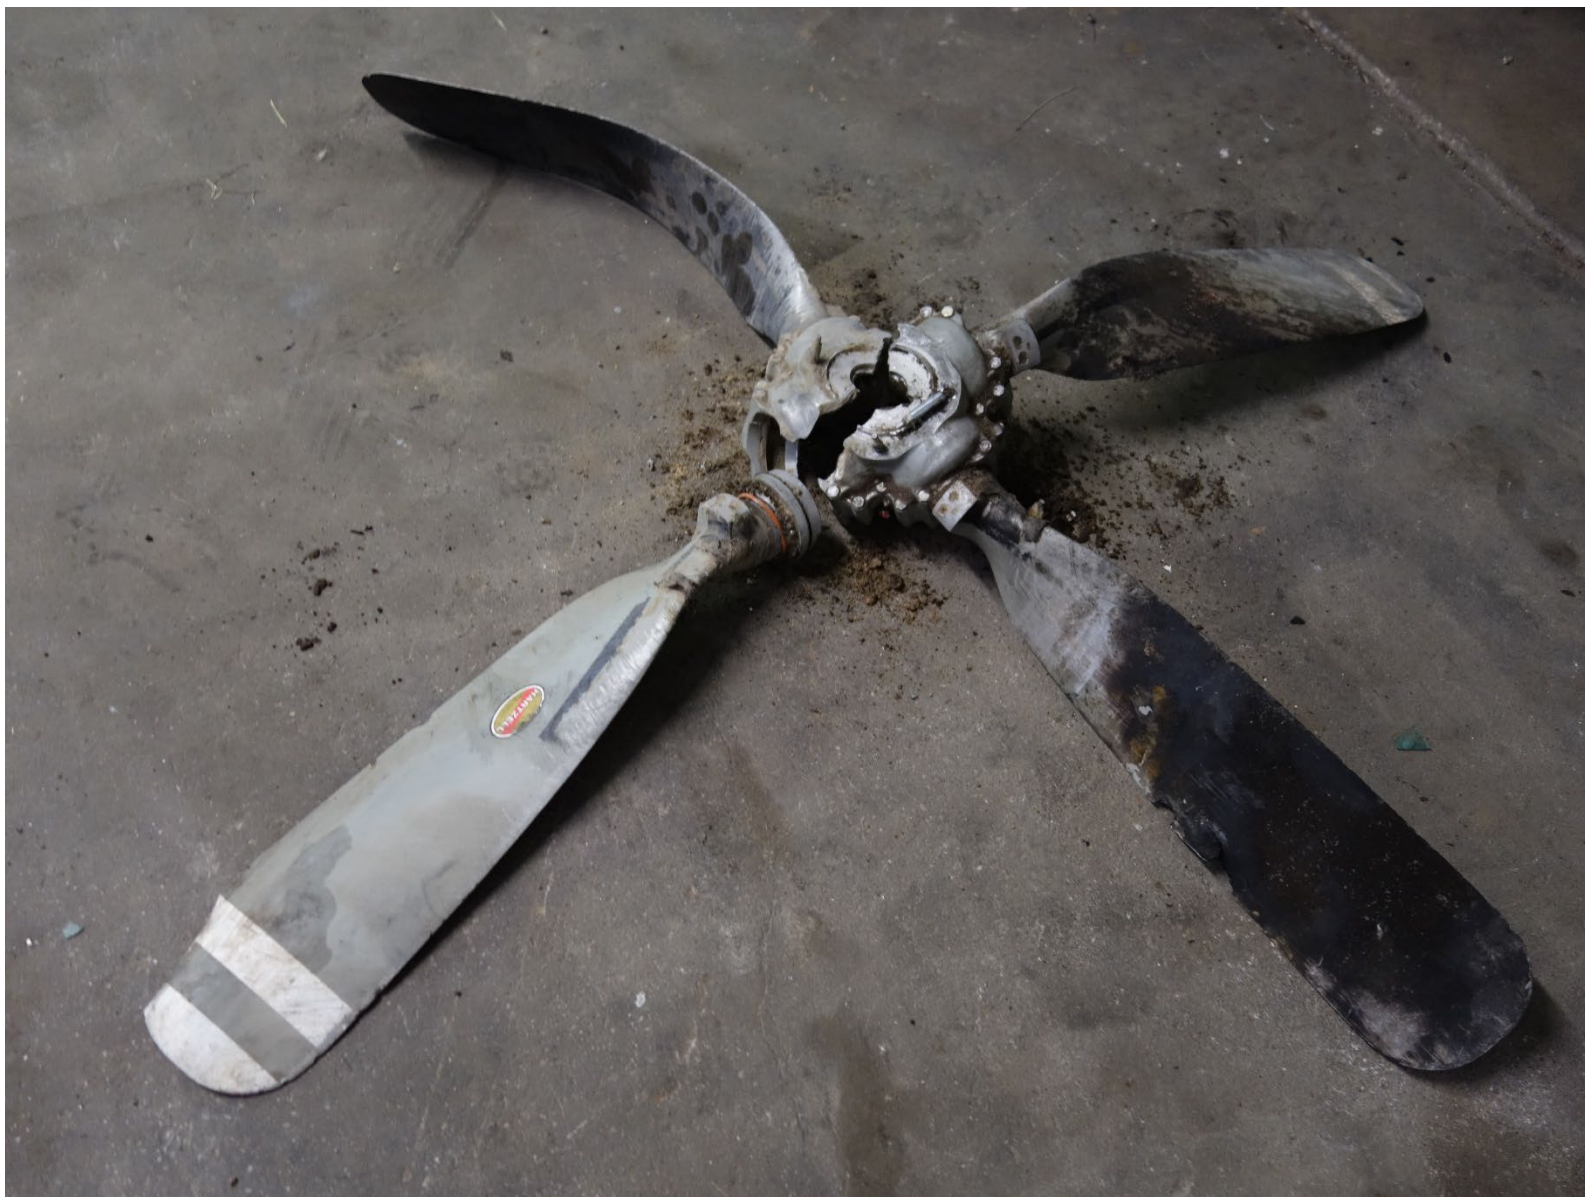
**Photograph 5 - Propeller assembly (Courtesy of Piper Aircraft, Inc.)**

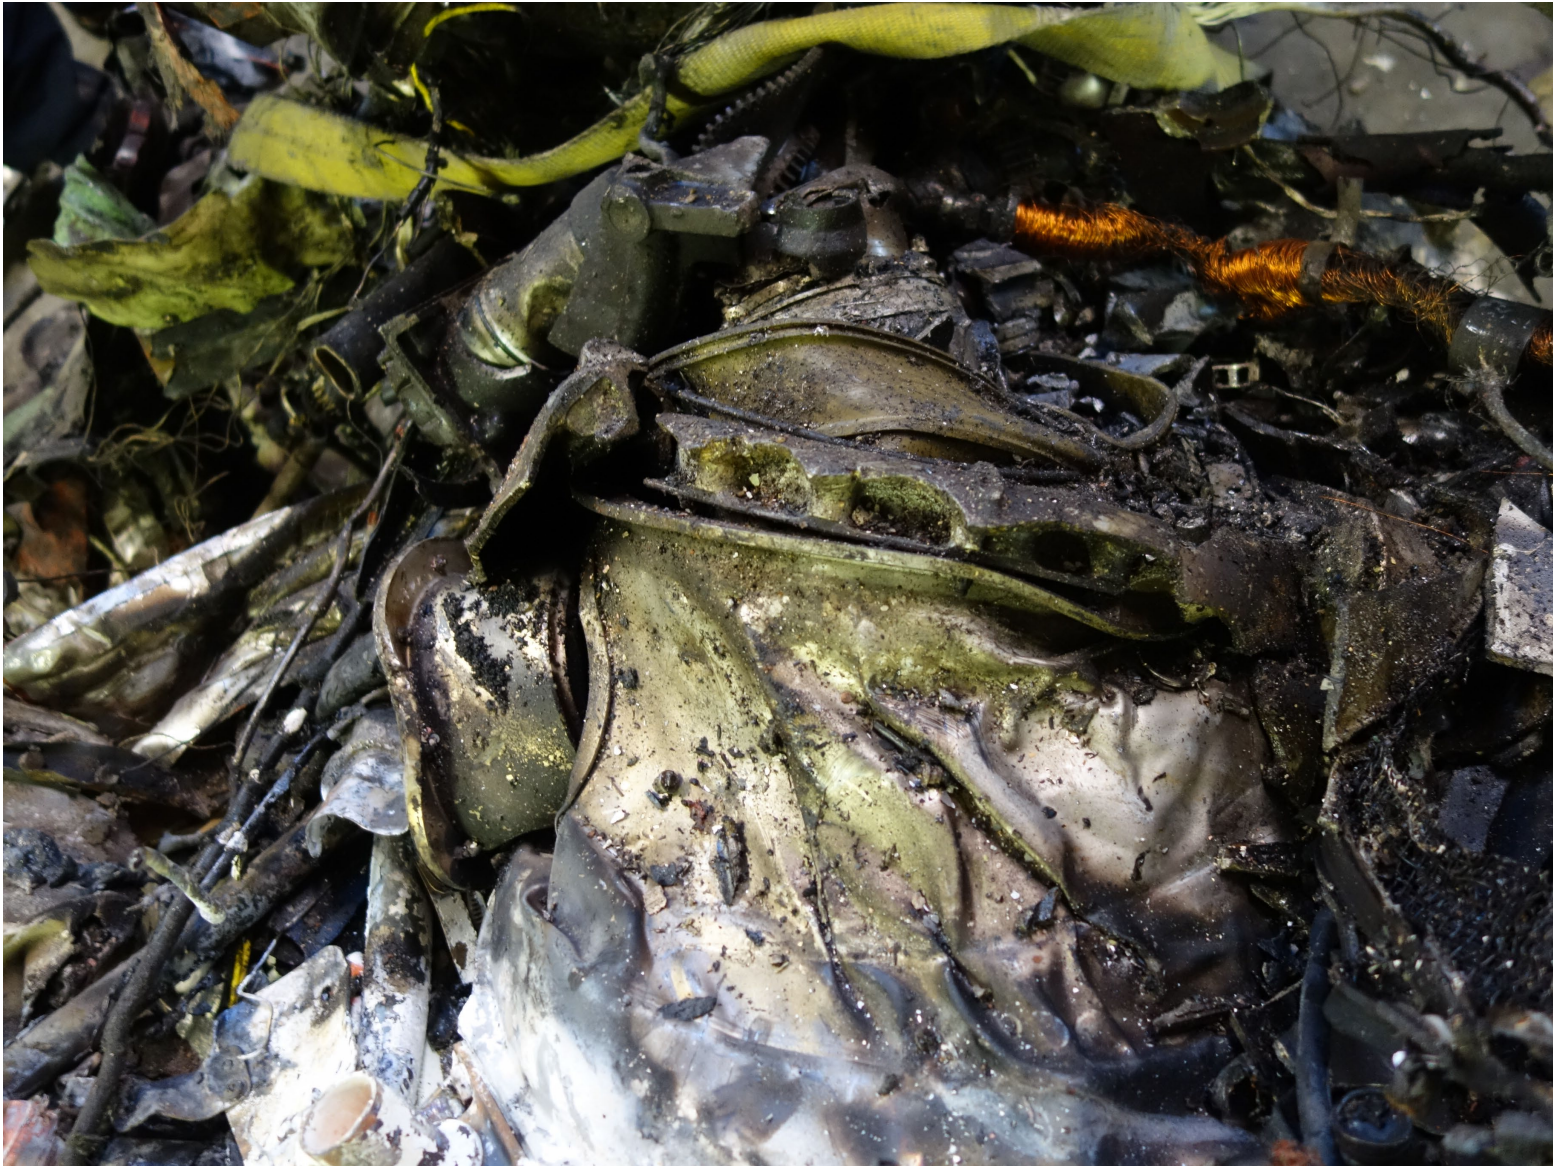
**Photograph 6 - Engine compressor and turbine modules (Courtesy of Piper Aircraft, Inc.)**
