# National Transportation Safety Board

CEN23FA045

## **AIRCRAFT EXAMINATION SUMMARY**

Location: Greenfield, Indiana  
Date: 11/25/2022  
Time: 0800 EST  
1200 UTC  
Airplane: Cirrus Vision Jet SF50, N15VJ

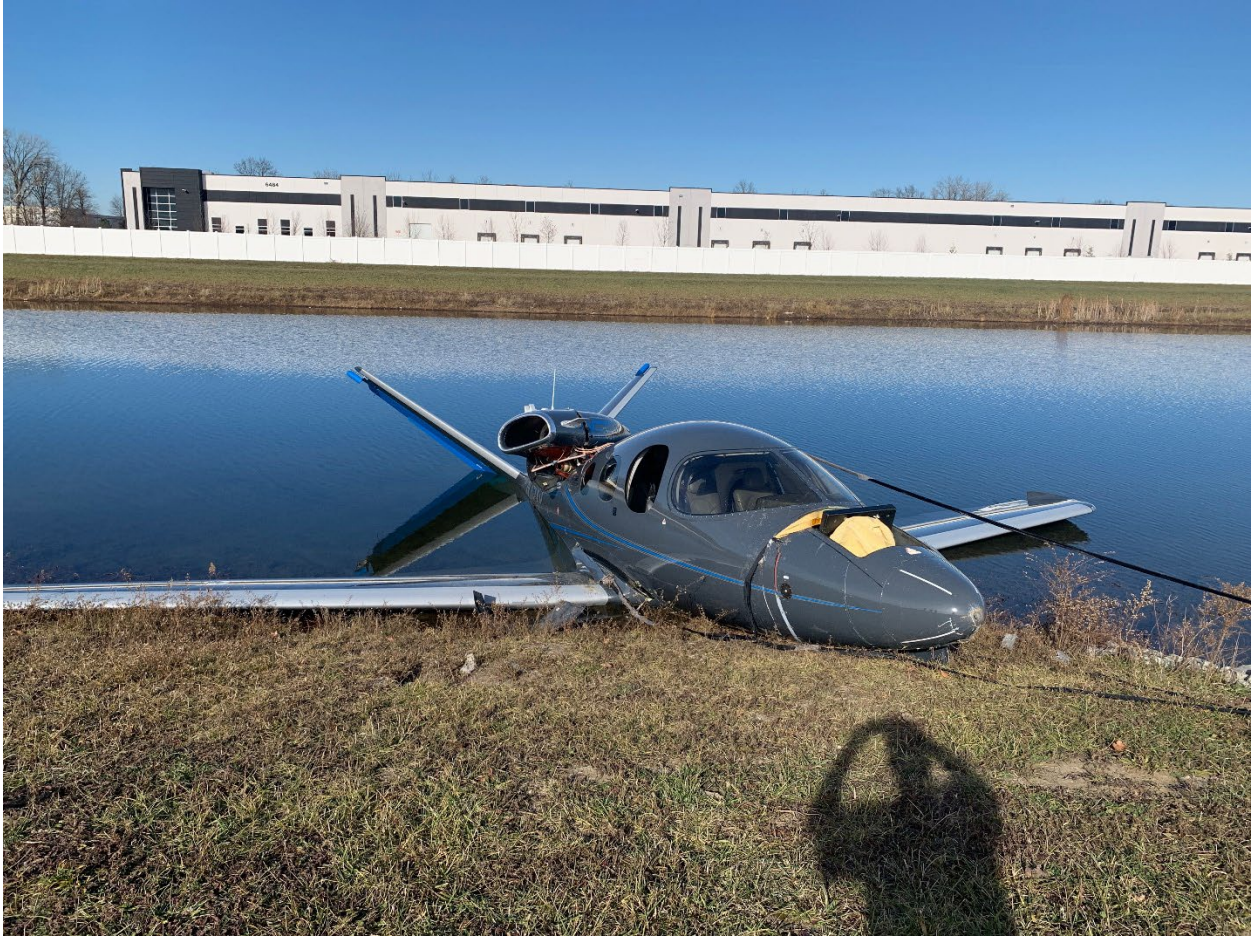
The airplane came to rest in a retention pond in an industrial area about 1 mile and 220° from the departure end of runway 25 at MQJ. The airplane was upright and the CAPS parachute had been deployed.
