# National Transportation Safety Board

CEN23FA071

## COMPUTED TOMOGRAPHY

Location: Galliano, Louisiana  
Date: December 29, 2022  
Time: 0834 central standard time  
1434 coordinated universal time (UTC)  
Helicopter: Bell 407; Registration: N595RL

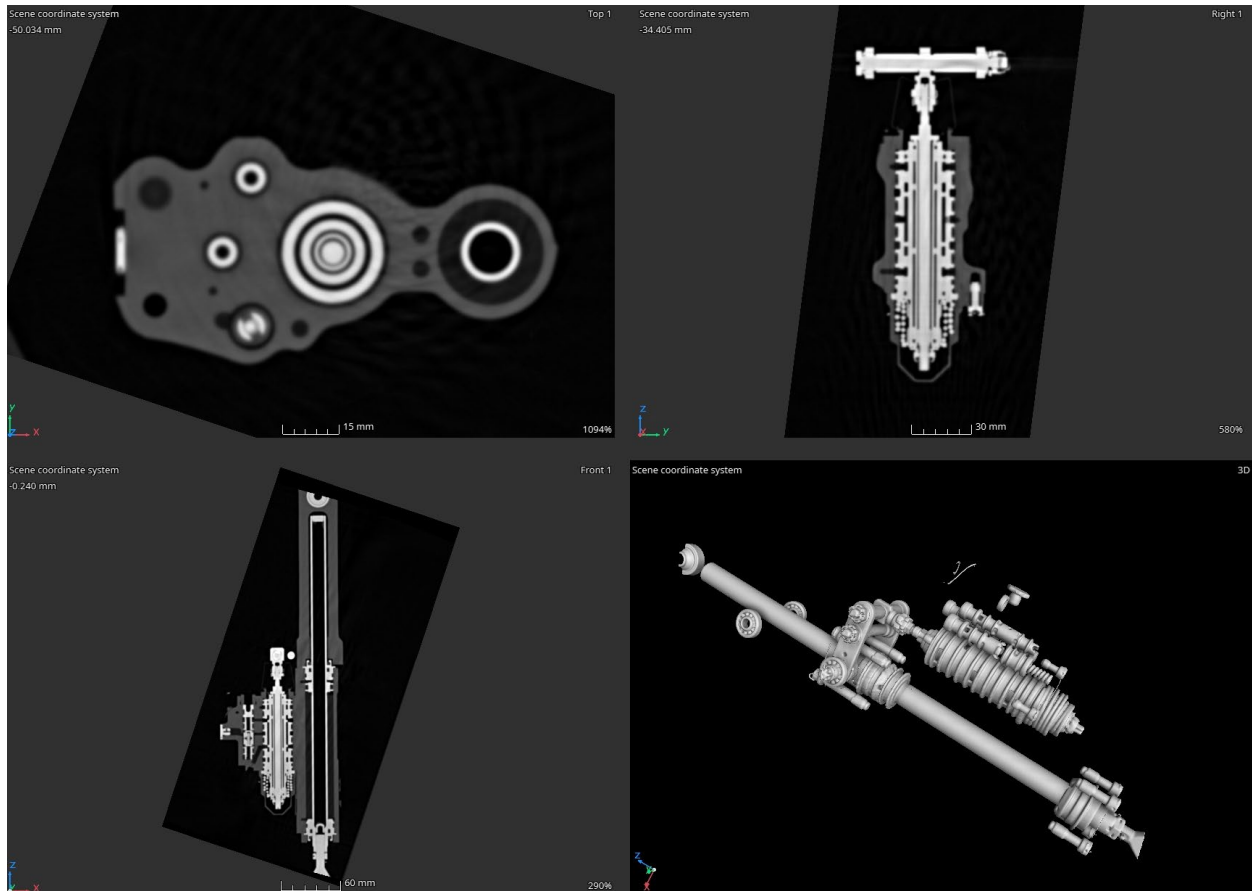
The CT results for the lateral hydraulic actuator are shown in Figures 1 through 13. Review of the images indicated that, when the scans were conducted, there were no indications of missing or broken components, blockages, or other abnormalities.

**Figure 1.** Lateral hydraulic actuator - overview.

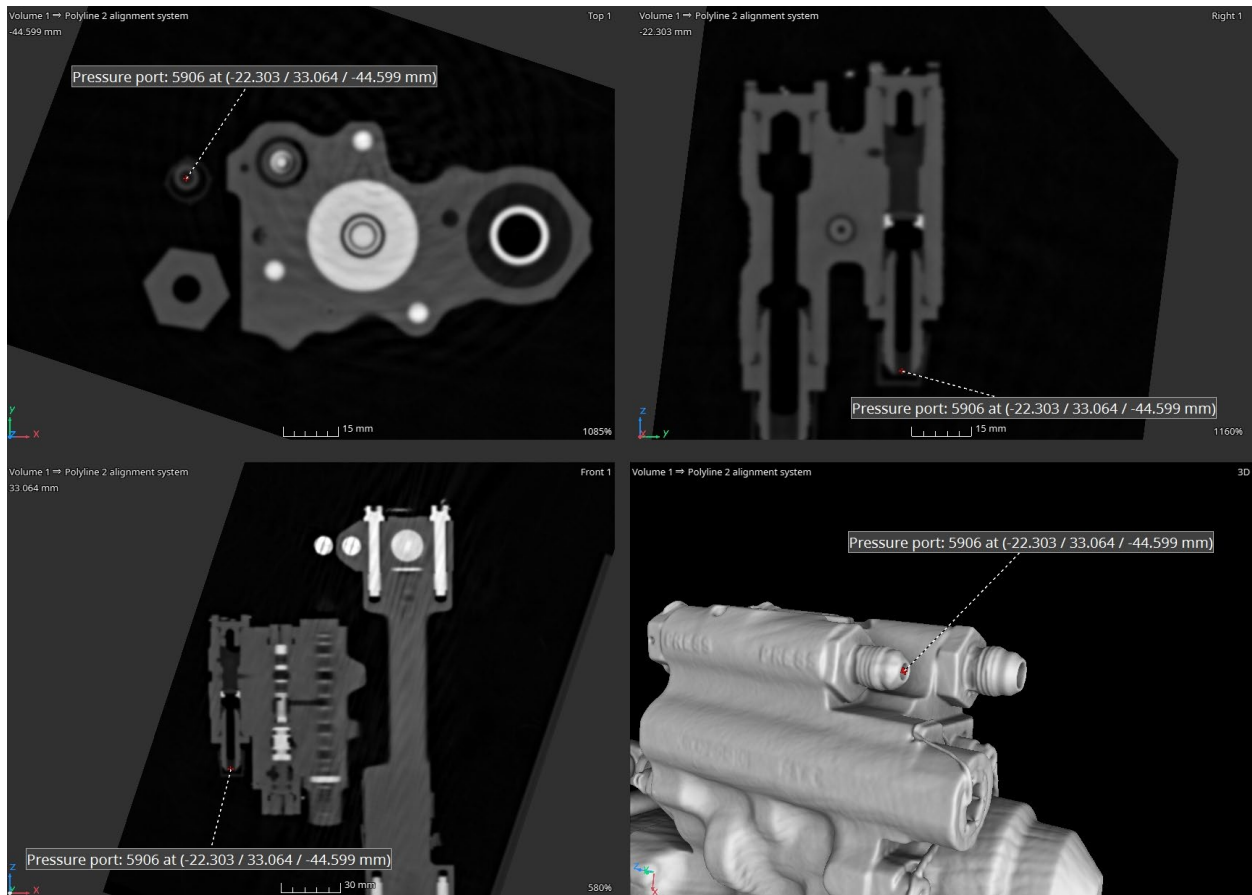
**Figure 2.** Lateral hydraulic actuator – pressure port.

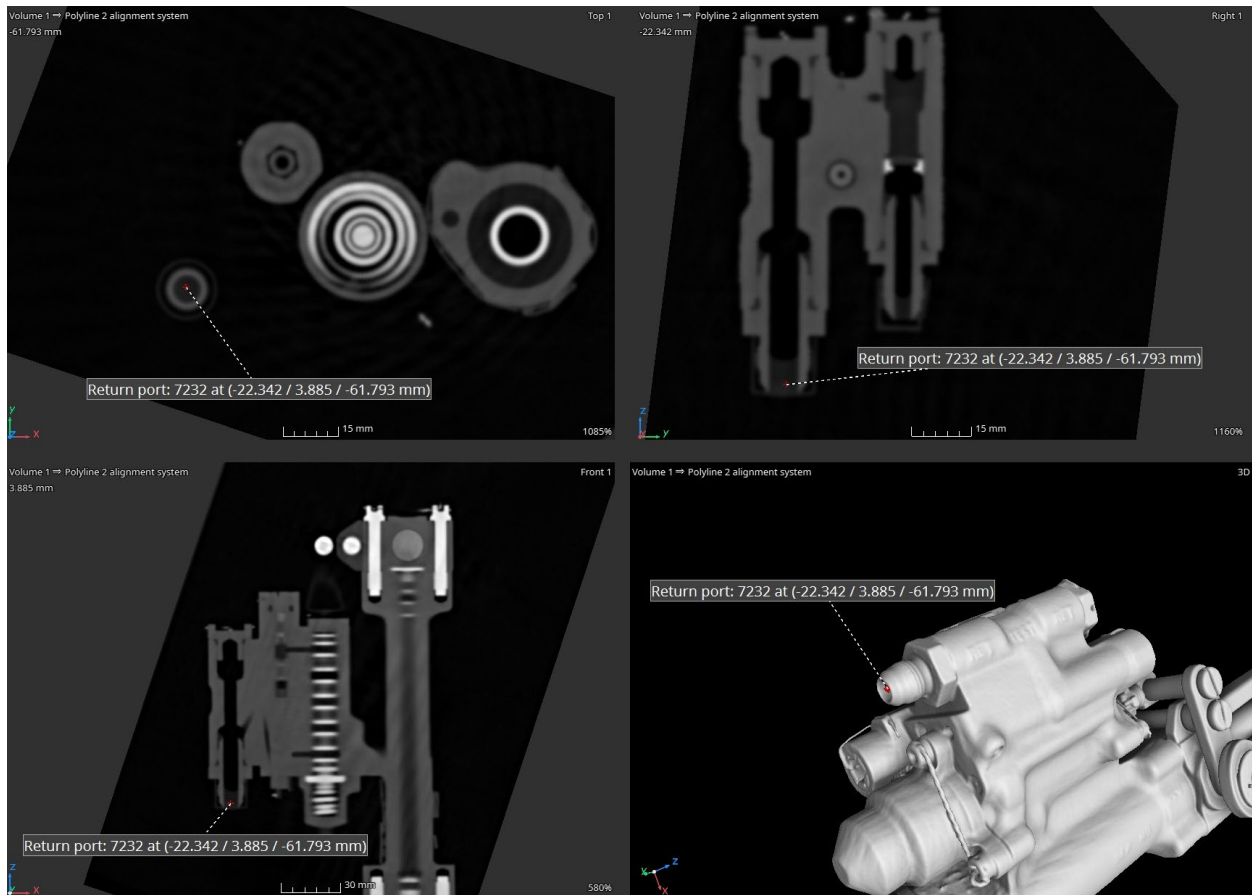
**Figure 3.** Lateral hydraulic actuator - return port.

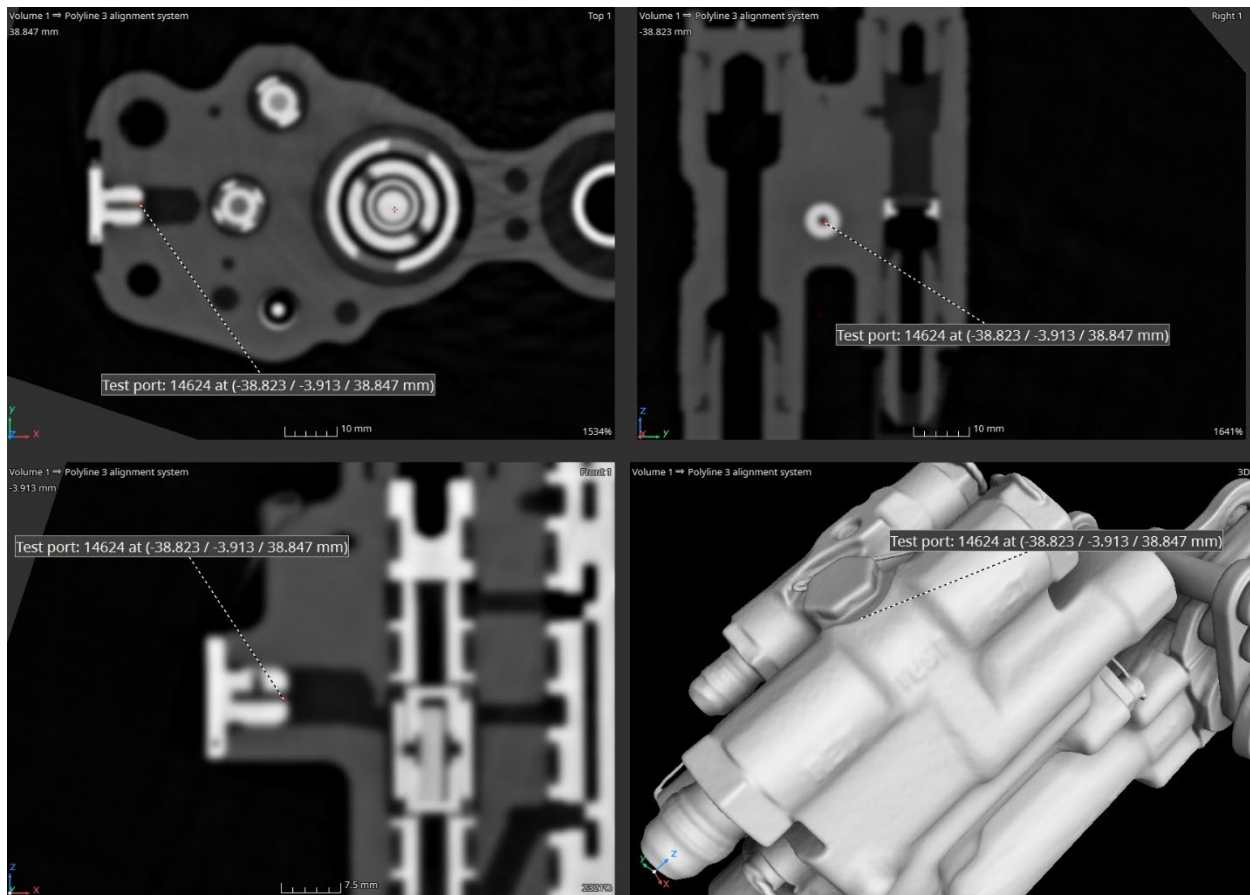
**Figure 4.** Lateral hydraulic actuator - test port.

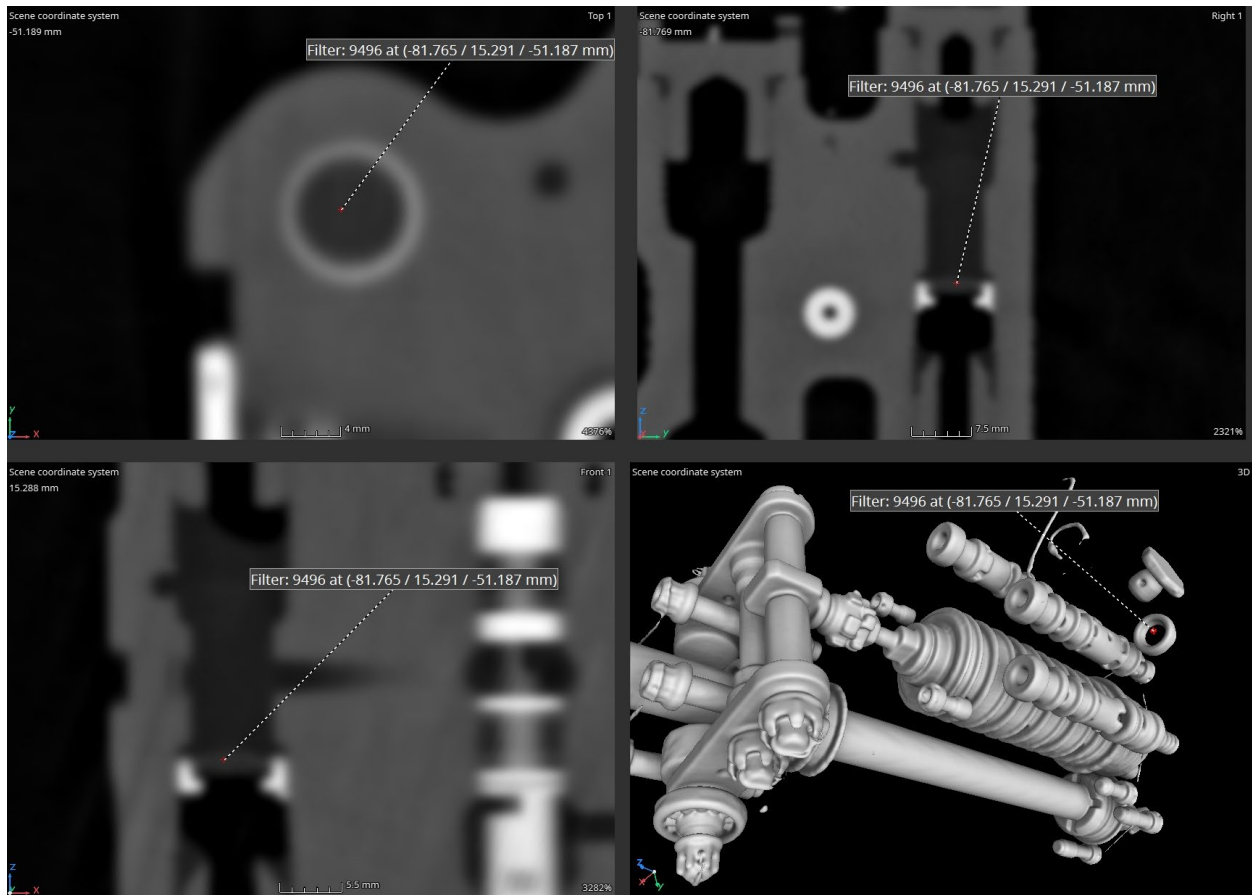
**Figure 5.** Lateral hydraulic actuator – pressure port filter screen.

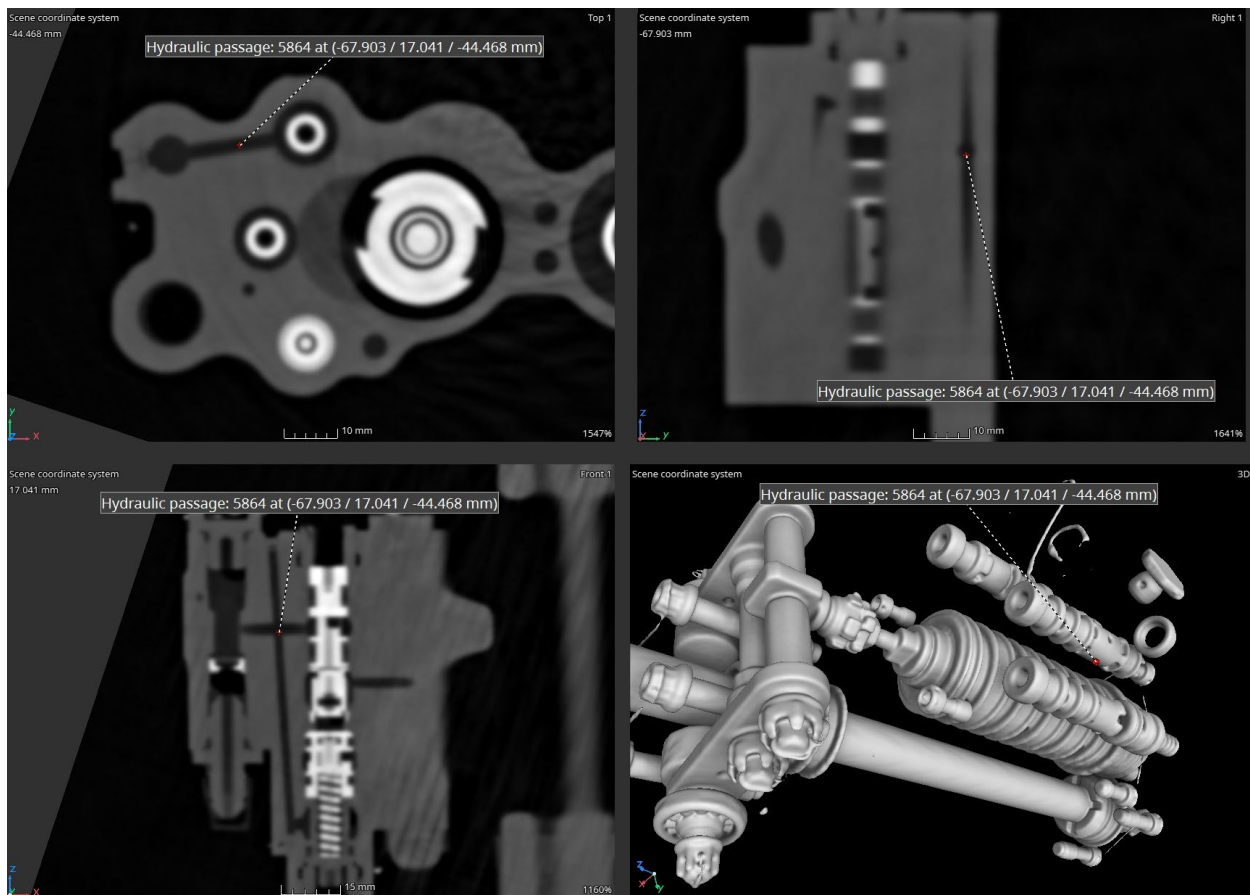
**Figure 6.** Lateral hydraulic actuator - hydraulic passage.

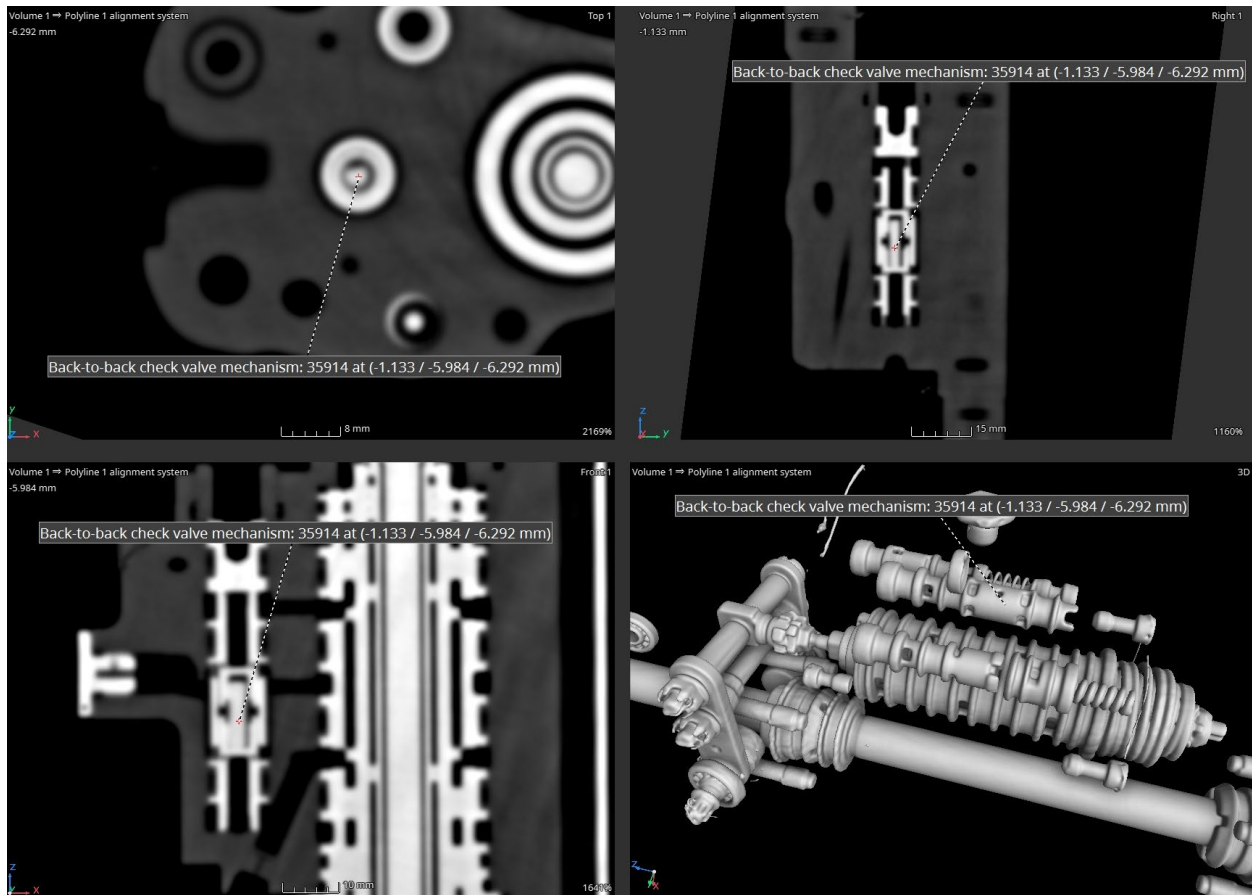
**Figure 7.** Lateral hydraulic actuator – back-to-back check valve.

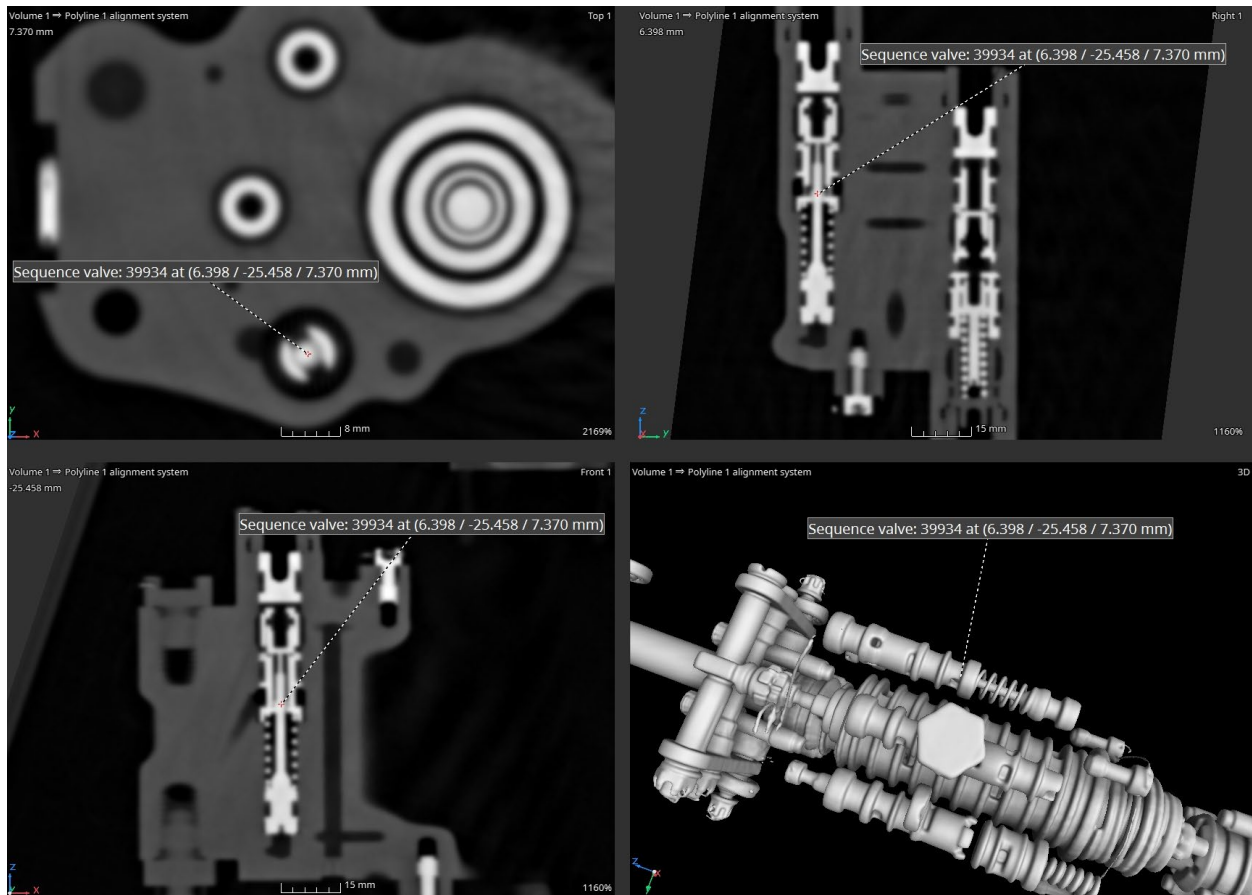
**Figure 8.** Lateral hydraulic actuator – sequence valve.

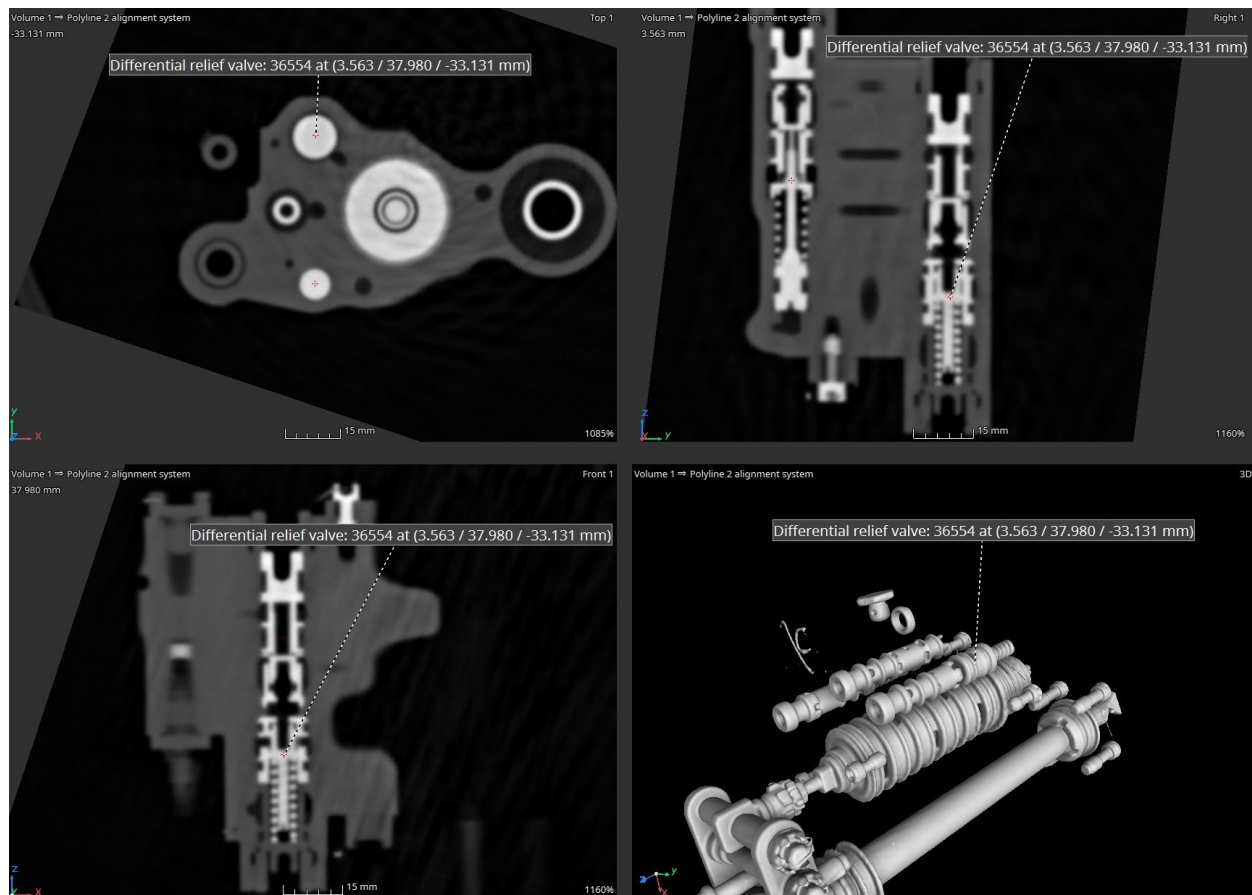
**Figure 9.** Lateral hydraulic actuator – differential relief valve.

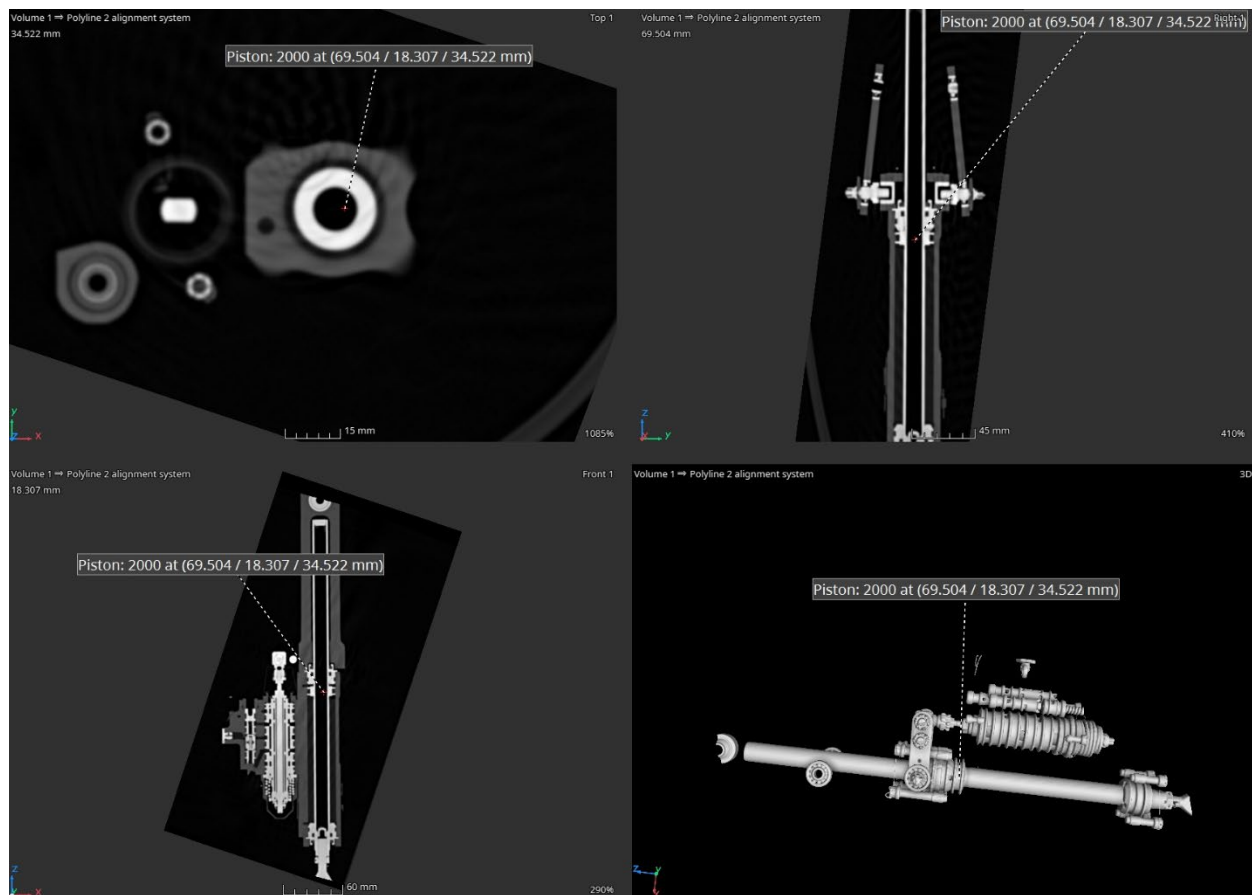
**Figure 10.** Lateral hydraulic actuator – piston.

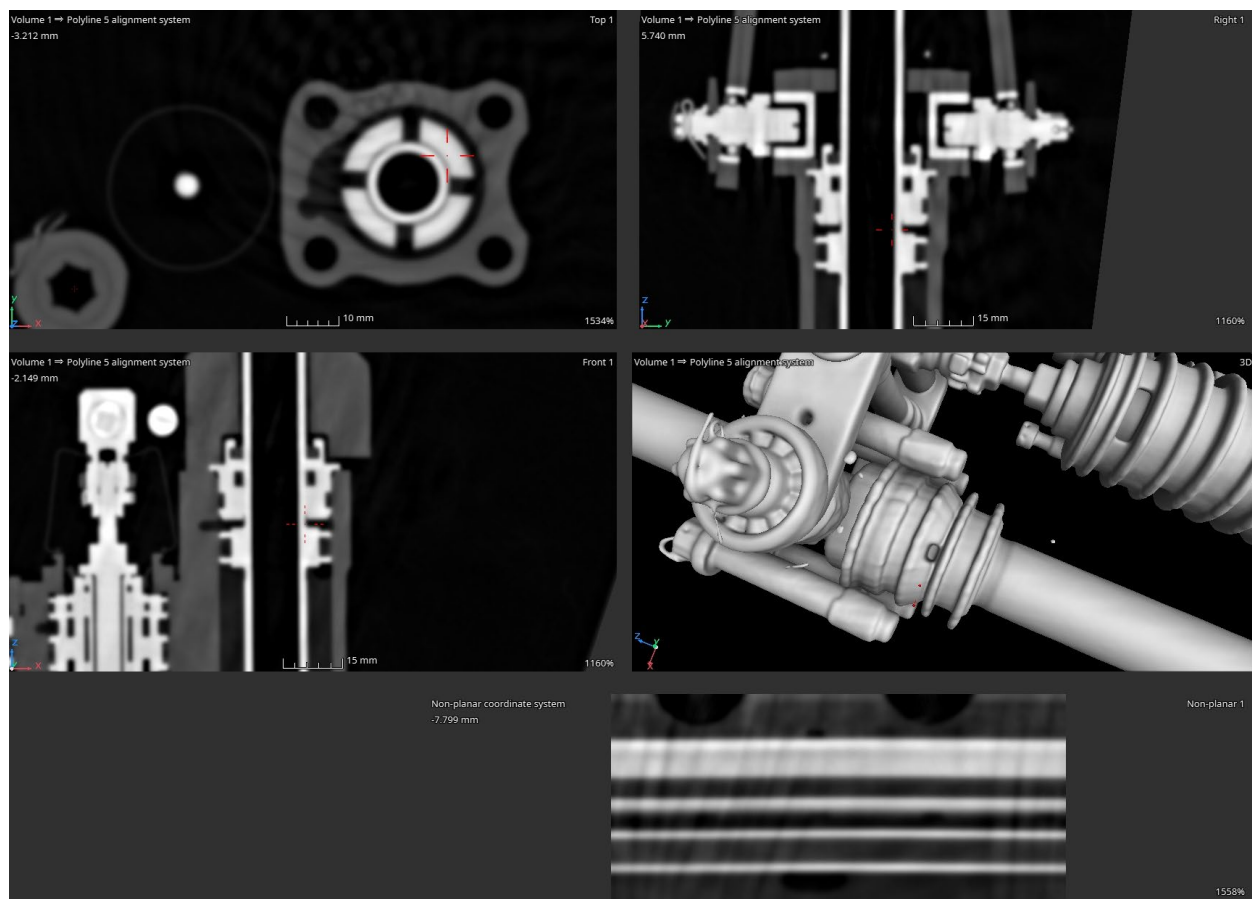
**Figure 11.** Lateral hydraulic actuator – piston and gland.

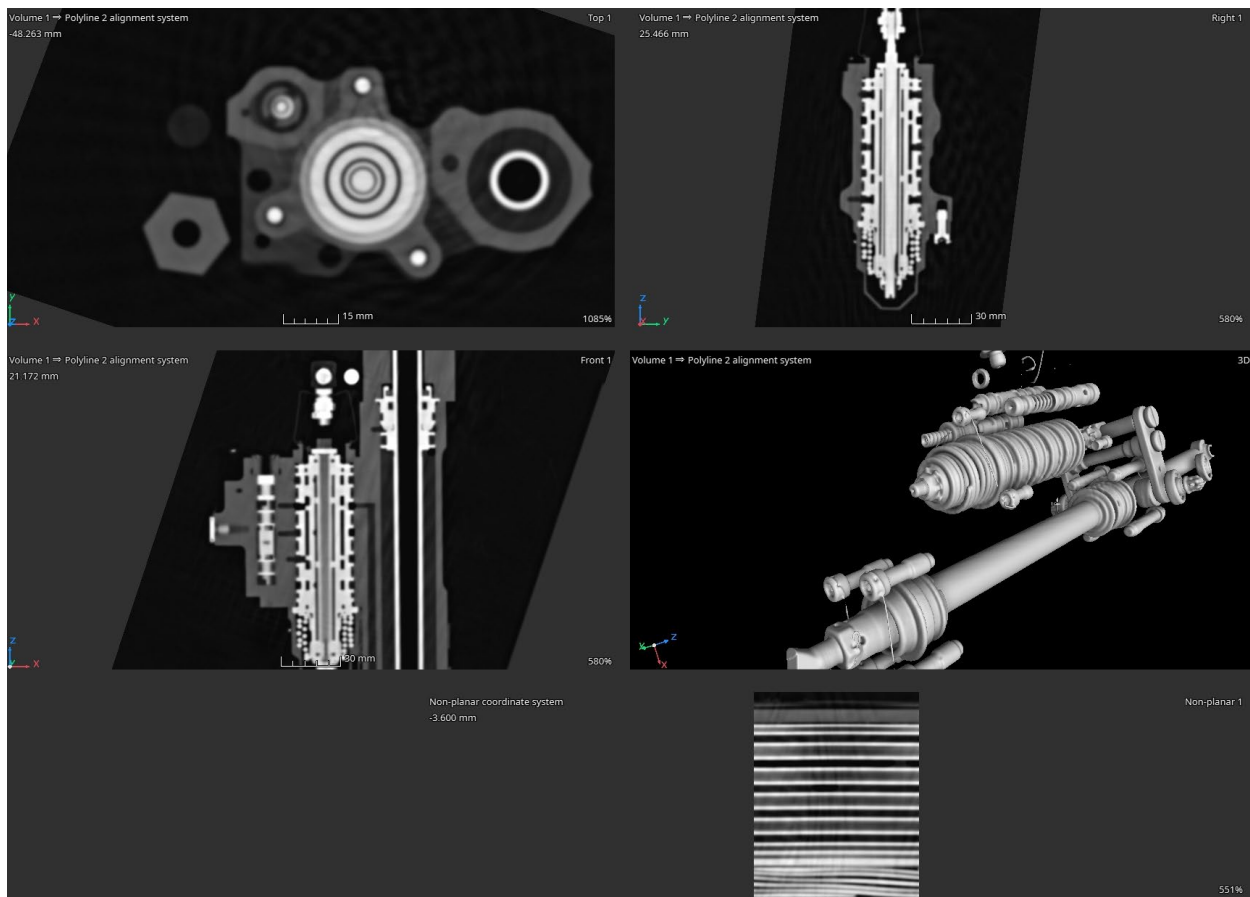
**Figure 12.** Lateral hydraulic actuator – spool.

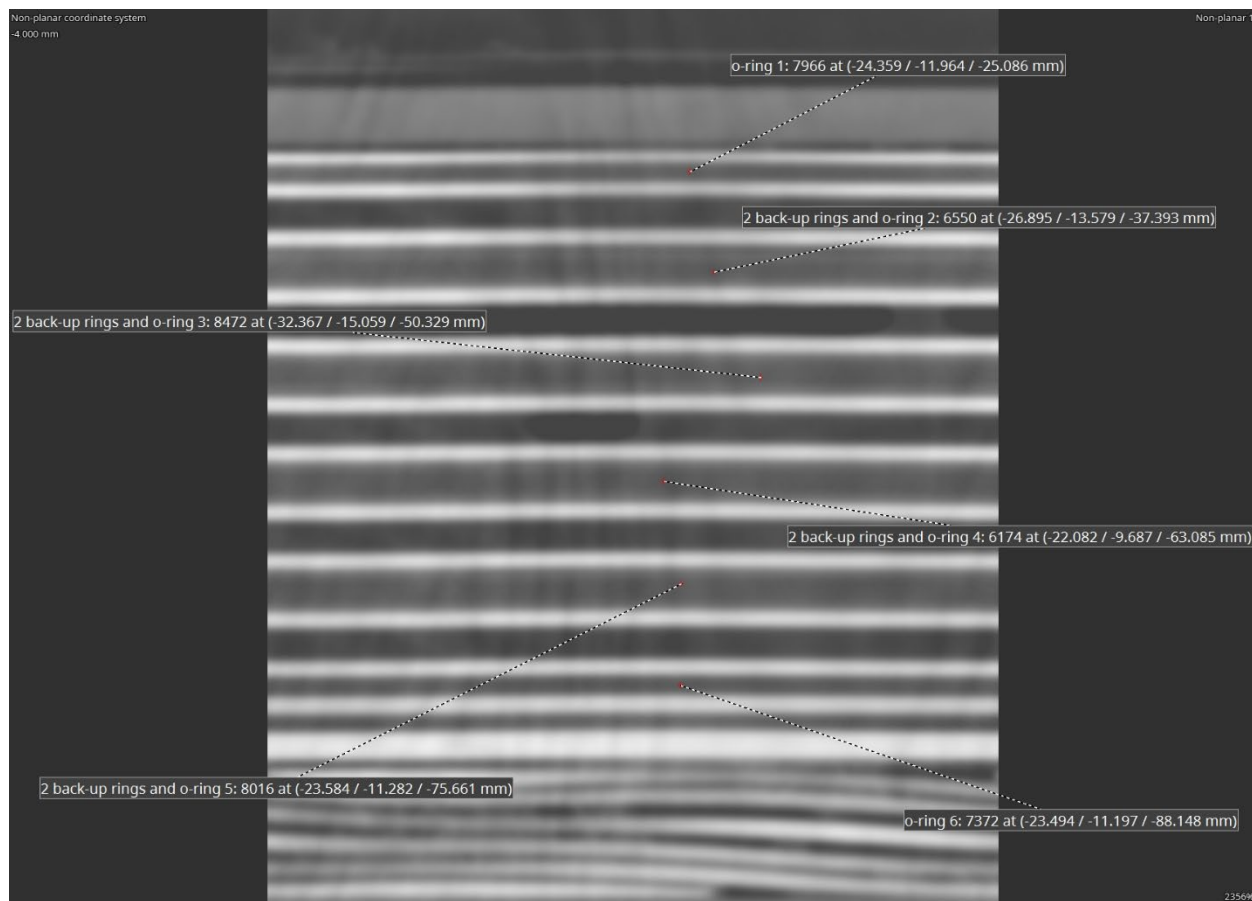
**Figure 13.** Lateral hydraulic actuator - spool unrolled.
