# National Transportation Safety Board

CEN23FA071

Group Chair's Factual Report - Addendum

Location: Galliano, Louisiana  
Date: December 29, 2022  
Time: 0834 central standard time  
Helicopter: Bell 407, registration N595RL

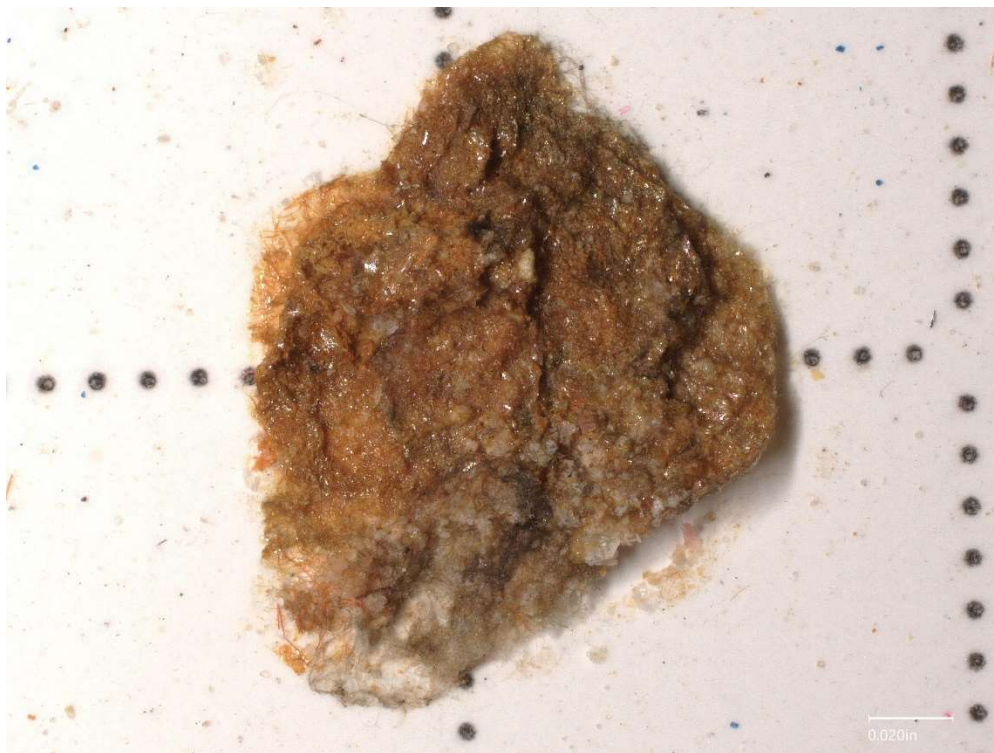
The debris collected from filtration (**Figure 1**) was examined using a Fourier transform infrared (FTIR) spectrometer with a diamond attenuated total reflectance (ATR) accessory. **Appendix A** shows the spectral peaks from this examination. A spectral library search was performed as well as a mixture analysis. The spectra were consistent with a mixture of materials such as surfactants and anti-corrosion products found in hydraulic fluid. The base material likely absorbed or was coated with hydraulic fluid, masking identification of the particulate material.

**Figure 1.** The debris collected from filtration during flushing of the actuator.

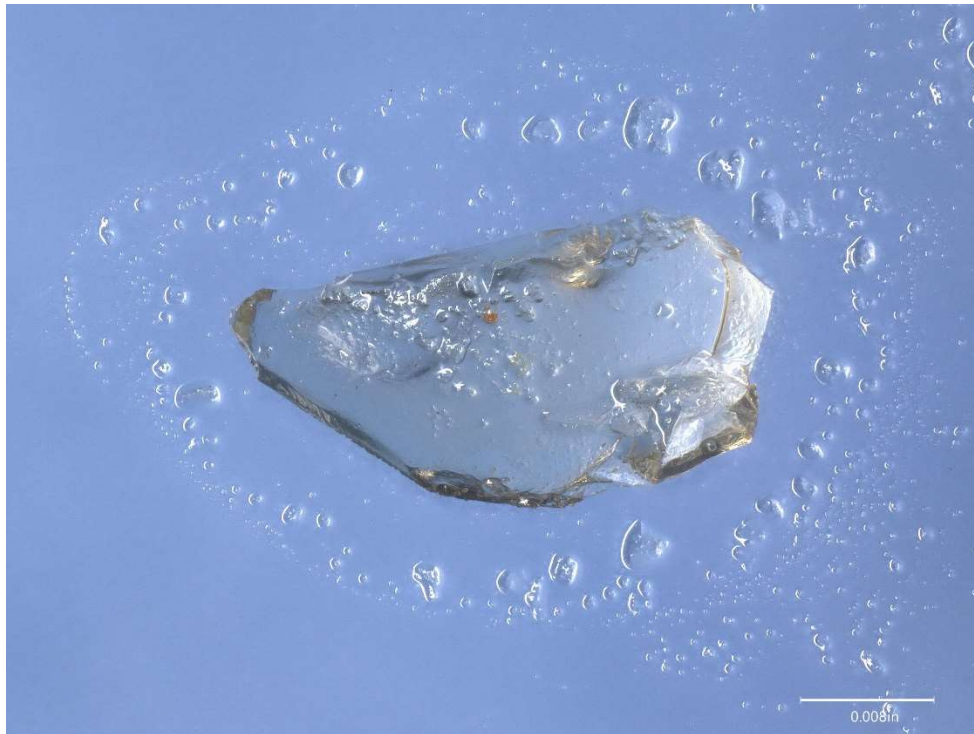
The clear debris from the spool (**Figure 2**) was examined using FTIR. No significant peaks were found in the FTIR spectrum indicating a lack of carbon and hydrogen bonds, consistent with it being an inorganic substance. The debris was examined using scanning electron microscopy (SEM) and semi-quantitative standardless energy dispersive X-ray spectroscopy (EDS). The EDS analysis found the presence of aluminum, sodium, chlorine, and oxygen. The sodium and chlorine present were consistent with sodium chloride. The aluminum and oxygen were indicative of aluminum oxide.

**Figure 3.** The clear debris from the spool of the actuator.

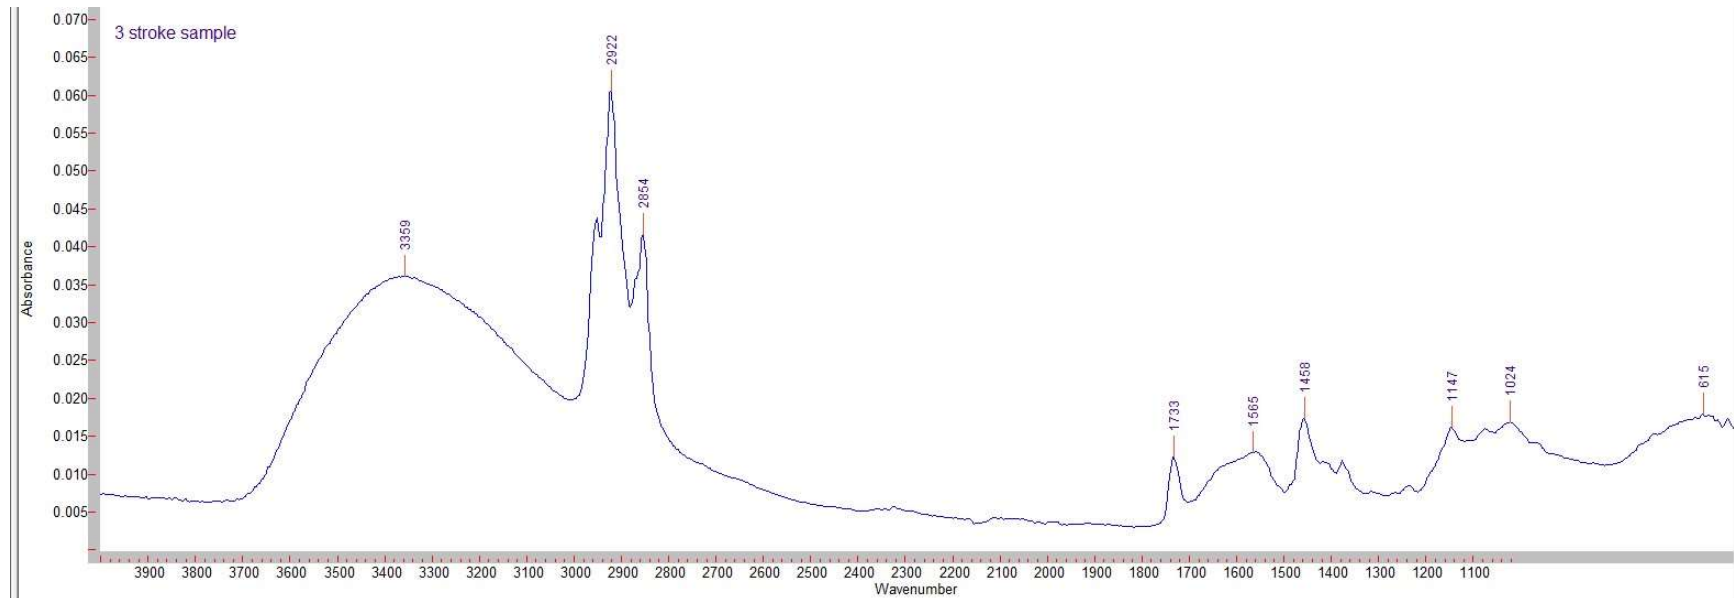
**Figure A-1.** The spectra of the debris collected during filtration of the hydraulic fluid from the lateral servo actuator.
