# National Transportation Safety Board

CEN23FA079

## **AIRCRAFT EXAMINATION SUMMARY**

Airplane: 1980 Piper PA-32-301T, N8266D

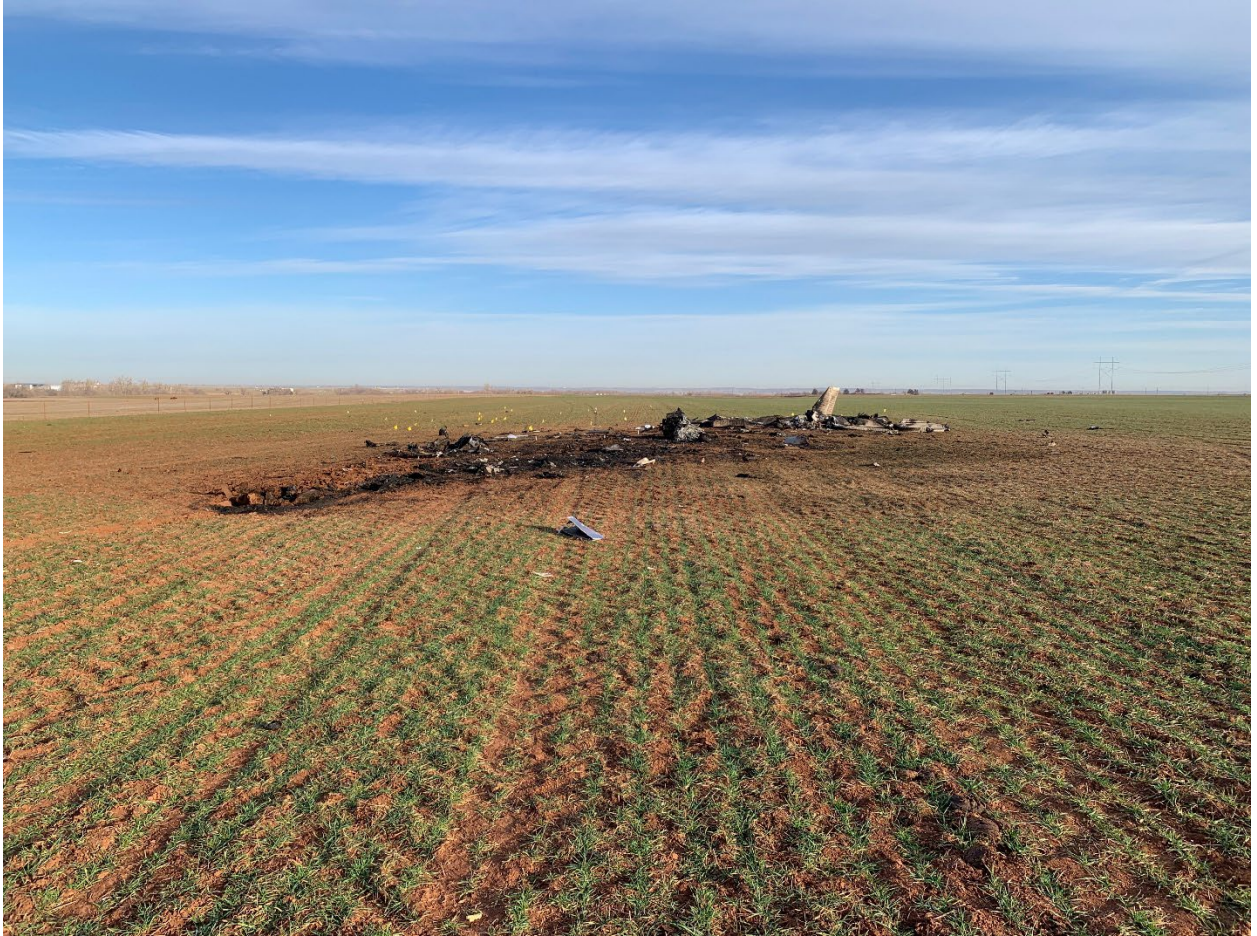
### **1.0 Accident Site**

The airplane impacted a level farm field with firm ground and little vegetation.

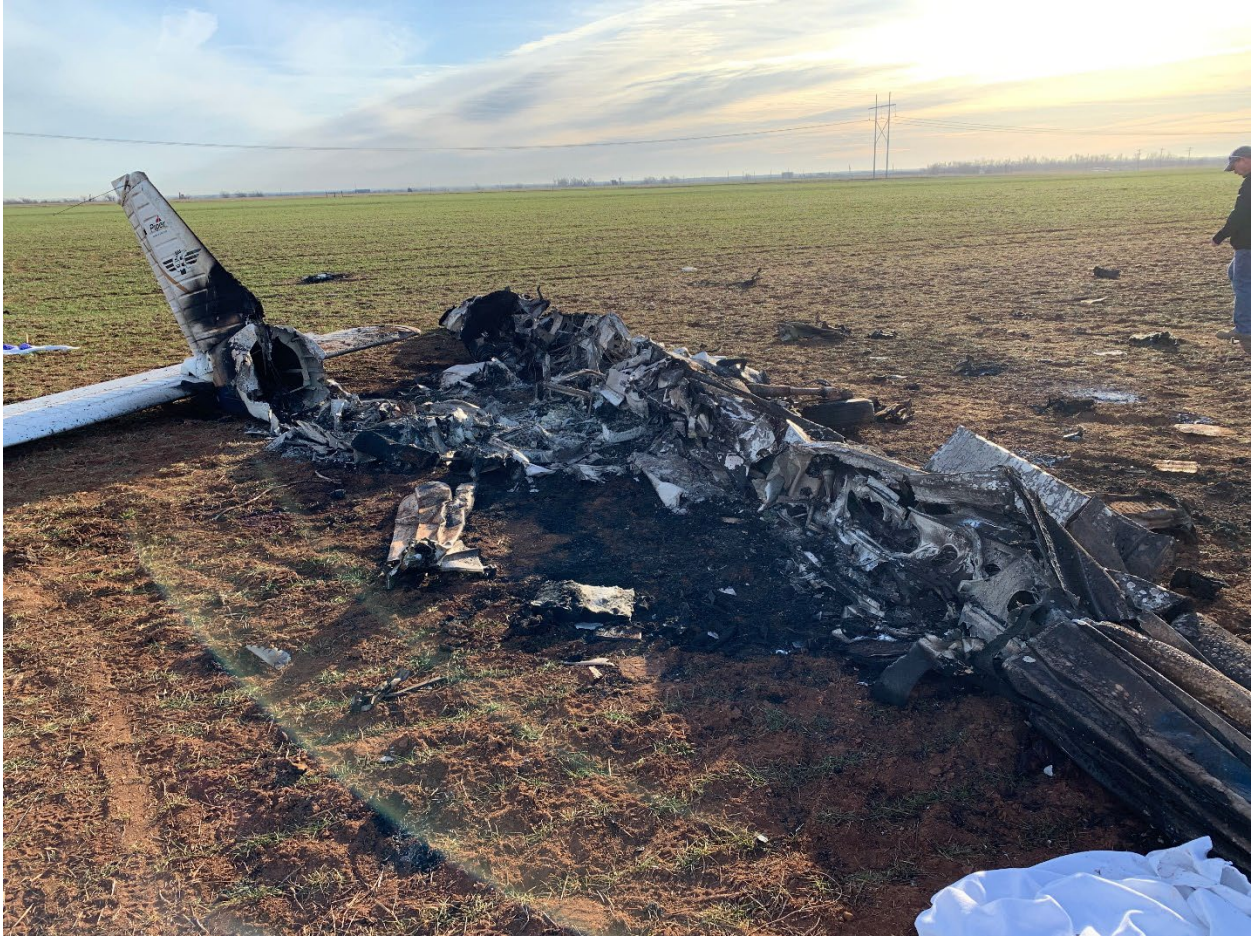
### **2.1 Fuselage**

The fuselage was almost entirely destroyed by fire. The fuselage from about the leading edge of the vertical tail and aft was all that remained intact.

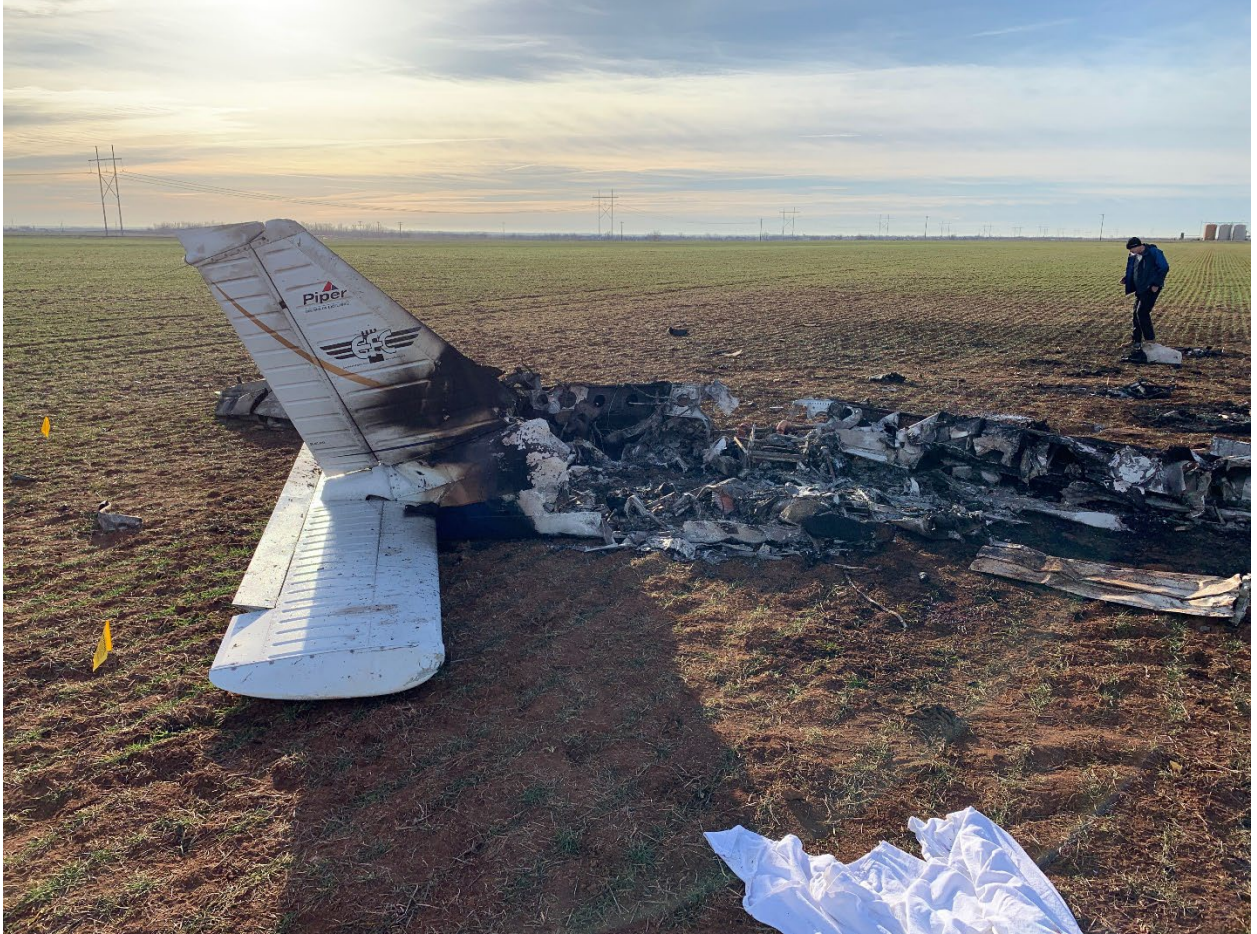
## 2.2 Empennage

The vertical tail, rudder, and horizontal stabilator remained attached to the aft fuselage and were mostly undamaged except for some impact related deformation of right tip. All of the tail surfaces exhibited varying amounts of thermal damage.

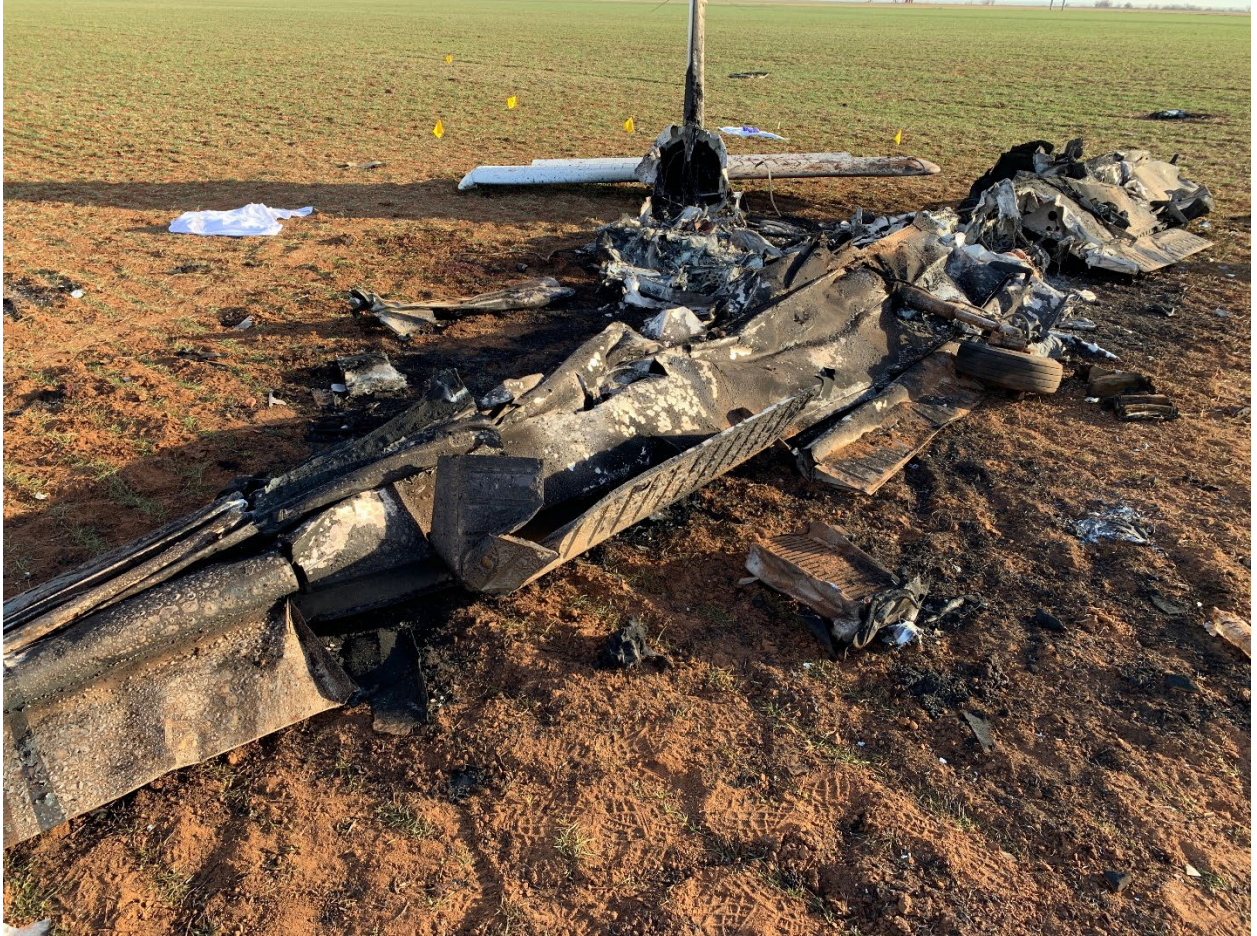
### 2.3 Wings

The wings came to rest inverted and inline with each other. There was melting of the center section spars in the cabin area. The leading edges of both wings were crushed aft and the fuel tanks ruptured. The ailerons and flaps remained attached to the wings.

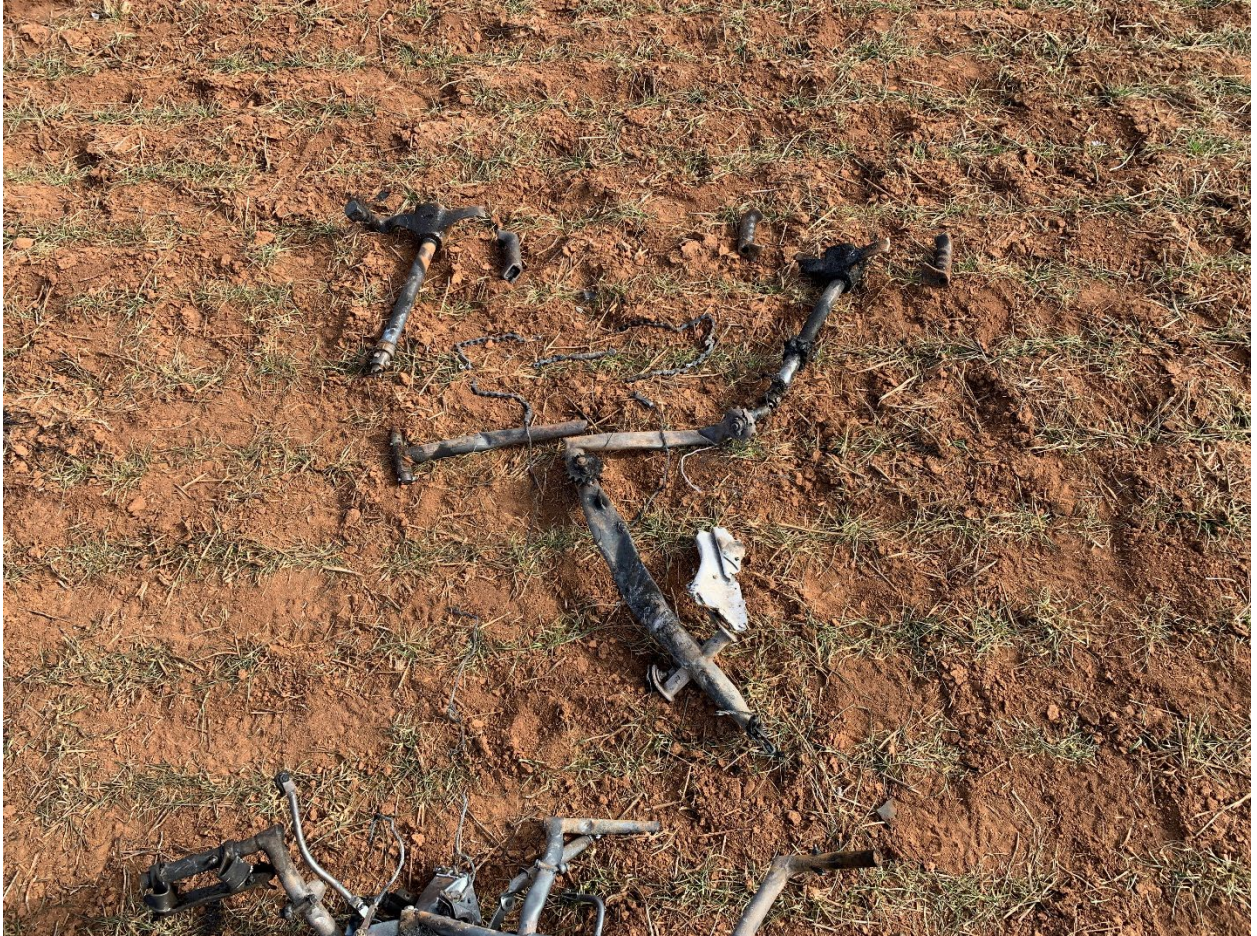
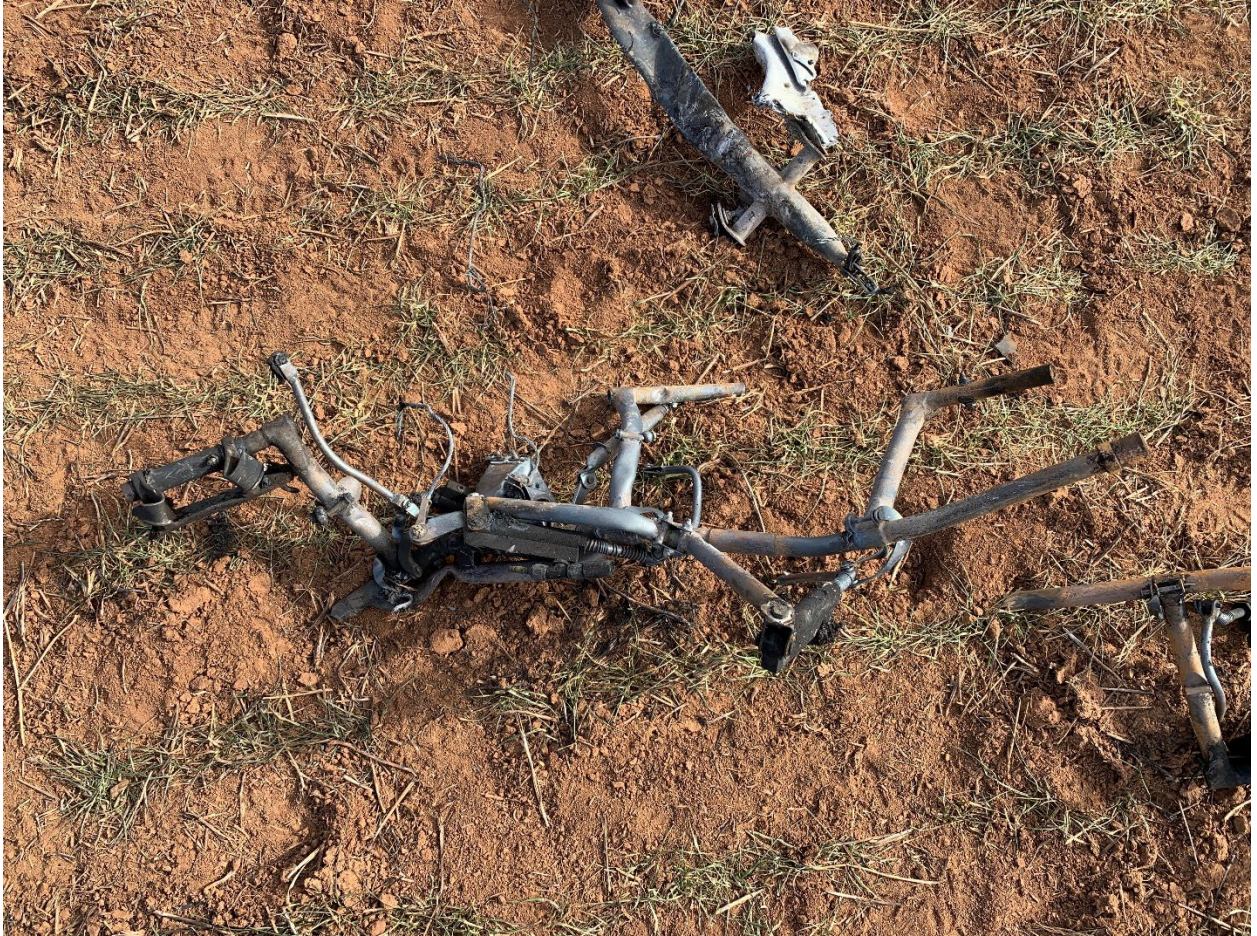
## **2.5 Other Systems**

The airplane flight control systems were examined. The rudder cables were continuous except for breaks near the attachment to the rudder pedals. The stabilator cables were continuous except for breaks near their attachment to the bottom of the control T-bar. The aileron cables were continuous except for breaks near their connection to the control column chain segment. The chain was broken into several pieces. The flap control lever was in the flaps retracted position and the cable was still attached and intact. The flap return spring was located but had disconnected from the flap control system. All exterior airplane doors were located at the accident scene.

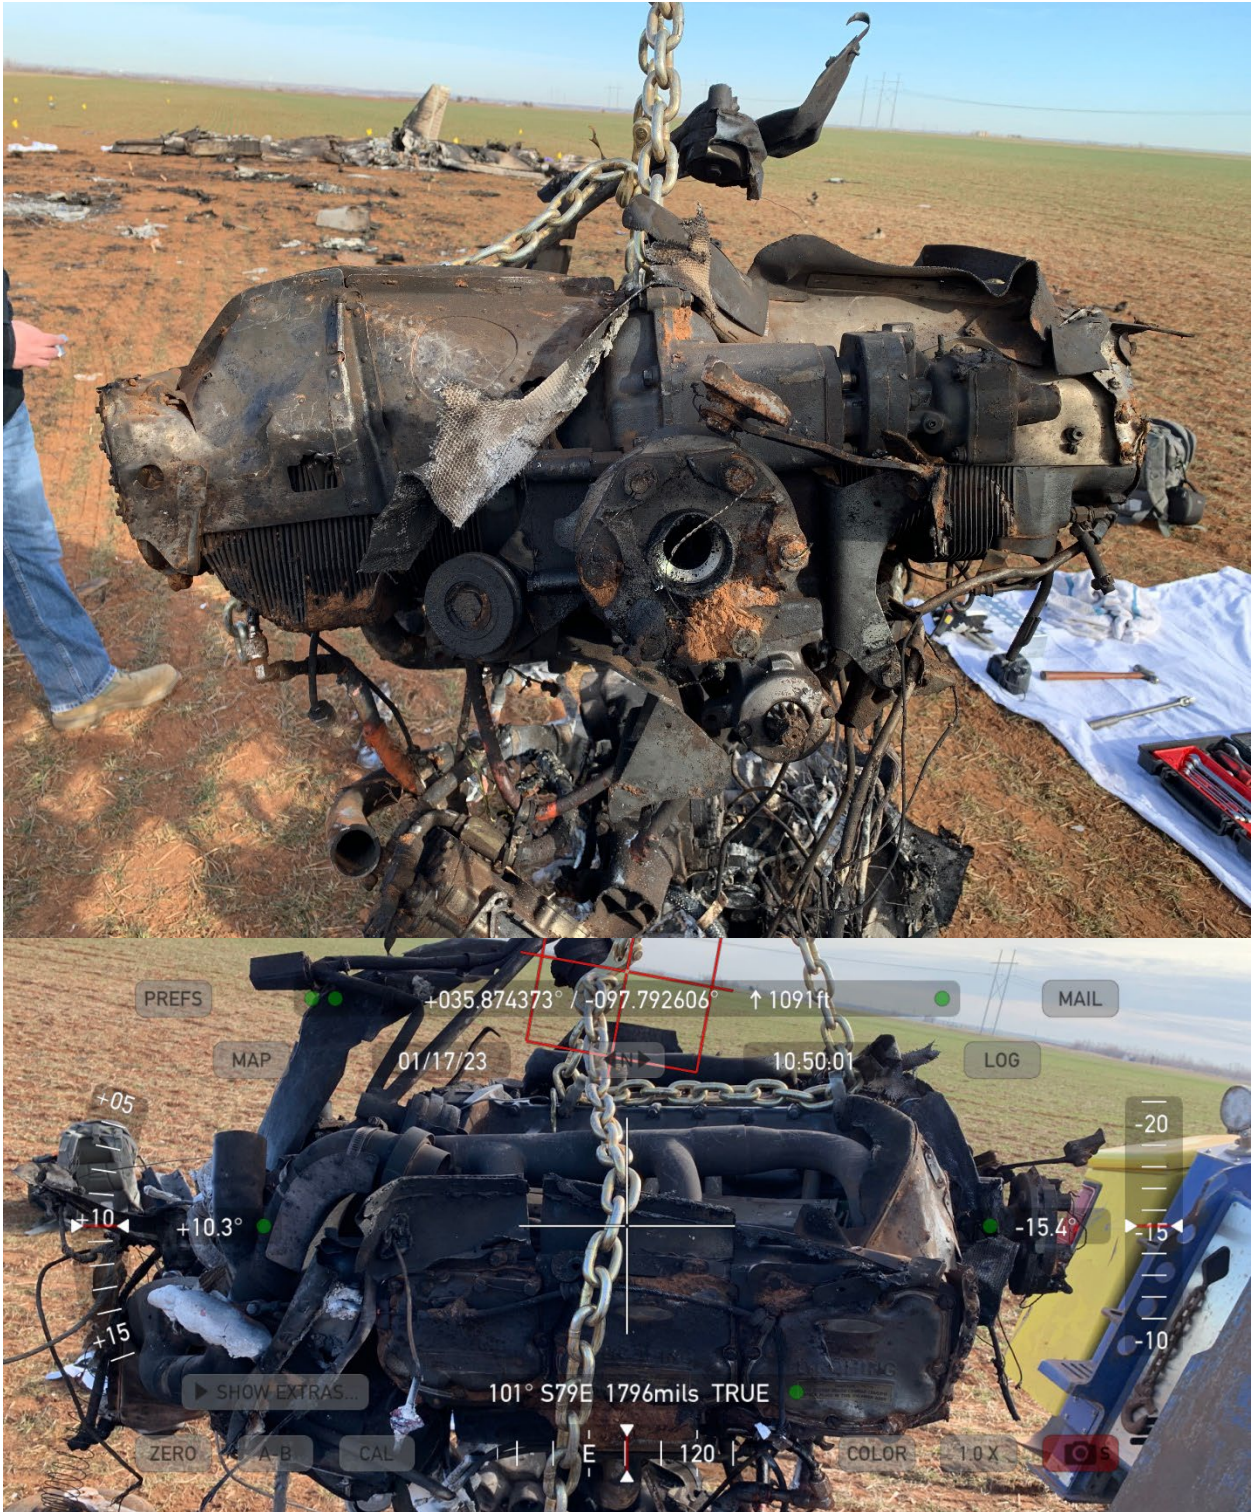
### **3.0 Engine Examination**

The engine was able to rotate with difficulty. Accessory gear continuity was confirmed and valve action was noted on all cylinders. The fuel injection throttle body and induction plenum were separated from the individual cylinder intake tubes. The single drive dual magneto was separated from the accessory case and was found in the debris field. The magneto case was fractured exposing the internal components of the magneto. The oil suction screen was removed and debris was found that was retained for further examination. There were several separations in the engine exhaust system. The turbocharger was displaced and had a hole in the induction side of the housing. All exhaust V-band clamps were located. The tailpipe had separated from the turbocharger, but the V-band clamp was still in place on the turbocharger side. The tailpipe and V-band clamp exhibited physical deformation.

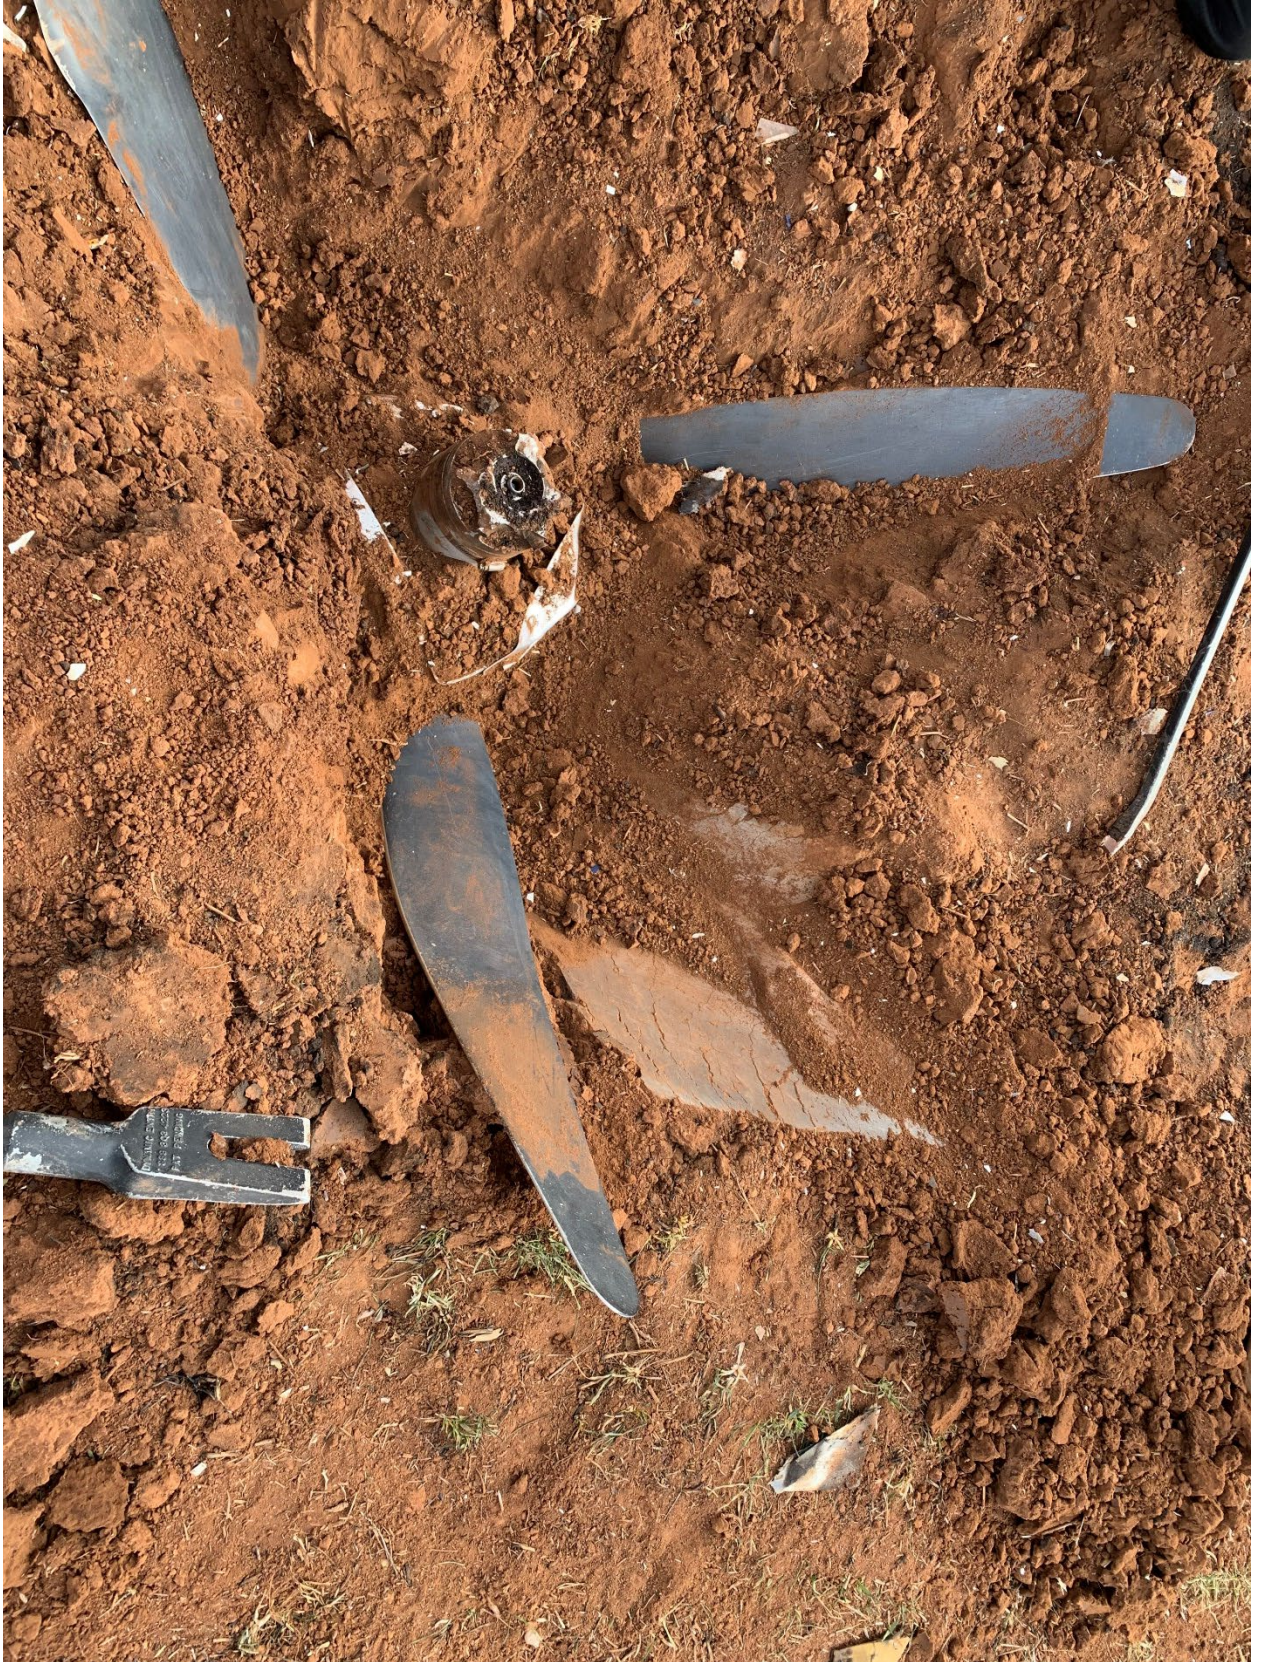
#### 4.0 Propeller Examination

The propeller was in a hole near the initial impact point. The prop position was with the rotational axis of the propeller in a near vertical orientation. The prop hub

was separated from the crankshaft but otherwise was intact. The 3 blades remained attached to the hub and all three blades were bent aft. Each blade exhibited varying degrees of leading edge polishing and chordwise scratching.
