CEN23FA079

## INVESTIGATION PHOTOGRAPHS

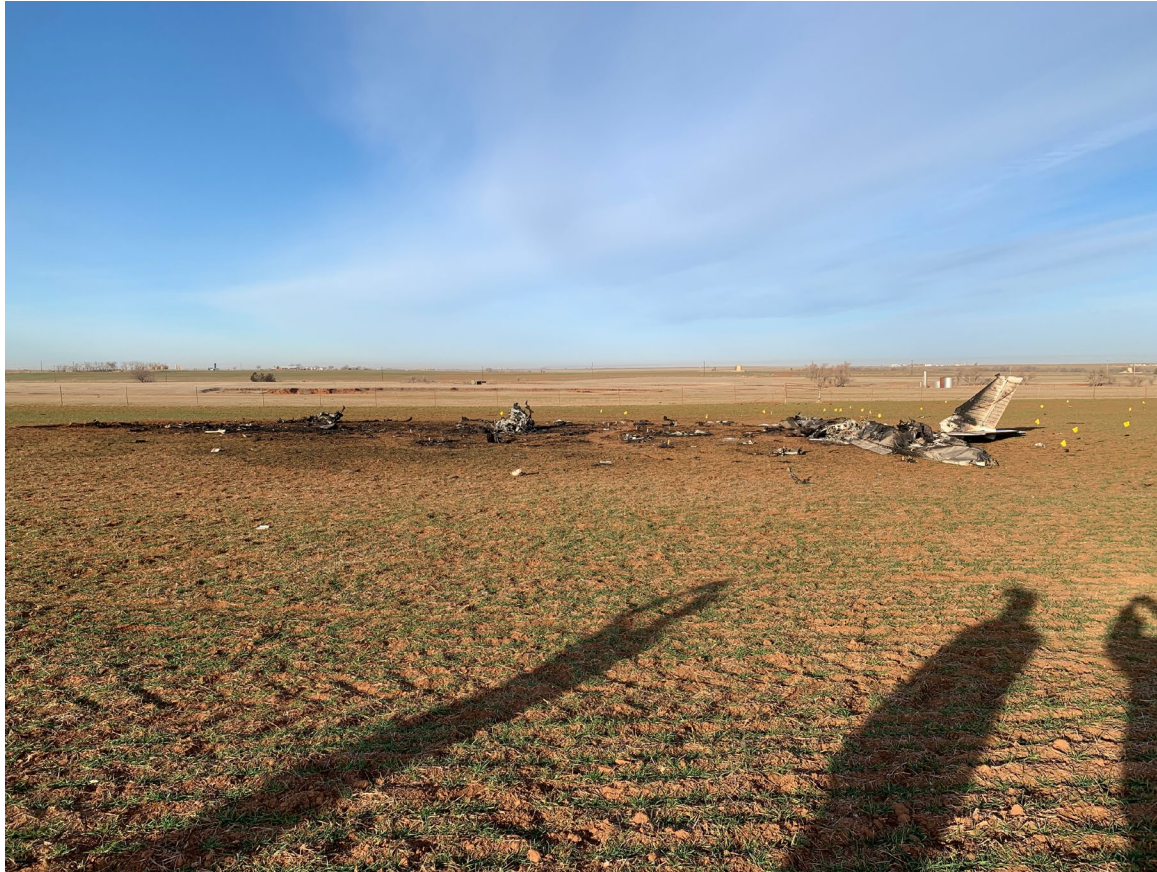
**Photograph 1 - Debris path viewed from left side of airplane (NTSB Photo)**

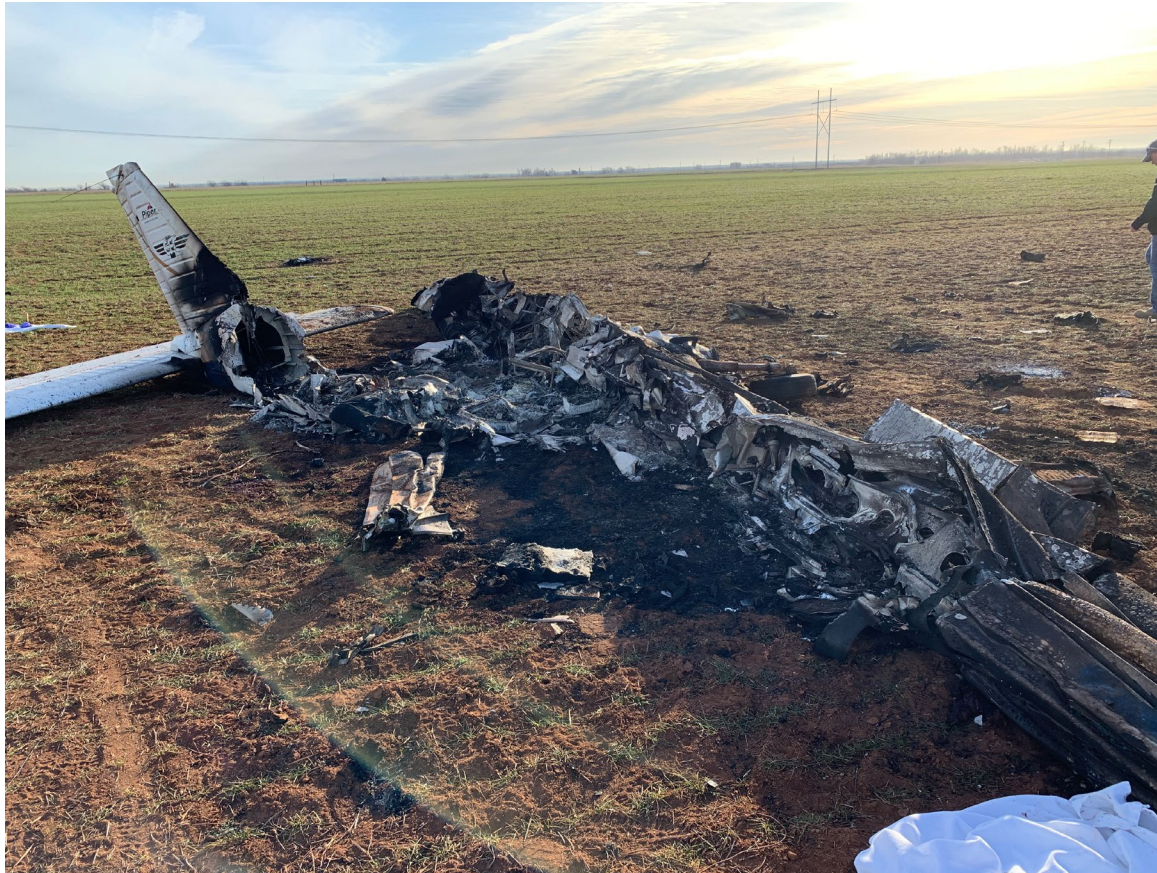
**Photograph 2 - View of airplane from front right (NTSB Photo)**

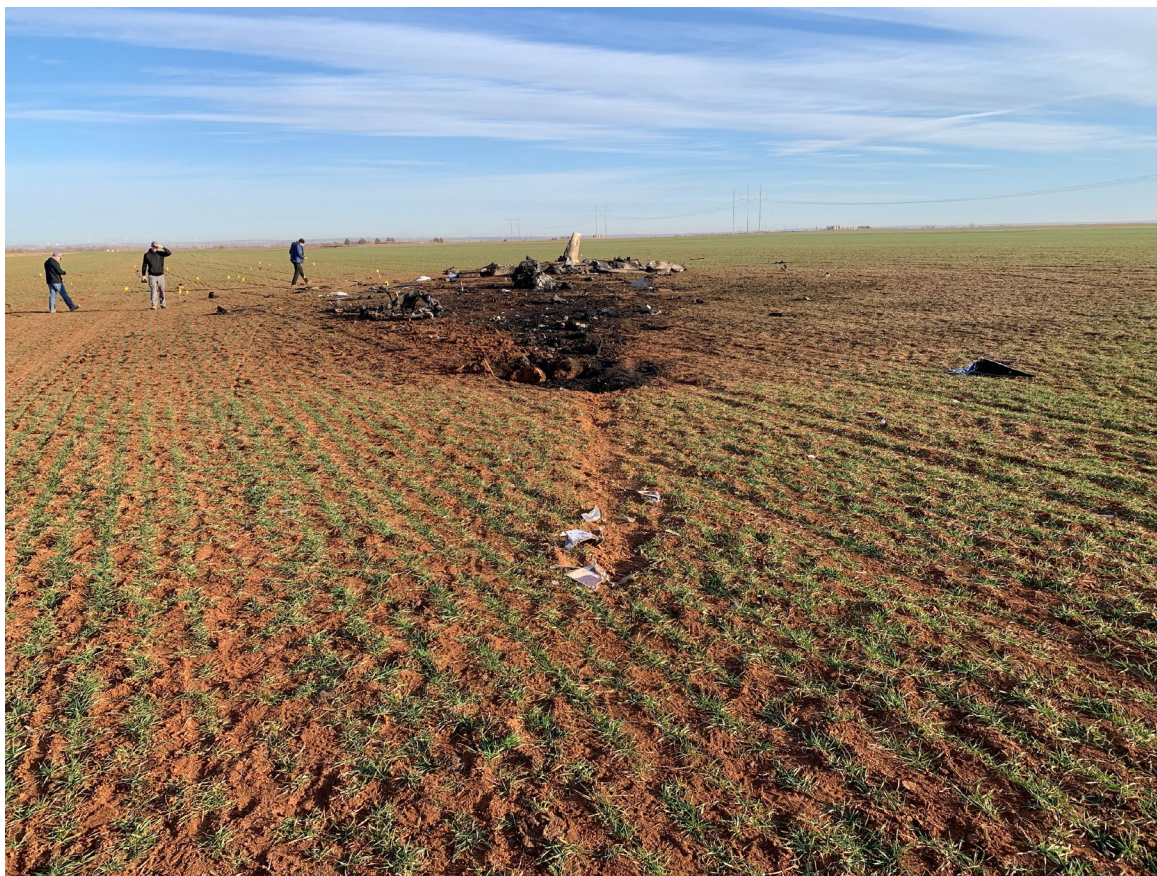
**Photograph 3 - Wreckage path (NTSB Photo)**

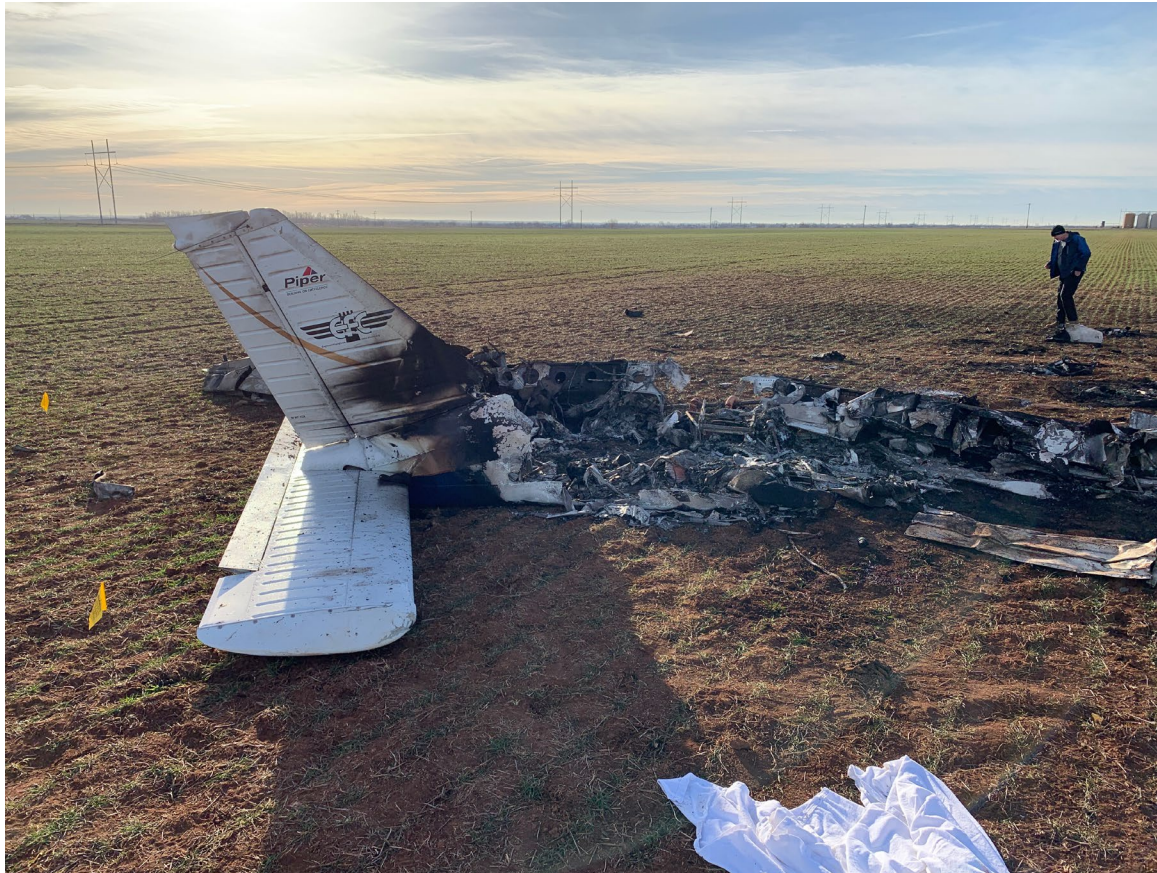
**Photograph 4 - View of airplane from right side (NTSB Photo)**

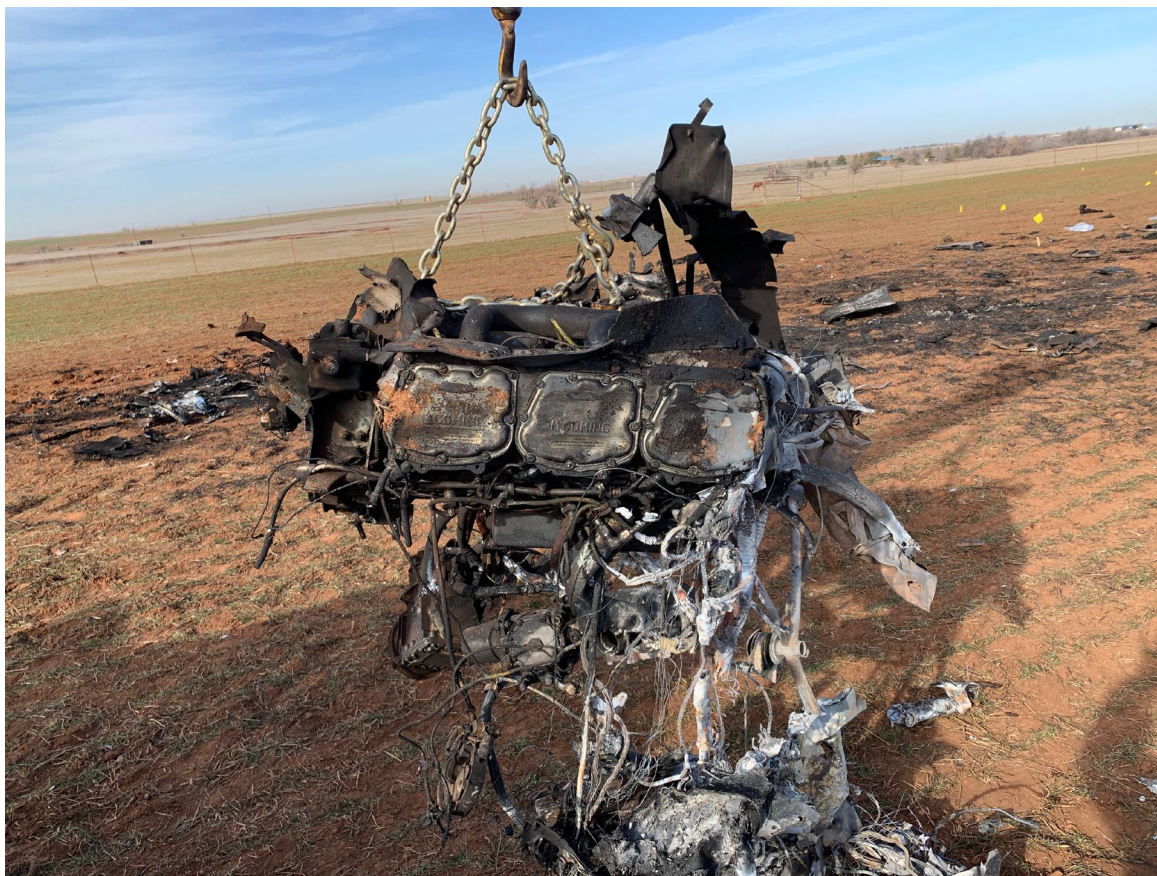
**Photograph 5 - Engine during on-scene examination (NTSB Photo)**

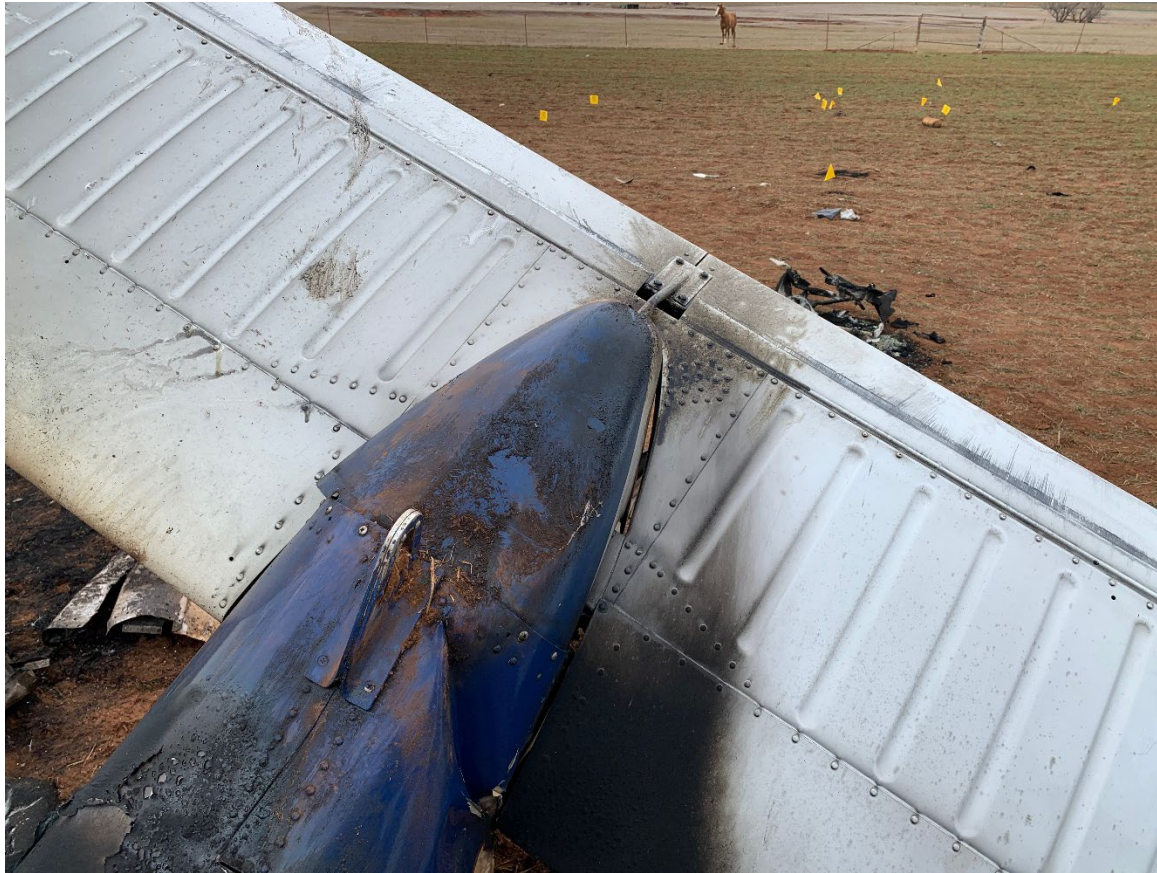
**Photograph 6 - View of tail showing oil streaking and sooting (NTSB Photo)**

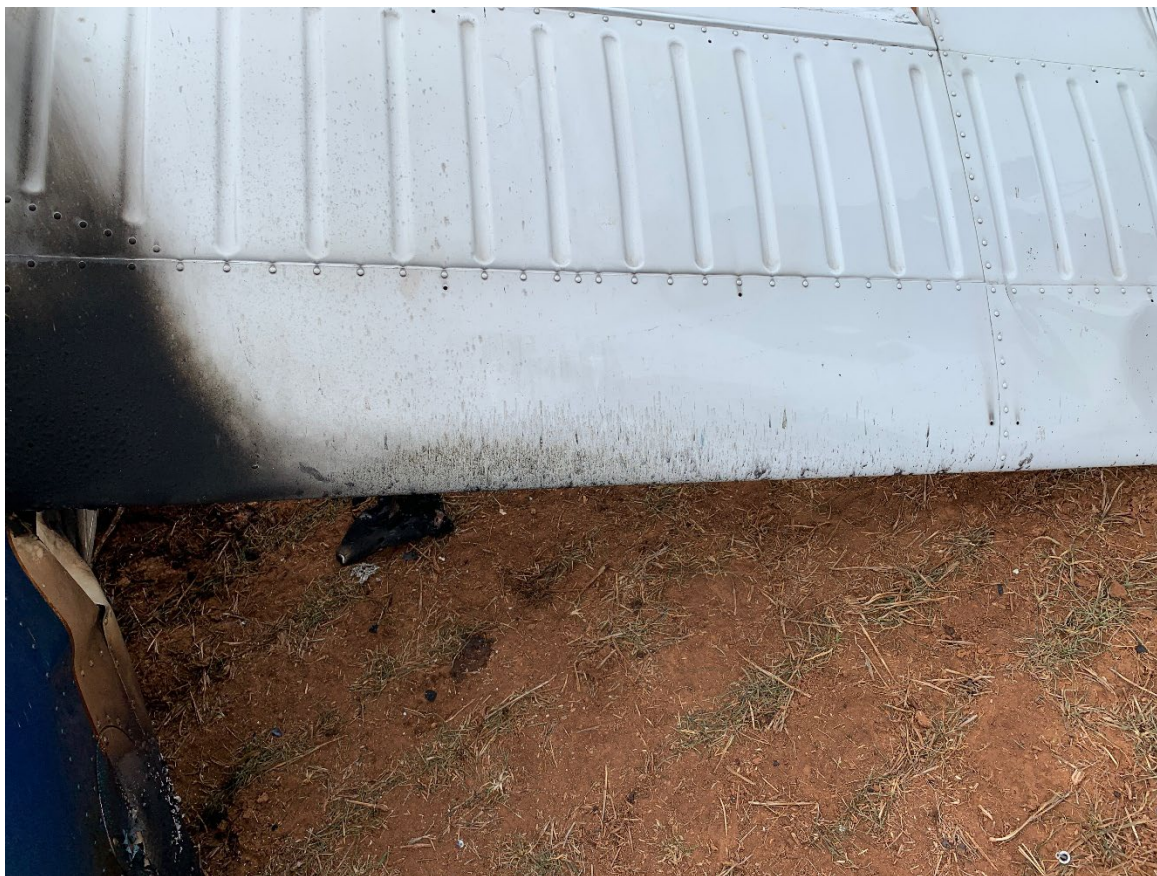
**Photograph 7 - View of tail showing oil streaking and sooting (NTSB Photo)**
