# National Transportation Safety Board

CEN23FA084

## **SURVIVAL FACTORS**

Specialist's Factual Report

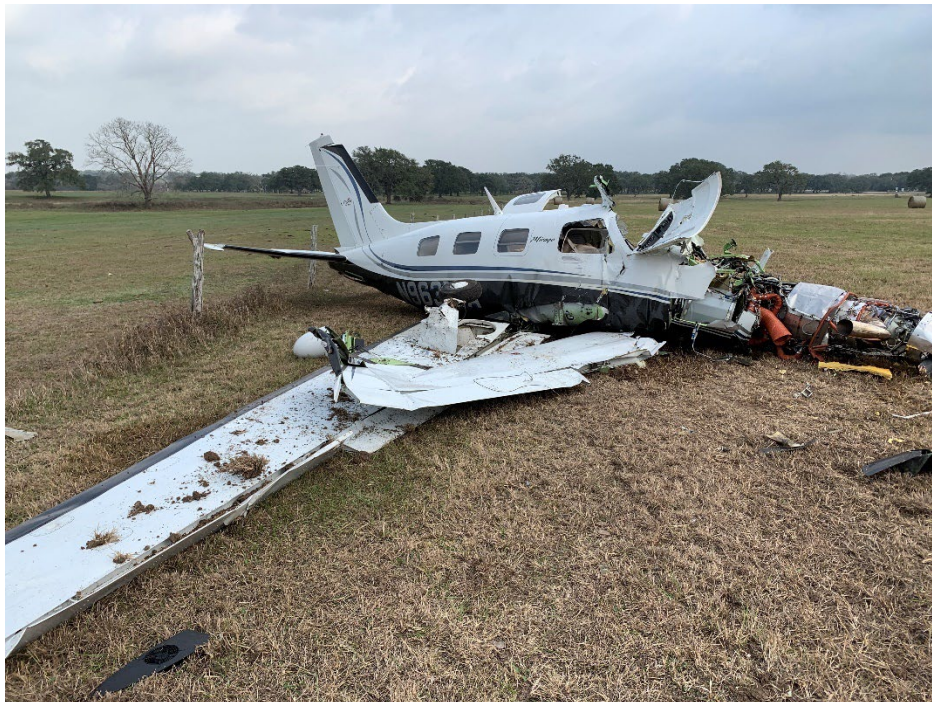
**Figure 3.** N963MA right side as found at the accident site. (Source: Piper Aircraft)

The airplane was found upright by investigators at the accident site. Both wings separated from the fuselage, and there was significant damage to the front of the airplane with loss of overhead structure in the cockpit (See figure 3 and 4).

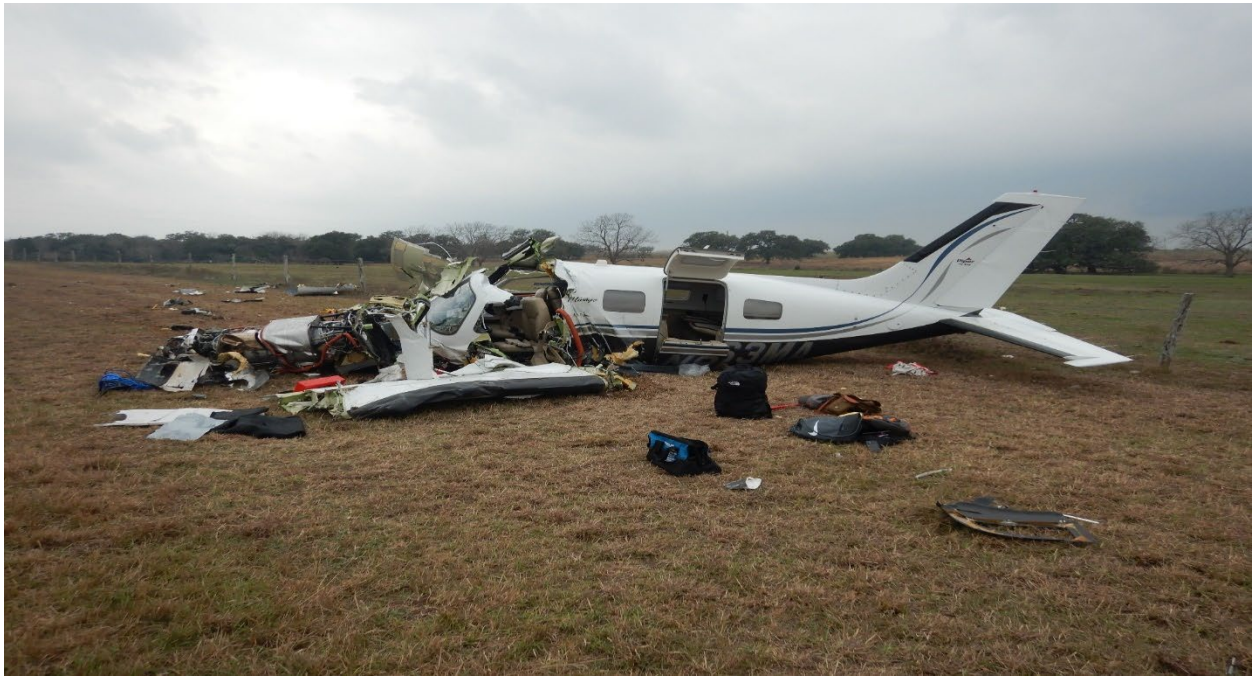
**Figure 4.** N963MA left side as found at the accident site. (Source: Piper Aircraft)

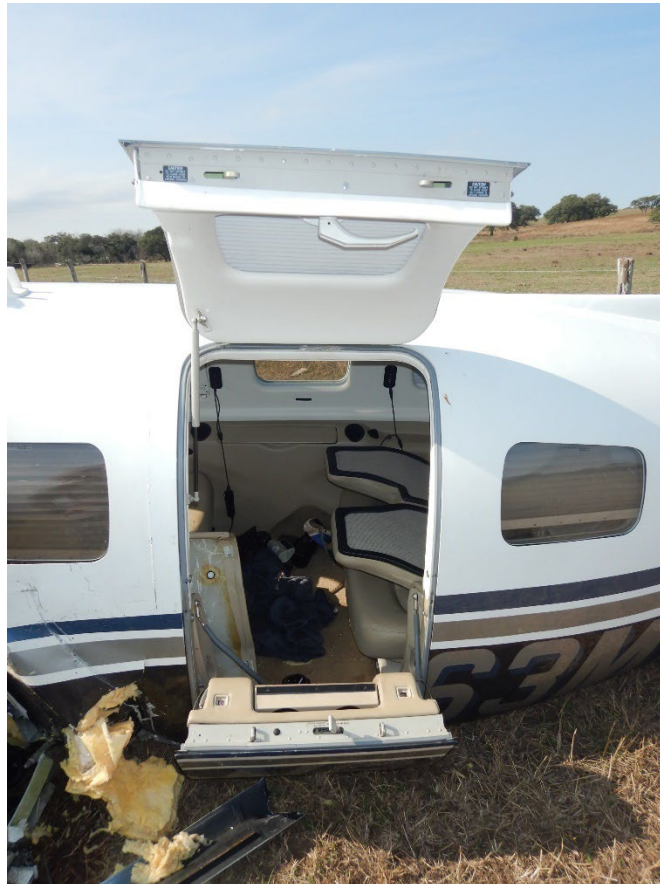
During normal operation, the airplane interior was accessed by a clam shell-type, two-piece door located adjacent to seat 5. The door was operated from the interior by rotating a lever clockwise, which released the top portion, allowing it to open with an outward push and its pneumatic assists. The bottom portion was opened by pulling up on a lever located on the top of the bottom half structure (see figure 5). According to a statement provided by the survivor, the door popped open during the accident sequence. First responders found the door open upon arrival (see figure 6).

**Figure 6.** Main door as found by investigators at the accident site. (Source: Piper Aircraft)

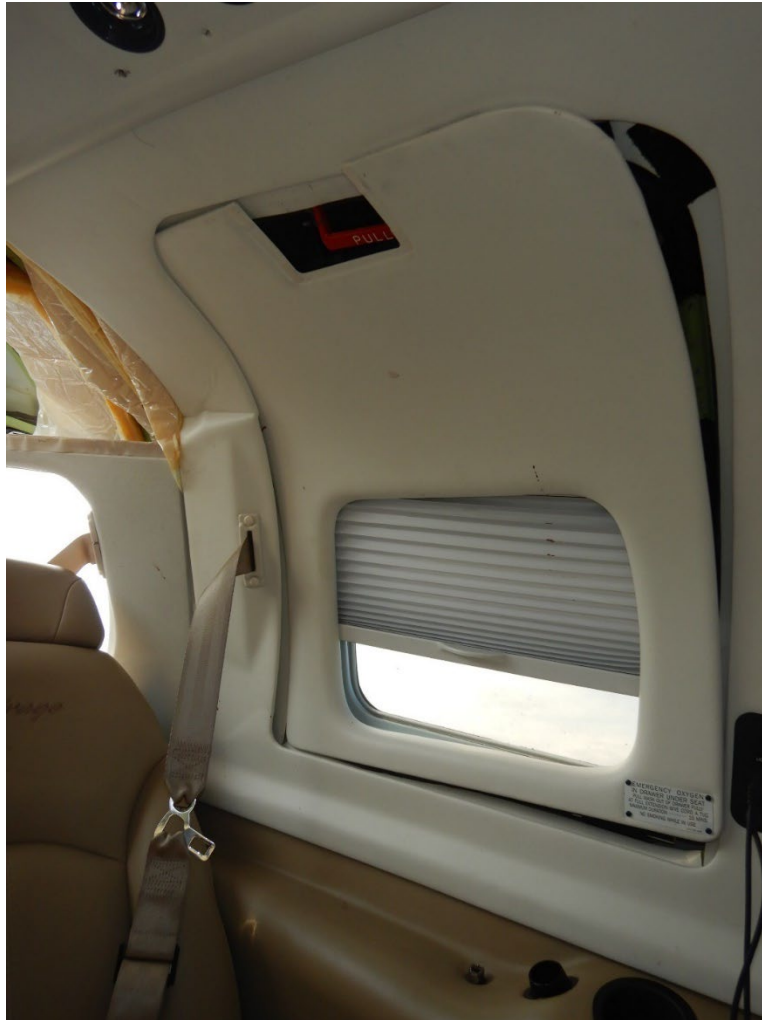
There was an emergency exit hatch located adjacent to seat 4 that was closed and secured when first responders and investigators arrived. The trim on the door was dislodged (see figure 7). The hatch was opened normally and without resistance at the salvage facility.

**Figure 7.** Emergency exit as found by investigators at the accident site. (Source: Piper Aircraft).

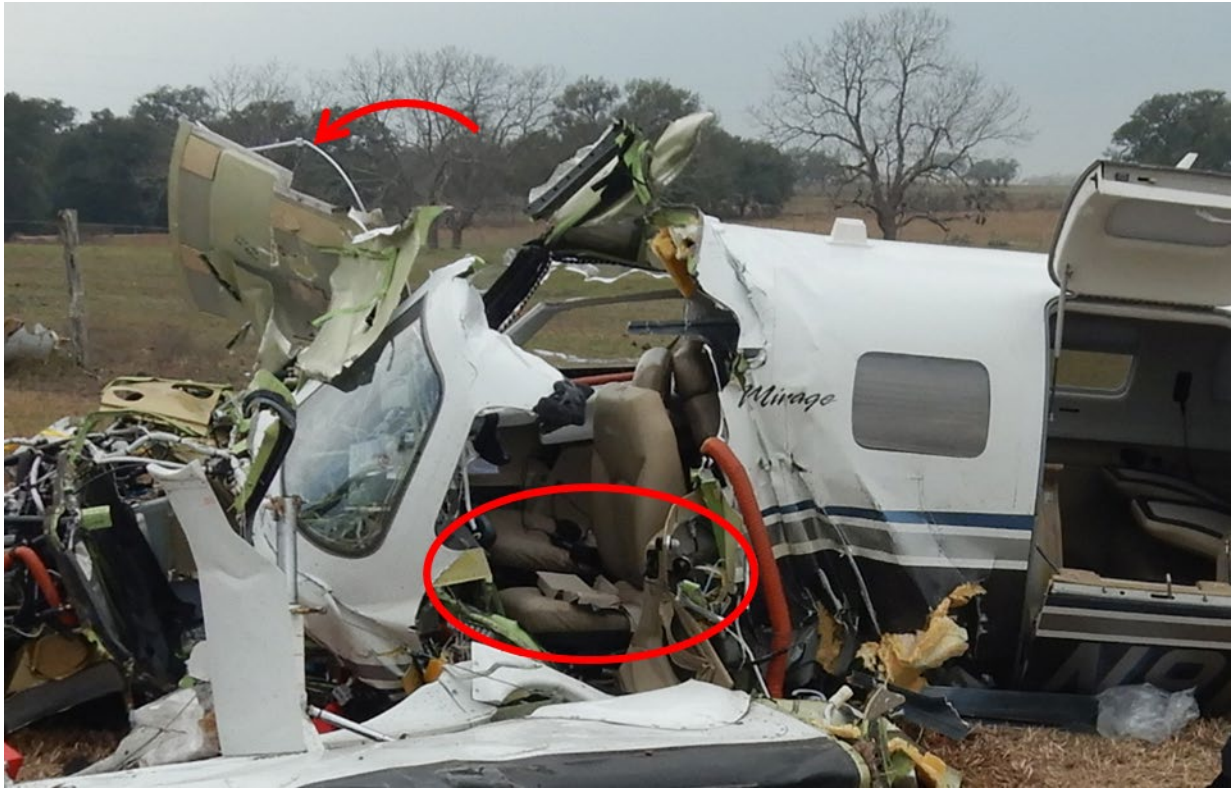
The cockpit area sustained substantial damage upon impact. Additionally, during the extrication of the occupants, emergency responders cut away structure and debris (see figure 8). The overhead trim was bent forward, and flight control cables next to the front, left seats were moved or cut as required.

**Figure 8.** The cockpit area marked where emergency services moved structure to remove the occupants.

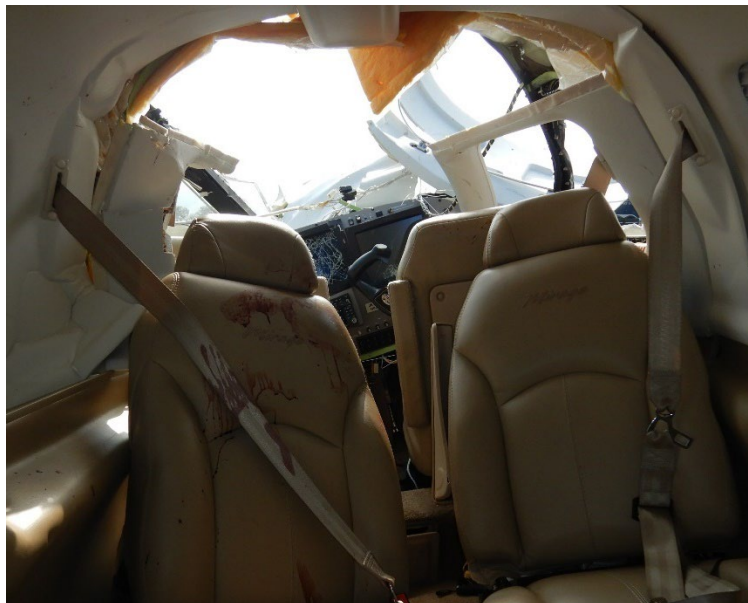
**Figure 9.** Forward-facing view of seats 3 and 4.

Measurements were taken from the floor to the ceiling in between seats 3 and 4 and measured about 46 inches, the nominal height as provided by Piper Aircraft was 46.67 inches. The height from the boxed structure that seats 5 and 6 were secured on to overhead structure measured about 41 inches. The nominal height provided by the representative from Piper Aircraft was 40.17 inches.

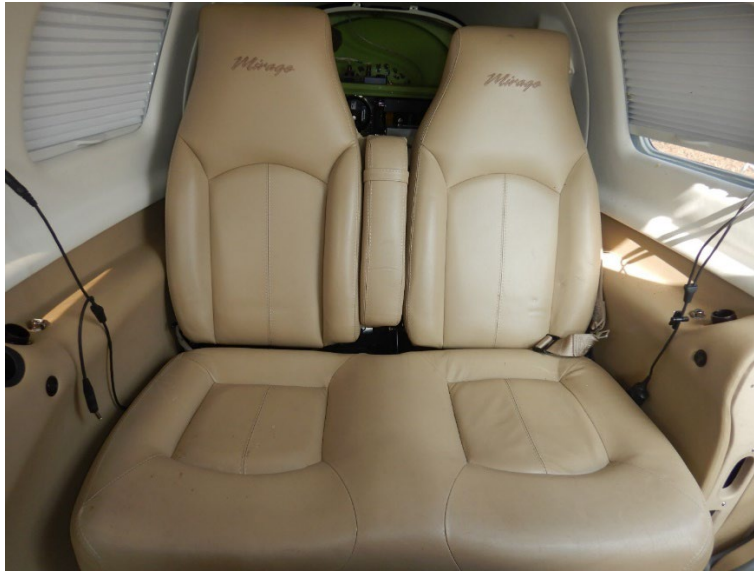
**Figure 10.** Aft-facing view of seats 5 and 6.

Measurements were taken across the back at seats 5 and 6 and measured 44 inches, with the nominal as provided 44.24 inches. The width at the pilot, copilot, and seats 3 and 4 were unable to be measured due to cabin damage from the impact.

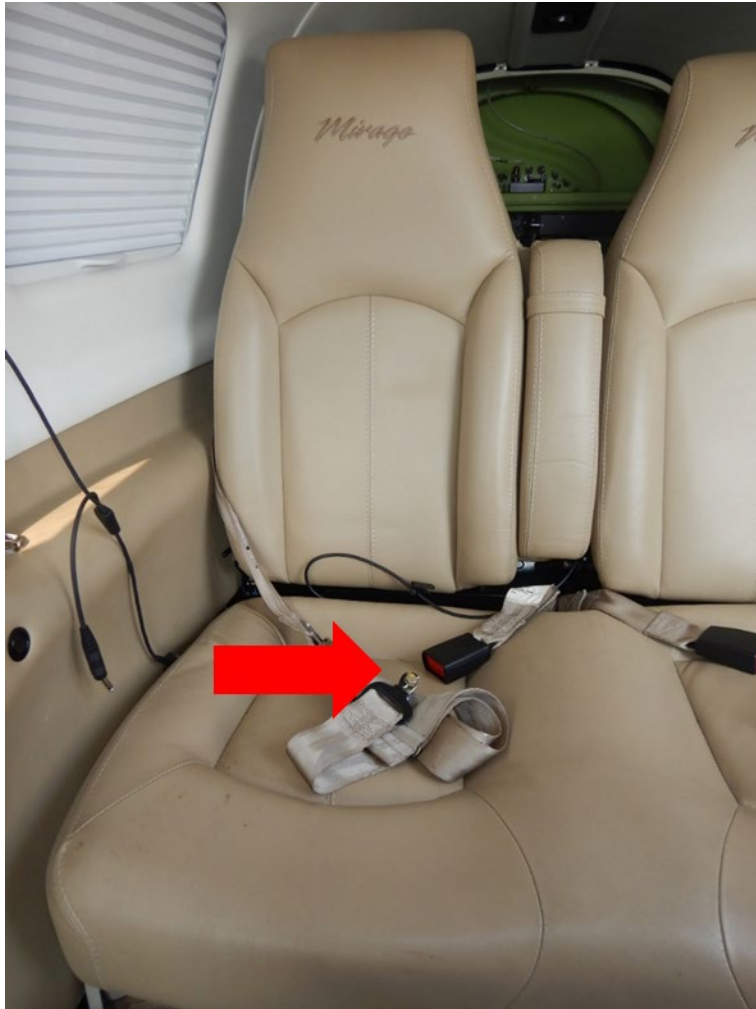
The surviving passenger in seat 6 stated he was wearing his 3-point restraint at the time of the accident. The outboard lap belt attachment point was found separated from the structure (see figures 12 to 14). The passenger did not report the failure in flight but did remember unlatching his restraint system. Photographs of the failed lap belt anchor hardware were sent to NTSB metallurgists, who determined based upon those the failure appeared to be likely consistent with overload signatures. Additionally, it was noted that the shoulder belt had about a 4.5-inch wear mark on the webbing about 10 inches from the buckle insert tab. When the insert tab was inserted into the buckle it would not latch. According to the survivor he unbuckled his restraint without difficulty before evacuating the airplane.

**Figure 12.** Outboard anchor failure at seat 6.

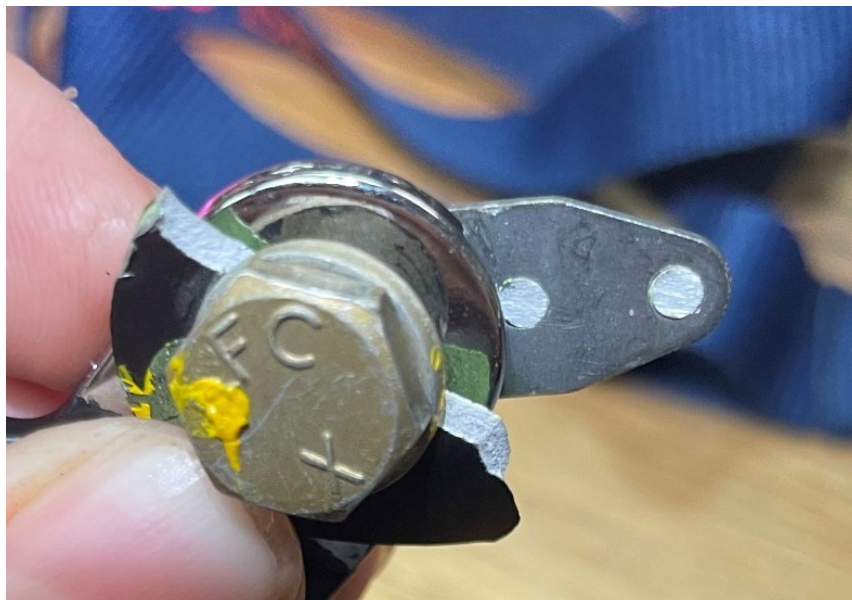
**Figure 13.** Close up view of the seat 6 outboard anchor with through bolt still secured.

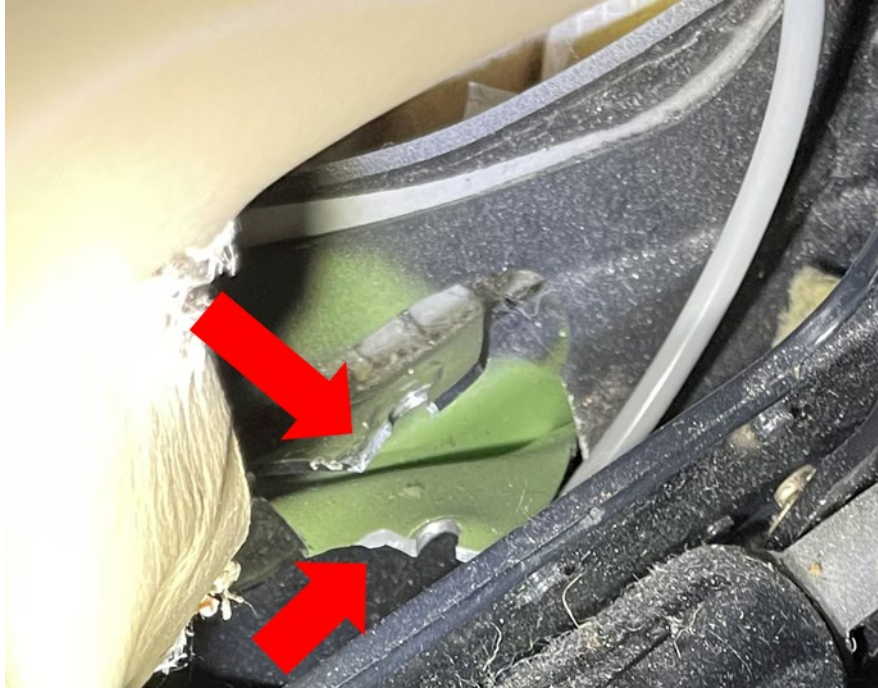
**Figure 14.** Seat 6 outboard anchor point airplane bracket, red arrows point to failed portion of the bracket.

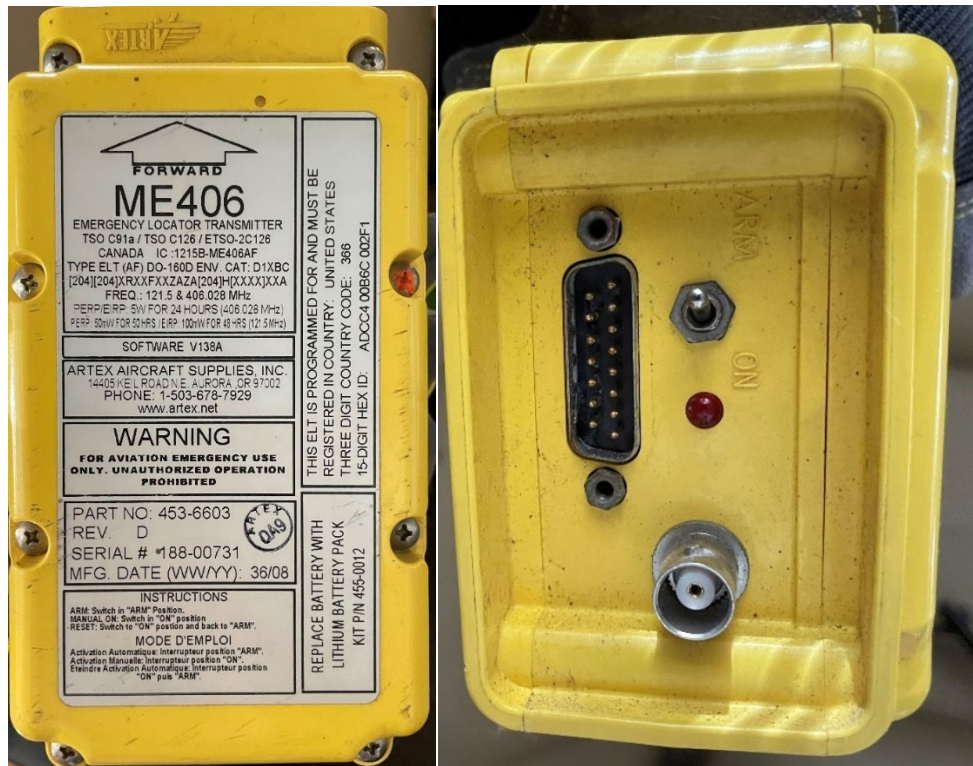
DPS stated that the airplane's 406 MHz ELT was operating when they arrived and was removed from the airframe by first responders to stop the signal. The ELT was located in the debris at the salvage facility with the switch set in the armed position (see figure 16 and 17).

**Figure 16.** ELT information, including the switch in the armed position.

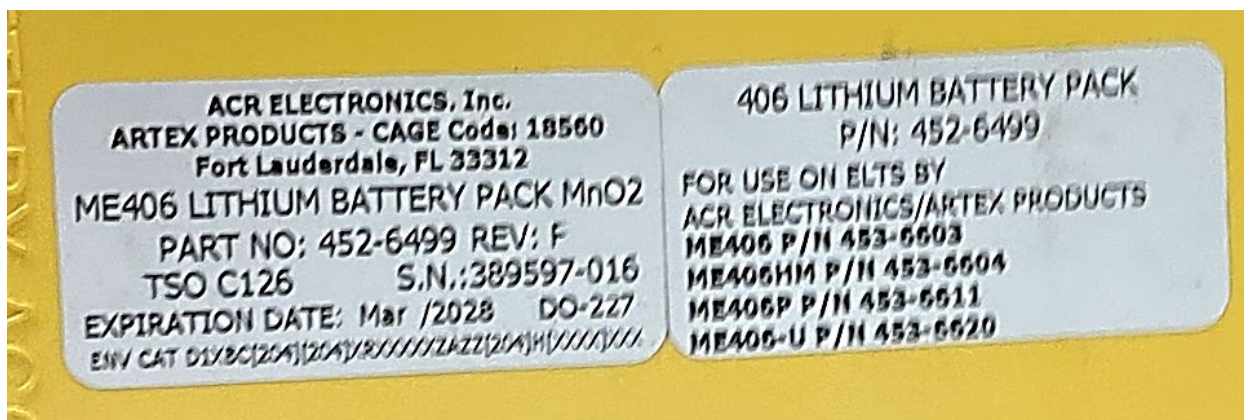
**Figure 17.** ELT battery information.
