# National Transportation Safety Board

CEN23FA095

## **AIRCRAFT EXAMINATION**

Location: Hooker, OK  
Date: January 28, 2023  
Time: 1902 CST  
0102 UTC  
Airplane: N6482B, Cessna 172

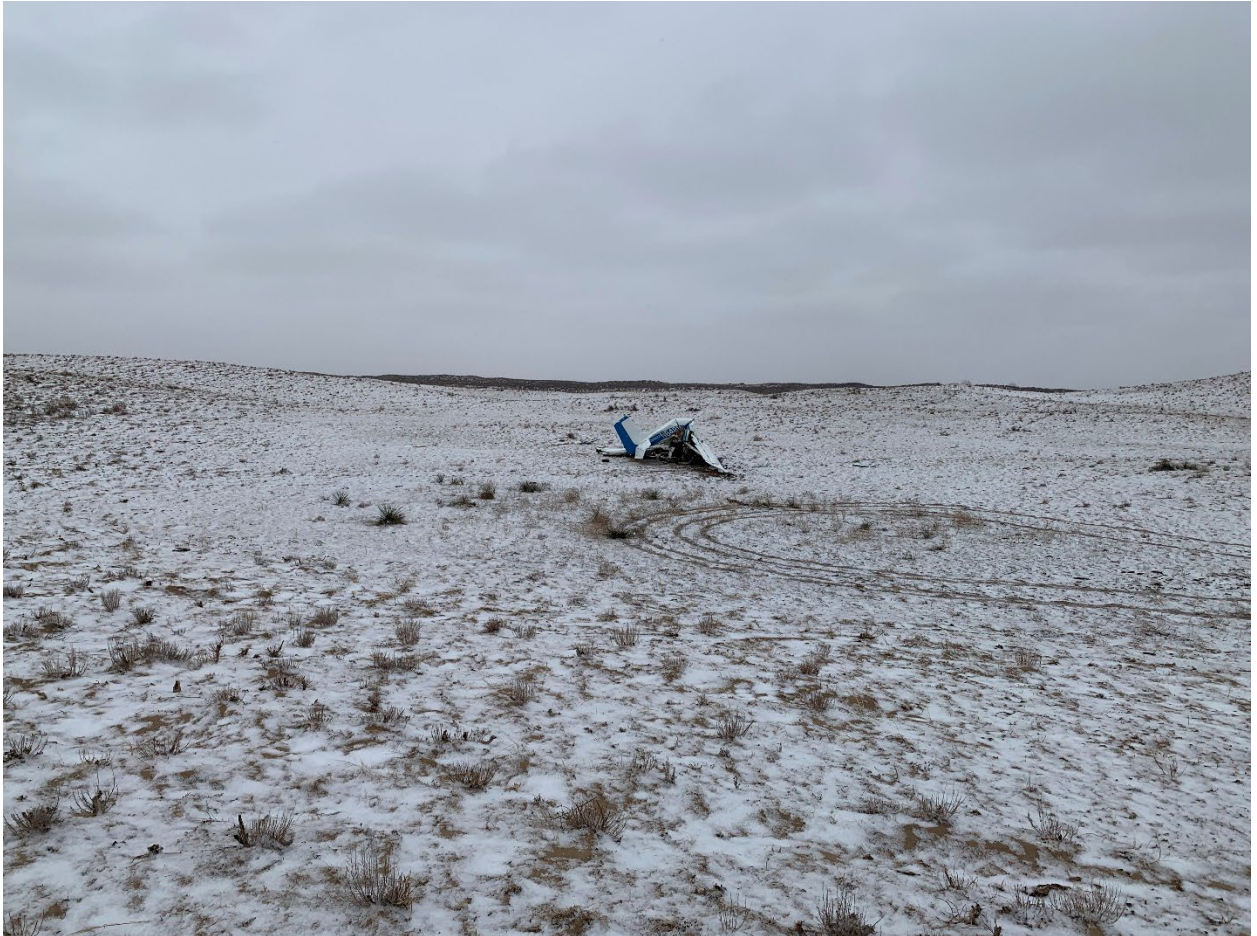
The airplane impacted rolling terrain at coordinates 38:58:15N 101:17:26W. The area where the accident occurred was rural rolling terrain. There were few structures nearby. The nearest town was several miles away and the area where the accident happened would have little ground lighting sources.

Figure 1: Accident terrain

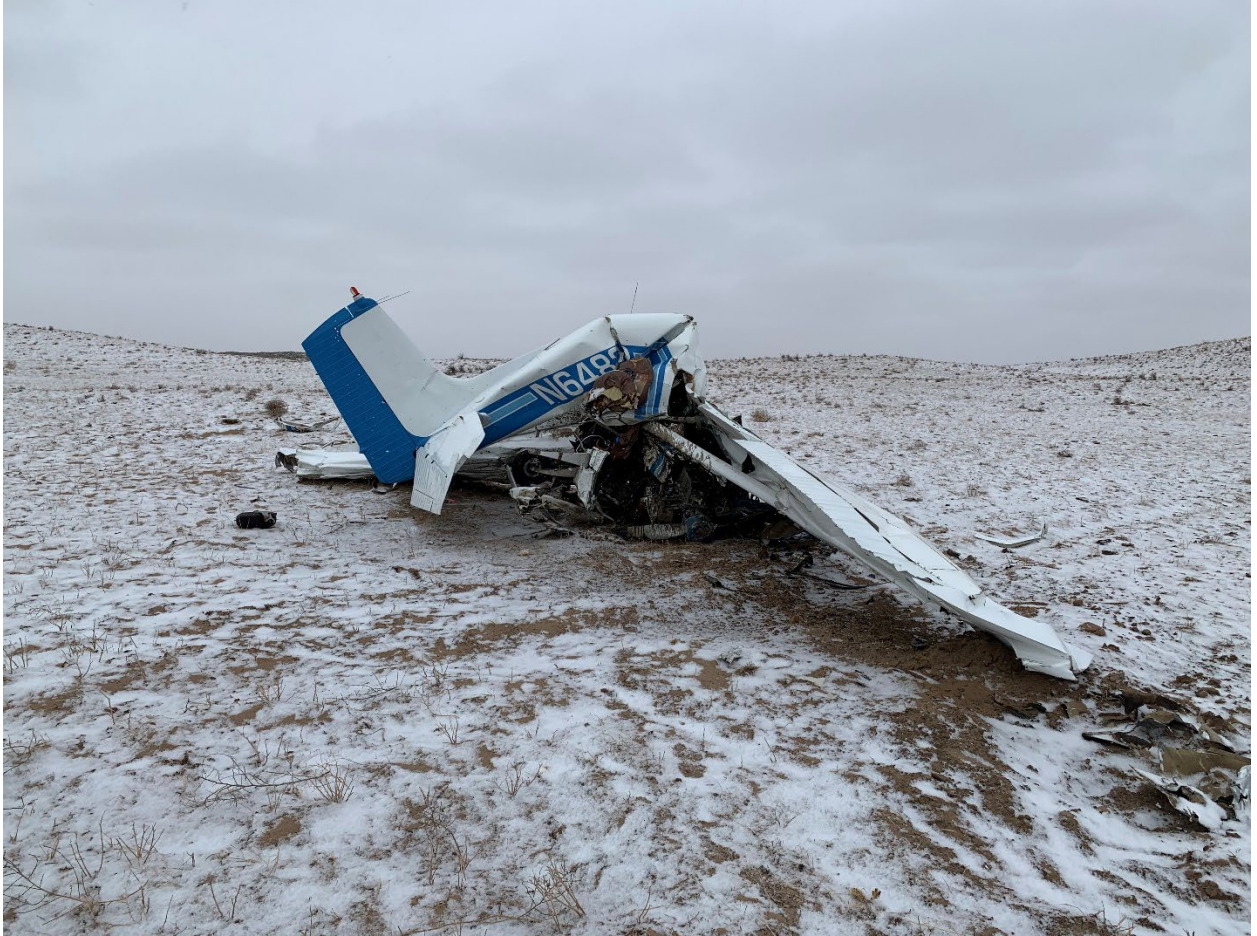
The airplane came to rest in a nose down attitude. All major components of the airplane were accounted for in the immediate area of the accident site. The aft fuselage was bent downward relative to the rest of the airplane. The wing leading edges were crushed rearward and consistent with a near vertical impact.

Figure 2: Airplane at accident site

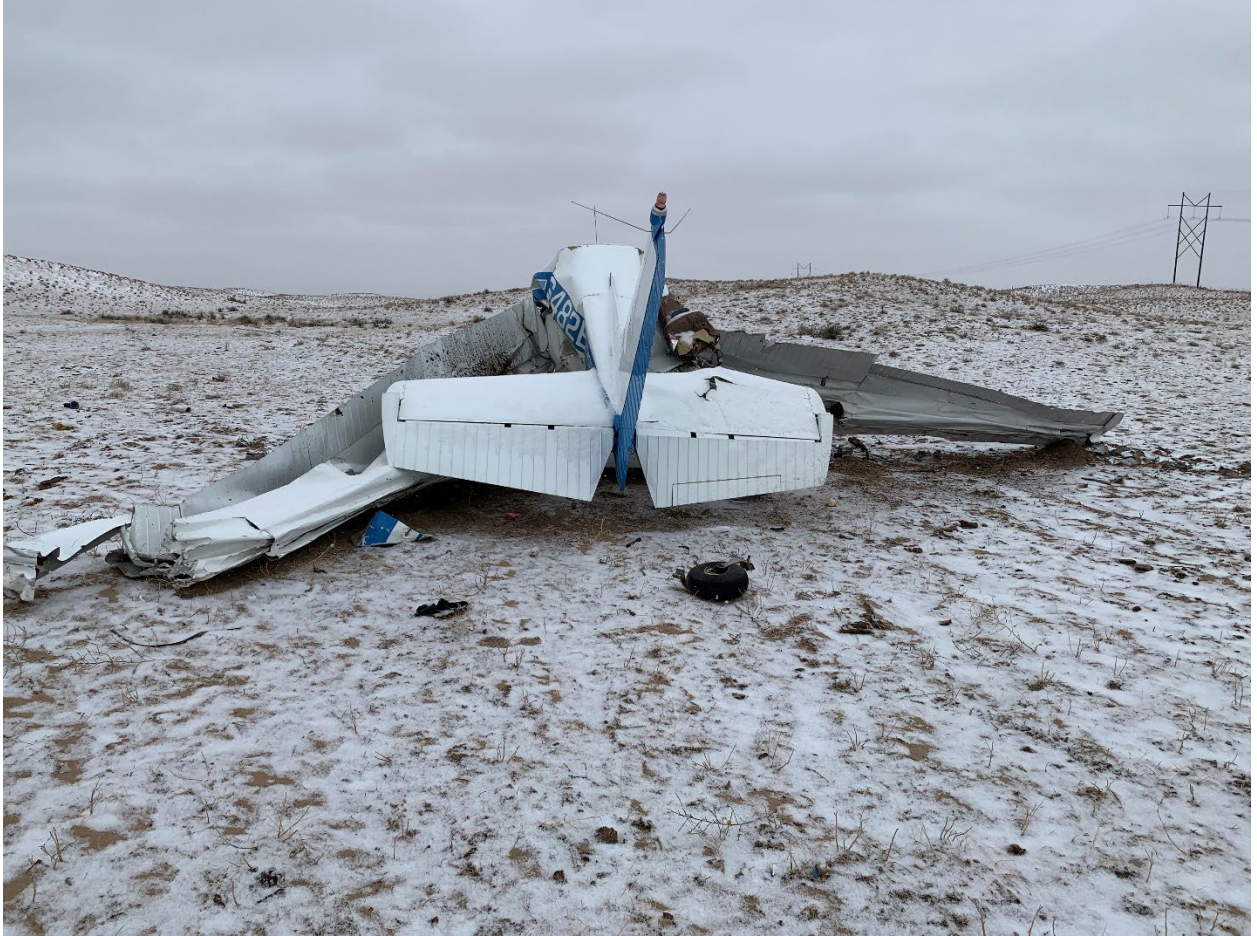
The tail surfaces remained attached to the airplane and were predominately intact but with impact damage to the right stabilizer. The elevators remained attached to the horizontal stabilizer at all hinge locations and were intact. The rudder was still attached to the vertical stabilizer at all hinge locations and was intact.

Figure 3. View from rear showing tail surfaces.

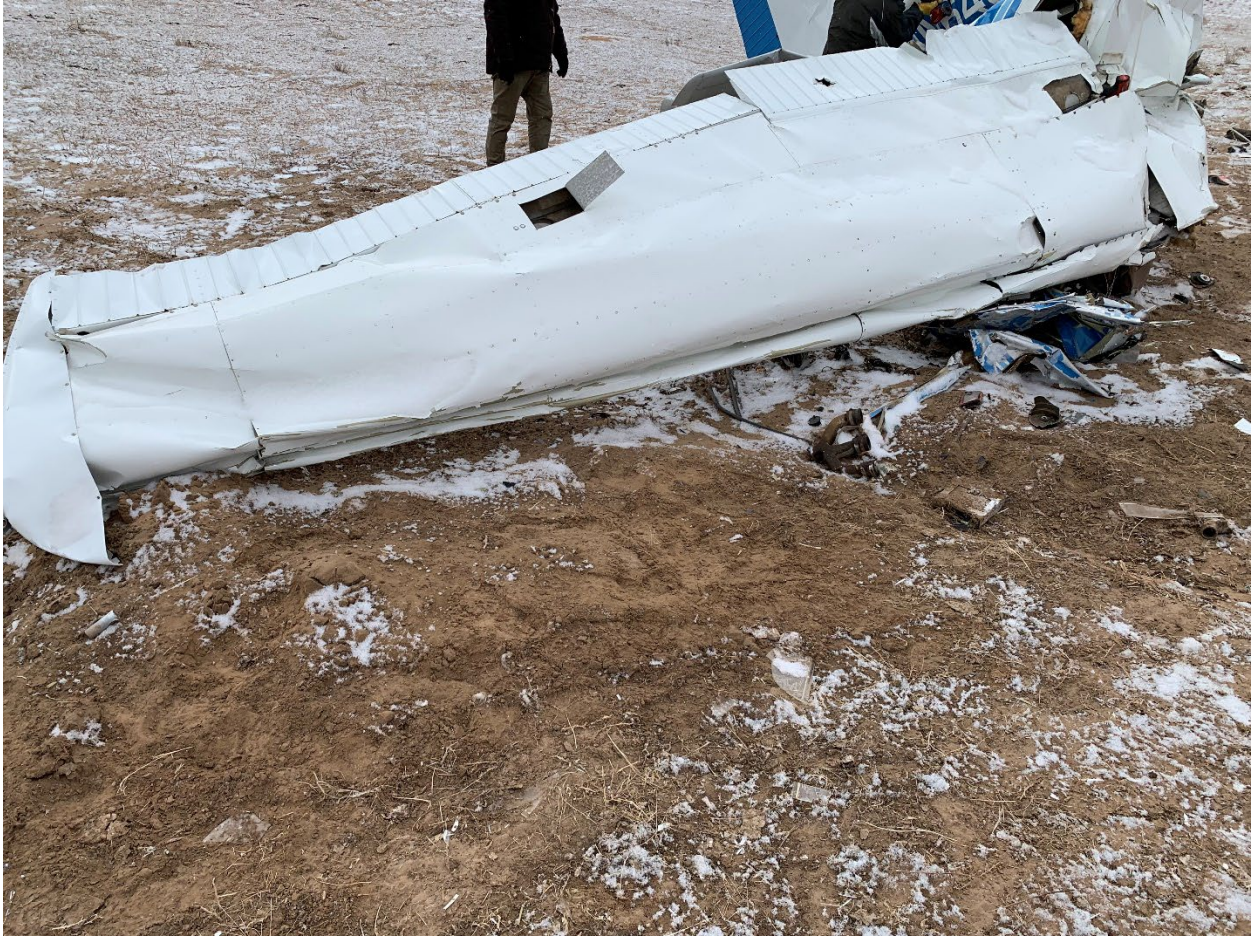
The wings had rearward crushing damage but remained partially attached to the fuselage and were located in the correct position. Both wings were continuous from root to tip and the flaps appeared to be in the retracted position. The wing struts were still in-place and attached at each end and the structure where the struts attach at both the wings and fuselage was deformed due to impact forces.

Figure 4. Right wing

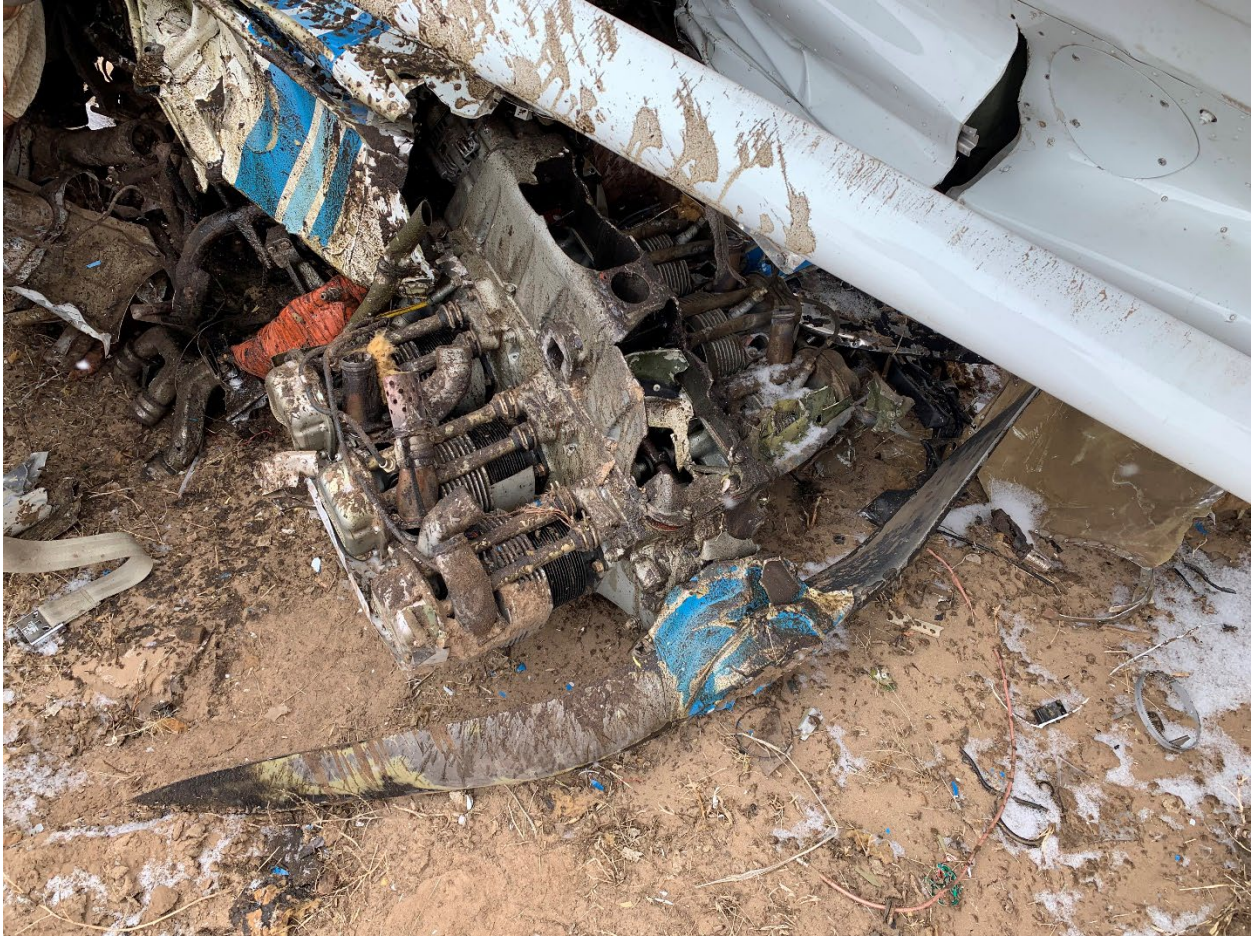
The engine could not be examined on-scene and was retained for further examination.

Figure - Engine at site
