# National Transportation Safety Board

CEN23FA095

## **ENGINE EXAMINATION**

Location: Hooker, Oklahoma  
Date: January 28, 2023  
Time: 1902 Local  
0102 UTC  
Airplane: Cessna 172

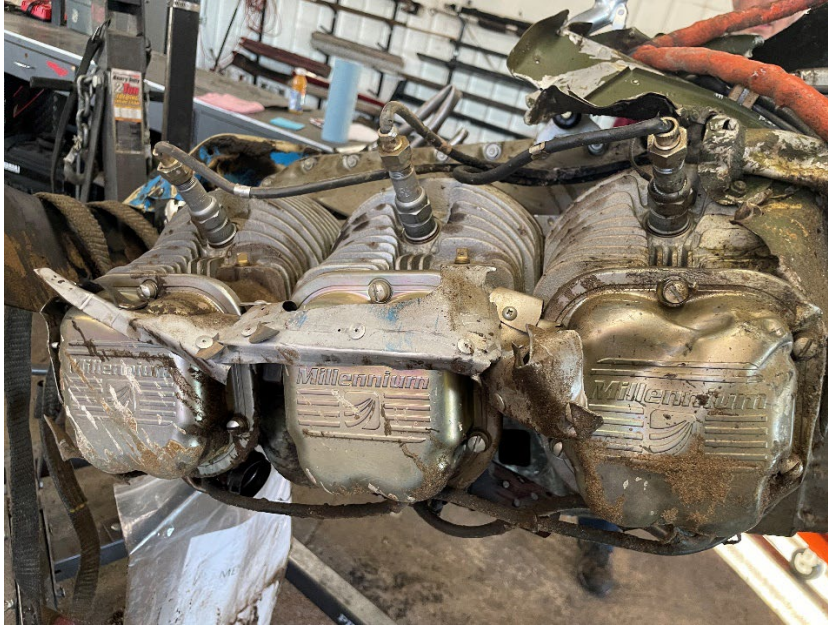
**Figure 1 Left Side of Engine**

The engine was impact and fire damaged. The propeller remained attached to the engine via the propeller flange. The dipstick was not present. The carburetor and vacuum pump were not located. Impact and fire damage was noted to the accessories.

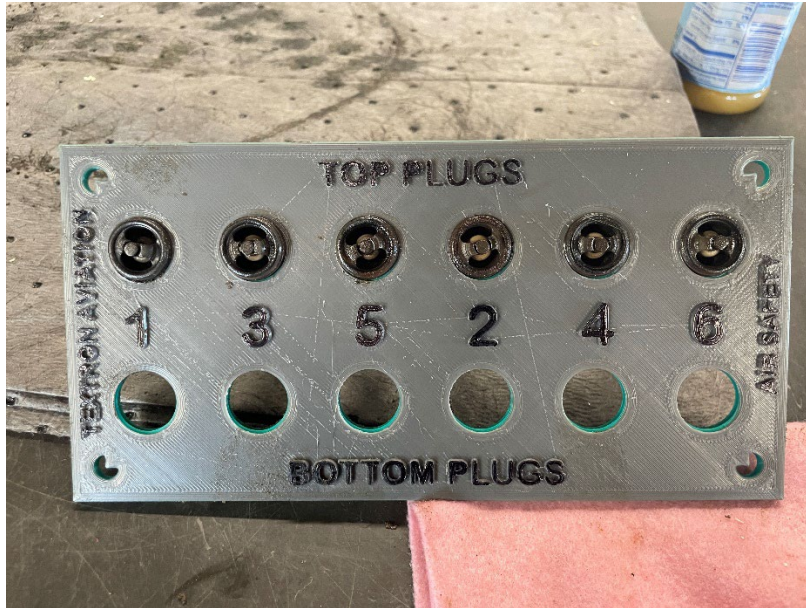
**Figure 3 Top Spark Plugs**

The top ignition harness leads were removed. The top bank of spark plugs were removed and photo documented.

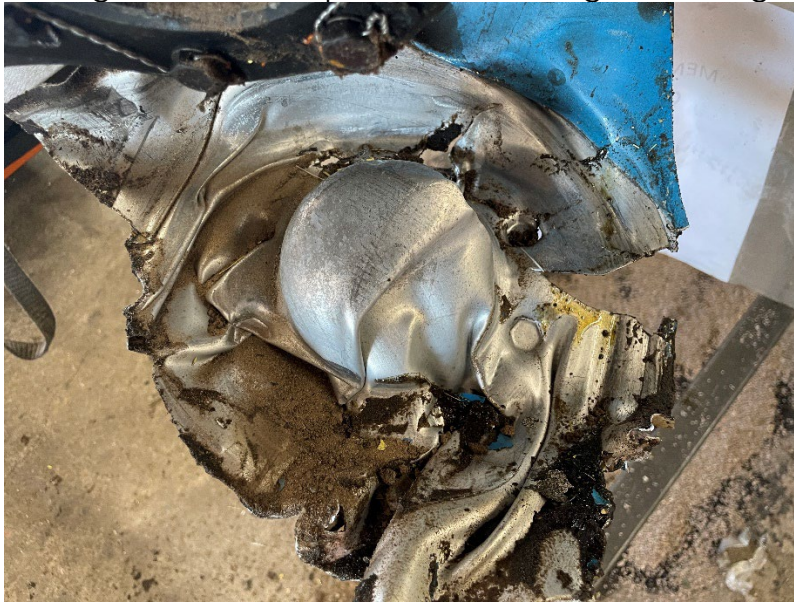
**Figure 4 Propeller Hub and Engine Cowling**

The engine could not be rotated via the propeller. Portions of the engine shroud appeared to impinge movement of the engine, so the propeller was removed. The propeller hub was crushed rearward into the propeller and rotational scoring was noted on portions of the engine cowling surrounding the hub.

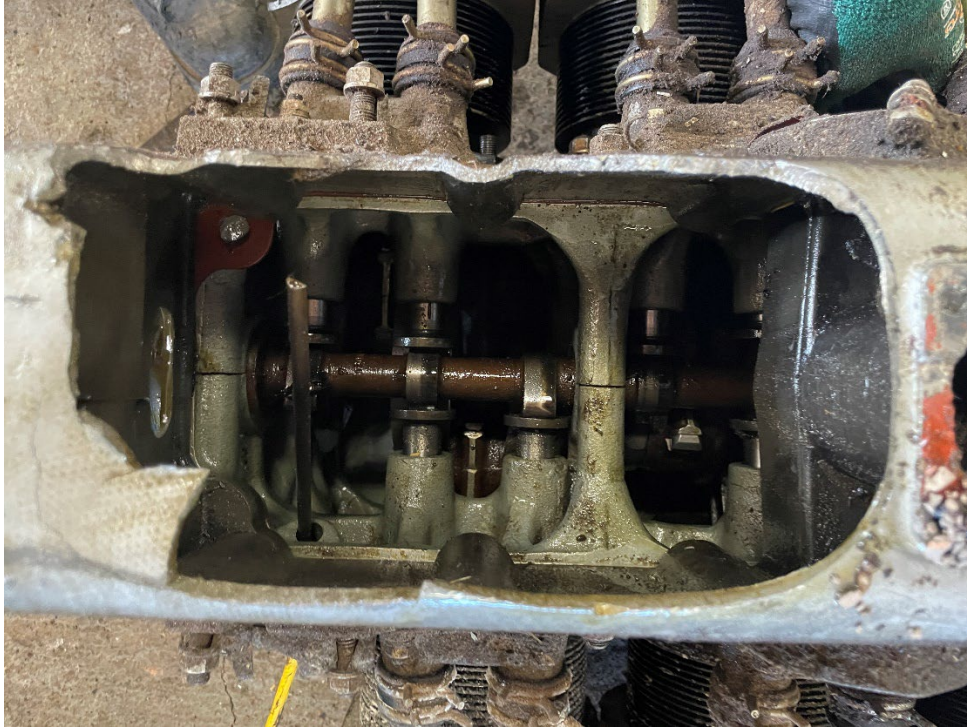
**Figure 5 Exposed Crankshaft**

Further attempts to rotate the engine were not successful. Borescope of the cylinders were unremarkable. The engine's oil sump was impact damaged and the crankshaft could be observed through the opening.

There was no evidence of thermal distress on the crankshaft. All counterweights were properly secured, and no failure of engine components were observed. Impact forces had pushed the propeller rearward resulting in displacement of the No. 6 connecting arm back into the No. 5 connecting arm. It is likely the engine would not rotate due to impact damage.
