# National Transportation Safety Board

CEN23FA113

## **AIRCRAFT PERFORMANCE**

Location: Little Rock, Arkansas  
Date: February 22, 2023  
Time: 11:56 central standard time  
17:56 UTC  
Airplane: Beech B200, N55PC

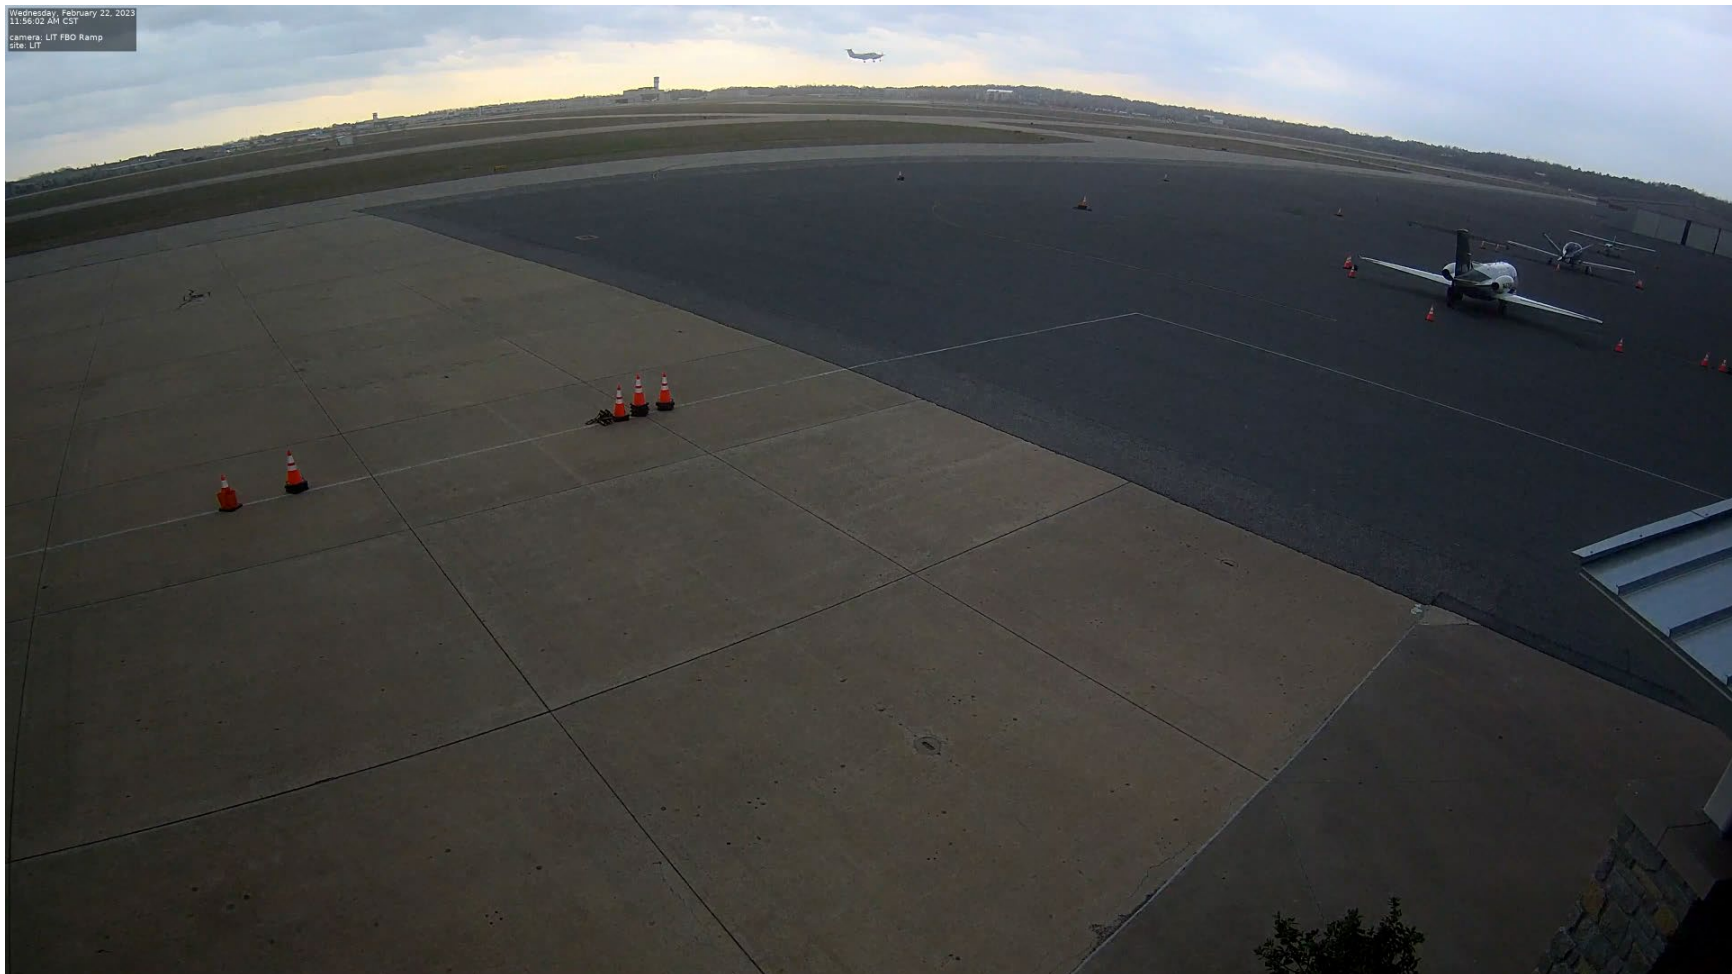
Neither the video from the ramp nor the video from the vehicle on Interstate 440 indicated any obvious problem with airplane. The flap position could not be determined in either video.

**Figure 1. Still image from the surveillance video from the ramp adjacent to runway 18, with the camera identified as LIT FBO Ramp. The accident airplane is visible at the top center of the image, and the time stamp is 11:56:02 CST.**

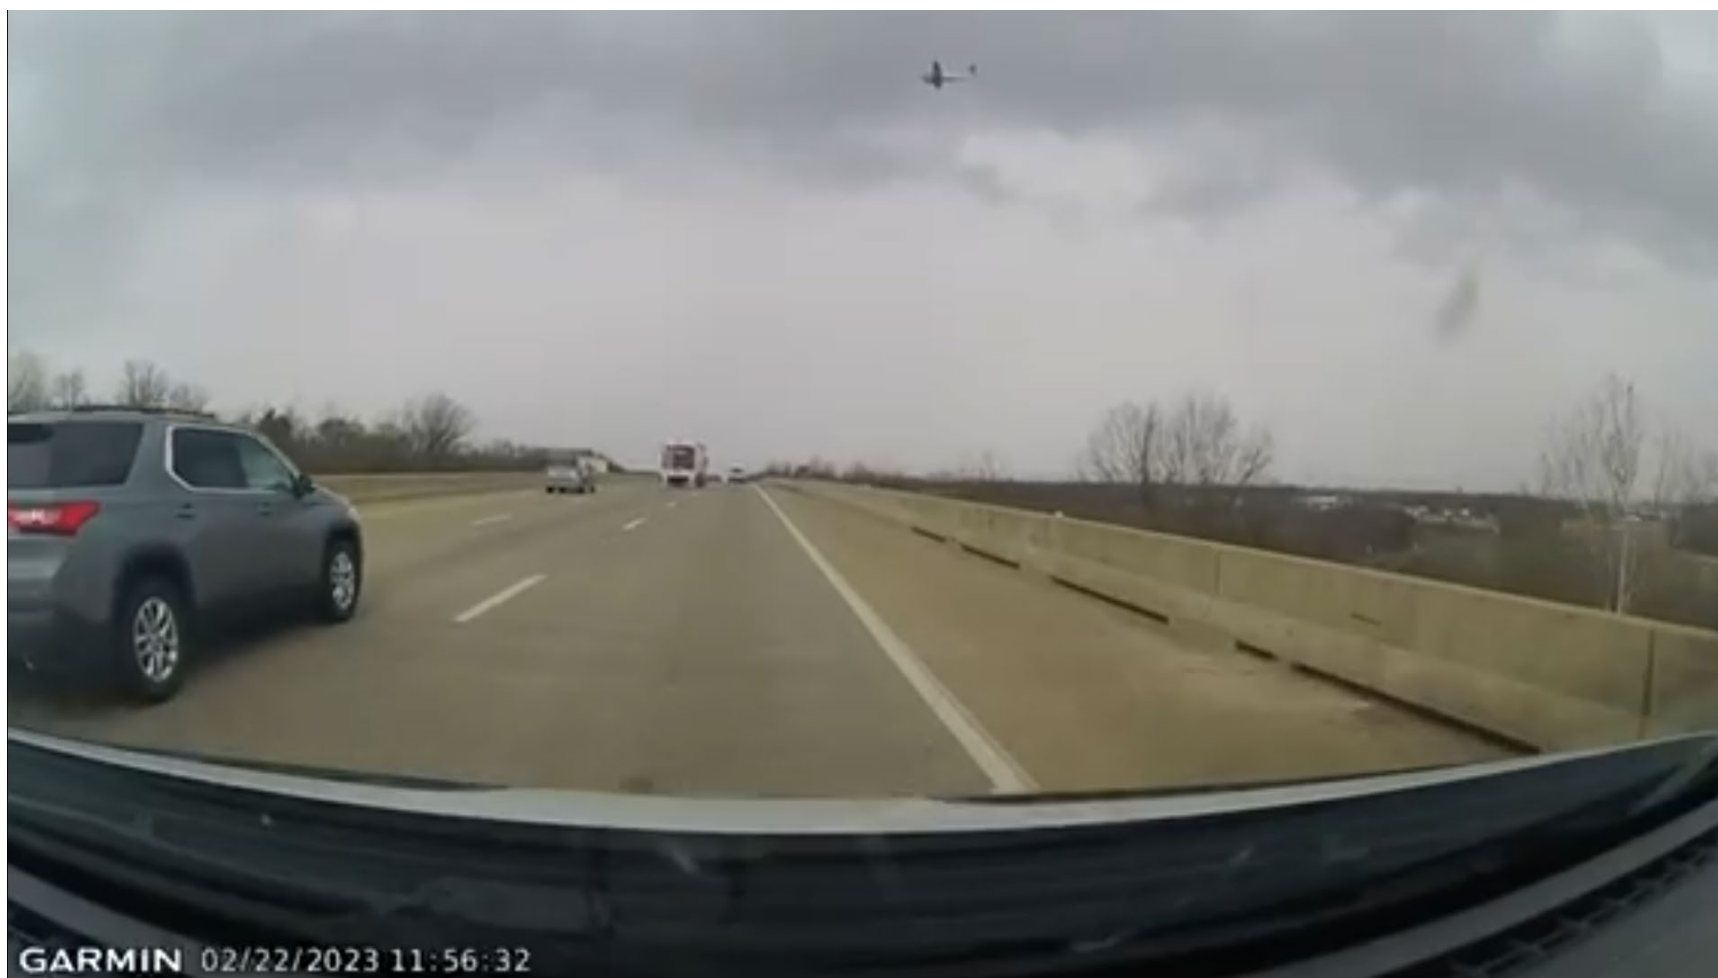
**Figure 2. Still image from the video taken by a camera mounted on a moving highway vehicle as the accident airplane passed over Interstate 440. The video is labeled Garmin, and the video time stamp is 11:56:32.**

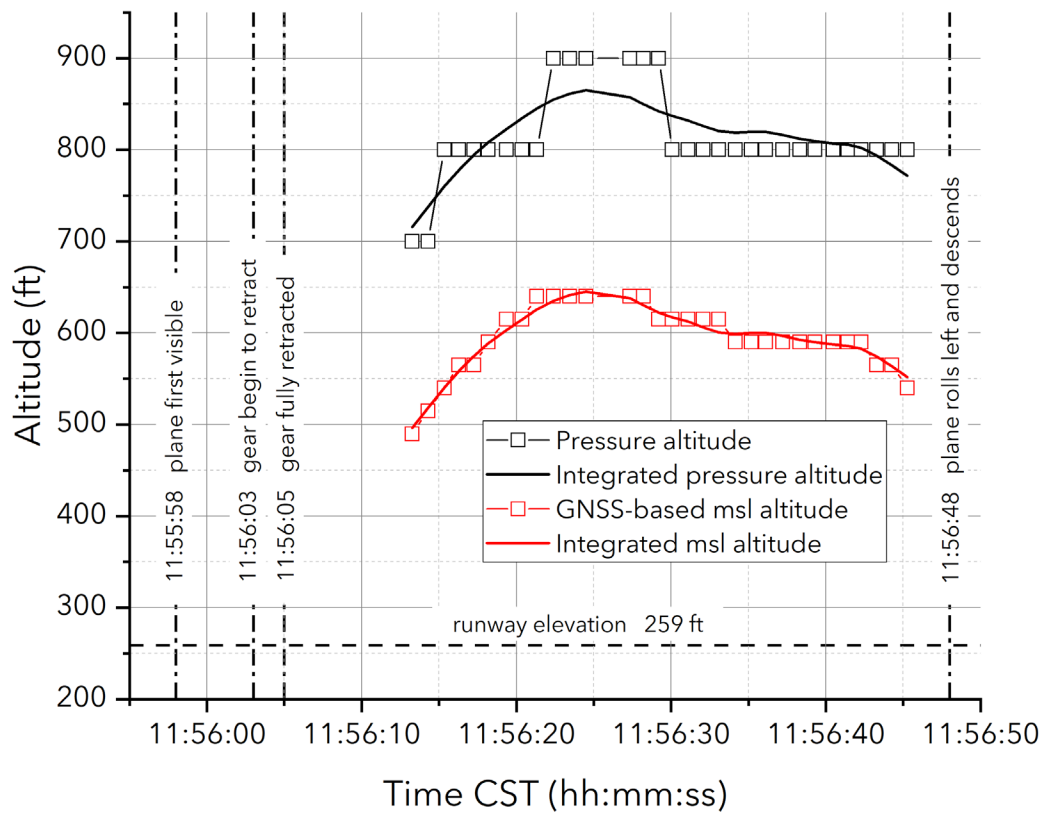
The pressure altitude and msl altitude for the flight are shown in Figure 5, along with event times from the video. The airplane reached its peak altitude about 11:56:25.

**Figure 5. ADS-B pressure altitude and GNSS altitude converted to msl, along with altitude traces calculated by integrating the avionics-reported rate of change of pressure altitude. Events identified in the surveillance video from the camera adjacent to the ramp are indicated, along with the runway elevation.**

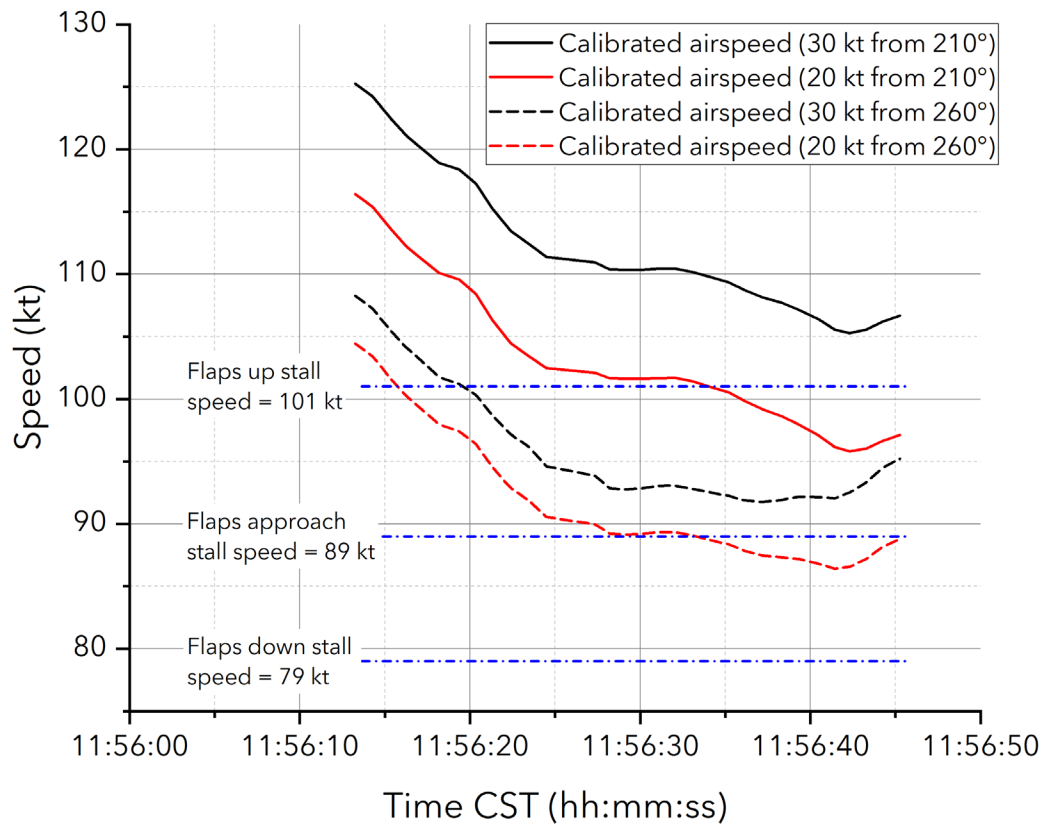
Figure 8 shows the calibrated airspeeds for the different assumed wind conditions, along with the power-idle, wings-level stall speeds from the POH. The calibrated airspeeds are about 3 kt less than the true airspeeds in Figure 7. The calibrated airspeed remains above the flaps-up stall speed only for the case assuming a wind of 30 kt from 210°. The cases assuming winds from 260° have calibrated airspeeds below the flaps-up stall speed for nearly the entire time of recorded data, and for the case assuming a wind of 20 kt from 260°, the calibrated airspeed also drops below the flaps-approach stall speed for about 10 s.

If the flaps were up during the flight, a lower wind speed and/or wind from the west (260°) would have led to calibrated airspeeds below the flaps-up, wings-level, power-idle stall speed of the airplane. The left roll captured by the video at the end of the flight was consistent with a post-stall wing drop.

**Figure 8. Calibrated airspeeds for the different winds assumed, along with stall speeds from the POH.**

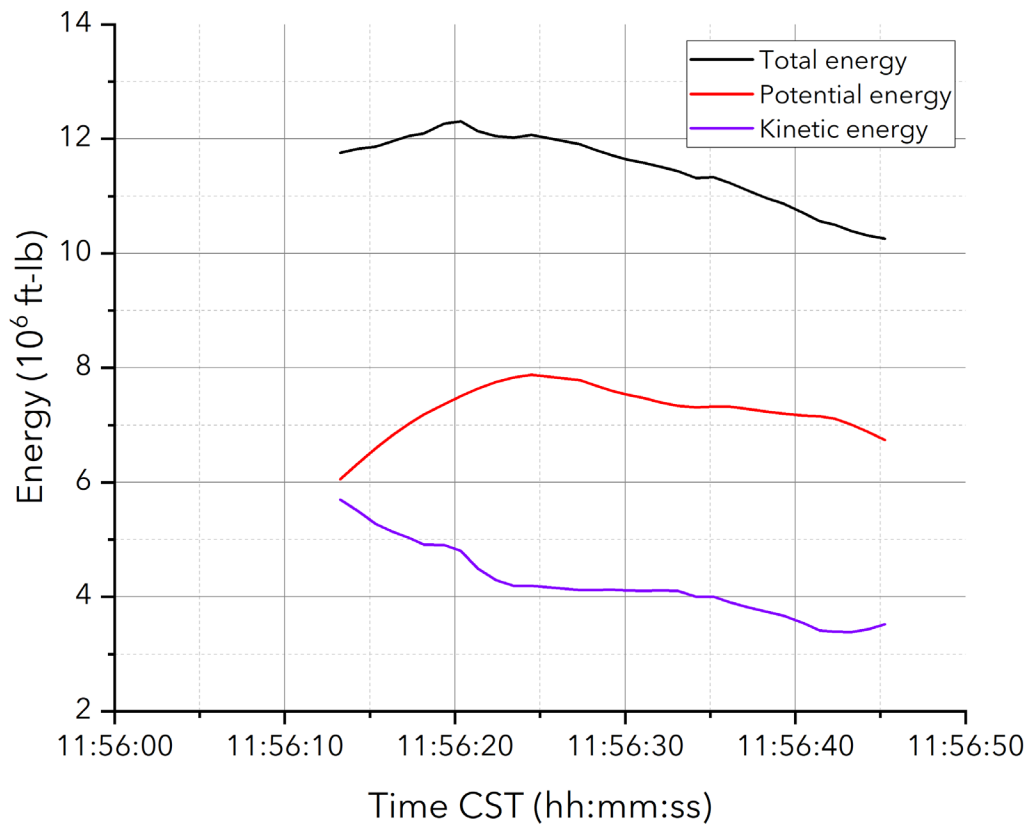
Figure 9 shows the potential energy, the kinetic energy calculated from the inertial speed (groundspeed coupled with rate of climb), and total energy during the flight. The data indicate that the total energy began to decrease about 11:56:20, which was 5 s before the peak altitude was reached. The slight increase in groundspeed at 11:56:43 was offset by the decrease in altitude at the same time, with the total energy continually decreasing.

**Figure 9. Potential energy, kinetic energy calculated from the inertial speed (groundspeed combined with rate of climb) and total energy (the sum of potential and kinetic energy) for the accident flight.**

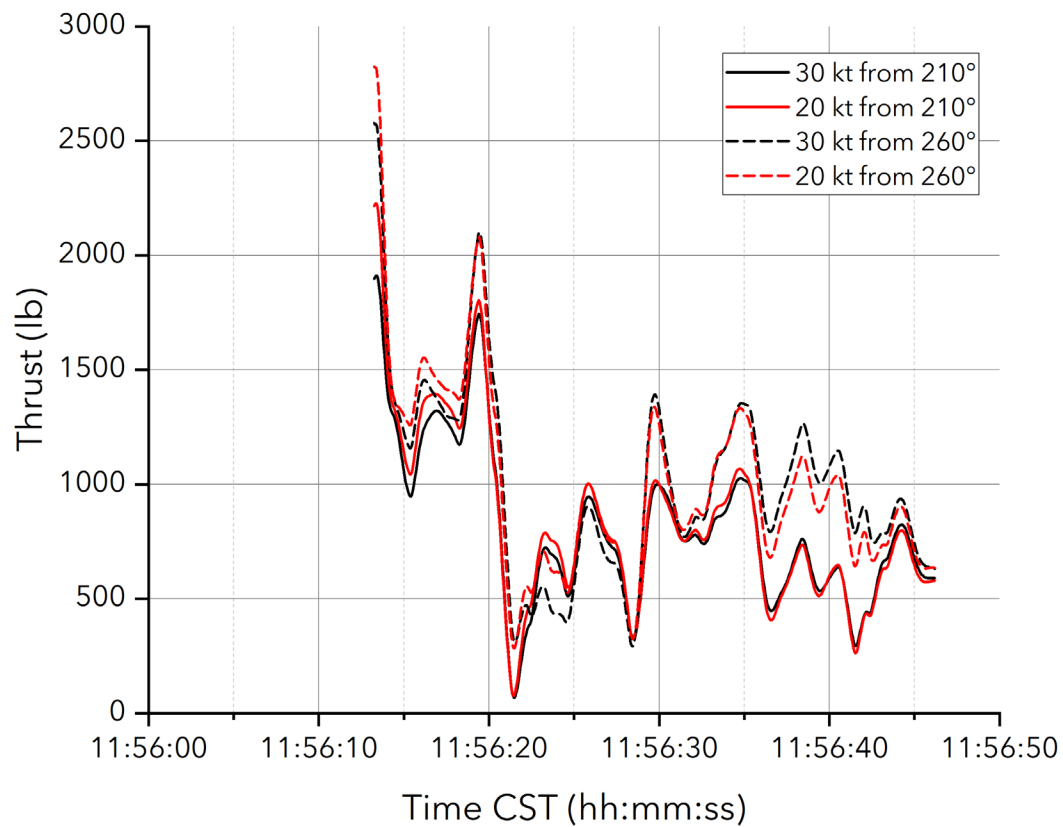
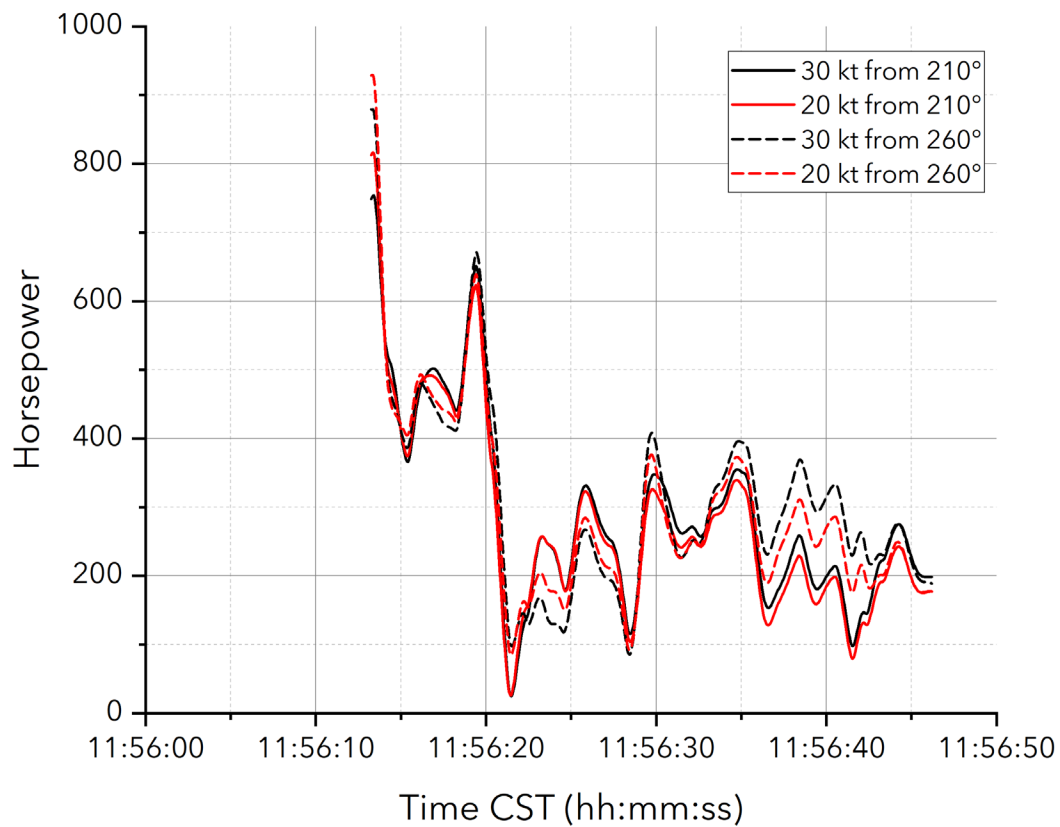
A simplified mathematical model of the airplane was used to calculate the thrust and the power (thrust multiplied by true airspeed) required by the airplane during the flight. The lift coefficient is assumed to be a linear function of angle of attack, and there is no provision to identify or model stall behavior. The drag coefficient is a function of lift coefficient and flap setting. The flaps-up calculated thrust required for each assumed wind condition is shown in Figure 10, and the flaps-up calculated horsepower is shown in Figure 11. Both the thrust and horsepower

show a sharp decrease at 11:56:20, consistent with the decrease in total energy shown in Figure 9. Each engine is rated at 850 shaft horsepower, for a total of 1700 horsepower; the actual power delivered to the airframe will be less than that total because the engines and propellers are not 100 % efficient. In this case, the maximum value calculated was only about 900 horsepower, and after 11:56:20, the value was less than 400 horsepower.

**Figure 10. Thrust calculated for the different wind conditions assumed, using a simplified mathematical model of the airplane, with flaps up.**

**Figure 11. Horsepower calculated for the different wind condition assumed, using a simplified mathematical model of the airplane, with flaps up.**

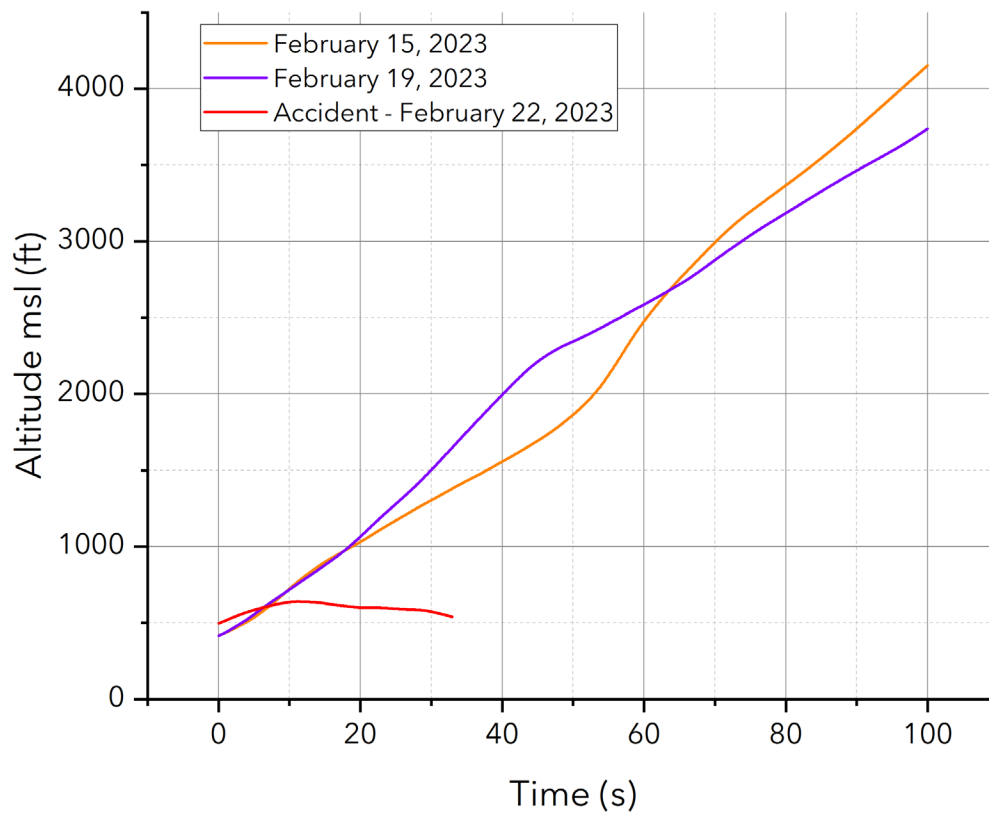
Altitudes for the three flights are compared in Figure 12, with time shifted to the first ADS-B data point for each set of data. The ADS-B data did not extend to the runway surface for any of the flights. Only the first 100 s of data is shown. In the earlier takeoffs, the airplane climbed at about 2000 ft per minute.

**Figure 12. Altitudes for the accident flight and two prior takeoffs. Times are shifted to align the first ADS-B data point for each flight at zero, and the data for the prior flights is limited to the first 100 s.**

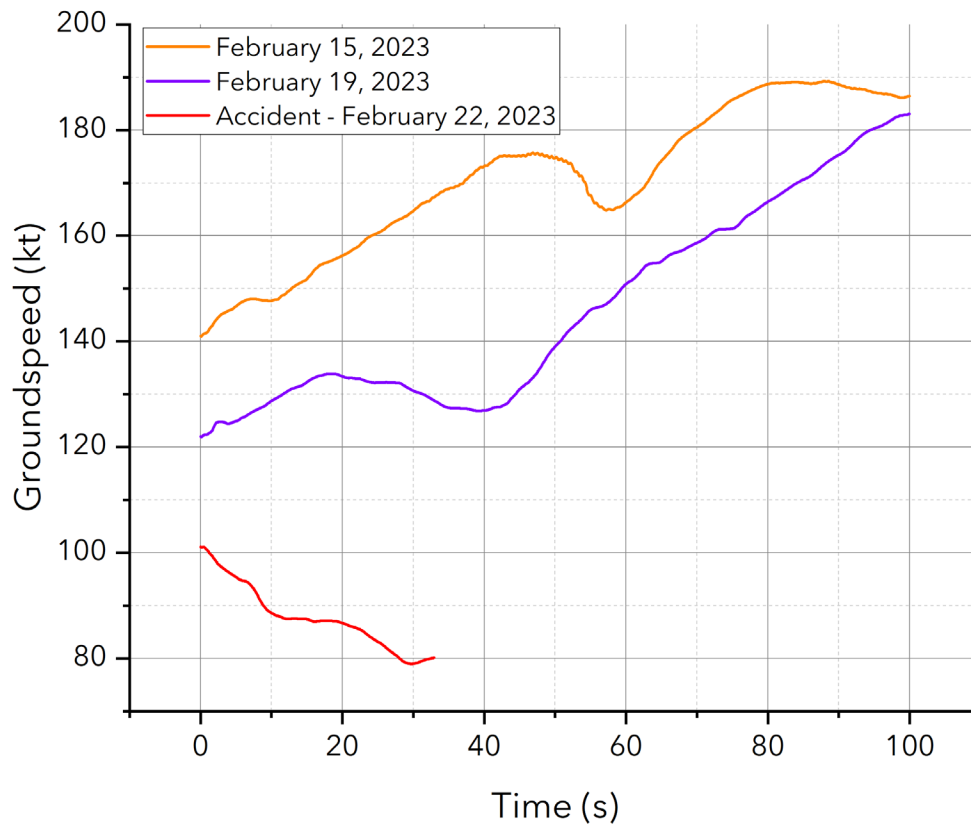
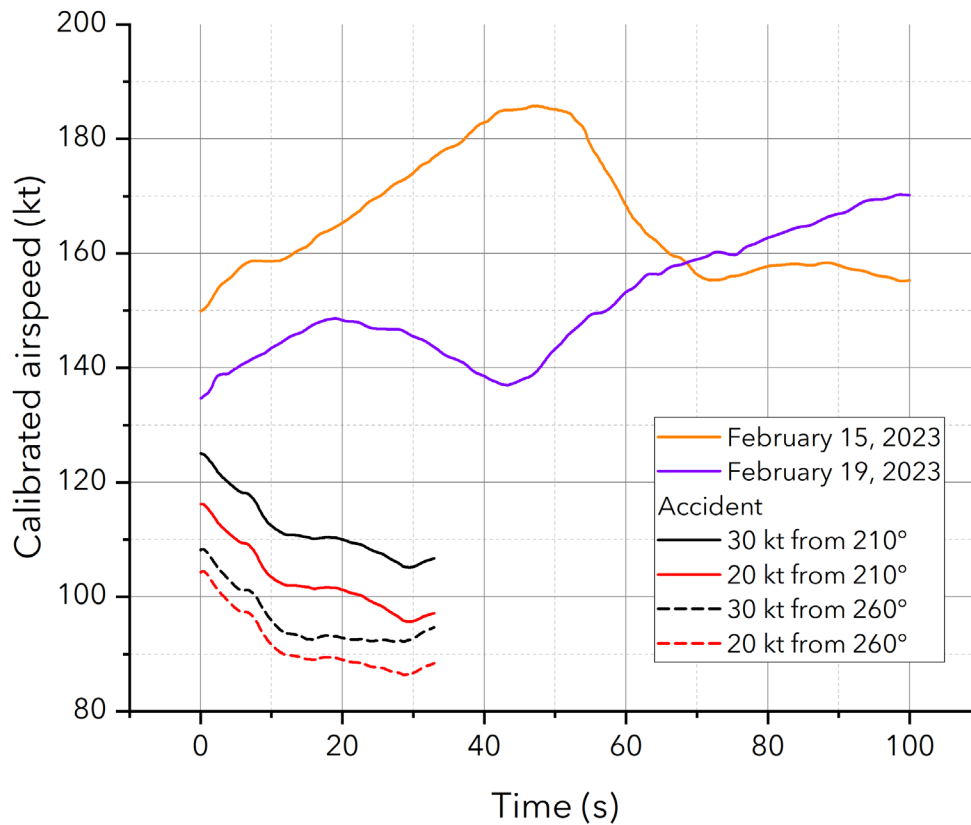
Figure 13 compares the groundspeeds and Figure 14 compares the calibrated airspeeds. The speeds demonstrated in the earlier flights are substantially higher than in the accident flight.

**Figure 13. Groundspeeds for the accident flight and two prior takeoffs. Times are shifted to align the first ADS-B data point for each flight at zero, and the data for the prior flights is limited to the first 100 s.**

**Figure 14. Calibrated airspeeds for the accident flight (for the assumed wind conditions) and two prior takeoffs. Times are shifted to align the first ADS-B data point for each flight at zero, and the data for the prior flights is limited to the first 100 s.**

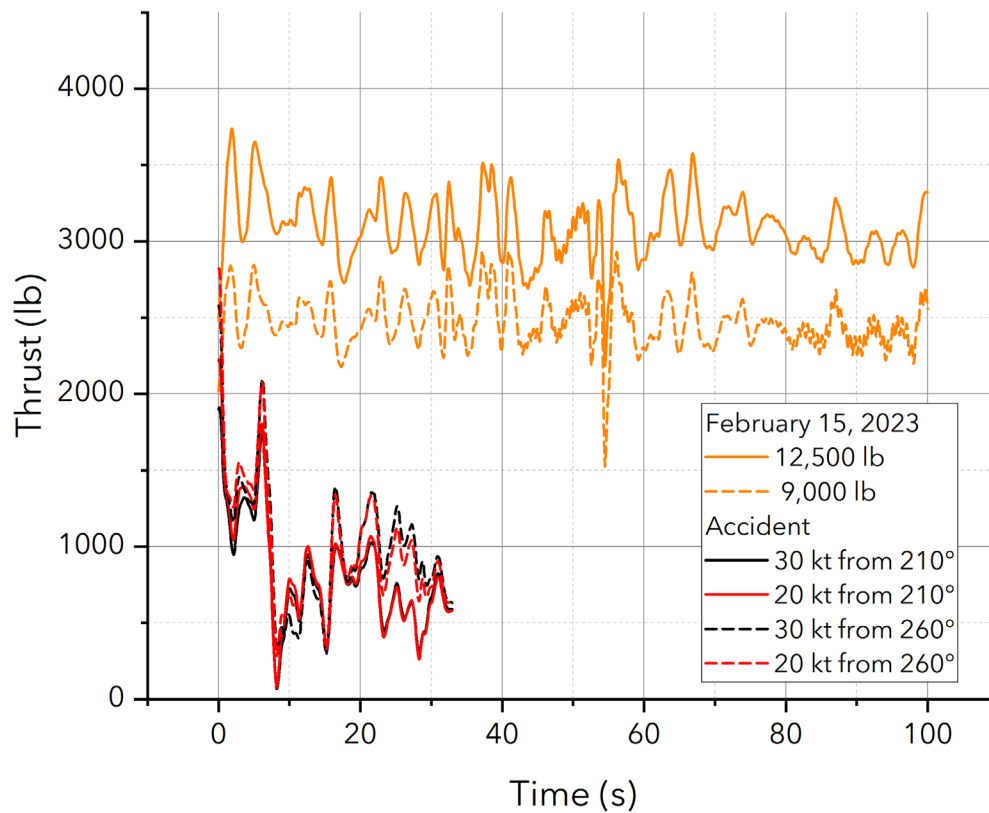
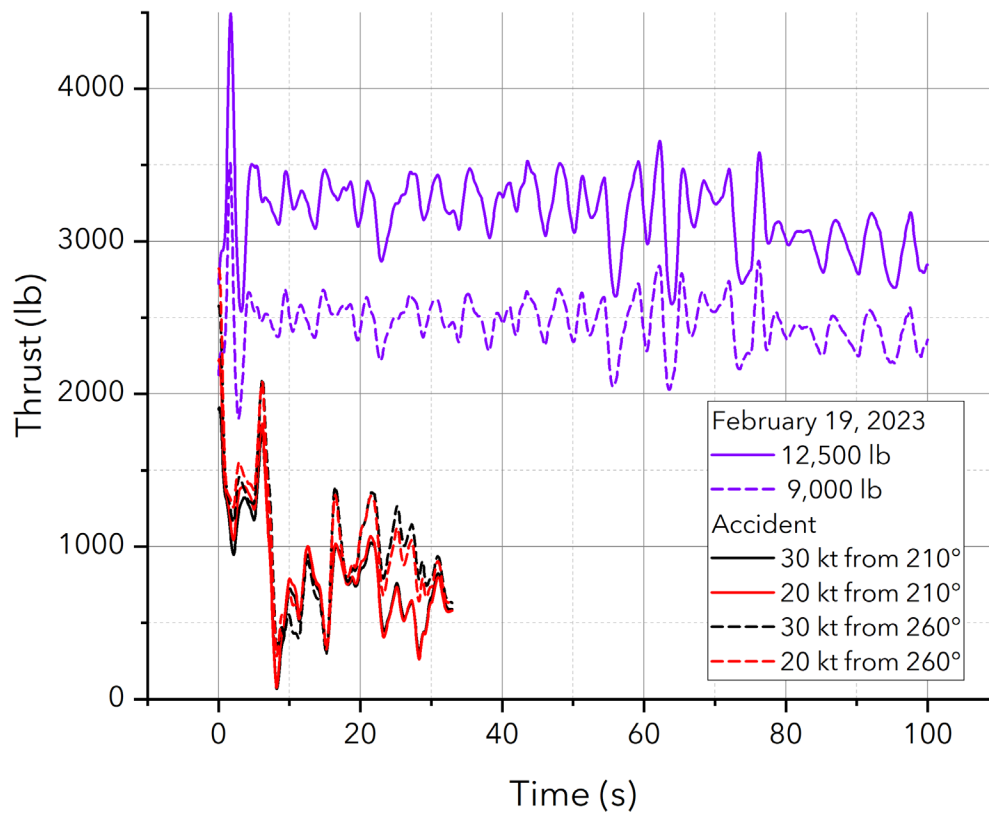
Figures 15 and 16 compare the thrust calculated from the mathematical model of the airplane. The weight of the airplane during the earlier flights is unknown, so two cases were examined, one with the airplane at the maximum takeoff weight of 12,500 lb and one with the airplane at 9,000 lb, which is the lowest weight shown in the take-off distance or stall speed charts in the POH. Figure 15 compares the thrust calculated for the takeoff on February 15, 2023, with the thrust calculated for the accident flight (previously shown in Figure 10). Figure 16 compares the takeoff on February 19, 2023, with the accident flight. During the prior flights, the airplane was developing 2500 lb to 3500 lb of thrust, while during the accident flight it was developing only 1000 lb of thrust or less after the first 10 s of data.

**Figure 15. Thrust calculated for the accident flight (for the assumed wind conditions) and the prior flight on February 15, 2023.**

**Figure 16. Thrust calculated for the accident flight (for the assumed wind conditions) and the prior flight on February 19, 2023.**

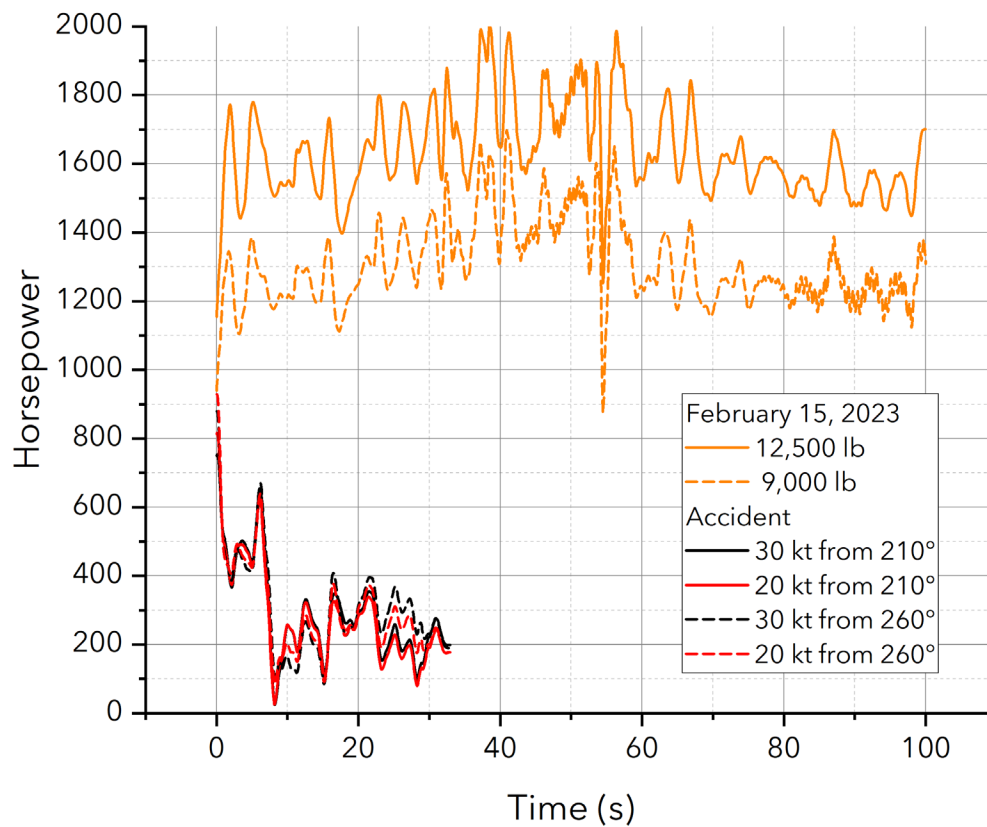
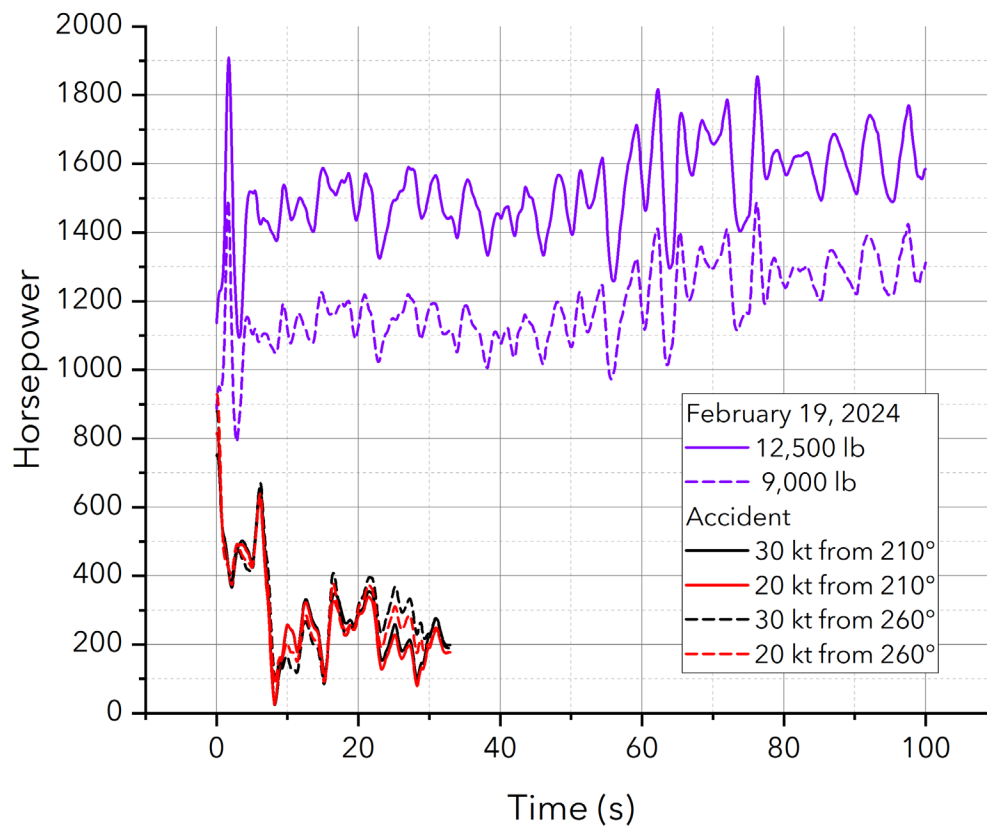
Figures 17 and 18 compare the horsepower calculated from the mathematical model of the airplane. The weight of the airplane during the earlier flights is again taken as either 12,500 lb or 9,000 lb. Figure 17 compares the horsepower for the takeoff on February 15, 2023, with the horsepower for the accident flight (shown in Figure 11). Figure 18 compares the takeoff on February 19, 2023, with the accident flight. The horsepower calculated for the prior flights is consistent with what would be expected from the two 850 shaft horsepower engines, while the accident flight

was developing less than 400 horsepower after the first 10 s of data. Figures 17 and 18 also indicate that increasing the weight of the airplane from 9,000 lb to 12,500 lb requires an increase of 300 – 400 horsepower. If the airplane during the accident flight had been heavier than the 12,208 lb reported, the calculated horsepower required would increase, but it is unlikely that an error in weight could explain the extremely low horsepower computed for the accident flight.

**Figure 17. Horsepower calculated for the accident flight (for the assumed wind conditions) and the prior flight on February 15, 2023.**

**Figure 18. Horsepower calculated for the accident flight (for the assumed wind conditions) and the prior flight on February 19, 2023.**

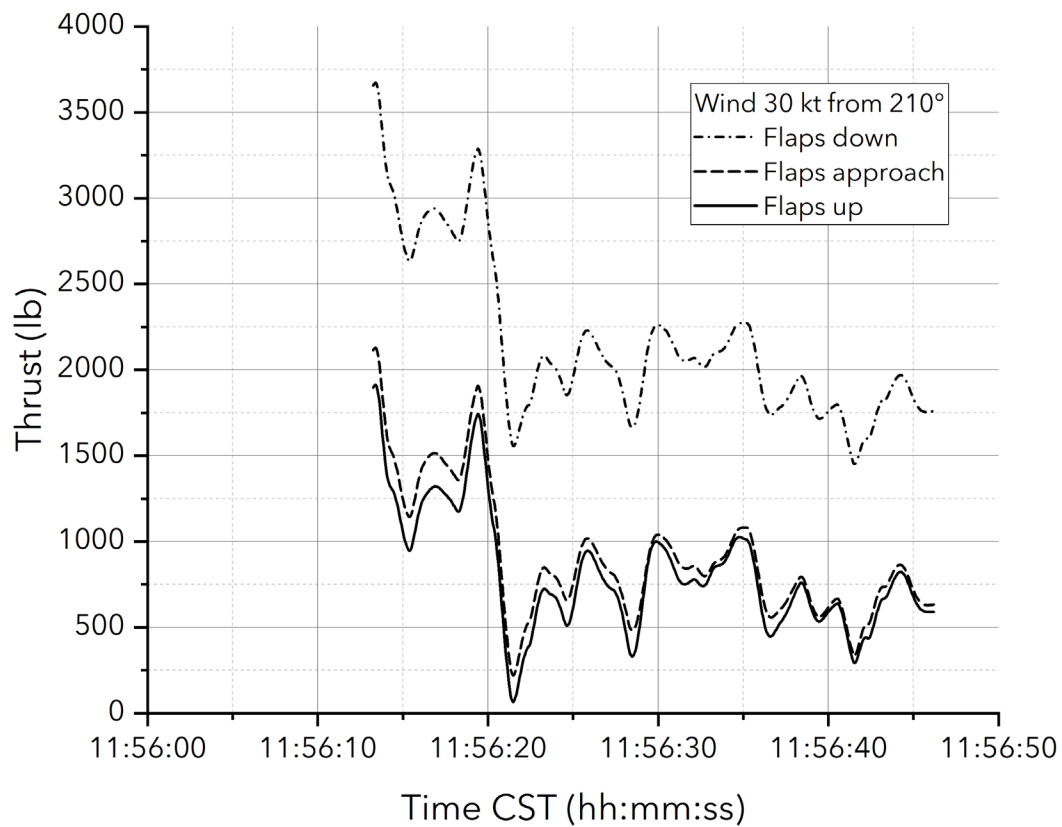
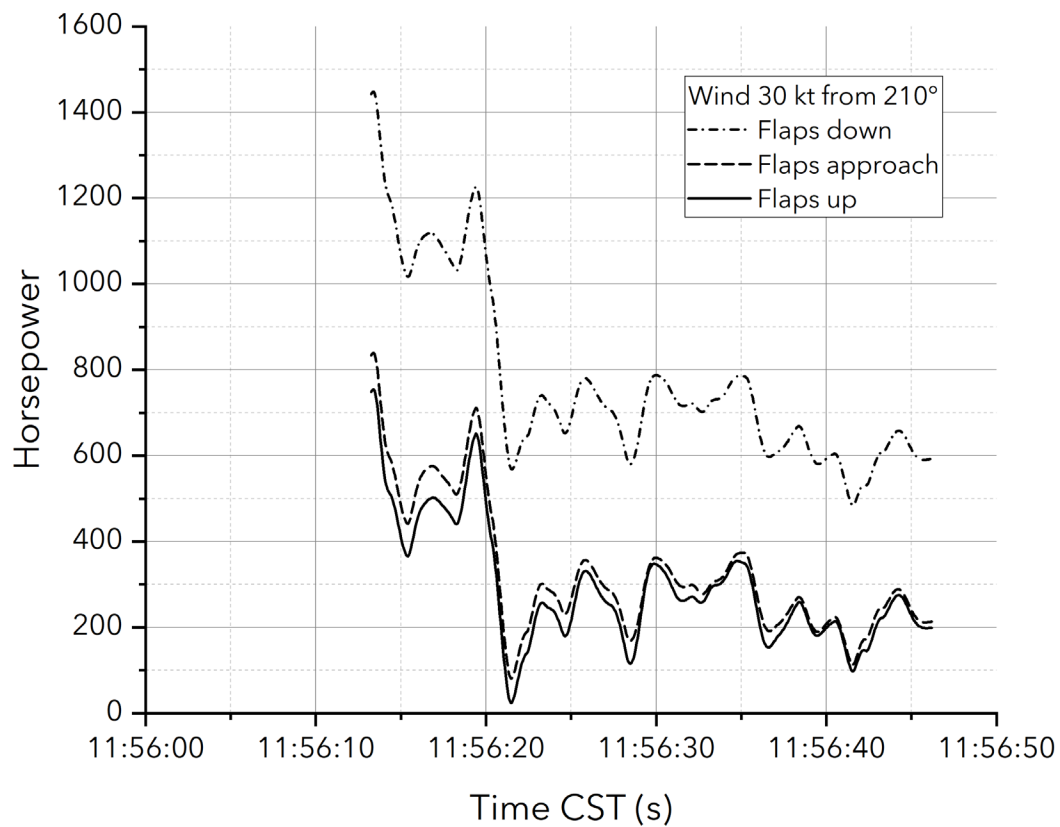
The mathematical model of the airplane was also used to estimate the effect of flap position on the calculated thrust and horsepower required. The POH provides takeoff distance charts for flaps up and flaps approach. The normal operations section of the POH specifies that the gear are to be raised once a positive climb is established, and flaps are to be retracted once the airspeed reaches 121 kt. As shown in Figure 8, the calibrated airspeed might not have exceeded 121 kt, depending on the wind speed and direction assumed. Figure 19 indicates the effect of flap position on the thrust required, and Figure 20 indicates the effect of flap position on horsepower. Figures 19 and 20 both show results for wind assumed to be 30 kt from 210°, which required the highest thrust and horsepower for the flaps-down case. Full flaps result in a substantial increase in drag, requiring greater thrust and horsepower for the airplane to fly through the recorded data. However, the required thrust and horsepower are still much less than those plotted in Figures 15 – 18 for the prior flights.

Even with the added drag corresponding to the flaps fully deployed, the thrust calculated during the last 25 s of ADS-B data from the accident flight was only about 80 % of the thrust calculated for two prior takeoffs. Similarly, with flaps fully down, the horsepower calculated during the last 25 s of ADS-B data from the accident flight was only about 56 % of the horsepower calculated for the two prior takeoffs.

**Figure 19. Thrust calculated for the accident flight assuming wind of 30 kt from 210° at different flap settings.**

**Figure 20. Horsepower calculated for the accident flight assuming wind of 30 kt from 210° at different flap settings.**
