Alexander Lemishko  
Senior Air Safety Investigator  
NTSB, Central Region

**Date:** February 22, 2023

**Subject:** Memorandum for the Record CEN23FA113  
Propeller Examinations

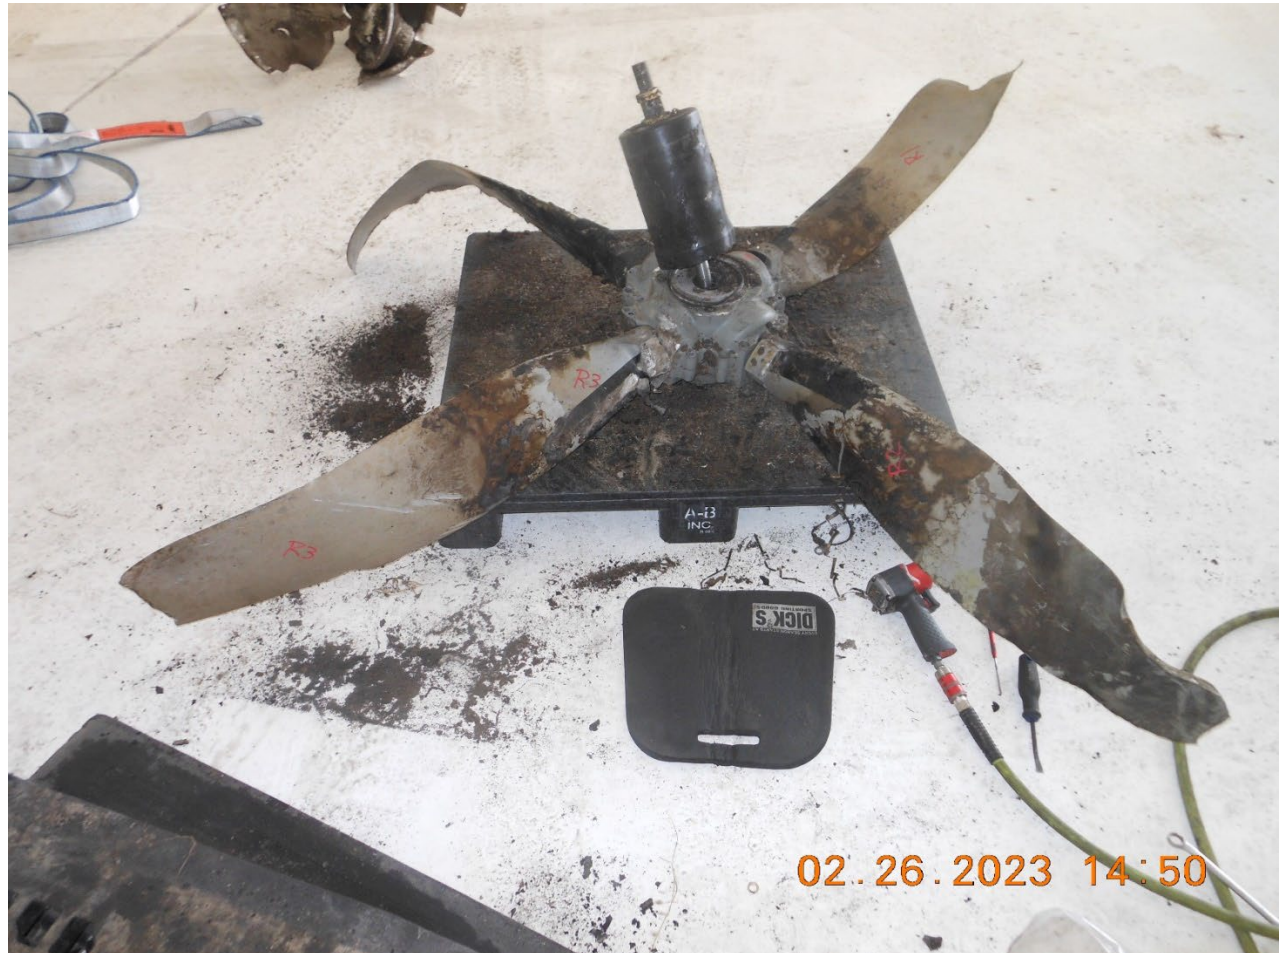
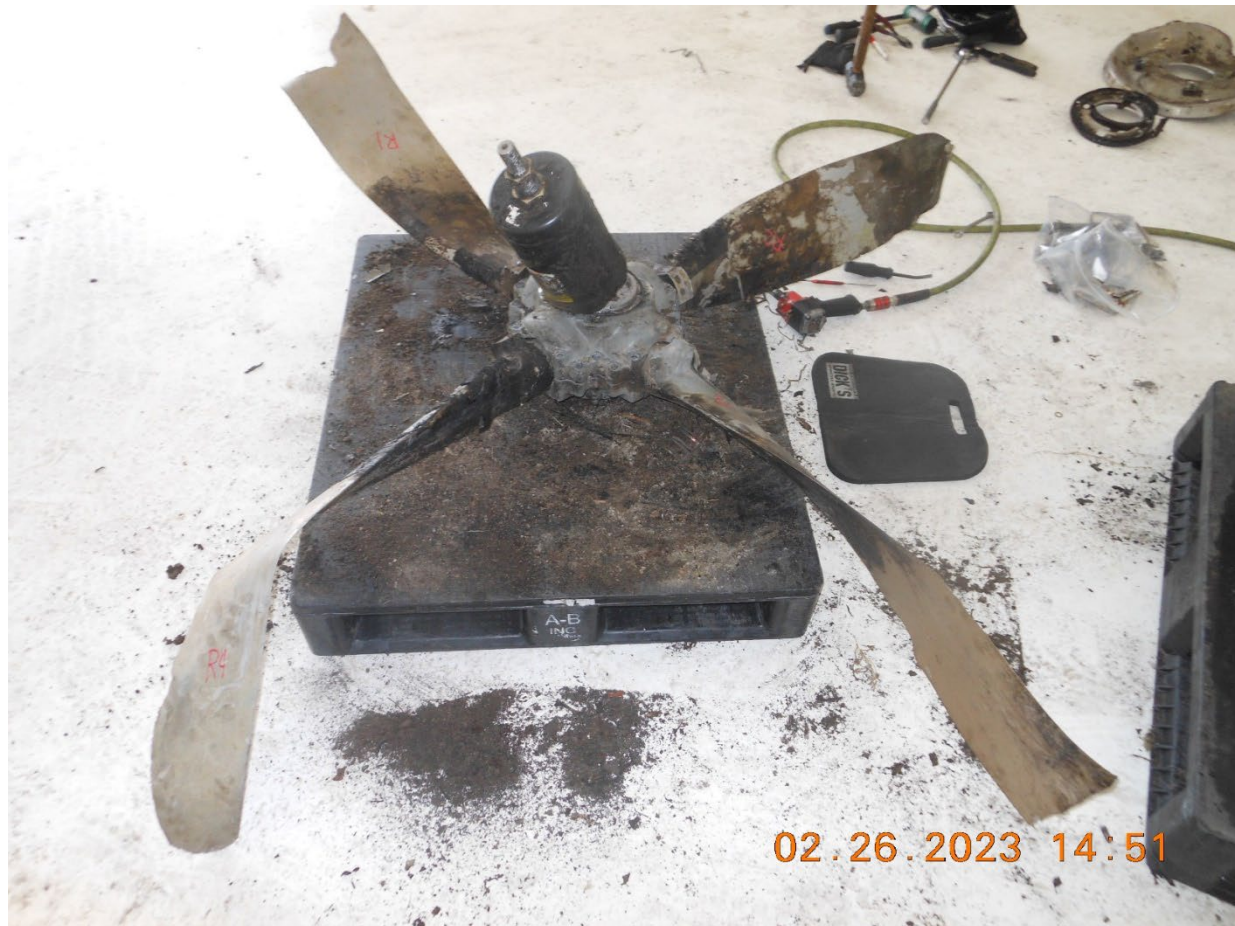
Right Propeller Assembly

The propeller hub was found separated from the engine and was found in the debris field. The propeller was found lodged between two trees adjacent to the main airframe wreckage. All four counterweights were found fractured from their respective blades. All four blades varied in blade angle position. The spinner dome was crushed and torn. The propeller cylinder was separated from the hub but remained attached to the assembly via the pitch change rod. The propeller had varying degrees of heat discoloration and damage.

Blade R1 was fractured in the mid-blade region, 26" from the hub, and the fractured segment was not recovered. The blade was bent in the forward/thrust direction with no discernable twisting damage. The blade exhibited heat discoloration and paint blistering.

Blade R2 was fractured in the mid-blade region approximately 30-37 inches from the hub, and the fractured segment was not recovered. The blade exhibited S-bending with no discernable twisting damage. The blade exhibited heat discoloration and paint blistering.

Blade R3 was fractured in the tip-region, approximately 36" from the hub, and the fractured segment was not recovered. The blade was bent aft and twisted towards low pitch. The blade exhibited heat discoloration and paint blistering.

Blade R4 was partially consumed by the post-crash fire along the tip and trailing edge area. The blade was bent aft and twisted towards low pitch. The blade exhibited heat discoloration and paint blistering.

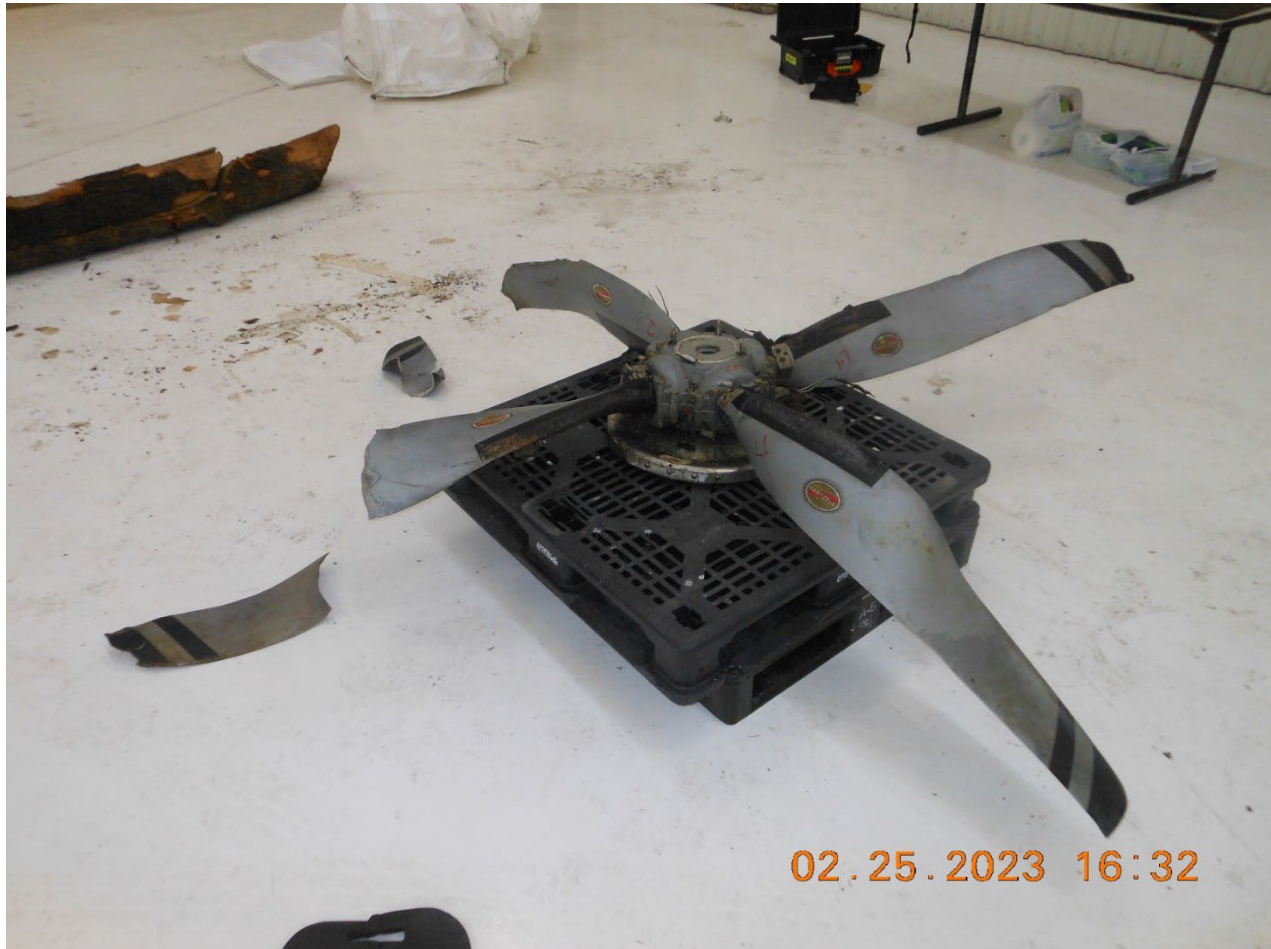
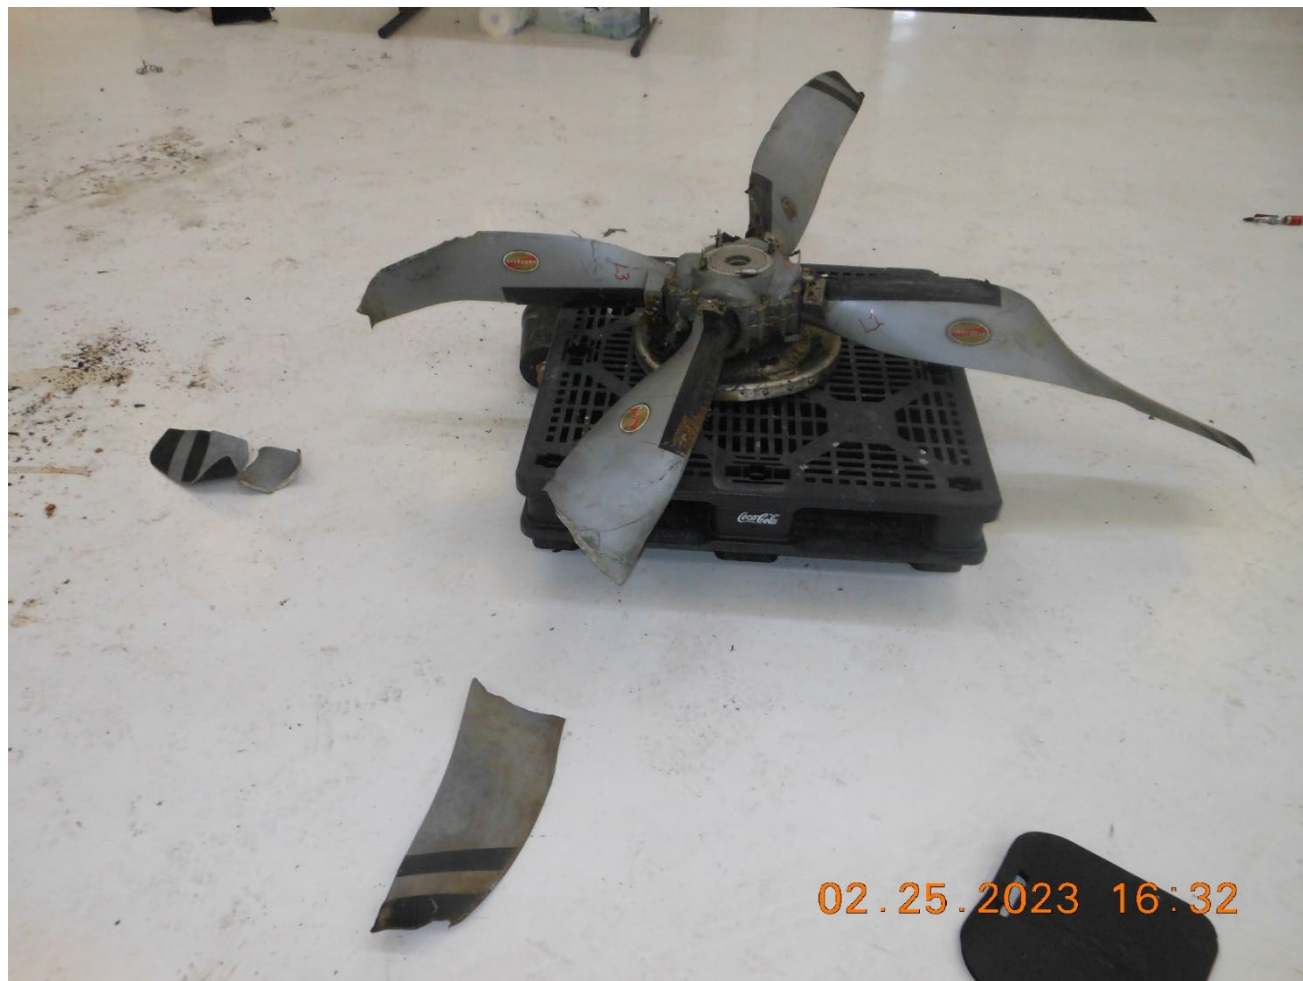
Left Propeller Assembly

The propeller assembly was found separated from the engine and was found in the debris field near the main wreckage. The propeller shaft flange remained attached to the propeller with all eight mounting bolts secured and lock wired. The propeller was found on the ground near the initial impact point. All four counterweights fractured from their respective blades. All four blades varied in blade angle position. The spinner dome was crushed and torn and there was some rotational scoring on the back of the spinner bulkhead.

Blade L1 was bent aft and twisted towards low pitch with a wave-type bend the leading edge. Blade L1 could be rotated in the hub by hand force.

Blade L2 was fractured near the mid-blade region approximately 25 inches from the hub, and the fractured segment was recovered in the debris field. The blade exhibited chordwise/rotational scoring and S-bending. The L2 blade retention pocket was fractured near the aft-trailing edge quadrant and the bearing races were fractured.

Blade L3 was fractured in the mid-blade region, approximately 29" from the hub, portions of the fractured segments were recovered in the debris field. The blade was bent forward and twisted towards low pitch.

Blade L4 exhibited chordwise/rotational scoring, was bent forward and twisted towards high pitch. There was a wave-type "S" bend in the leading edge and could be rotated by hand force.
