Alexander Lemishko  
Senior Air Safety Investigator  
NTSB, Central Region

**Date:** February 22, 2023

**Subject:** Memorandum for the Record CEN23FA113  
Engine Examinations

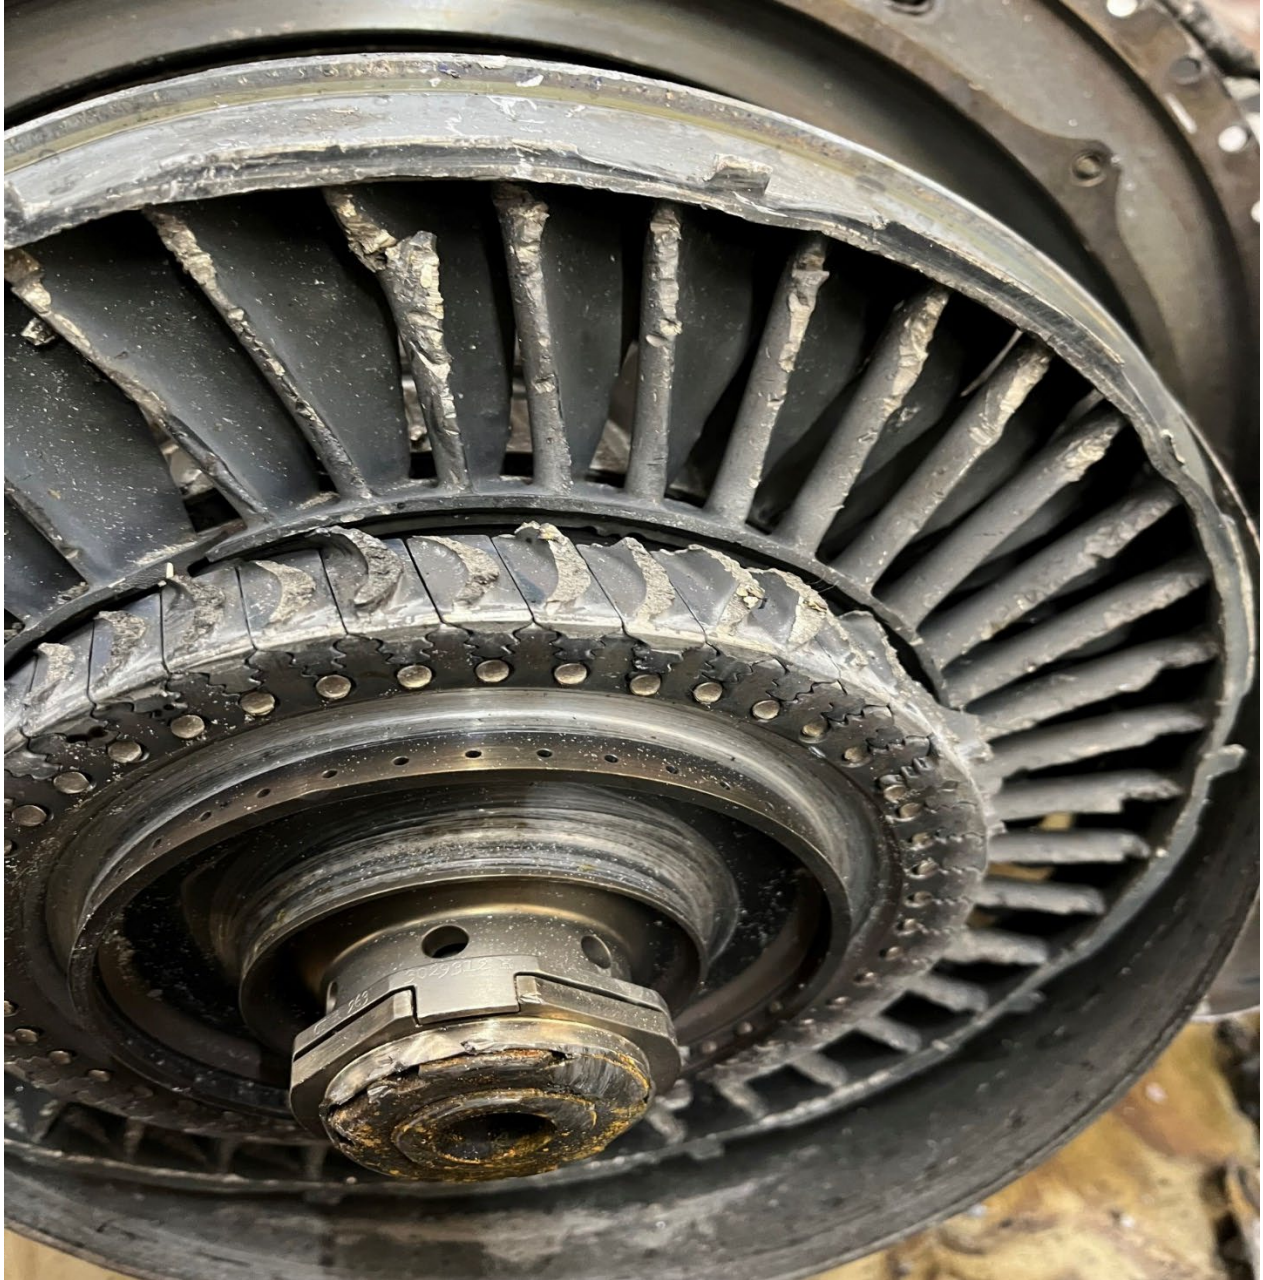
The starter generator was present. The fuel control was present, but damaged from impact. Reduction gear case was presented for examination. Tach generator was missing. The propeller governor was presented for examination. The fuel oil heater was sheared off from impact and not presented for observation. The compressor rotated with difficulty by hand force. Both bleed valves were in the open position. The fuel pump was still attached to the gear box. Accessory gear box was separated from gas generator at compressor strut housing. All components of the cam mechanism were in place and secured by cotter pin. The NG tach generator was in place. The P3 filter contained no obstructions. The P3 lines were in place and secure. The propeller shaft exhibited torsional twisting and was sheared and rotational scarring was observed on the compressor turbine segments. The oil filter was clean with no debris observed. The compressor turbine segments exhibited rotational scarring. The reduction gear box was presented for observation. Power turbine vane housing separated from power section with significant rotational damage. All

PT #1 blades sheared at base. The chip detector was missing due to impact. The exhaust housing exhibited twisting deformation.

Left Engine Power Turbine Section

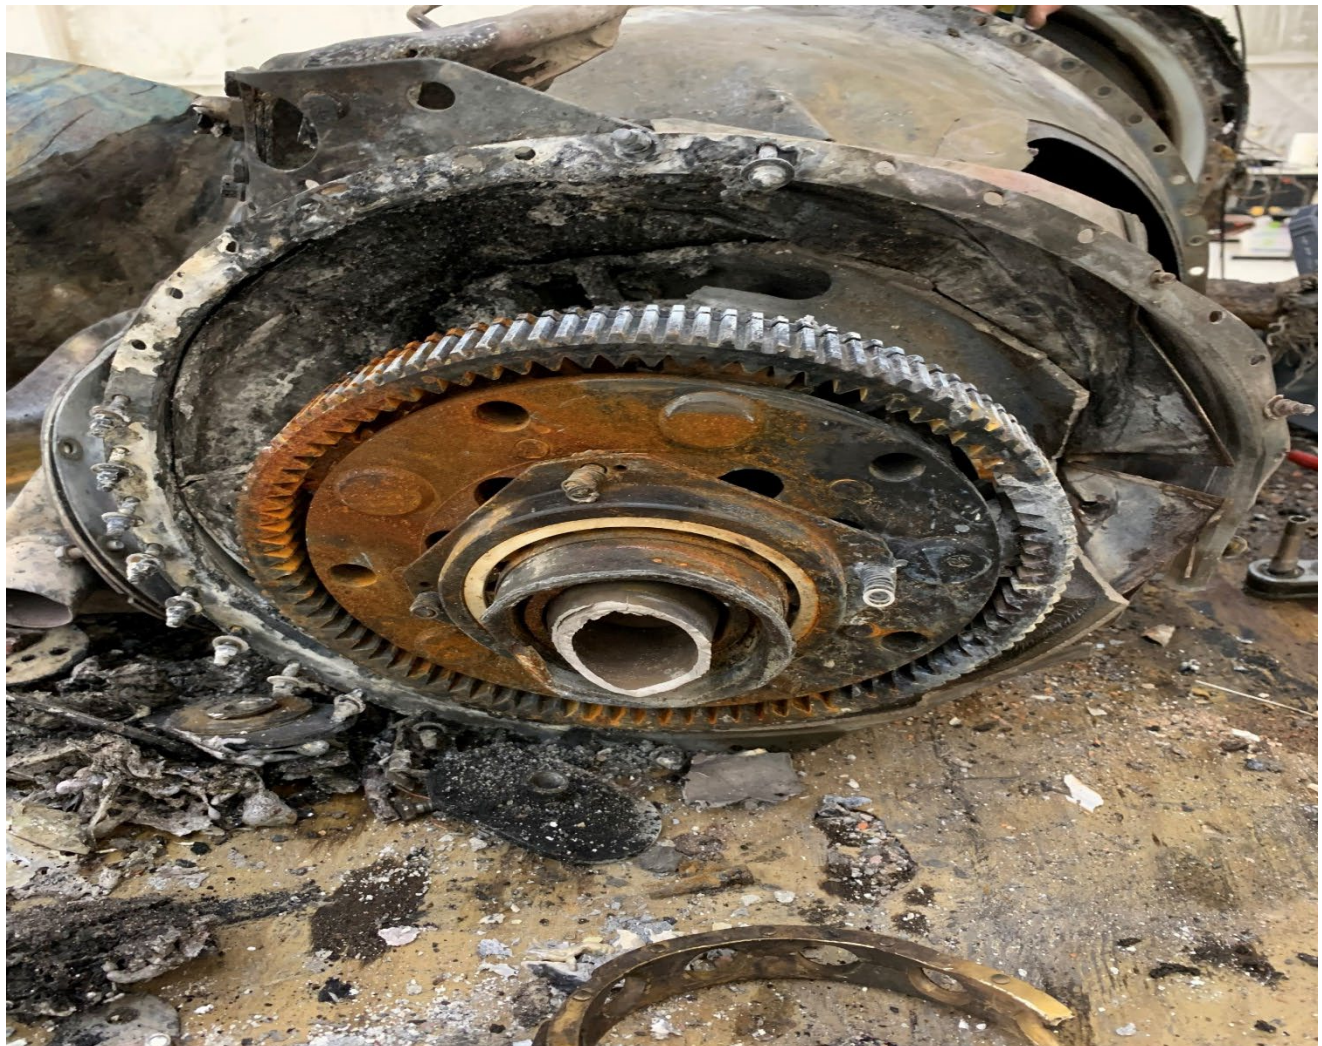
The starter generator was sheared off. The fuel control was intact, but damaged from impact. Gear case was not presented for examination. The propeller governor was not presented for examination. The fuel oil heater was sheared off from impact and not presented for observation. The compressor rotated with difficulty by hand force. Both bleed valves were in the open position. The fuel pump was separated from the gear box. All components of the cam mechanism were in place and secured by cotter pin. The NG tach generator was in place. The P3 filter contained no obstructions. The P3 lines were in place and secure. The propeller shaft exhibited torsional twisting and was sheared and rotational scarring was observed on the compressor turbine segments. The oil filter was clean with no debris observed. The compressor turbine segments exhibited rotational scarring. There was an external puncture in oil tank below data plate approximately 1 inch in diameter. The reduction gear box was not presented for observation. The sun gear and planetary gears were present. The chip detector was missing due to impact. The exhaust housing exhibited twisting deformation.

Right Engine Sun Gear Assembly and Fractured Propeller Shaft
