Alexander Lemishko  
Senior Air Safety Investigator  
NTSB, Central Region

**Date:** February 22, 2023

**Subject:** Memorandum for the Record CEN23FA113  
Accident Site and Wreckage Examination

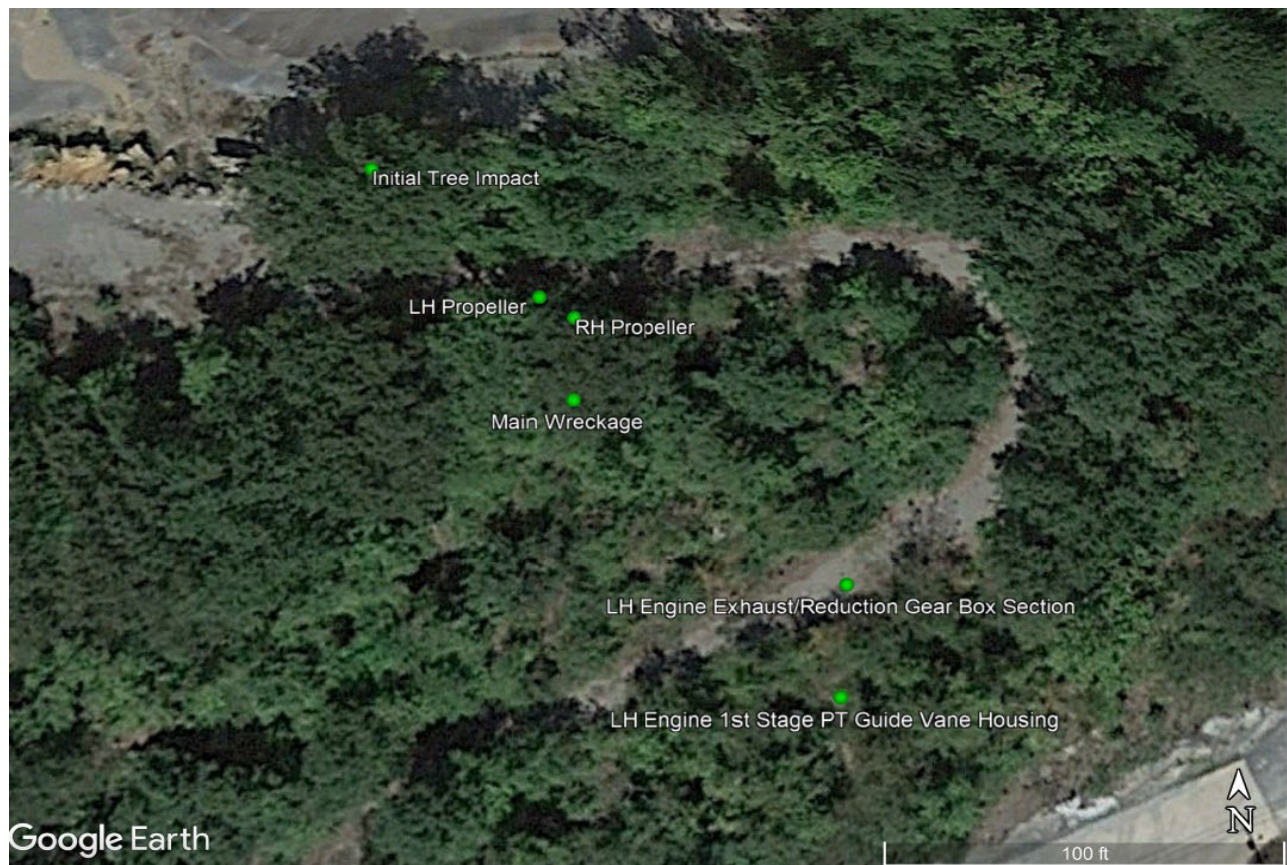
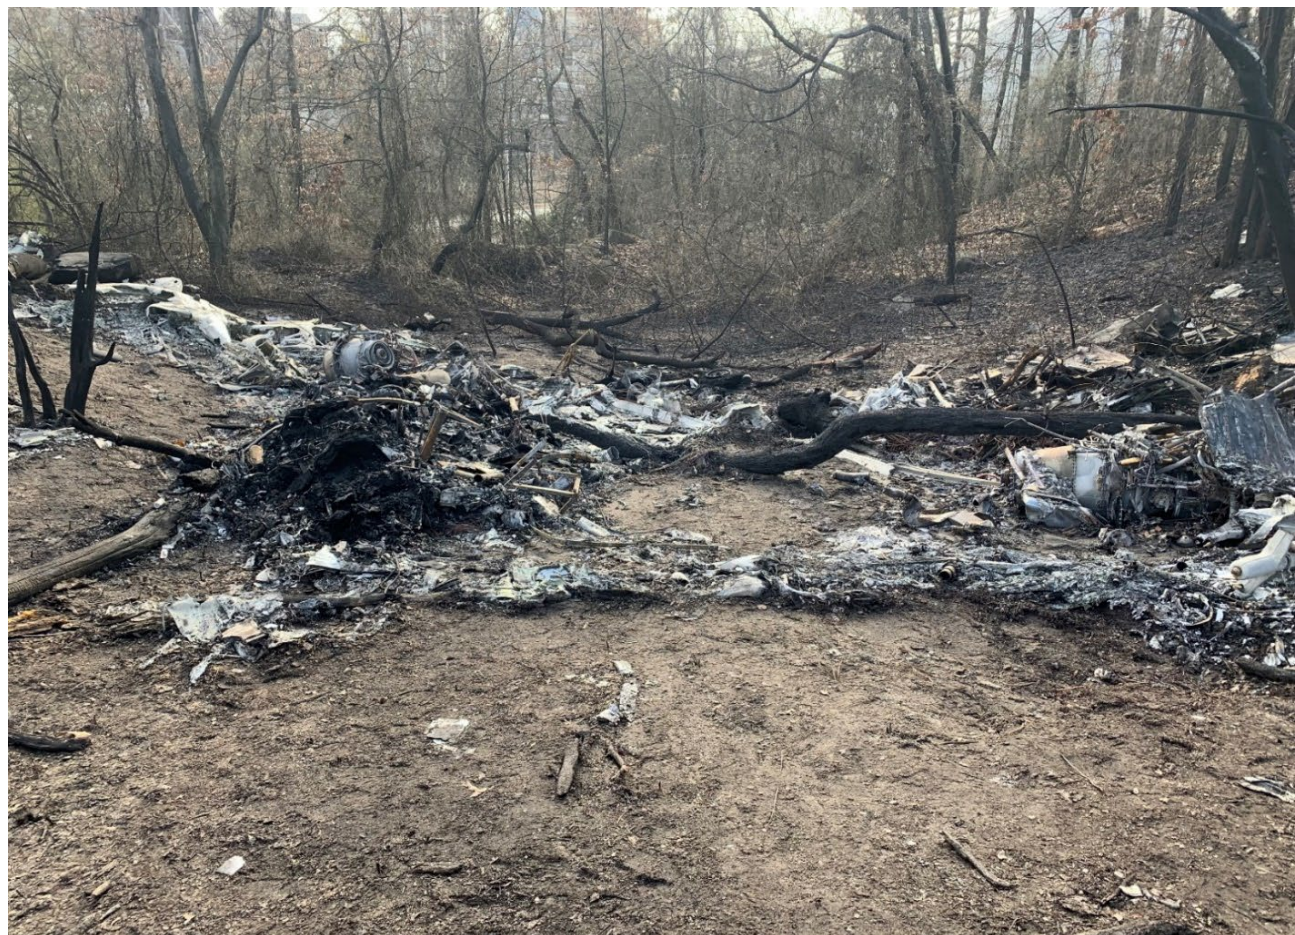
The aircraft initially impacted a large tree. That tree exhibited two propeller 45° cuts from the left propeller. The left propeller separated from the left engine and came to rest approximately 56' down from the initial tree impact resting on the ground. The right propeller separated from the right engine and came to rest approximately 67' down from the initial tree impact point resting against two trees. The right wing, engine, and main landing gear came to rest to left and behind the two trees where the right propeller came to rest. The cockpit area came to rest directly behind the two trees where the right propeller came to rest. Down from the cockpit was the rest of the aircraft; cabin, left wing, left main landing, nose landing gear, section of the left engine, and the empennage. The left engine exhaust and reduction gear box section came to rest down the hill and on the access road approximately 167' from the initial tree impact point. The left engine 1<sup>st</sup> stage power turbine guide vane housing came to rest approximately 188' from the initial tree impact point. The debris path was orientated of an approximate magnetic heading of 154°. Mostly all of the airframe was consumed by a post-impact fire.
