CEN23FA113

## INVESTIGATION PHOTOGRAPHS

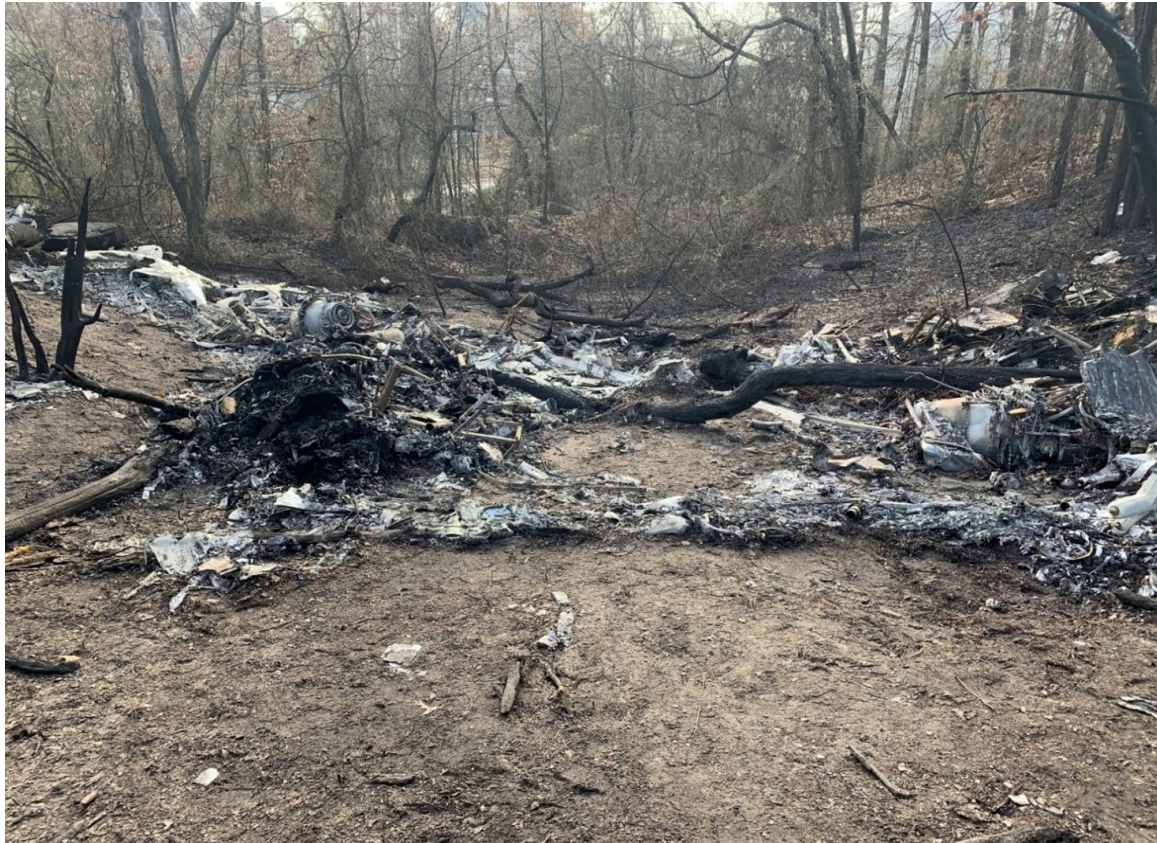
**Photograph 1 - Main Wreckage at Accident Site**

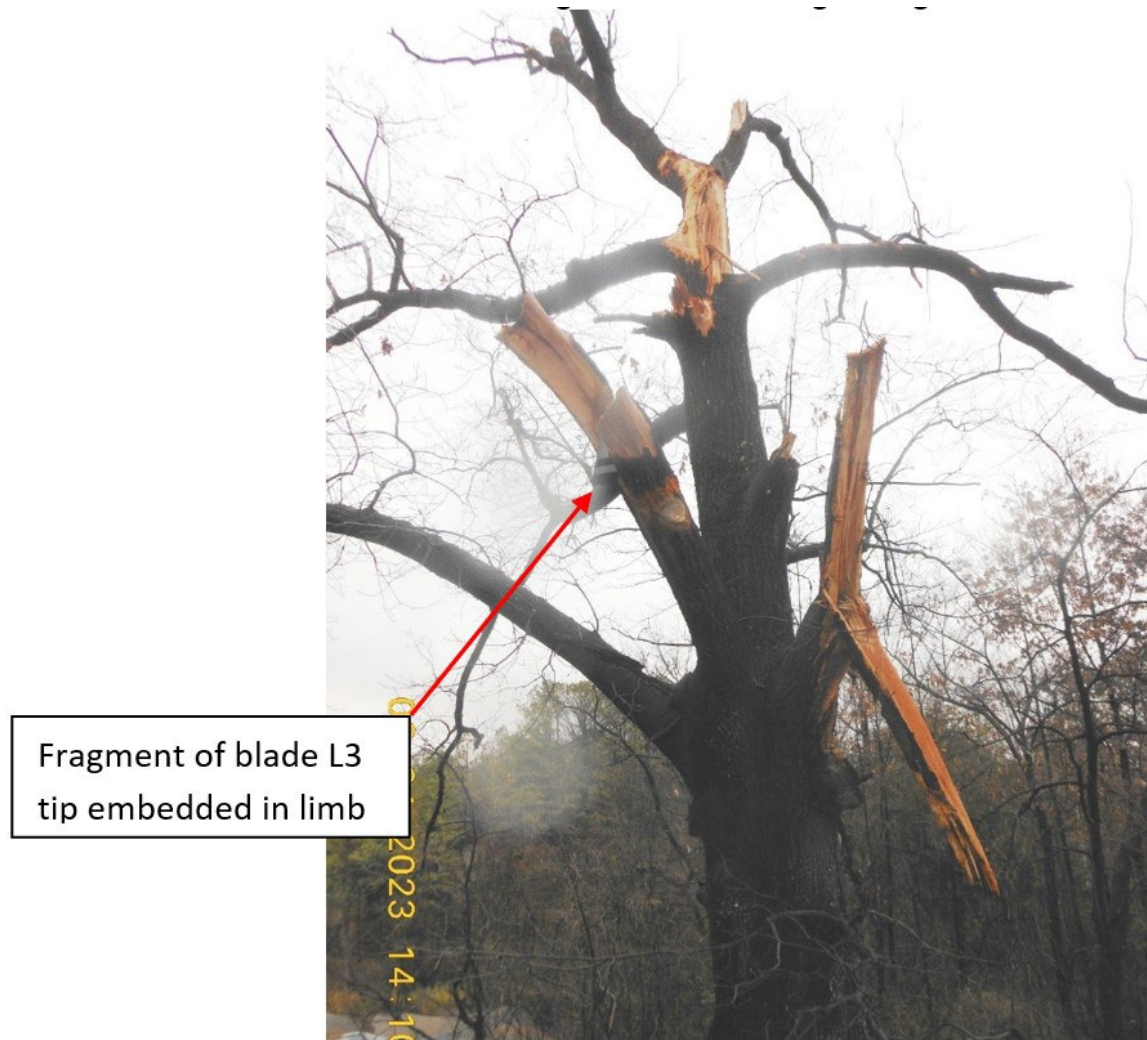
**Photograph 2 - Fragment of Propeller Blade Embedded in a Tree Limb**

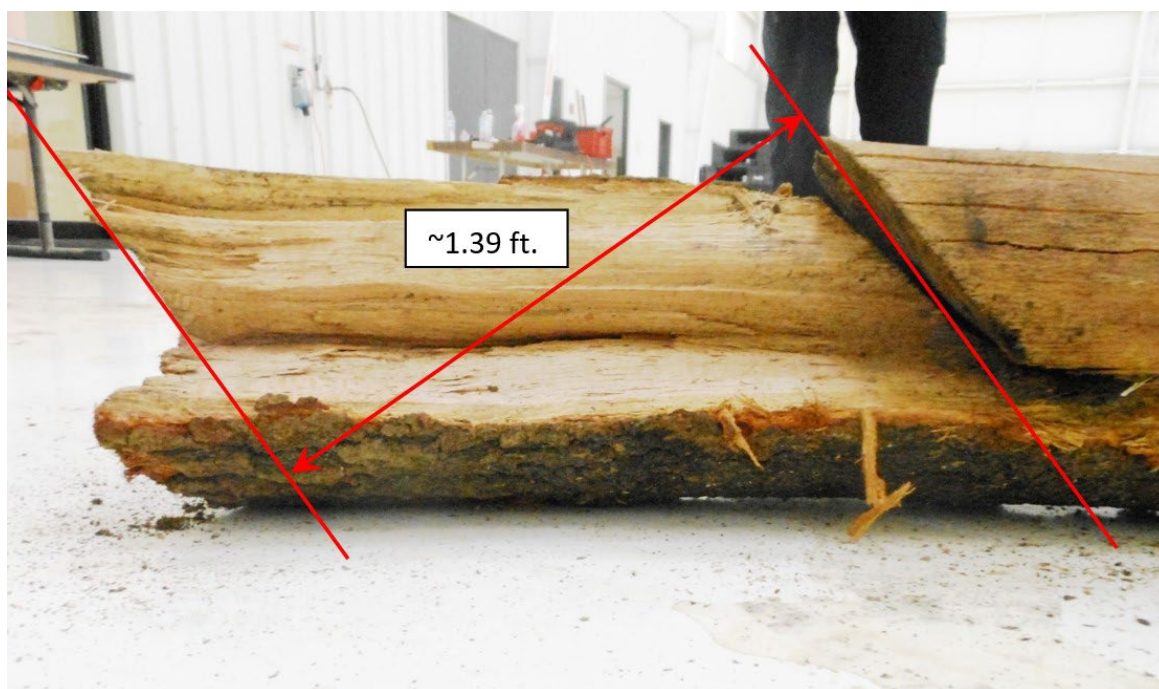
**Photograph 3 - Tree Limb Section Showing Propeller Blade Cut**

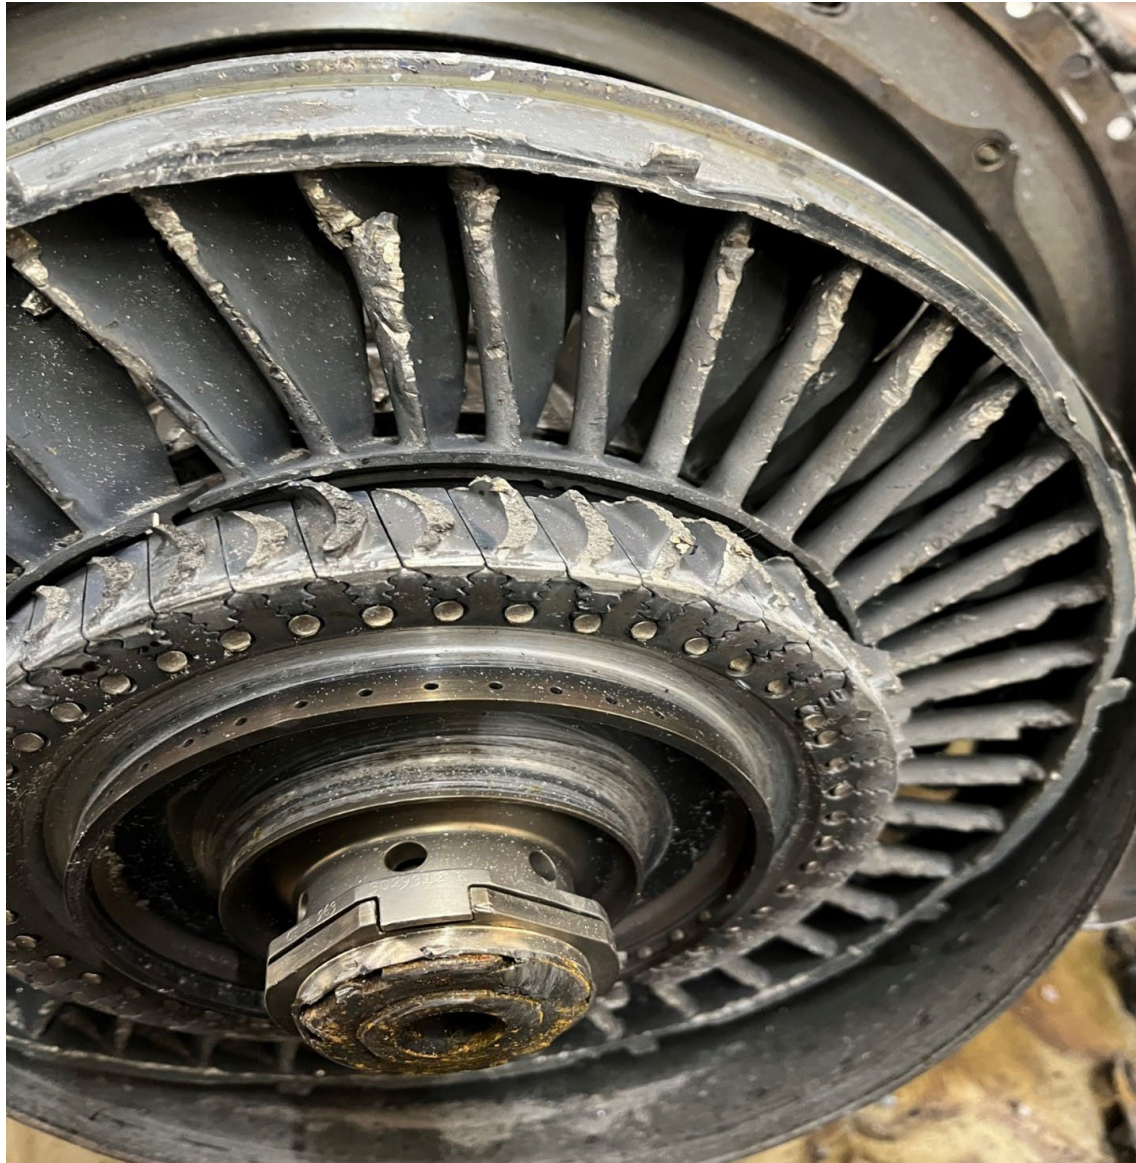
**Photograph 4 - Left Engine Power Turbine Section**

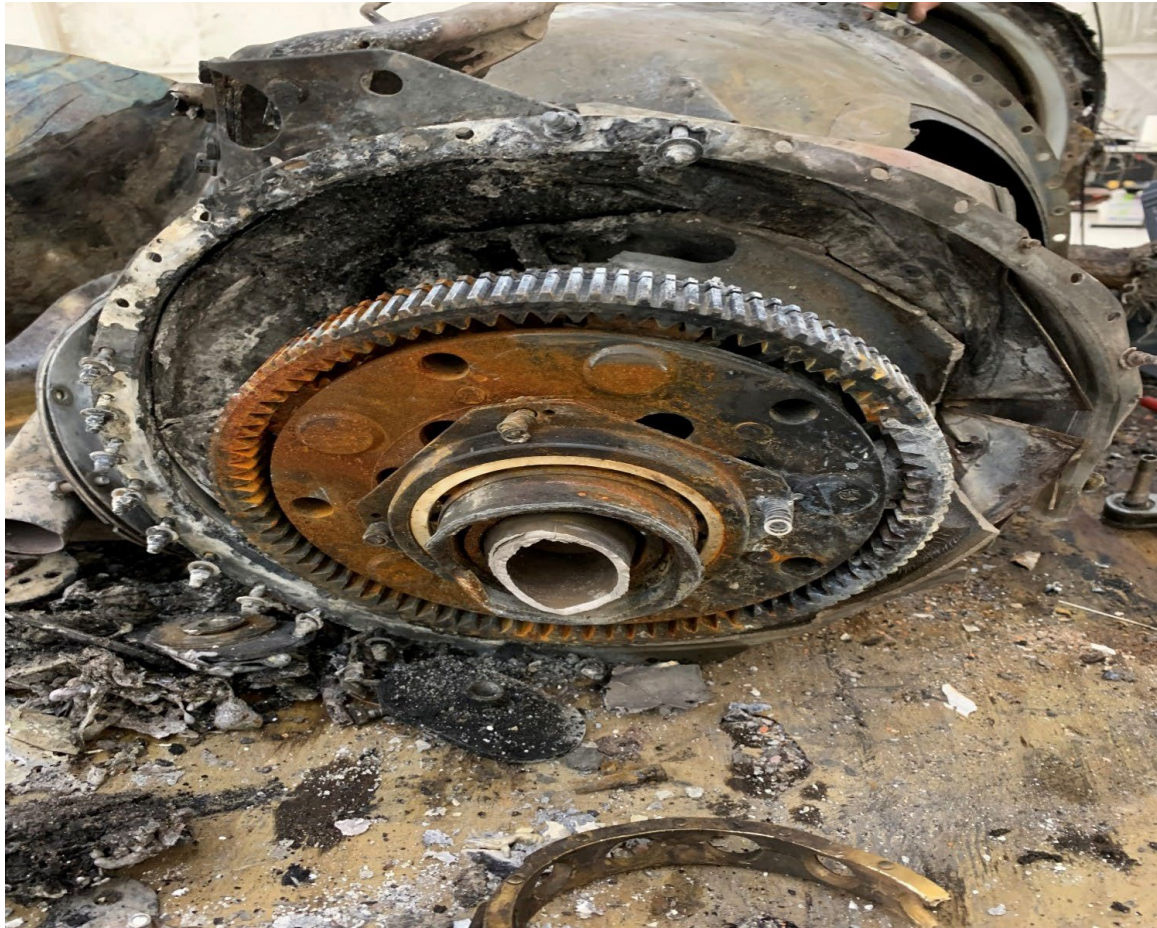
**Photograph 5 - Right Engine Sun Gear and Fractured Propeller Shaft**

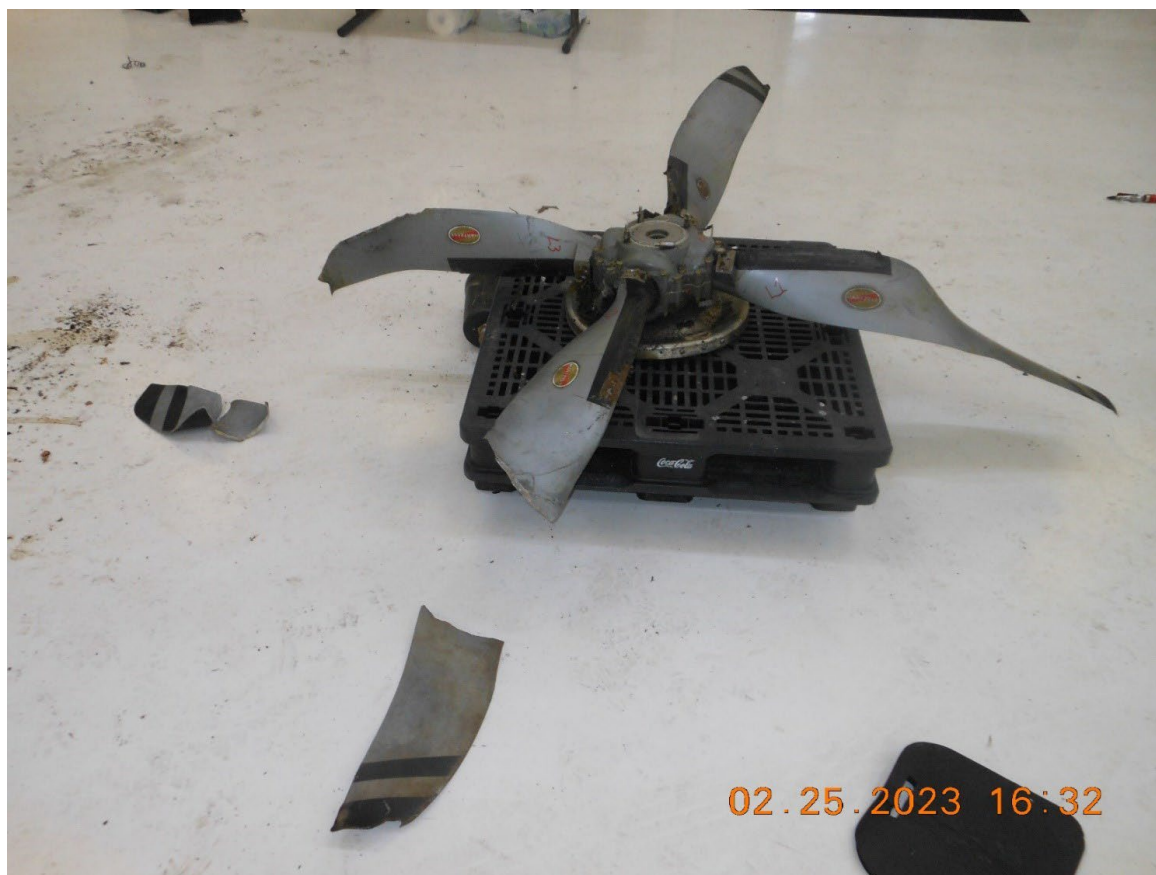
**Photograph 6 - Left Propeller Blade Assembly**

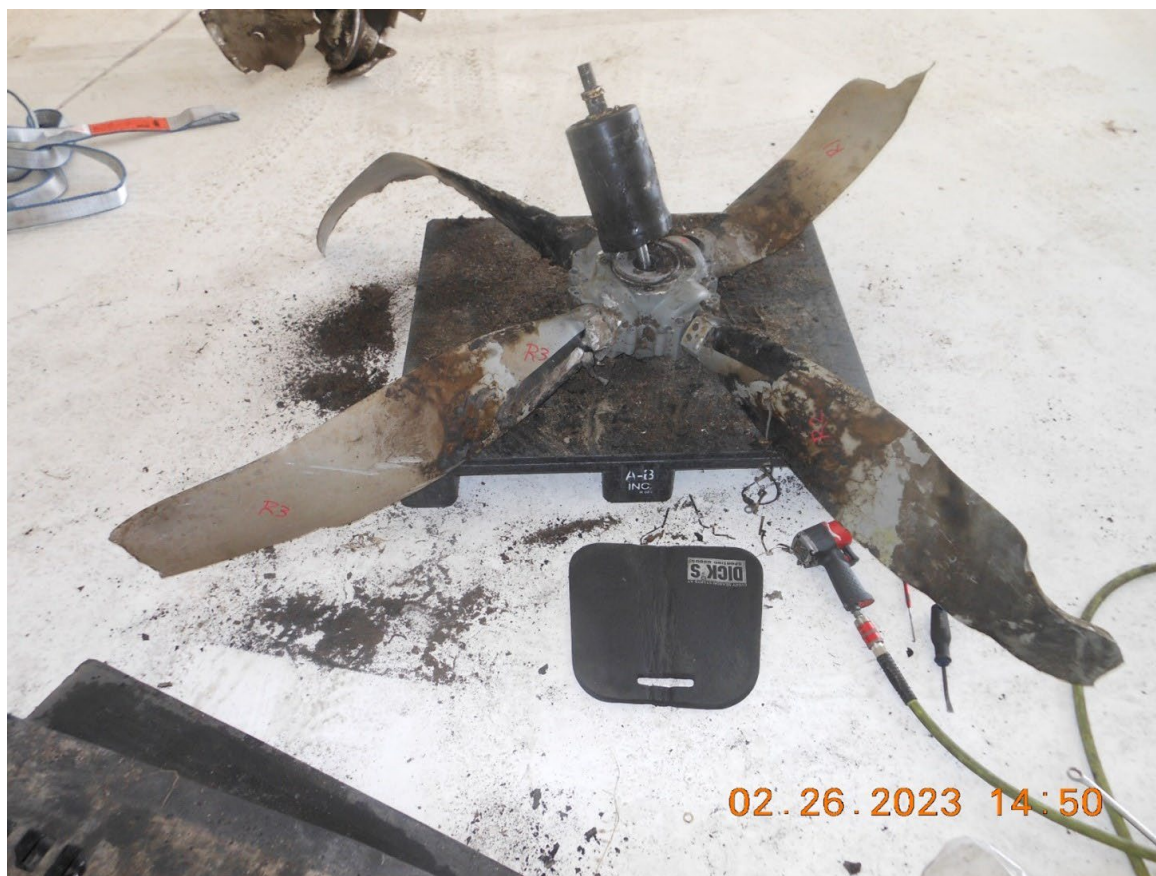
**Photograph 7 - Right Propeller Blade Assembly**
