# National Transportation Safety Board

CEN23FA142

## EXAMINATION SUMMARY

Location: Port Allen, LA  
Date: March 26, 2023  
Time: 02:38 Central Daylight Time  
Helicopter: Robinson R44 II

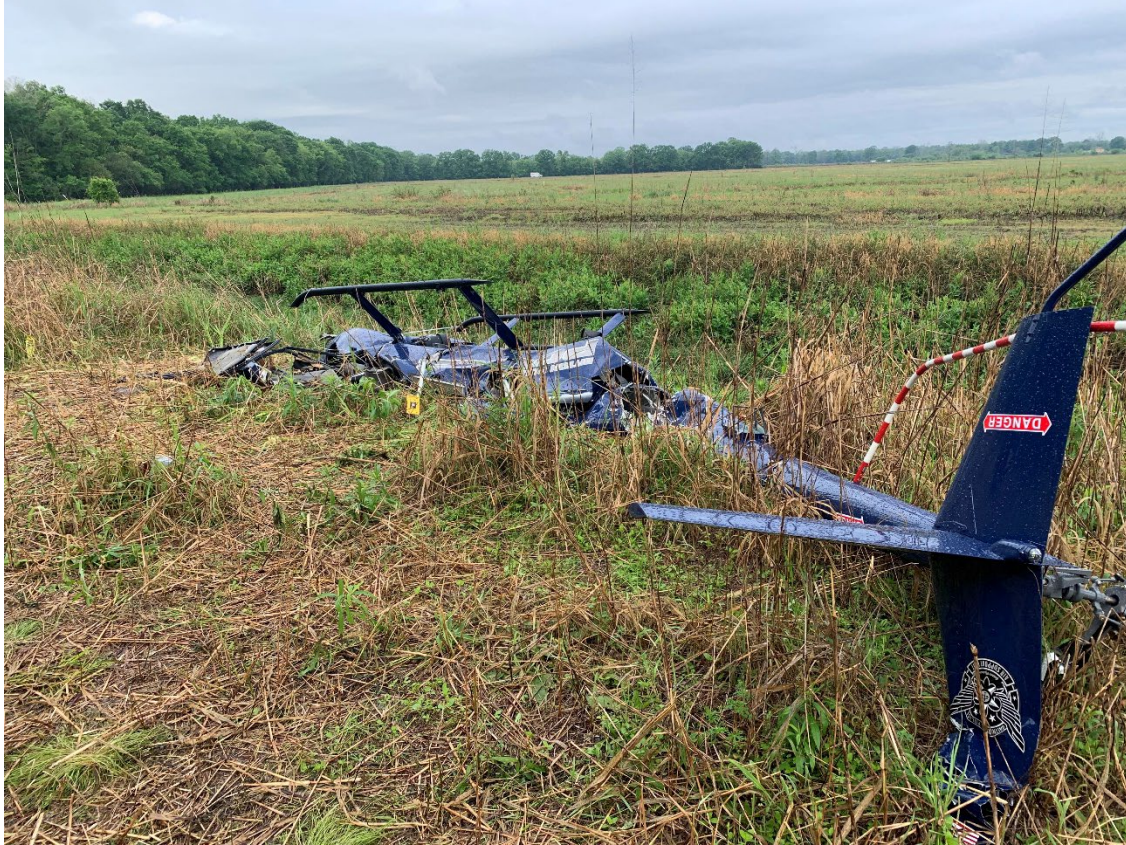
Figure 1. Main wreckage at accident site.

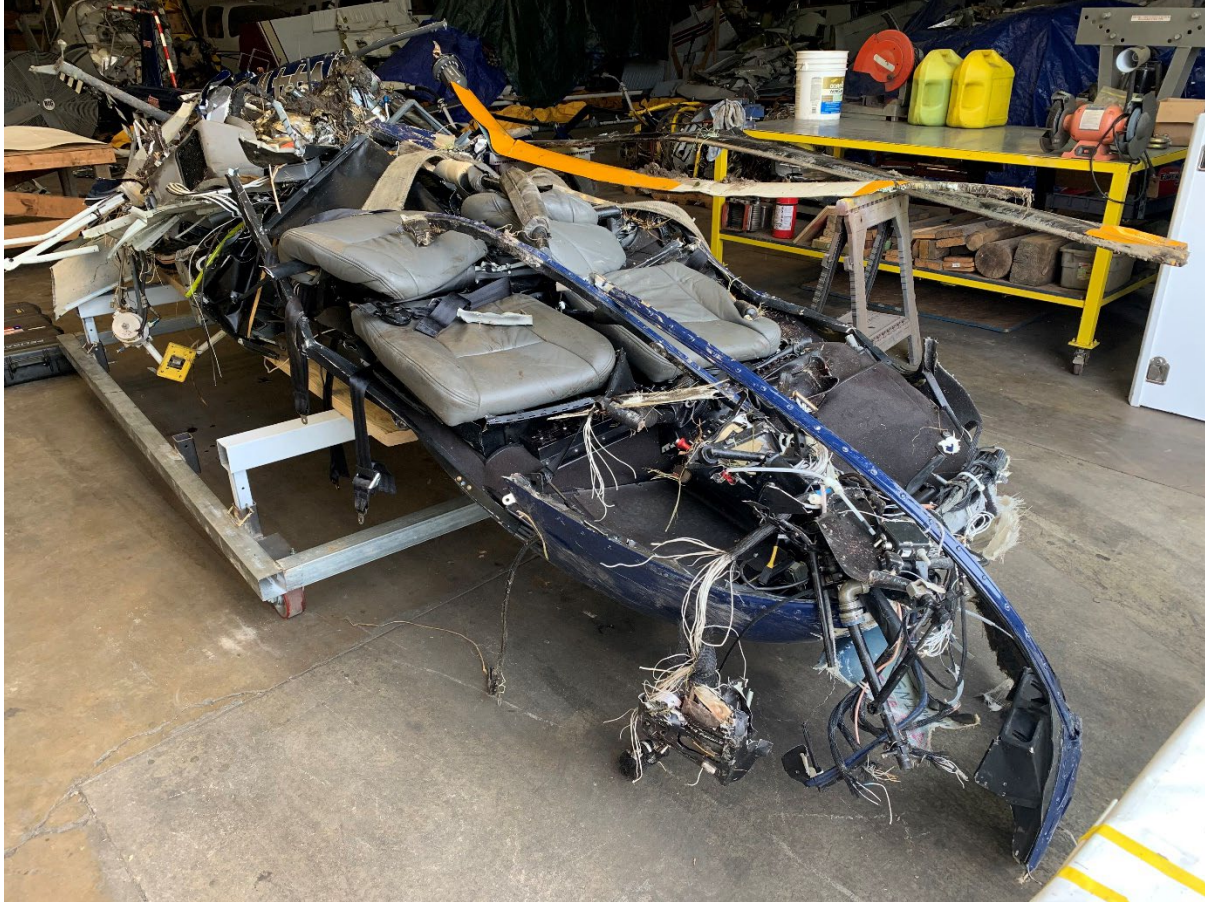
Figure 2. Main wreckage at recovery facility.

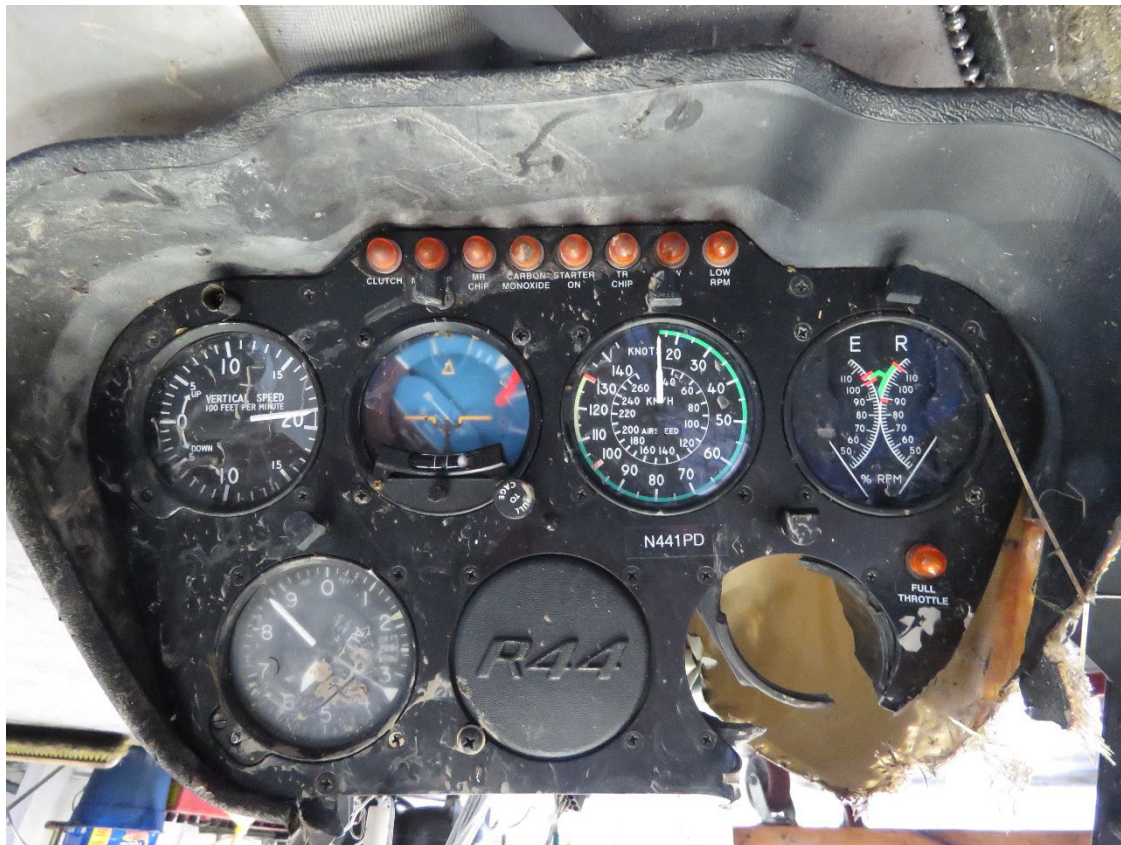
Cockpit/Cabin - collective found in a close to full up position. Throttle twist grip full on. Mixture full rich. Governor switch on. Removable pedals/collective installed. No option to remove cyclic. Warning/caution lights - low RPM - Broken, Clutch - stretched. Rotor brake - broken. Instrument console separated and located in debris field. 5-pt. restraints installed. Lower crotch strap did not appear to be secure.

Figure 3. Upper instrument console (Source: Robinson Helicopter).

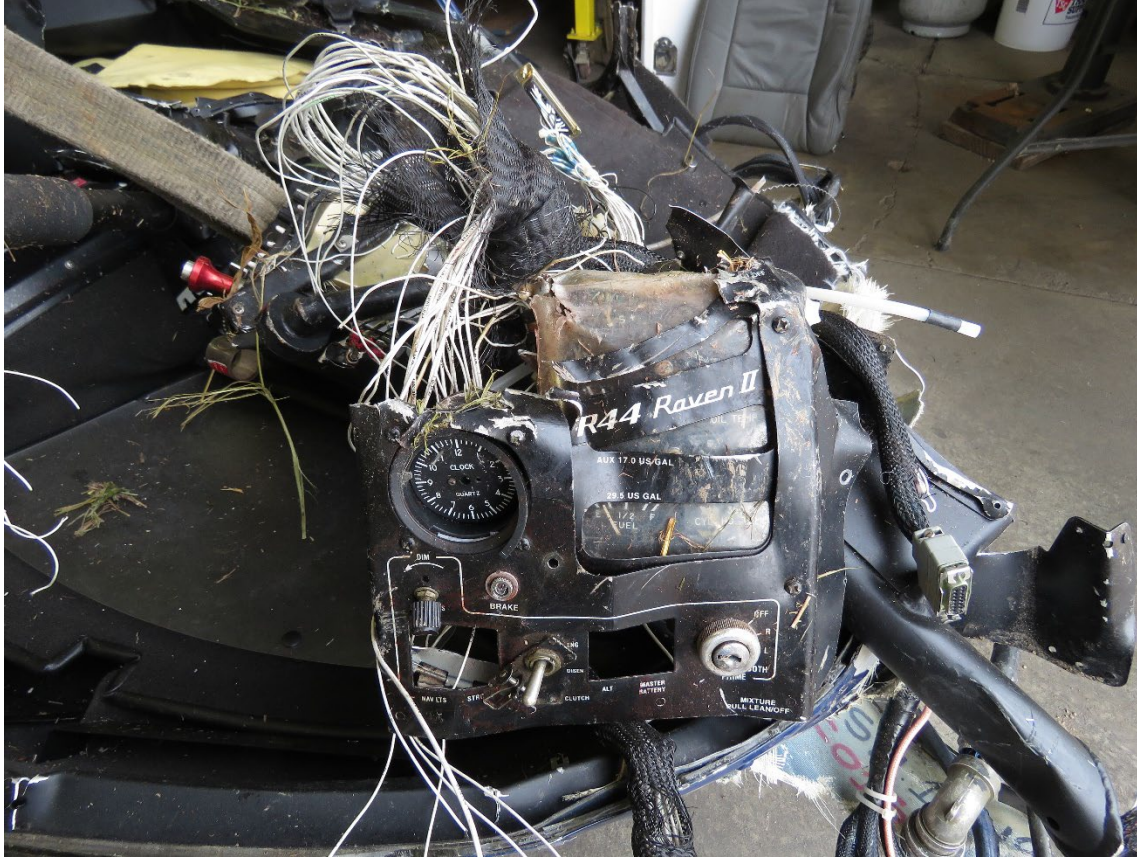
Figure 4. Lower instrument console (Source: Robinson Helicopter).

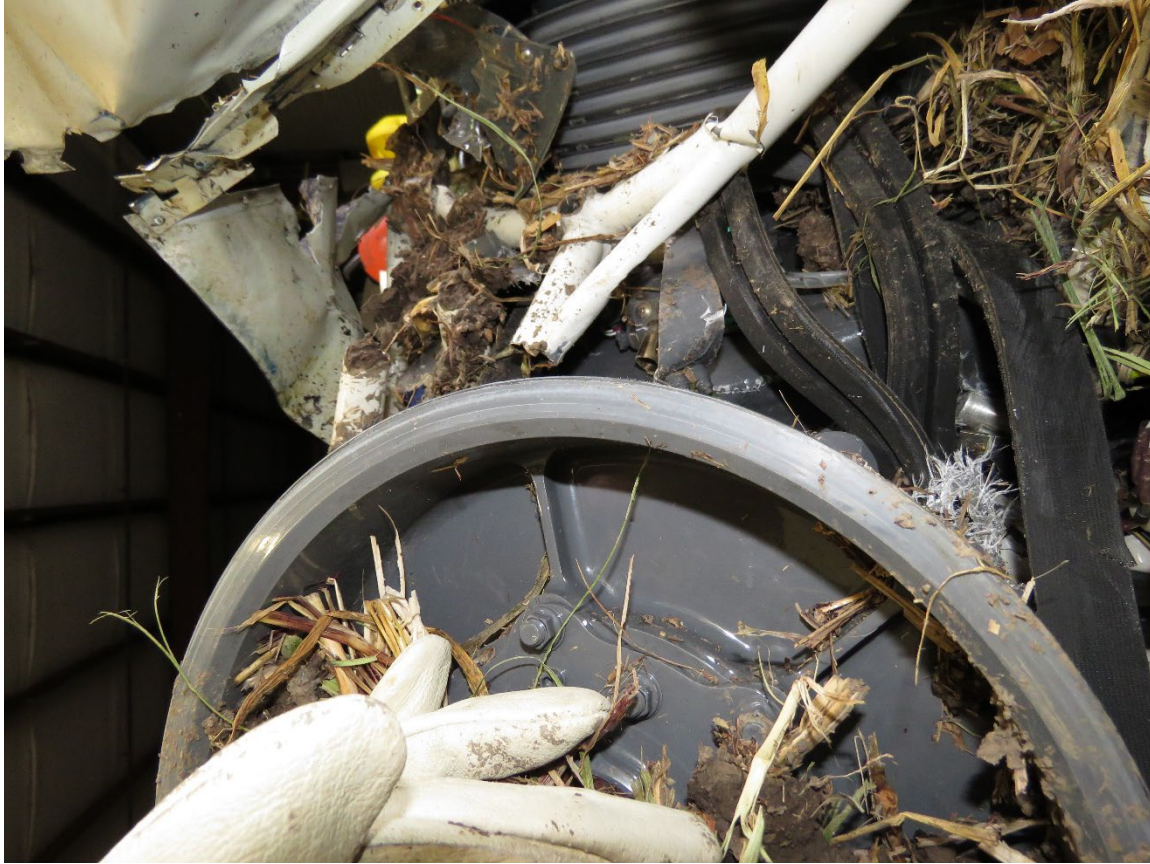
Rotation signatures - scoring on aft and forward surface of upper sheave. Little scoring on belt tension actuator. Rotation signatures on inlet rings for cooling fan scroll - upper and lower.

Figure 5. Rotational scoring on the forward surface of the upper sheave (Source: Robinson Helicopter).

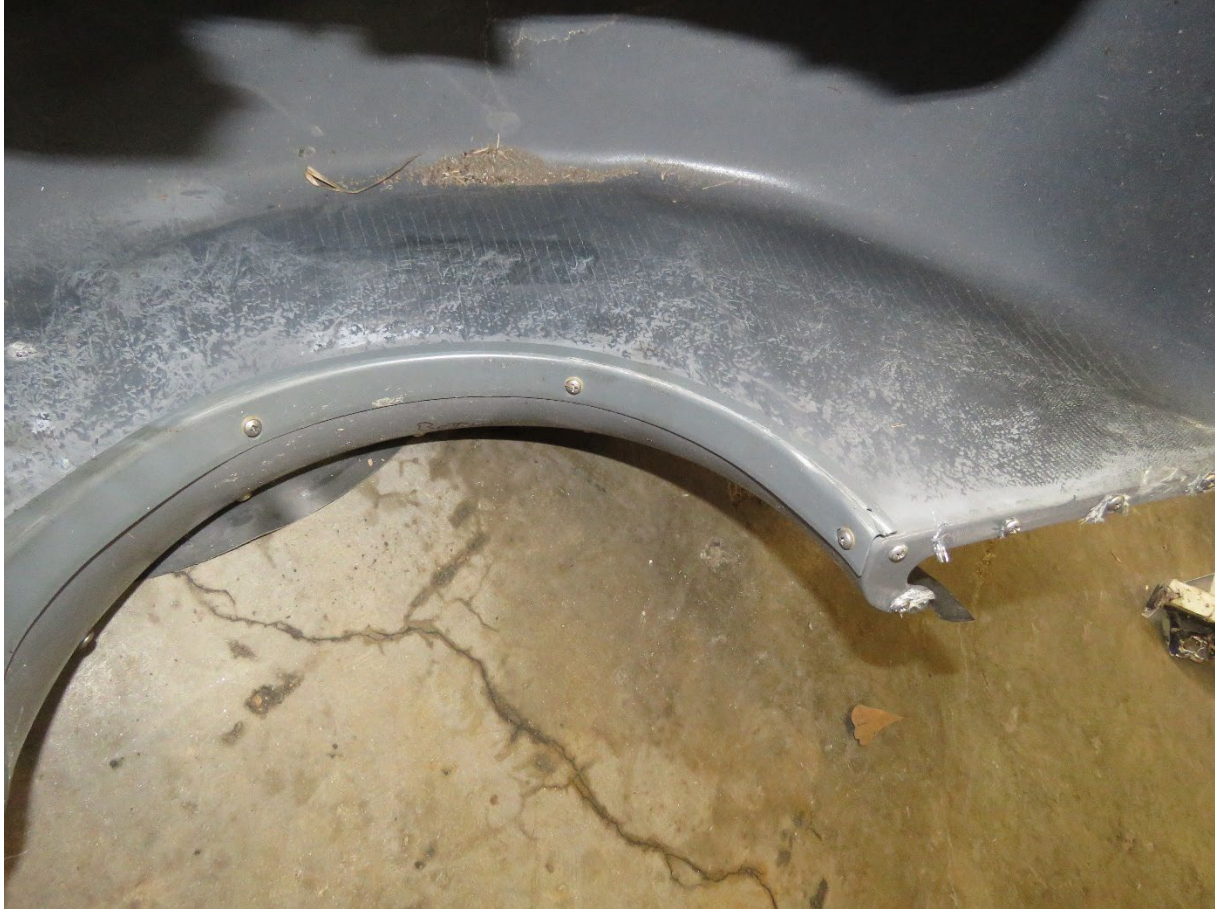
Figure 6. Rotational scoring on the lower half of the fan scroll (Source: Robinson Helicopter).

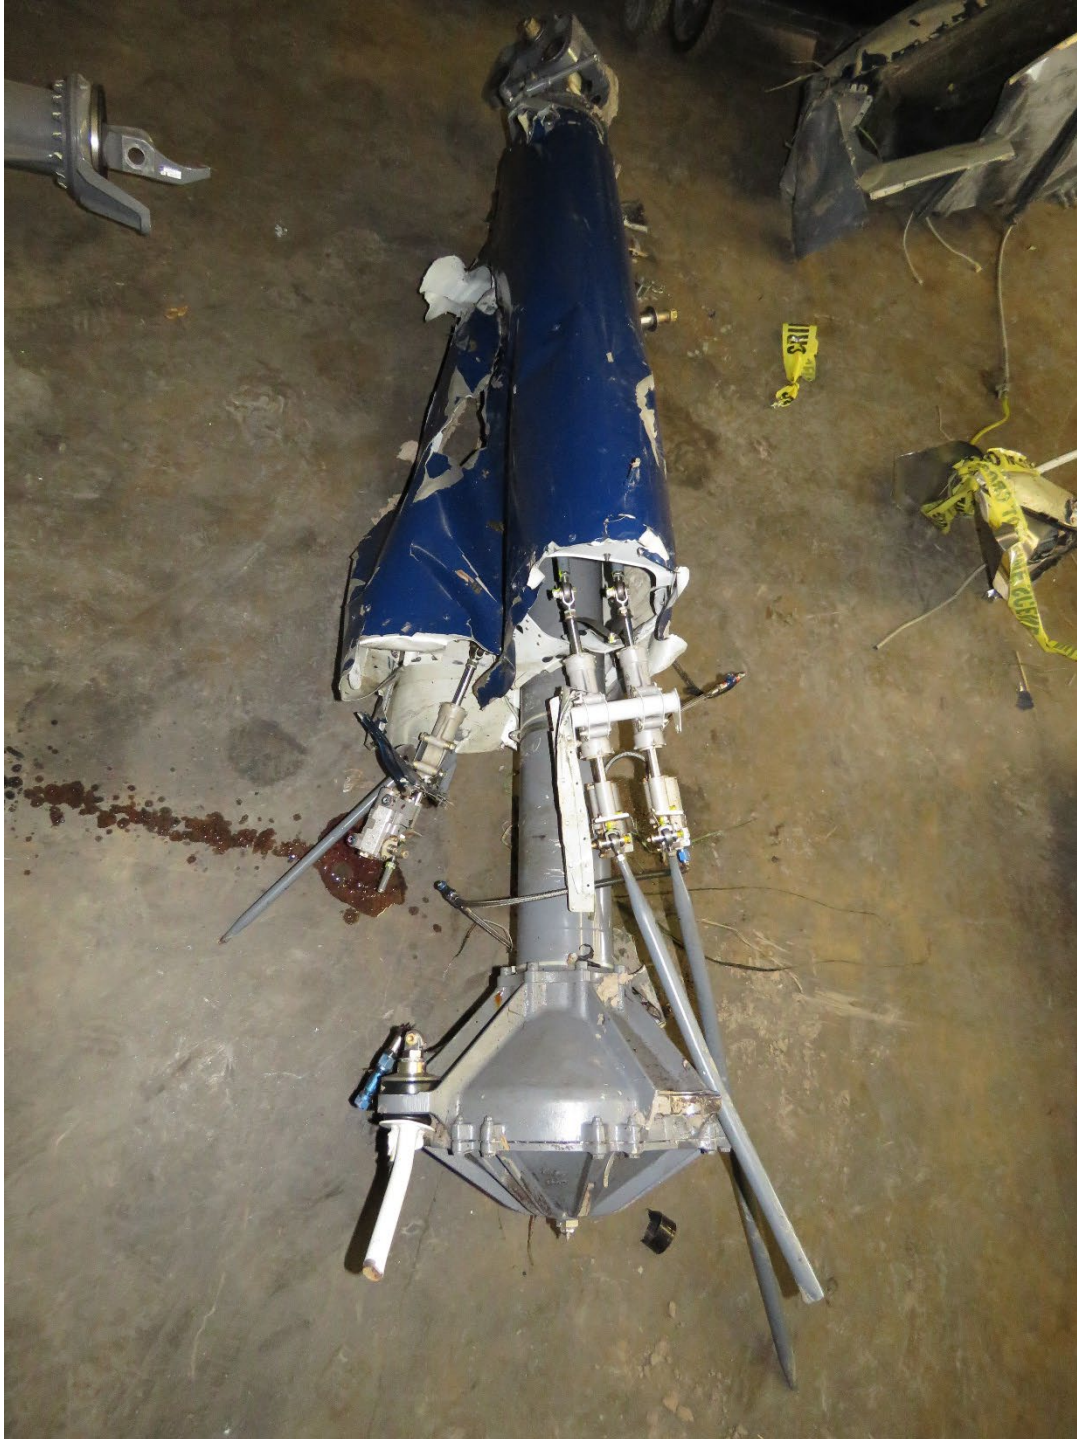
Figure 7. Main rotor gearbox and mast (Source: Robinson Helicopter).

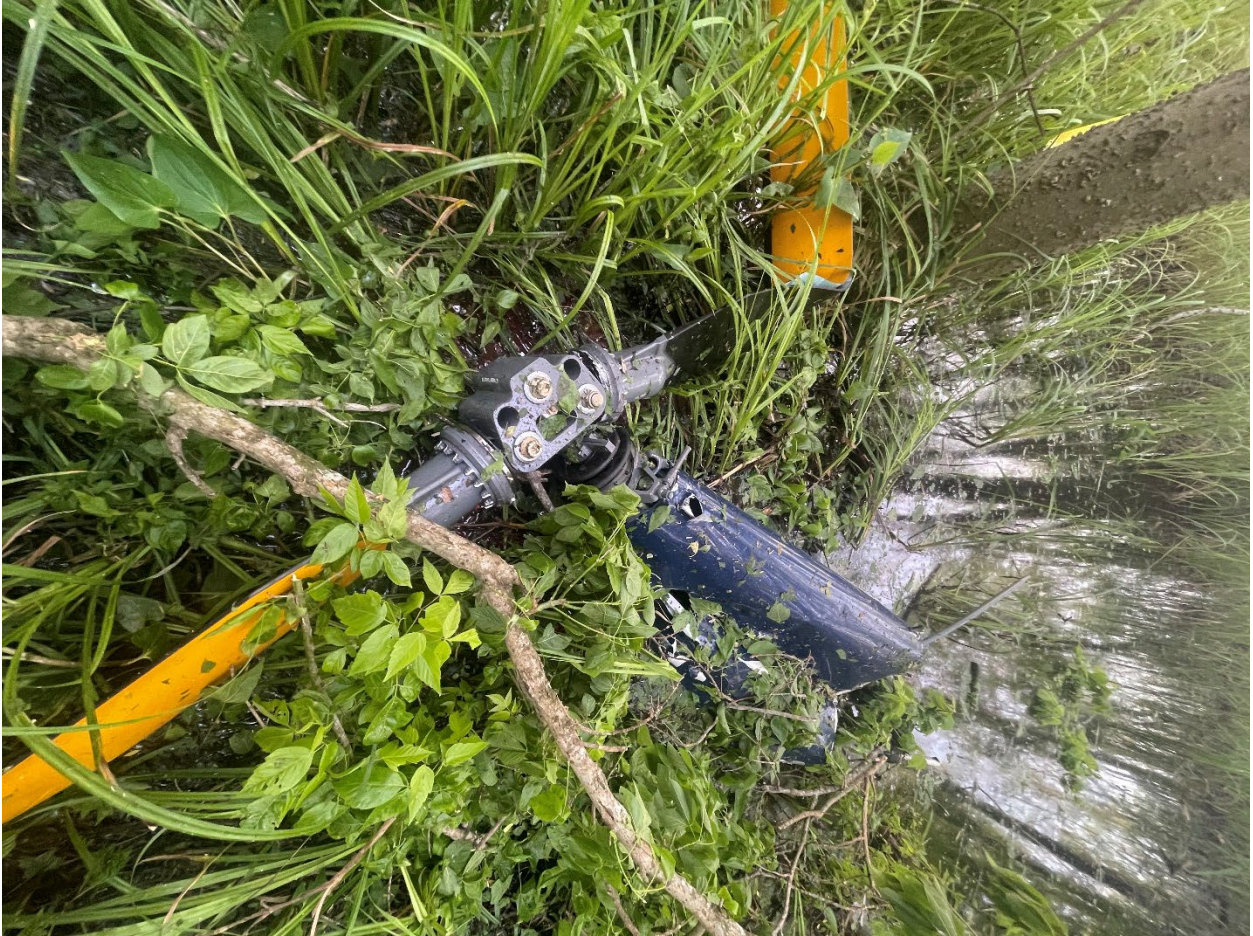
Figure 8. Main rotor head and inboard main rotor blades.

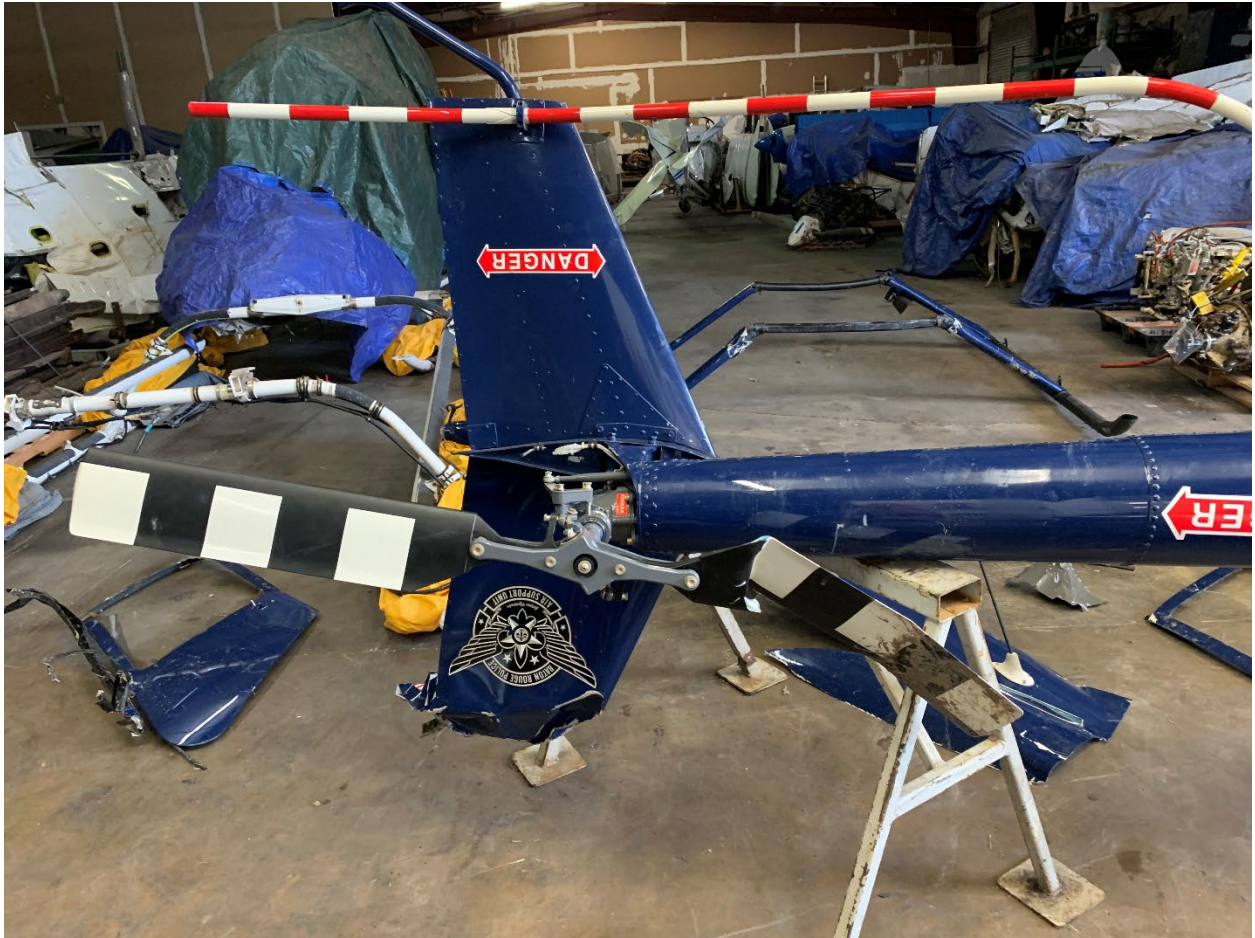
Figure 9. Tail rotor blades and gearbox.

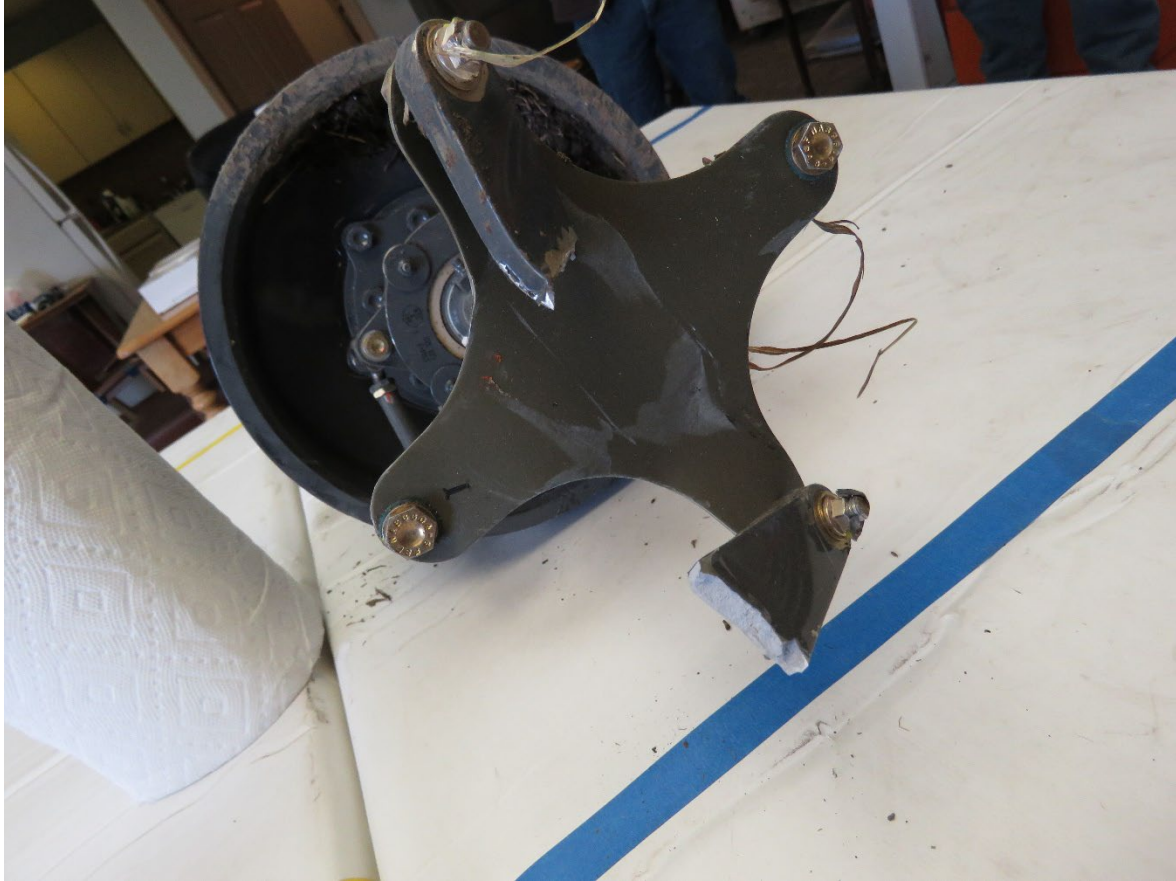
Figure 10. Intermediate flex coupling (Source: Robinson Helicopter).

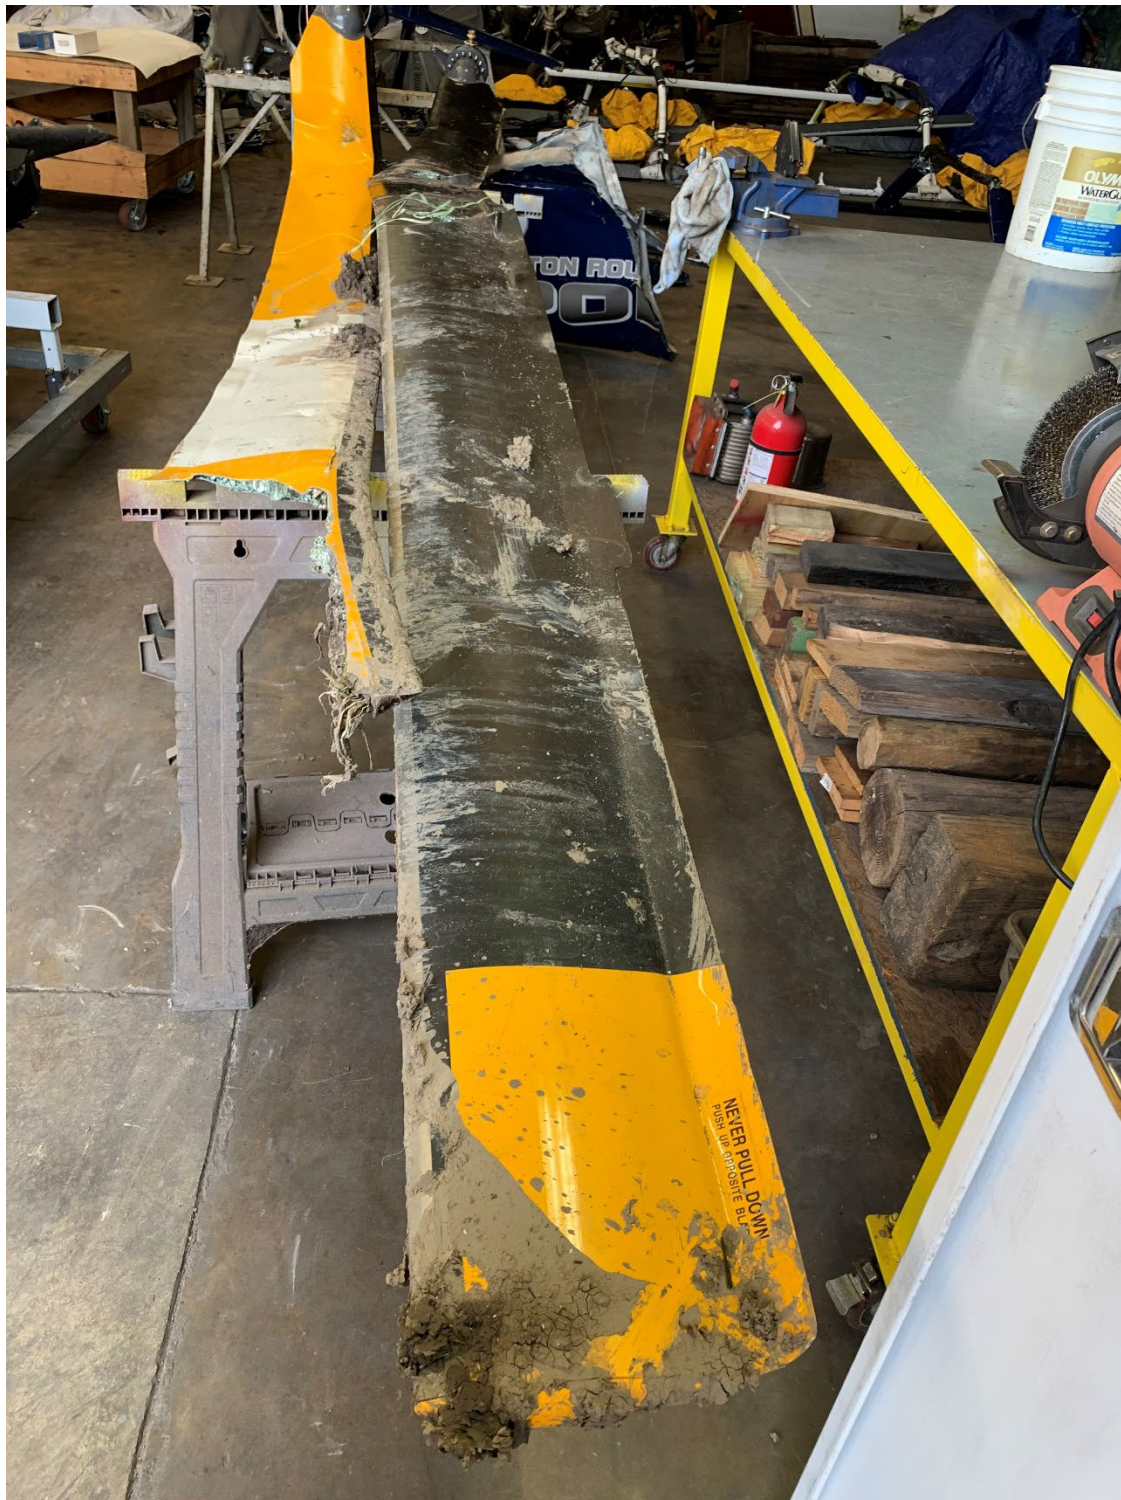
Figure 11. Main rotor blades and damage.

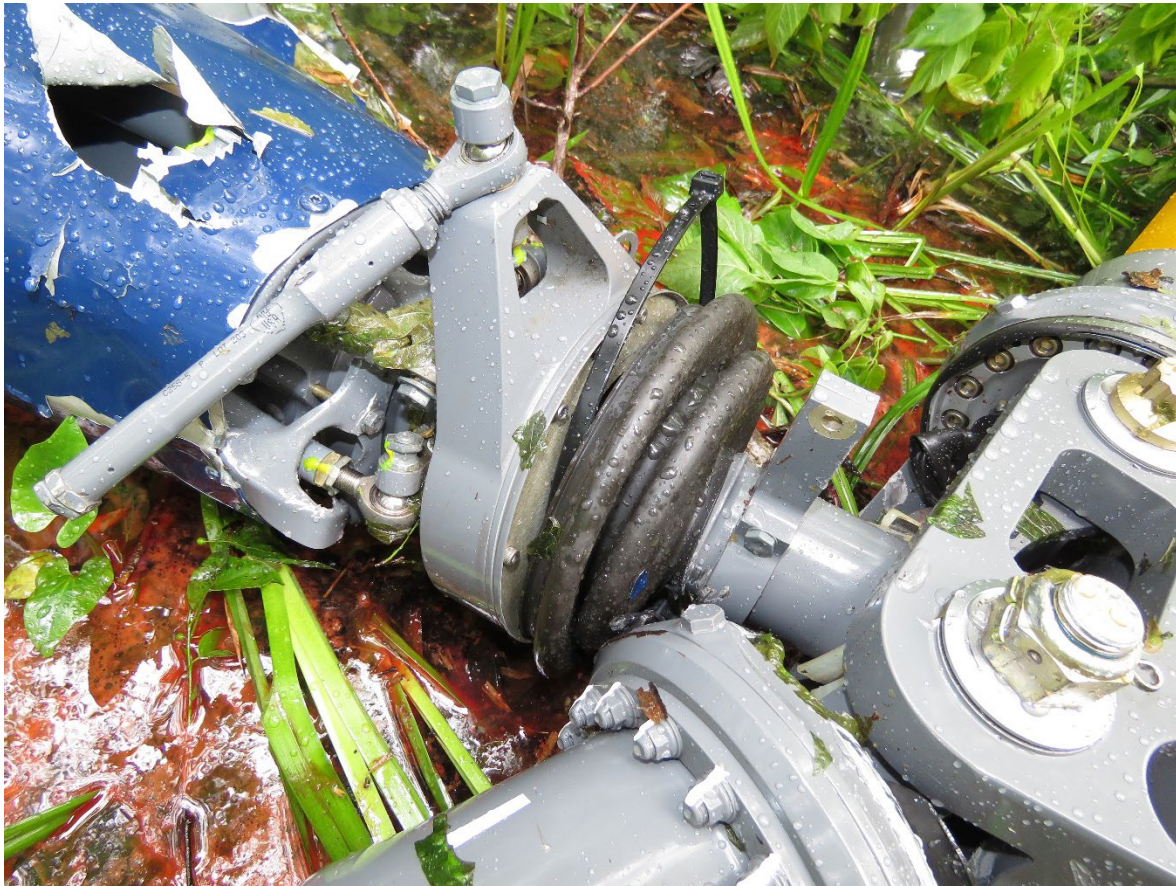
Flight controls - all 3 servos moved when manually input. All fractures were overload.  
Missing pilot cyclic grip, missing bottom of control tube between mixing bell crank

and servo. Missing rod end at main rotor blade pitch link. Tail rotor pitch change slider free to move.

Figure 12. Main rotor head controls (Source: Robinson Helicopter).

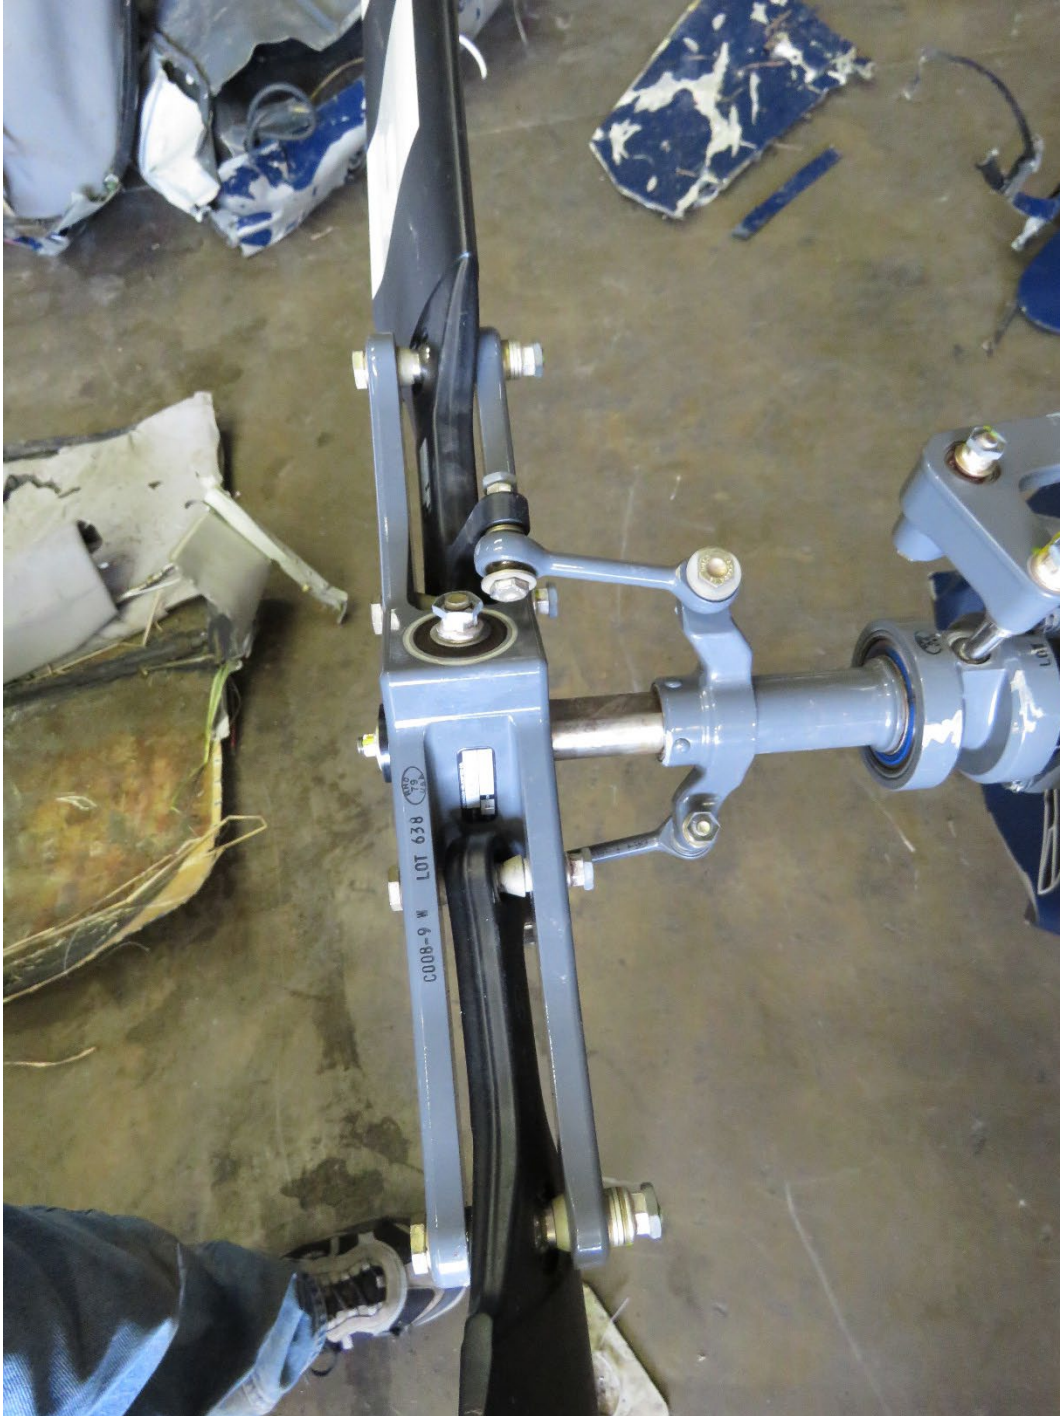
Figure 13. Tail rotor pitch links and bellcrank (Source: Robinson Helicopter).

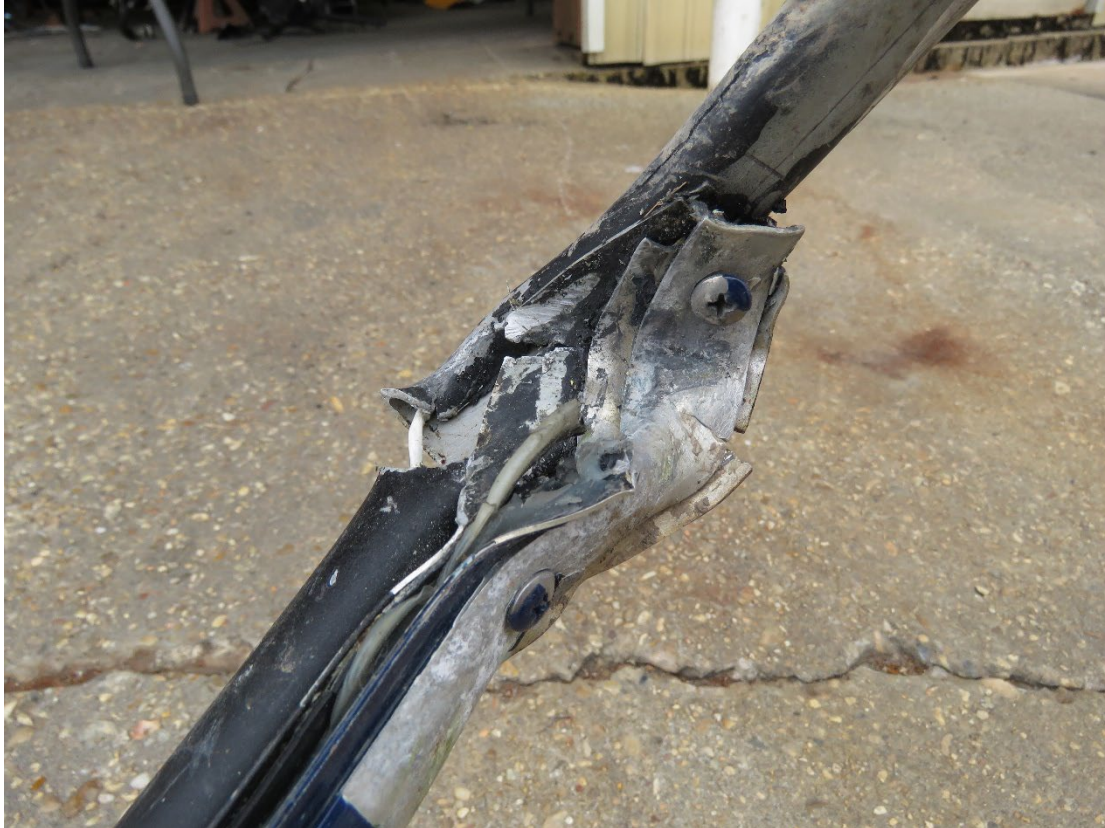
Structure - evidence of main rotor strike at cabin structure above FLIR ball, top of windshield bow, and door frame above left seat passenger. Mast fairing intact, but damaged. Tail cone/boom partially separated, retained by controls and cables. No evidence of main rotor contact. Stinger intact. Empennage intact, upper vertical bent over consistent with impact. Tail cone battery installed; battery separated. Main rotor

Figure 14. Top of windshield bow consistent with main rotor blade impact (Source: Robinson Helicopter).

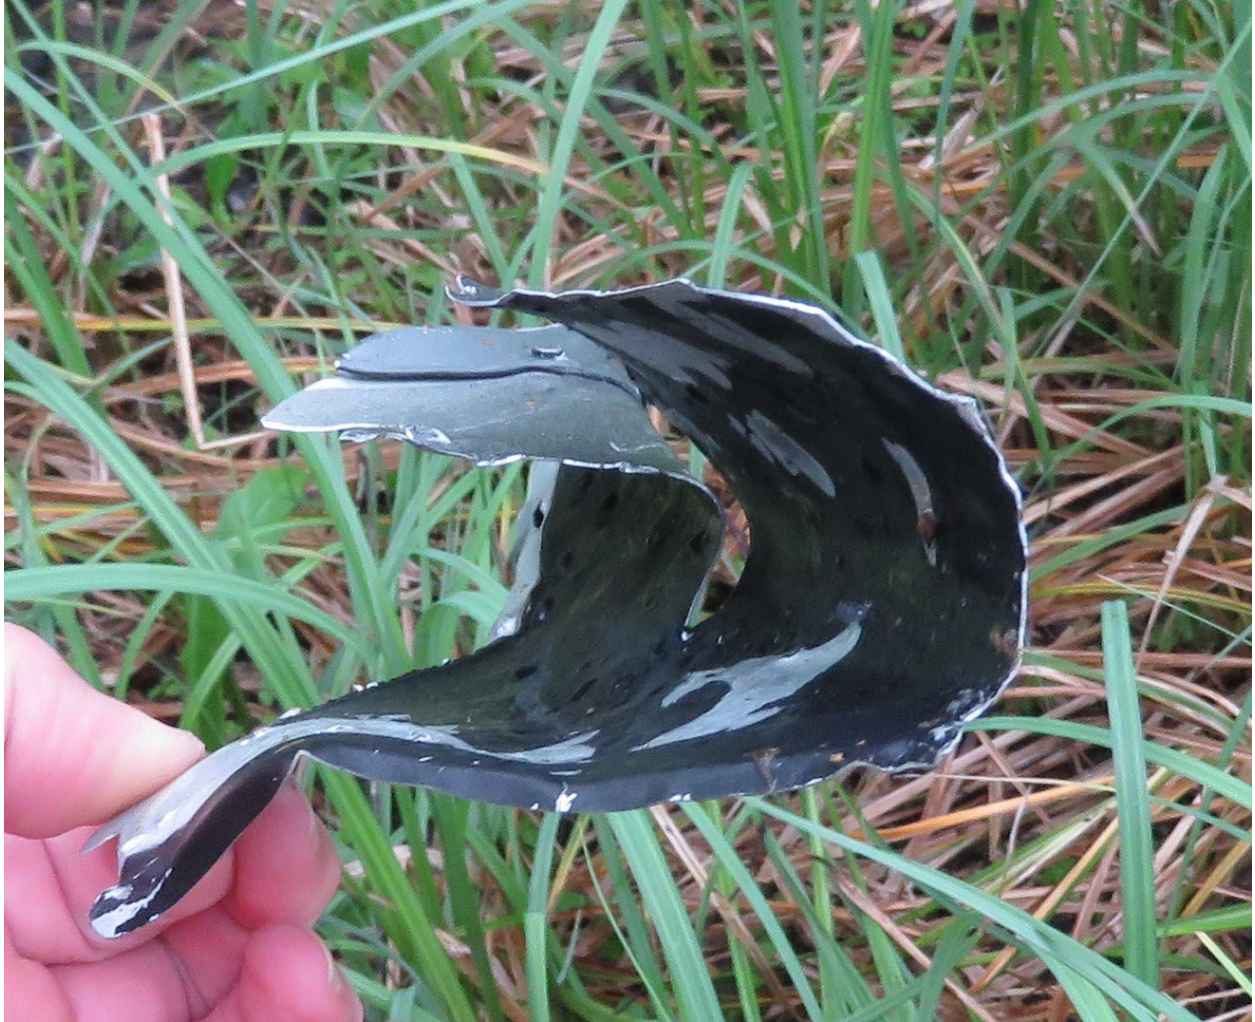
Figure 15. Separated metal from above camera gimbal mount consistent with main rotor blade impact (Source: Robinson Helicopter).

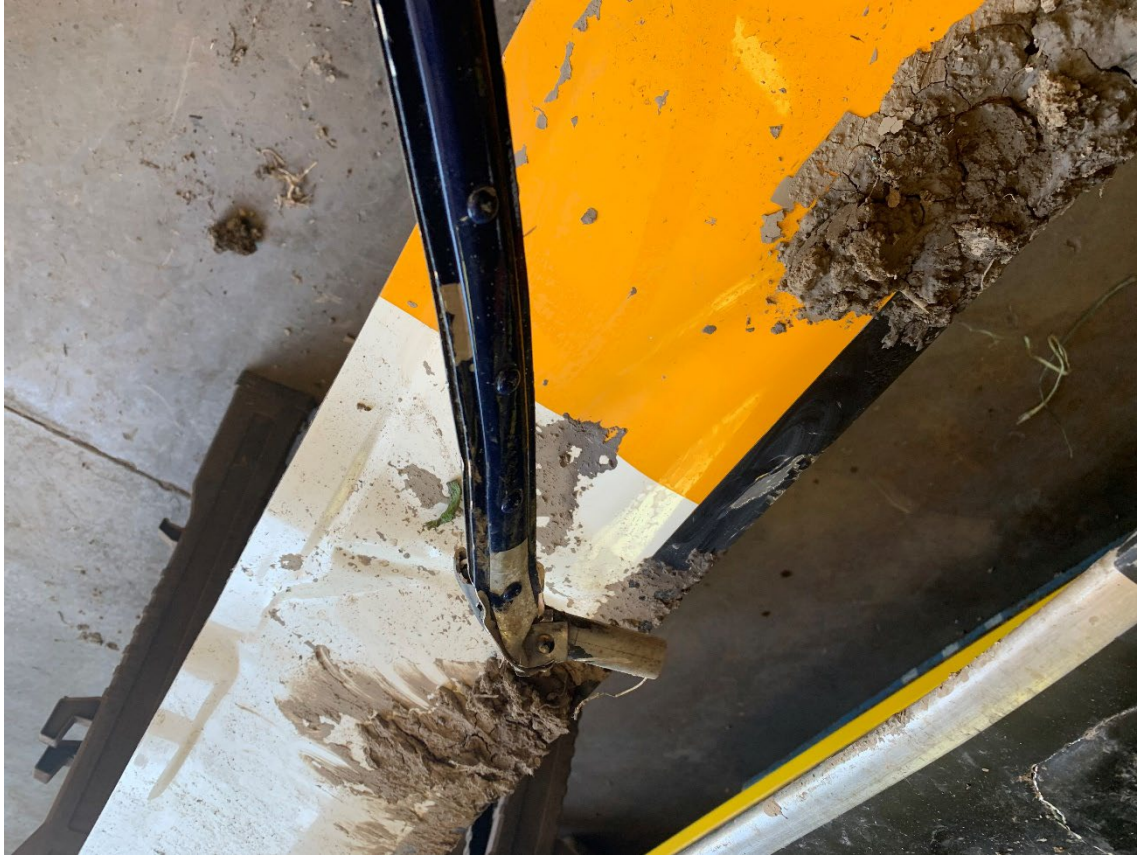
Figure 16. Windshield bow and corresponding main rotor blade impact.

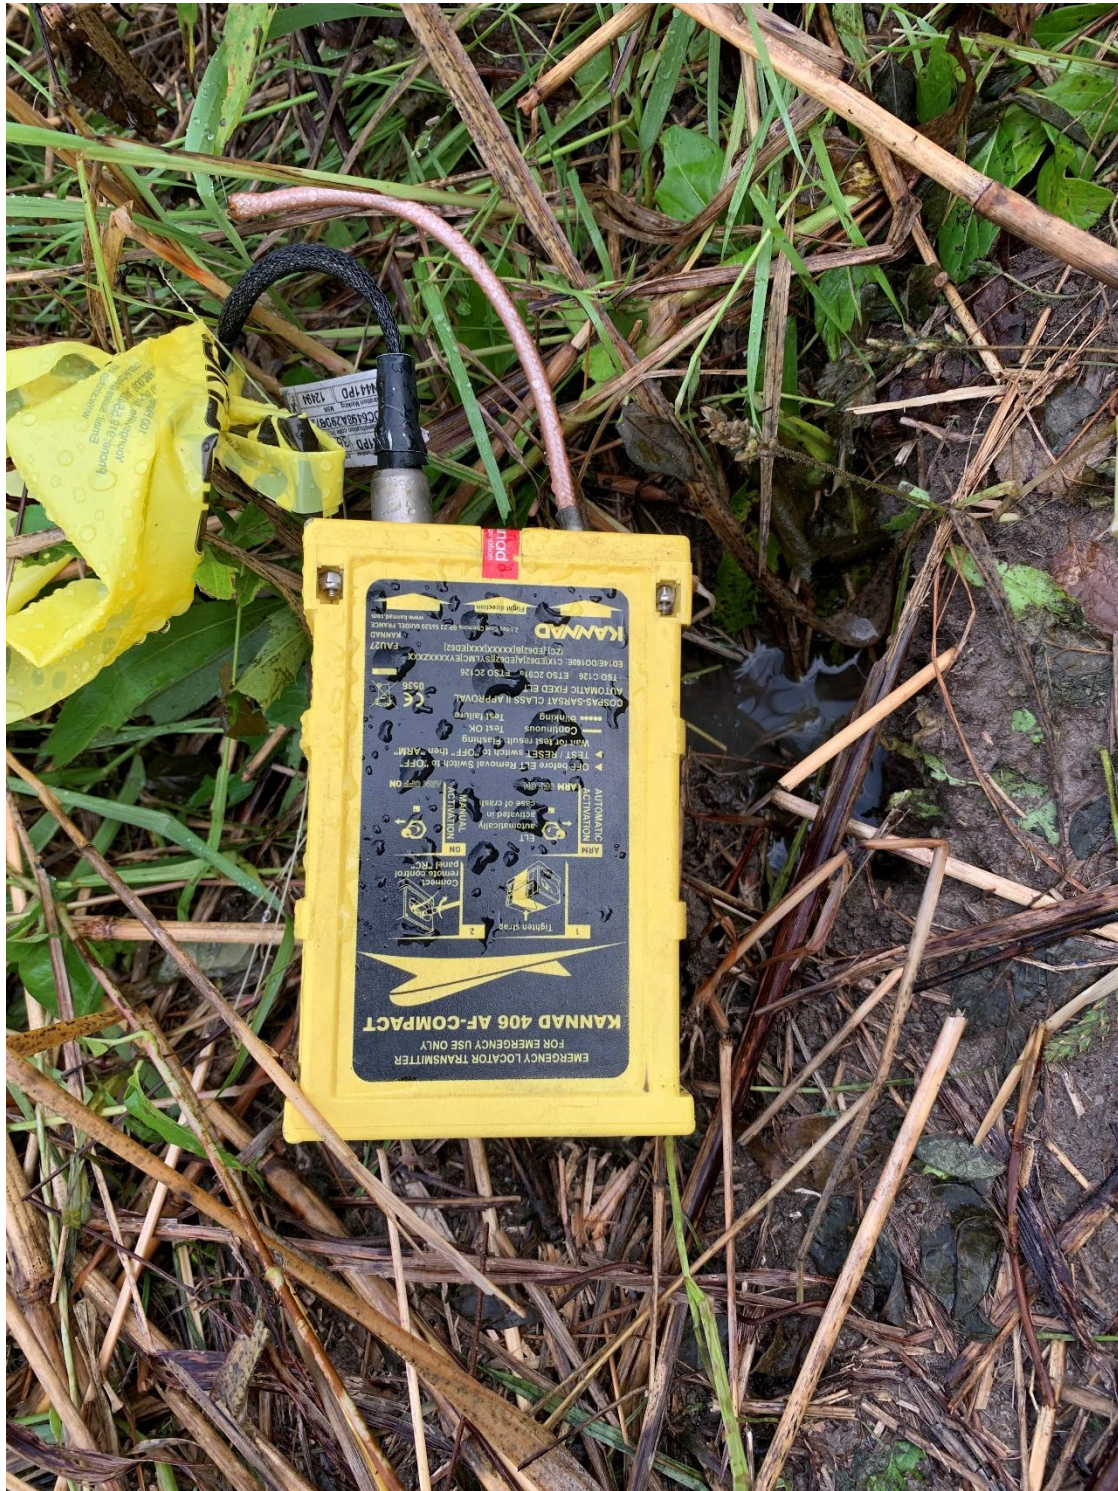
Emergency locator transmitter - found in debris field and separated from mounting structure. The antenna wire was severed about 4 inches from the transmitter.

Figure 17. ELT located in the debris field with antenna wire severed.

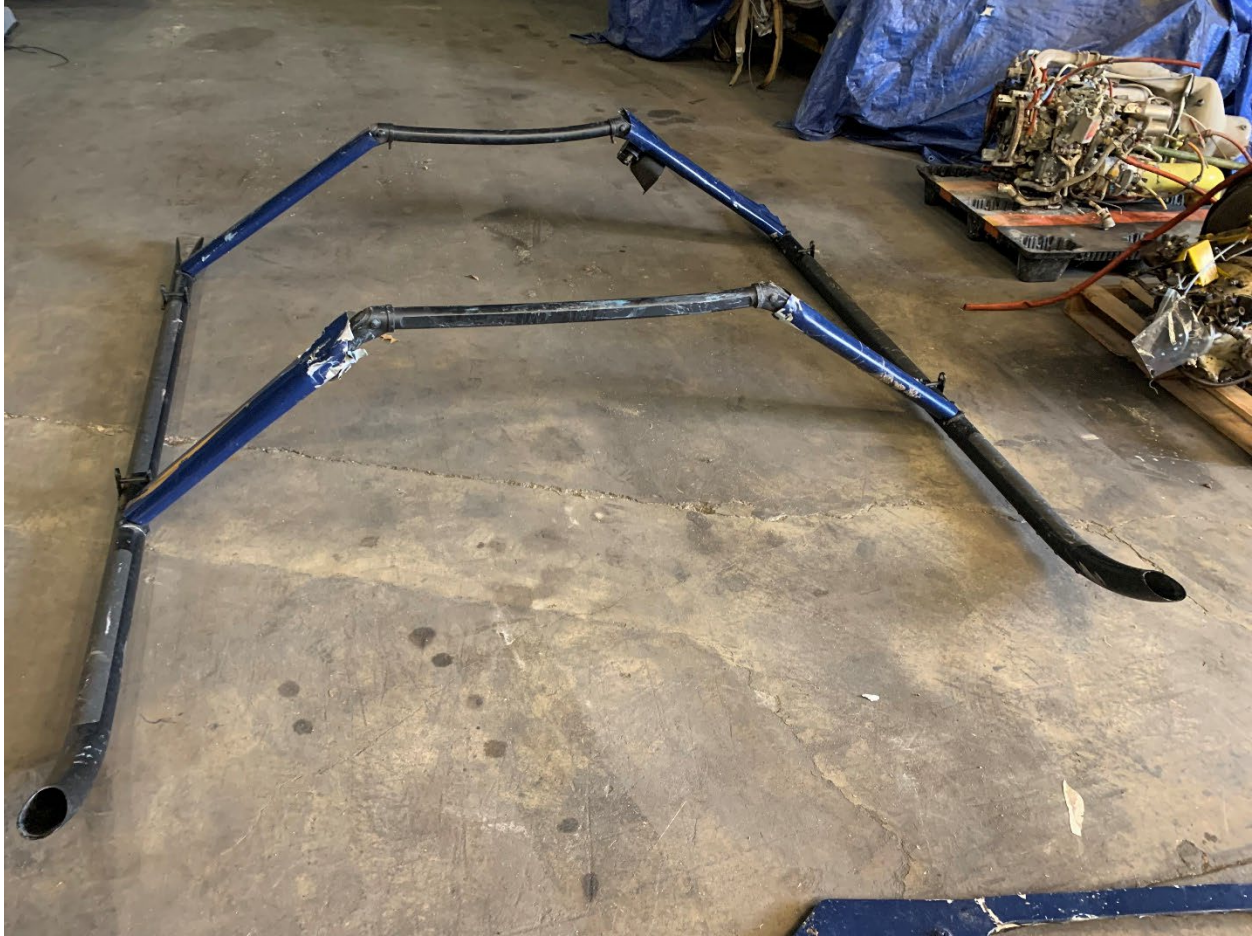
Landing gear - intact and partially separated from airframe.

Figure 18. Landing gear skids.
