# National Transportation Safety Board

CEN23FA142

## EXAMINATION SUMMARY

Location: Port Allen, LA  
Date: March 26, 2023  
Time: 02:38 Central Daylight Time  
Helicopter: Robinson R44 II

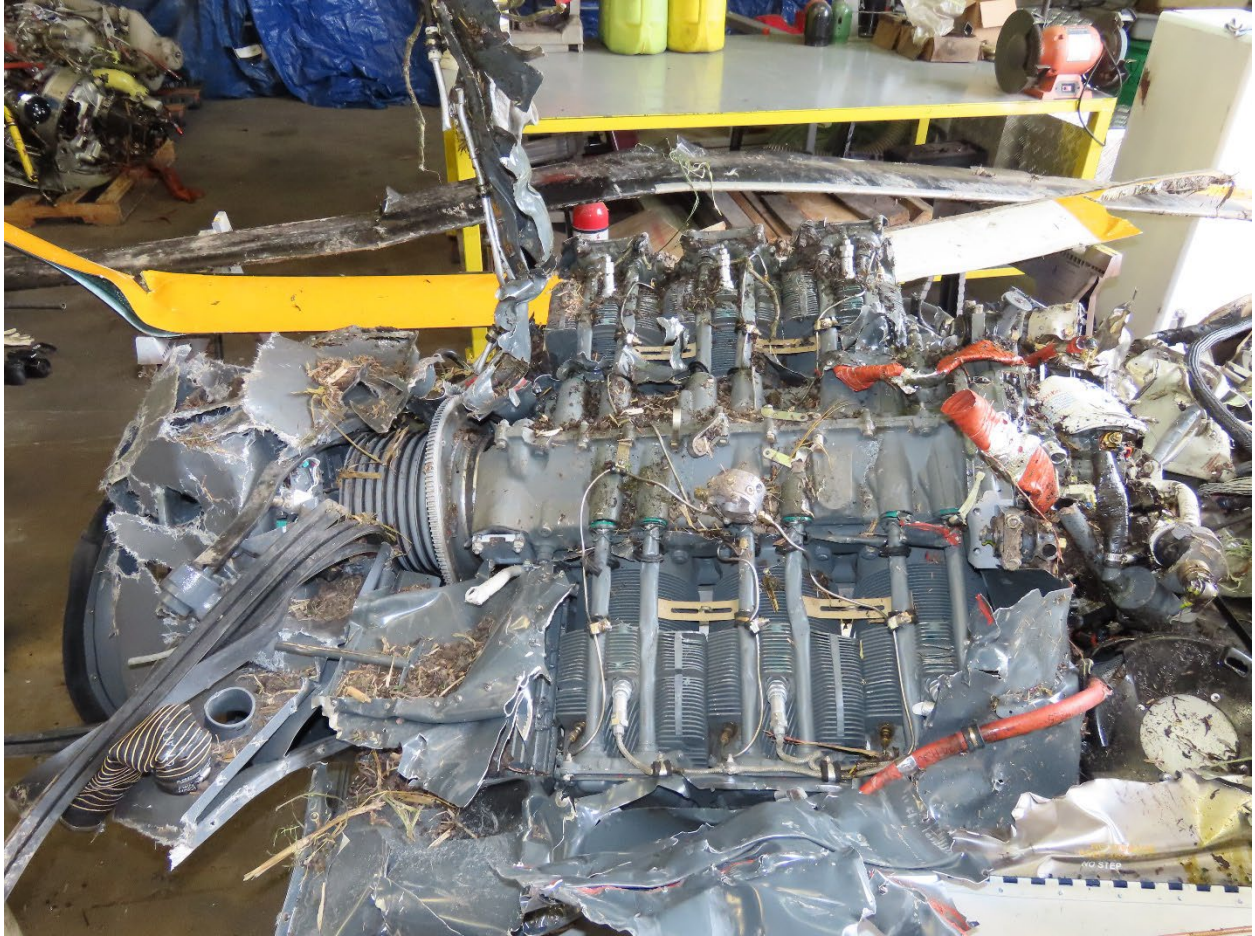
Cylinders 1, 3, 5, impact damage with molded valve covers and push rods. All top spark plugs, and valve covers removed, engine rotation confirmed by manually rotation. 3, 5 pushrods removed due to extensive bending. Suction and compression noted on all cylinders. Both magnetos separated from rear, left mag sparked with drill rotation. Right mag bent driveshaft, could not rotate. Oil filter damaged and could not be removed. Cut away a portion of filter can, element inspected and found clean. Oil suction screen clean. Oil present in oil sump. Boroscope inspection of all cylinders - unremarkable. Fuel servo installed. Fuel pump actuated - suction and compression observed at inlet and outlet ports. Fuel observed during actuation. Fuel inlet screen - clean. Flow divider separated from top of engine. Disassembled, diaphragm intact. All fuel nozzles removed and unobstructed. Spark plugs removed, all coloration normal operation, and normal wear pattern. All accessory drives rotated normally.

Figure 19. Engine after recovery (Source: Lycoming Engines).
