Alexander Lemishko  
Senior Air Safety Investigator  
NTSB, Central Region, Denver

**Date:** 4/13/2023

**Subject:** CEN23FA155  
Accident Site and Wreckage Examination

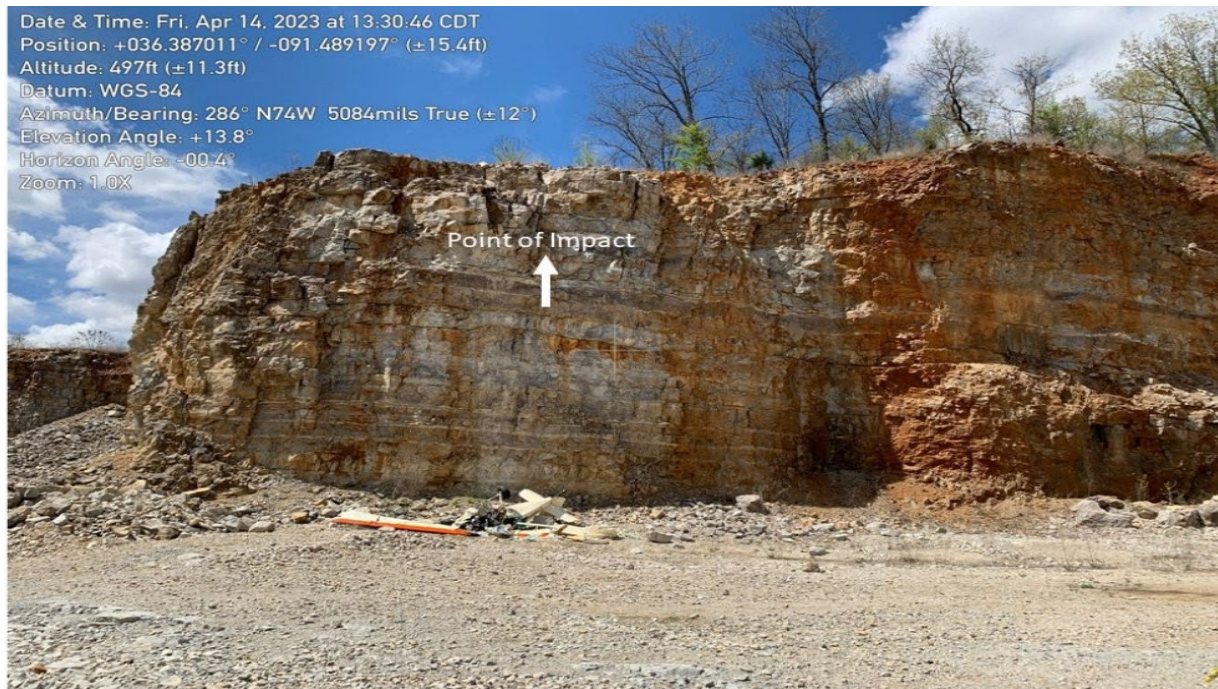
Photo 1 Accident Site

The accident site was located in a rock quarry that was owned by the pilot and his family. Examination of the accident site showed that the airplane collided with the 75-ft tall rock wall. Impact marks showed that the airplane impacted the wall about 20 ft below the top of the wall. See photo 1.
