# National Transportation Safety Board

CEN23FA167

## **AIRCRAFT EXAMINATION SUMMARY**

Location: Lewisville, AR  
Date: May 1, 2023  
Time: 1700 Local  
2200 UTC  
Airplane: Titan Tornado II, N31311

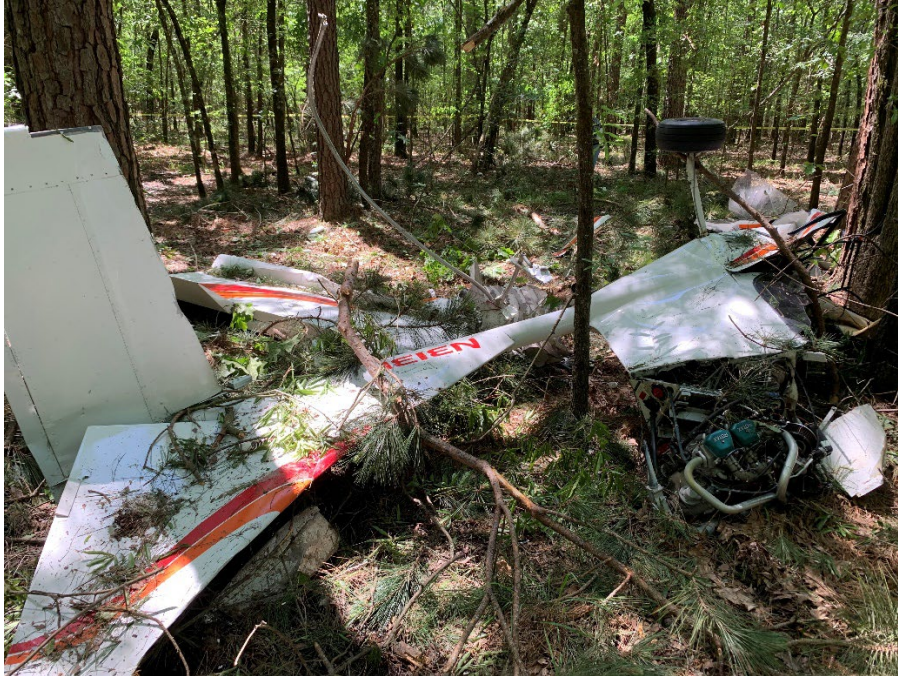
On-site examination of an experimental light sport Titan Tornado II airplane. According to witness information and an examination of the accident site, the airplane impacted trees and terrain in a heavily wooded marsh shortly after departing a private airstrip in Lewisville, AR. Federal Aviation Administration (FAA) inspectors were present to participate and assist. The examination revealed no pre-accident mechanical anomalies that would have precluded normal operation of the aircraft.

Figure 1: Accident airplane overview

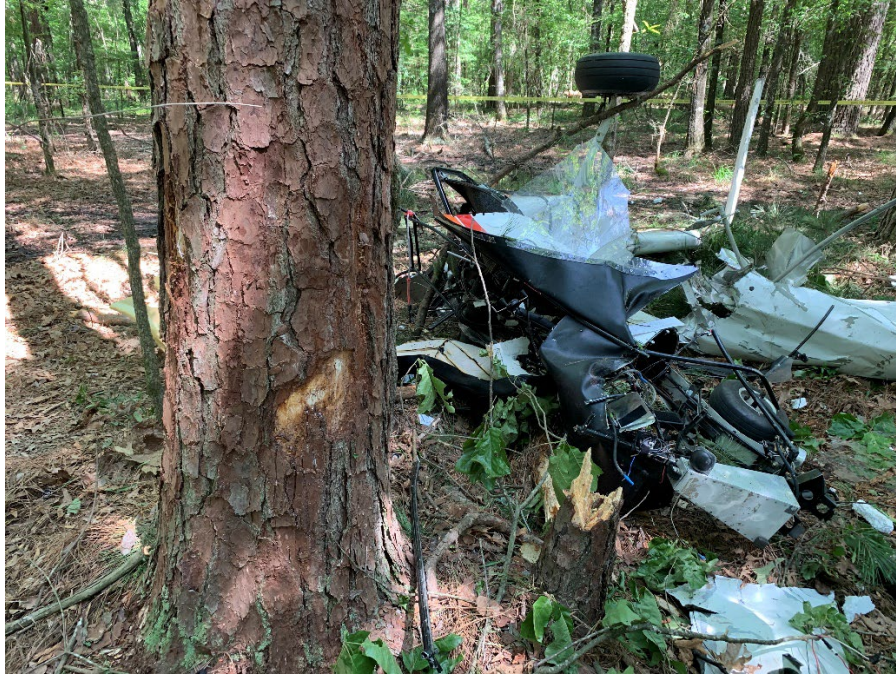
The airplane impacted trees and terrain (Lat/Long: +033.265673° / -093.574788°) in a heavily wood marsh about .14 nautical miles south of a private airstrip. The accident site location was consistent with a left crosswind after takeoff to downwind leg of the airplane traffic pattern. The airplane fuselage and left wing came to rest on a slight terrain rise above the surrounding partially wet marsh. The right wing was separated during contact with a tree and located in the crown of the tree about 80' above ground level. The accident flight path was on a 100° heading about a 61° nose down attitude.

The fuselage came to rest on the right side against a large pine tree with a small pine tree through the entire fuselage lengthwise. The small pine tree was observed to be broken at the trunk with lead bird shot ballast weight covering the fracture area. A large witness mark was observed on the trunk of the large pine tree that was consistent with the large semicircular crush impact damage on the left-wing leading edge. Several smaller witness marks were observed lengthwise along the tree consistent with fuselage impact. A large ground depression at the base of the large pine tree was observed that was consistent with impact of the left-wing tip.

Figure 2: Tree damage and fuselage location

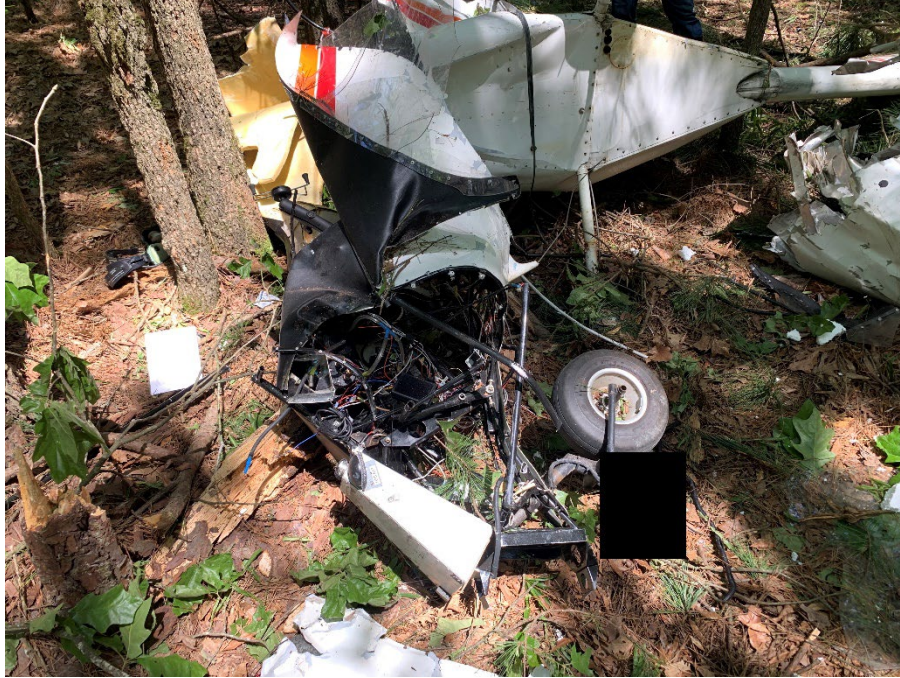
- No issues noted. The fuselage tubular frame structure was bent, distorted, and crushed in numerous areas. The forward and rear seats remained partially attached to the tubular structure.

Figure 3: Fuselage

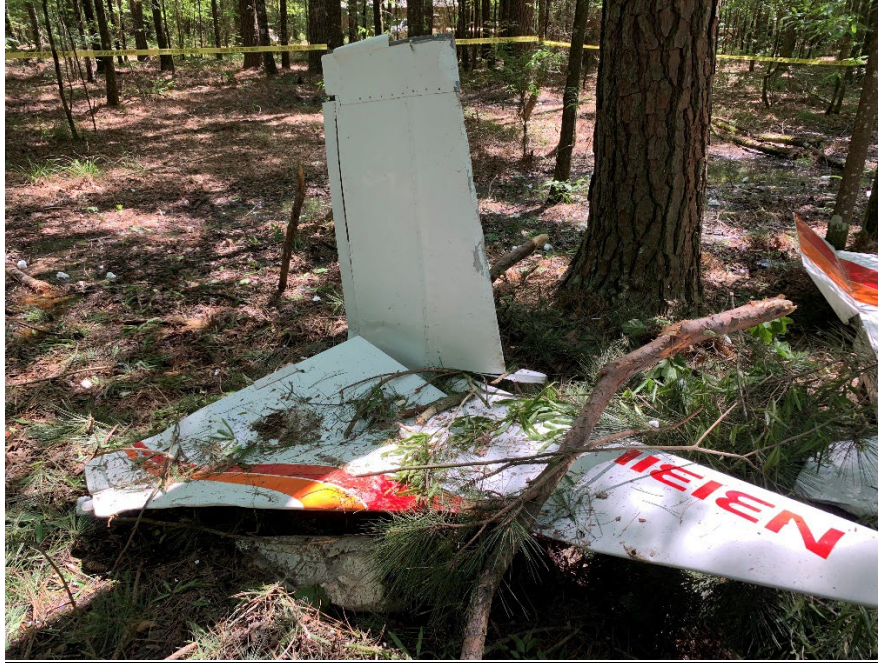
- No issues noted. The empennage structure was wrinkled and bent in numerous location consistent with the impact sequence.

- No issues noted. The right side was bent upwards and buried in the marsh. The left side displayed skin wrinkling and crush damage along the leading edge. Attached with free movement. Flight control continuity was established from the surface with no separations to the control sticks. The trim tab remained attached to the control surface.

- No issues noted. The vertical stabilizer and rudder had multiple areas of crush damage. Rudder was attached with free movement. Flight control continuity was established from the surface with no separations to the cockpit rudder controls.

Figure 4: Empennage

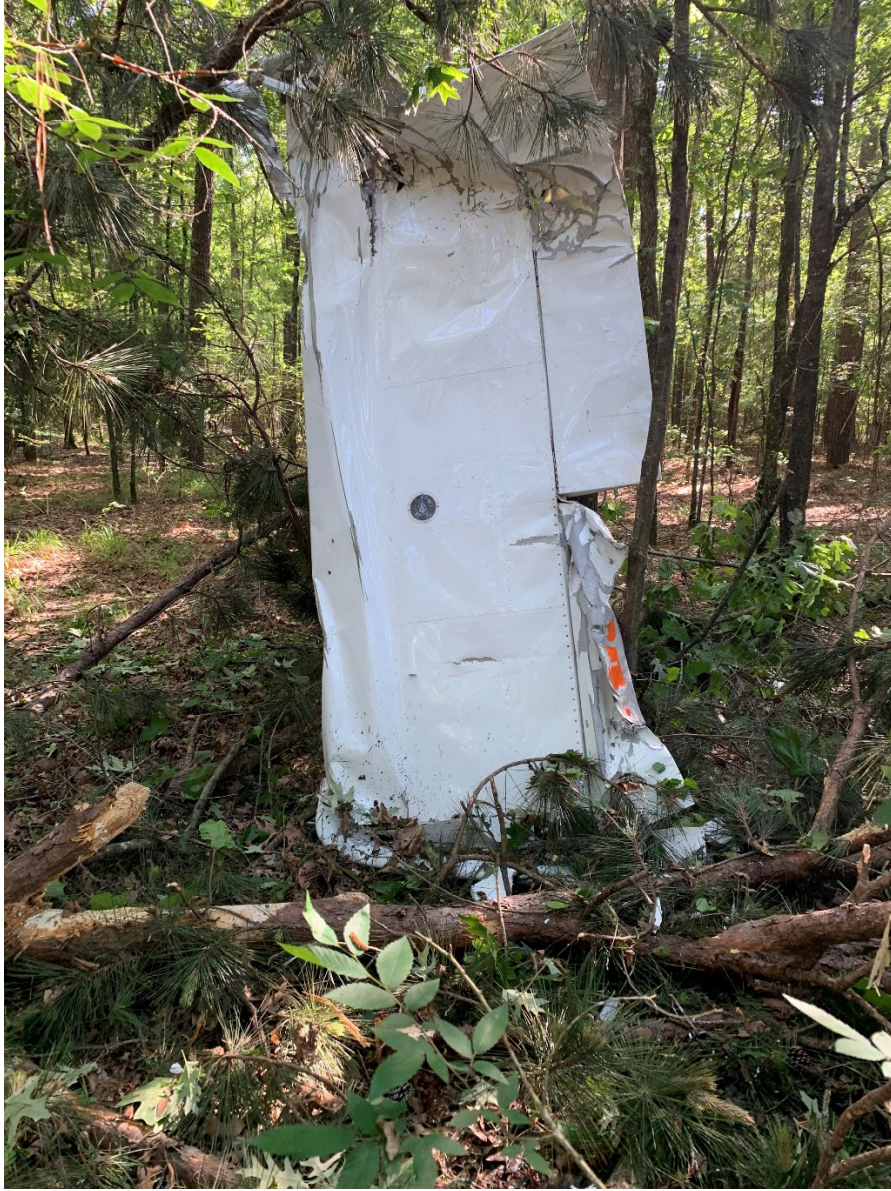
- No issues noted. Wing separated at root with fracture surfaces consistent with overload failure. Multiple witness marks from tree impacts were present on all surfaces. Crush damage on the lower surface with witness marks consistent with tree impact at about a 45° angle from the root leading edge to midspan of the flap. Crush damage along the entire leading edge. Skin wrinkling on all surfaces.

- Crush damage to the outboard portion beyond midspan and wing tip surfaces. The right wing was located in the canopy of a large pine tree prior to the tree being cut to recover the wing.

- Flight control continuity was established to flap and aileron. The flap torque tube and aileron push/pull tube were pulled from the wing and remained attached to their respective center driver at the left wing. The aileron turnbuckle, at the tip of the tube, rivets were pulled against the direction of wing failure with damage consistent with overload.

Figure 5: Right wing after recovery from the tree

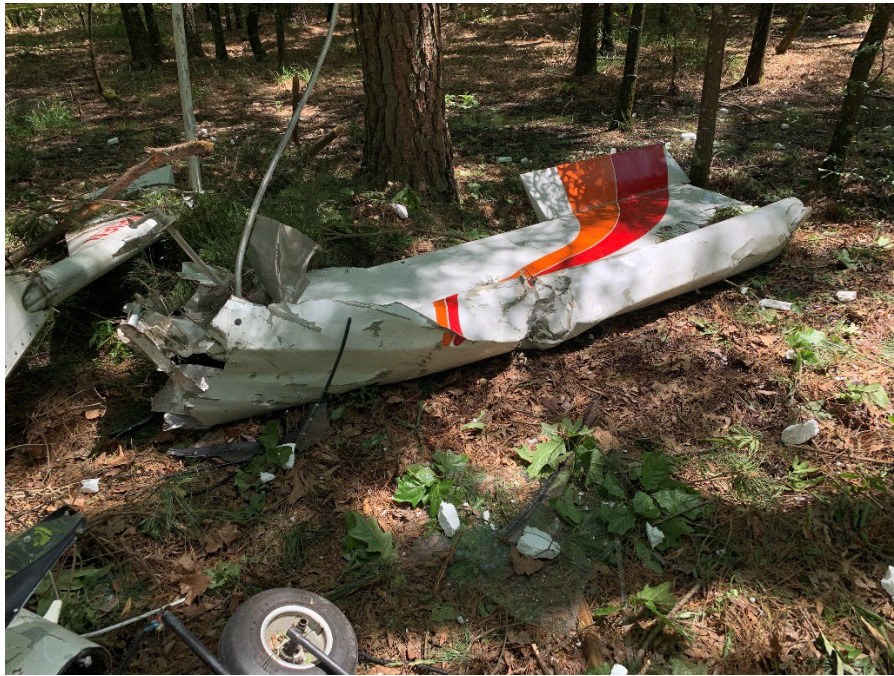
- No issues noted. Wing separated at root with fracture surfaces consistent with overload failure. Crush damage along entire leading edge with a semicircular crush damage into the structure of the wing at midspan. Numerous witness marks from tree and ground impact. Wrinkling was noted on all surfaces. Wing tip found separated with crush damage along leading edge and came to rest adjacent to the main wreckage.
- Flight control continuity was established for the flap and aileron to the fuselage separation. The right-wing flap torque tube and aileron push/pull tube remained connected to fuselage center driver. The fuselage center drivers were separated with fractures consistent with overload from its respective tubes.

Figure 6: Left wing

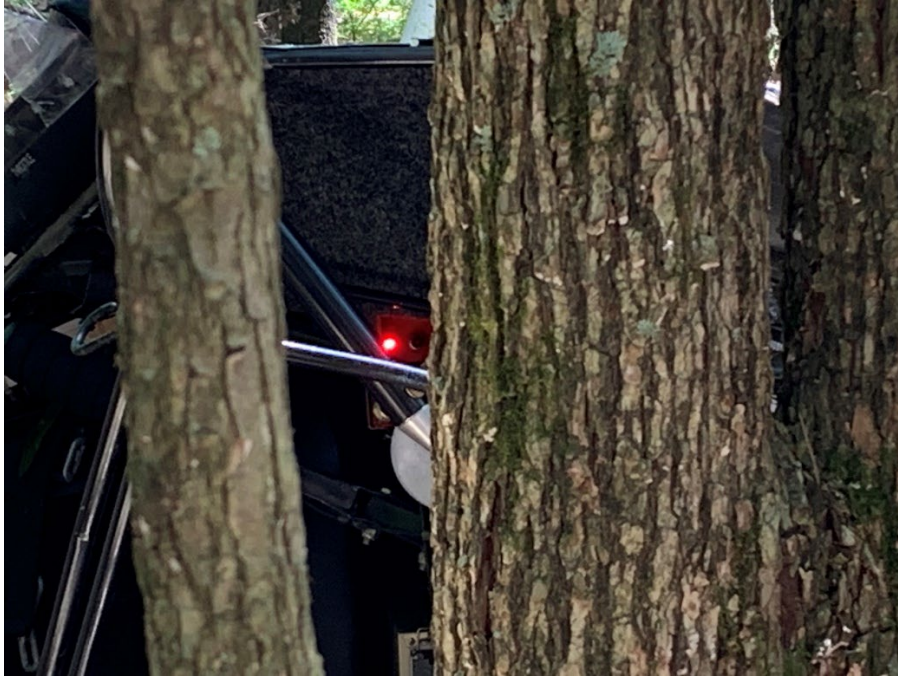
- Emergency Locator Transmitter (ELT) was found in the on position and actively transmitting. No reports of a signaling ELT were received from the rescue coordination centers.

Figure 7: ELT activation light.

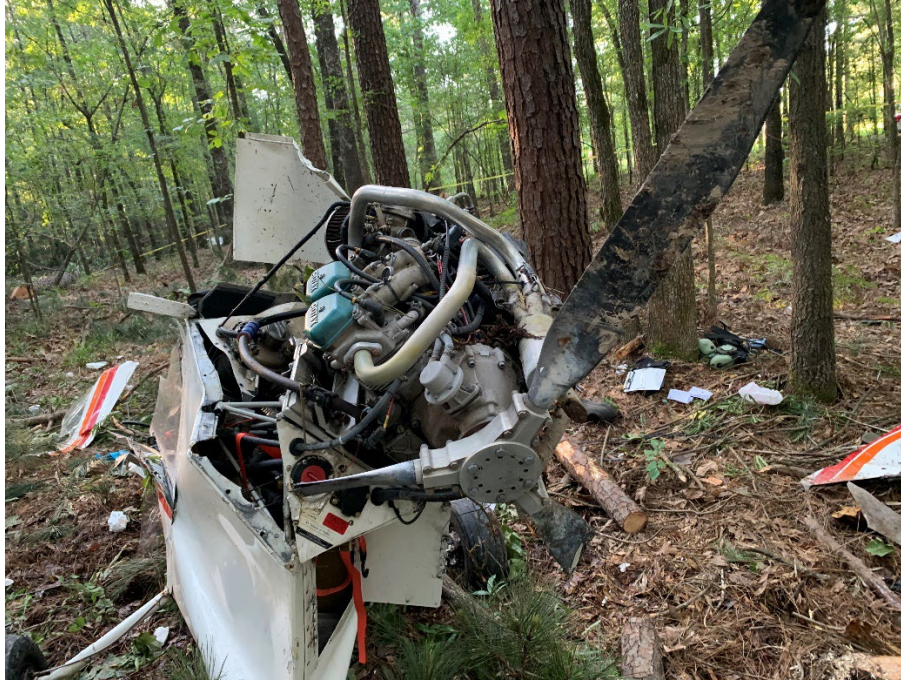
- Blade A (labeled for documentation purposes) remained attached to the hub with delamination noted in the carbon fiber structure.
- Blade B and C were found separated from the hub at the root with fragmentation of the carbon fiber structure.
- Separated blade sections were located within the debris field.
- Damage to blades was consistent with power at impact with the tree canopy and subsequent tree branches.

Figure 8: Propeller Hub
