**National Transportation Safety Board**

CEN23FA173

**ENGINE EXAMINATION SUMMARY**

## **PROPELLER EXAMINATIONS**

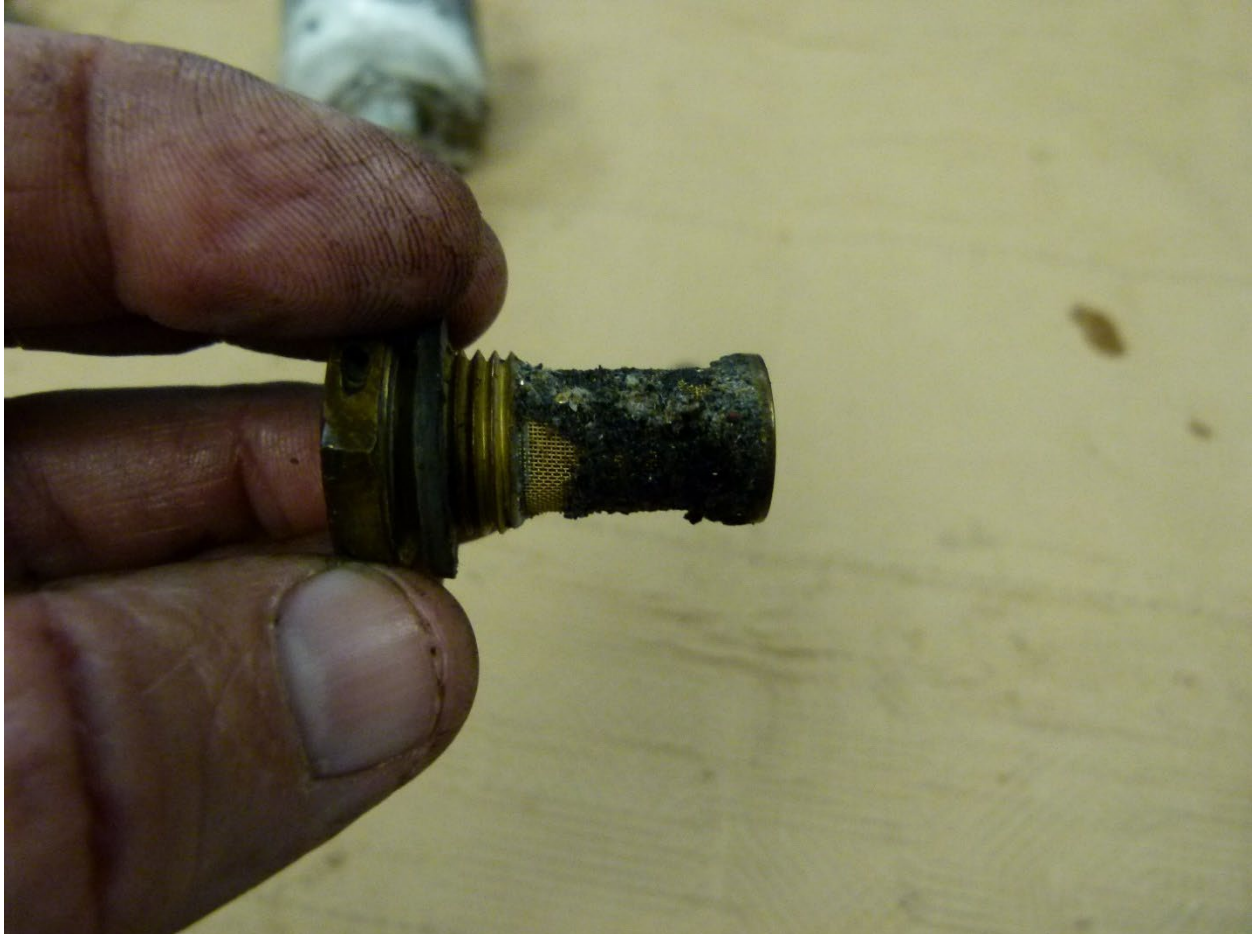
The throttle and control assembly were removed from the engine and examined. The "O" rings on the throttle metering cam and the mixture metering cam were inspected and found to be unremarkable. The fuel plug and screen assembly were removed from the fuel injection control assembly and the screen was obstructed with black

debris and string-like fibers. The screen was removed and sent to the materials lab in Washington, DC to identify the debris. The fuel screen was replaced with a clean, exemplar component. During the second test run, the engine started without hesitation and ran smoothly.

Photograph 1. Fuel plug and screen assembly from right engine (Photo from NTSB)

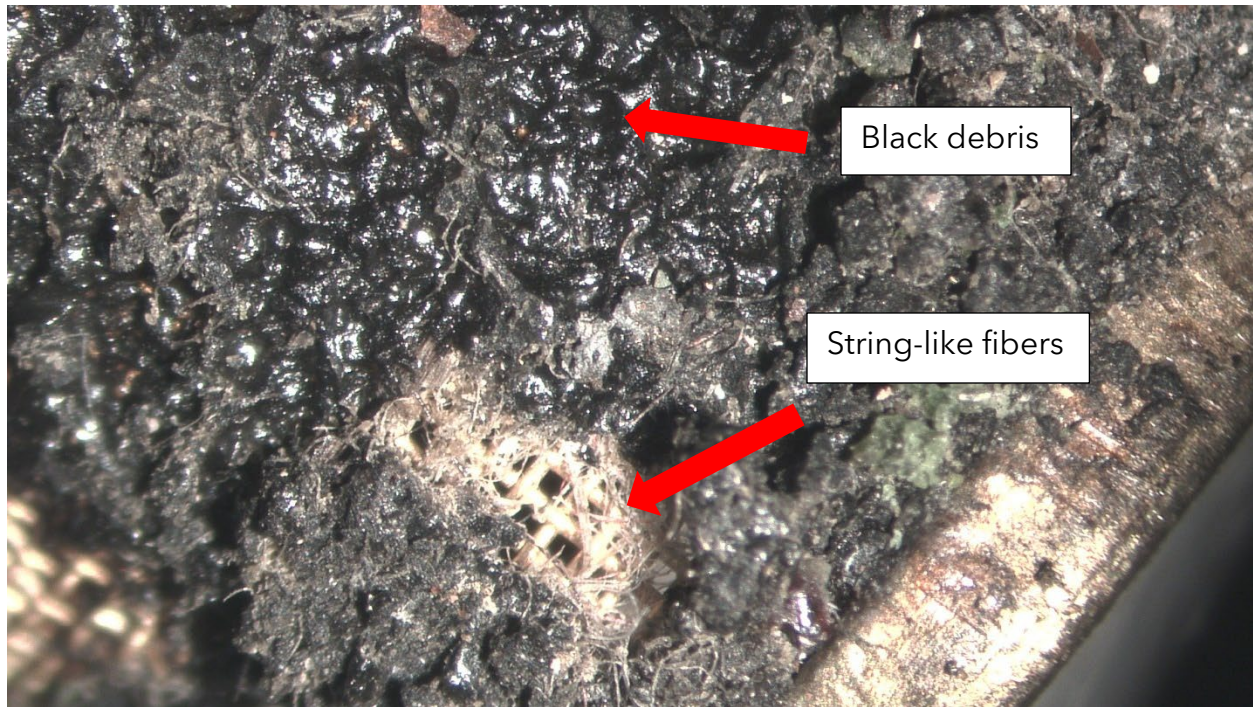
Photograph 2. Magnified image of fuel plug and screen assembly from right engine  
(Photo from NTSB)

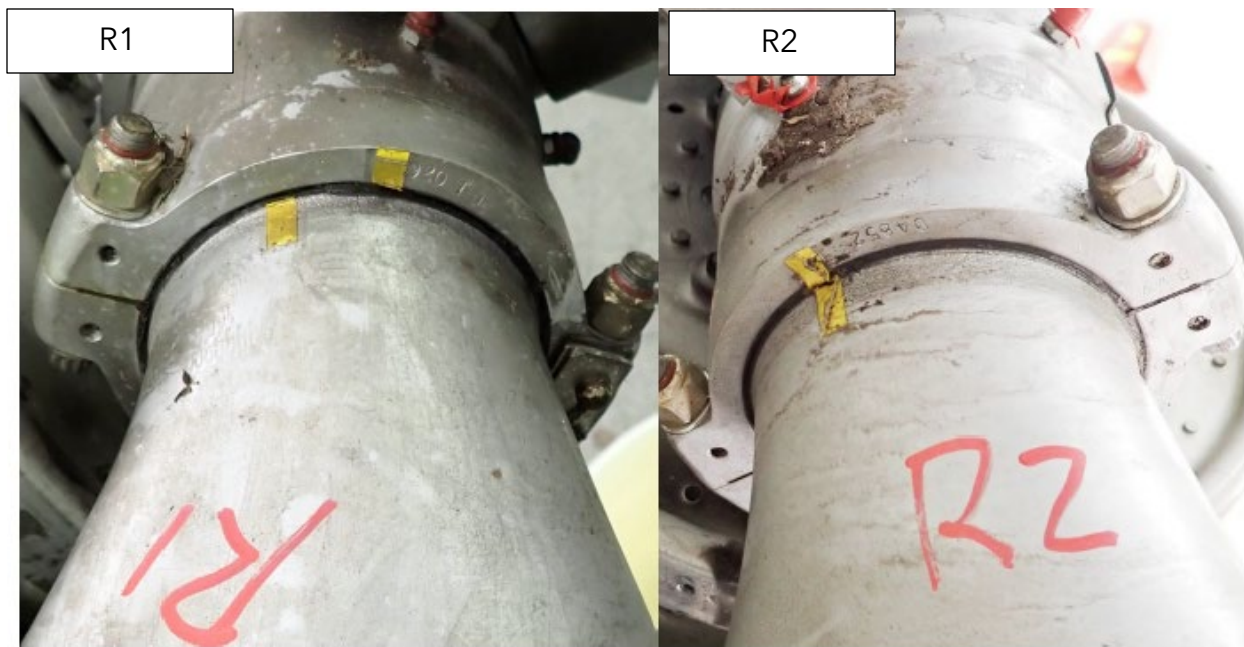
All mounting hardware appeared intact and secure. The spinner was crushed and formed around the piston and piston nut and partially formed around the hub and clamps. The dome was torn with spiral scoring and deformation. The counterweights for both blades punctured through the spinner dome. Both clamps appeared intact with only impact scoring damage. The clamp bolts were secure with safety mechanisms intact. Both blade clamps/start lock plates were resting on the start lock pins. The blade R1 slip indicator suggested the blade slipped in the clamp approximately 35° toward high pitch (Photo #1). The R2 slip indicator appeared relatively unchanged, possible slight movement toward low pitch (Photo #1).

Photo 1. Right propeller blade/clamp slip indicators

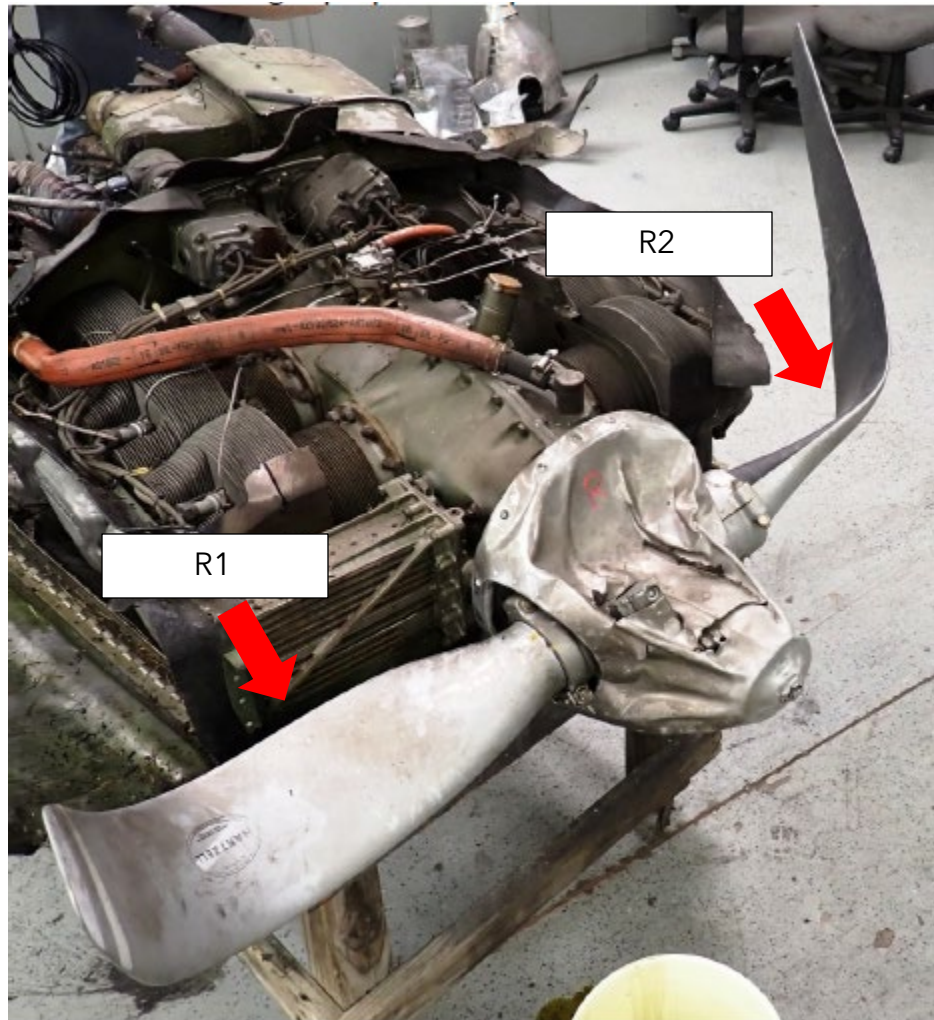
Blade R1 was bent forward with no remarkable twisting (Photo #2). Blade R2 was bent aft with no remarkable twisting (Photo #2). Blade R1 had some angled rotational scoring and abrasion on the face side (Photo #3) and minor chordwise abrasion on the camber side (Photo #4). Blade R2 had remarkable chordwise/rotational scoring on the camber side from mid-blade to tip (Photo #4) and chordwise/rotational scoring along the leading edge near the tip (Photo #3). Neither blade had any remarkable leading edge gouging or damage.

Photo 2. View of right propeller

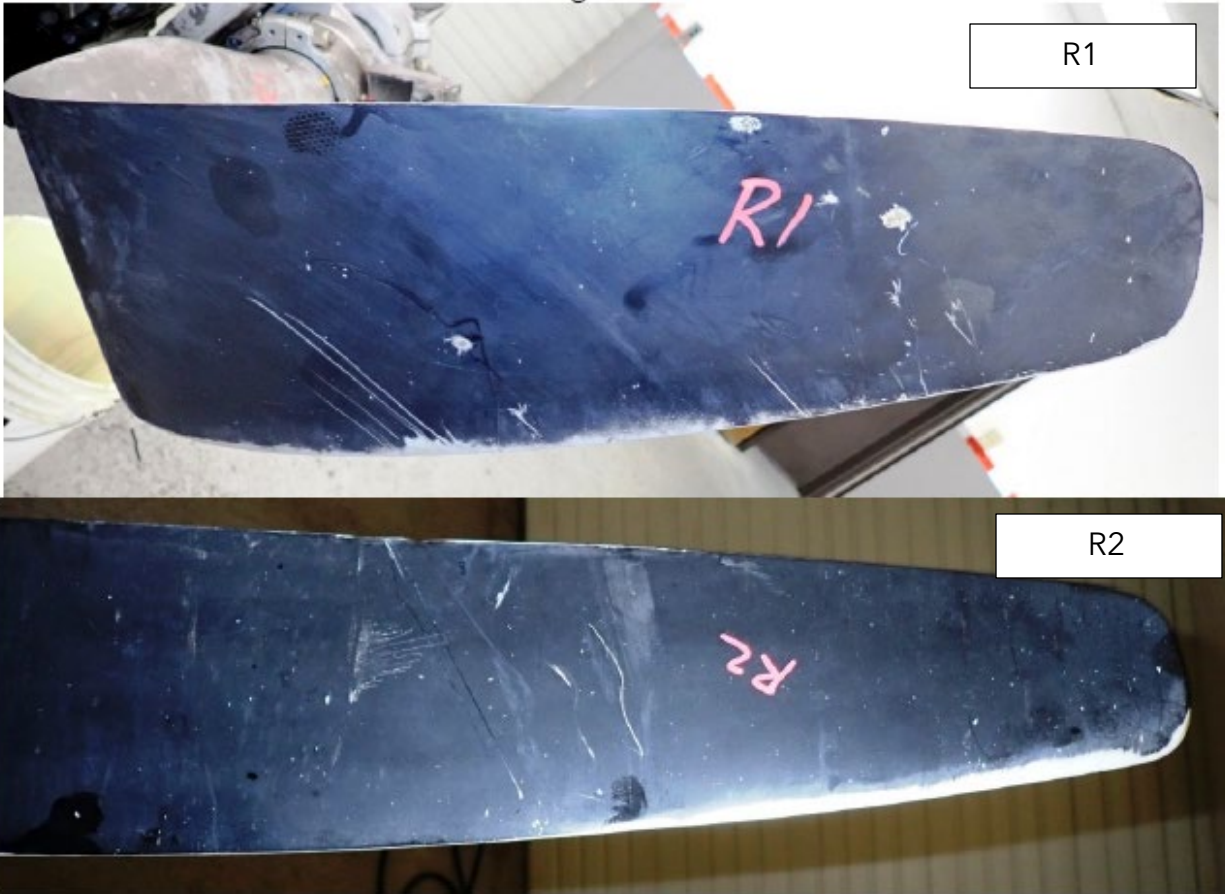
Photo. 3 Right propeller blades face sides

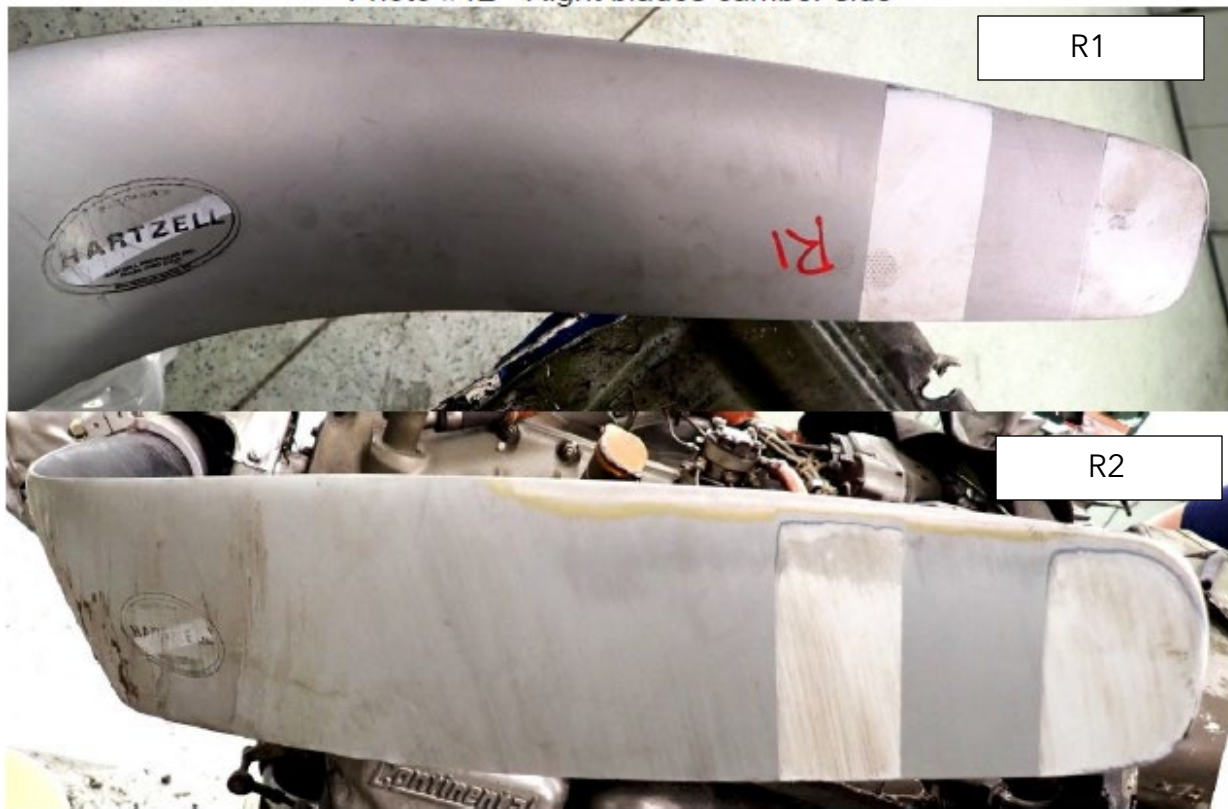
Photo 4. Right propeller blades camber sides

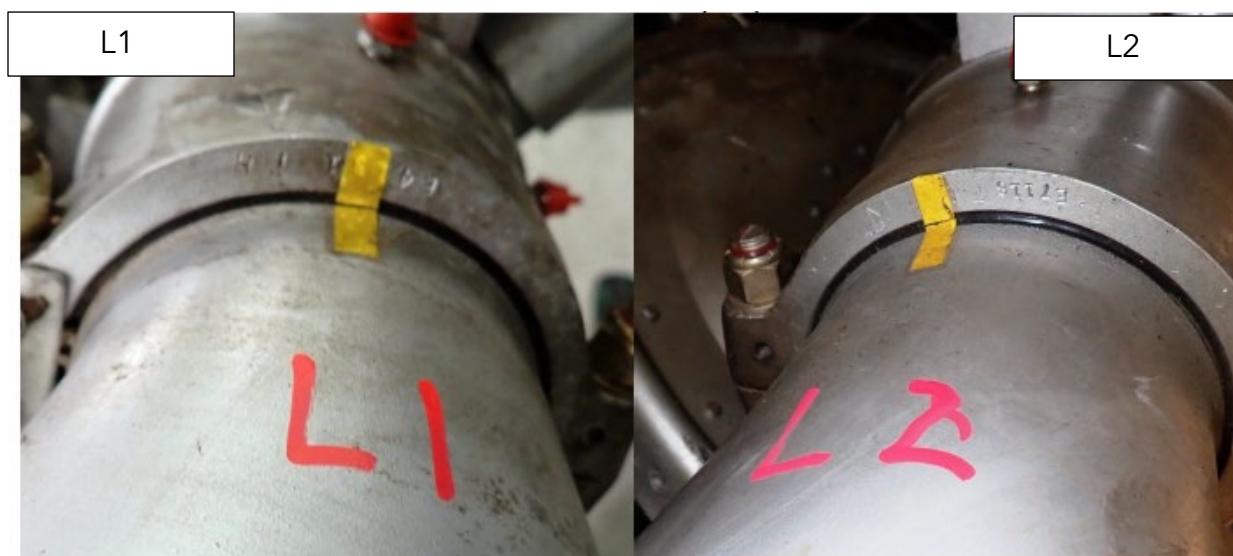
Neither the L1 nor L2 blade/clamp start lock plate was resting on the start lock pin, indicating the propeller actuation was bound between the start lock angle and low pitch angle. The L1 clamp appeared to be at slightly lower blade angle than L2

and the piston appeared cocked on the cylinder. Both blade slip indicators showed no rotational displacement (Photo #5).

Photo 5. Left propeller blade/clamp slip indicators

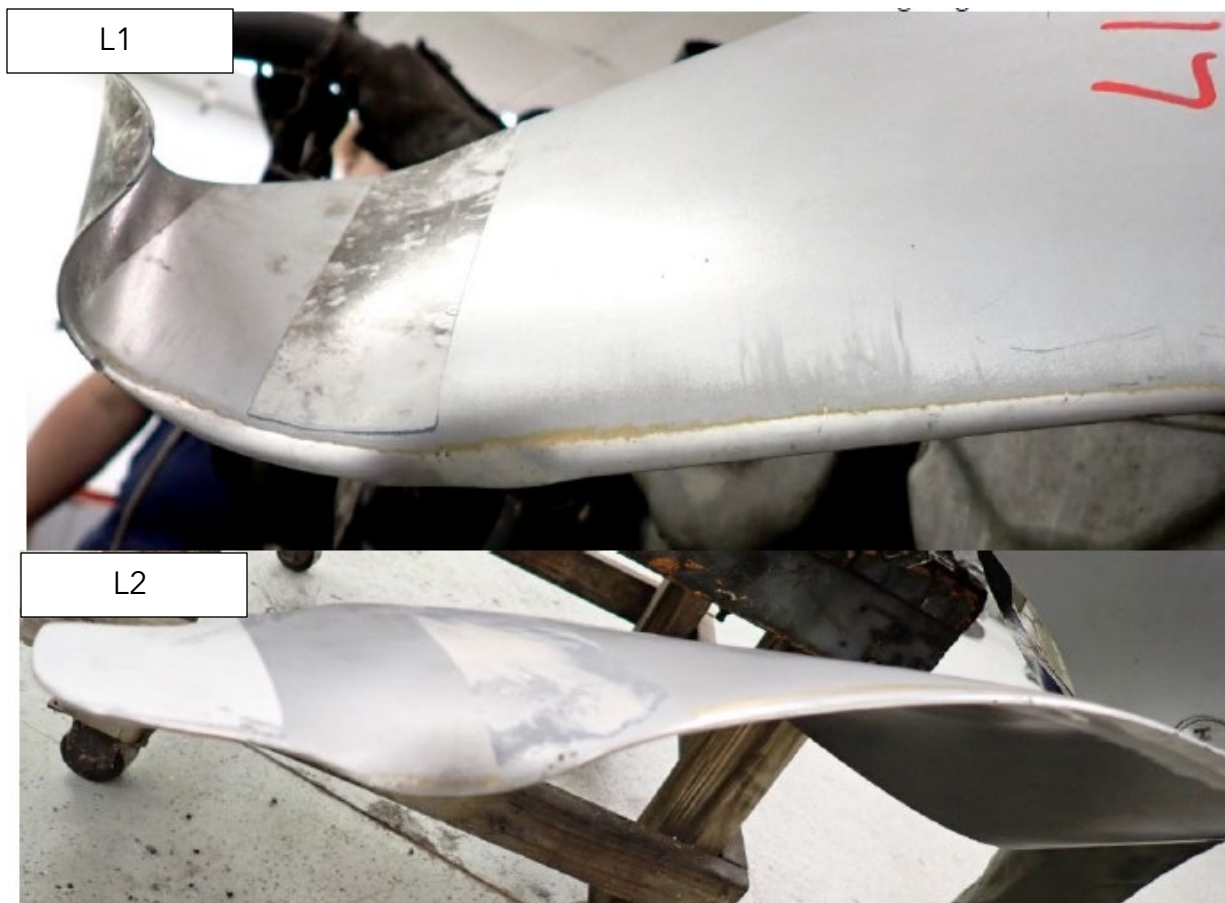
Blade L1 was predominantly bent aft with an approximate 3" section of the tip bent forward. There was no remarkable twisting except for the last 2" of the tip that was twisted toward high pitch. There were two, remarkable tree-strike wave bends in the leading edge (Photo #6), one at the tip that bent the leading edge toward high pitch and another at approximately 6" from the tip that bent the leading edge toward low pitch. There was remarkable chordwise/rotational scoring on camber side (Photo #6) from the mid-blade to the tip and on the face side near the tip (Photo #7).

Blade L2 was bent forward/folded approximately 170° in the mid-blade area with spanwise scoring in the bend on the face side. There was a tree-strike wave bend approximately 4" from the tip with the leading edge deformed toward low pitch (Photo #6). The blade was twisted towards low pitch in the tip region. There was chordwise/rotational scoring on both the camber and face sides (Photo #9 and Photo #8), most notably along the leading edge back to 10-30% chord.

Photo 6. Tree strike bends in L1 and L2 leading edges

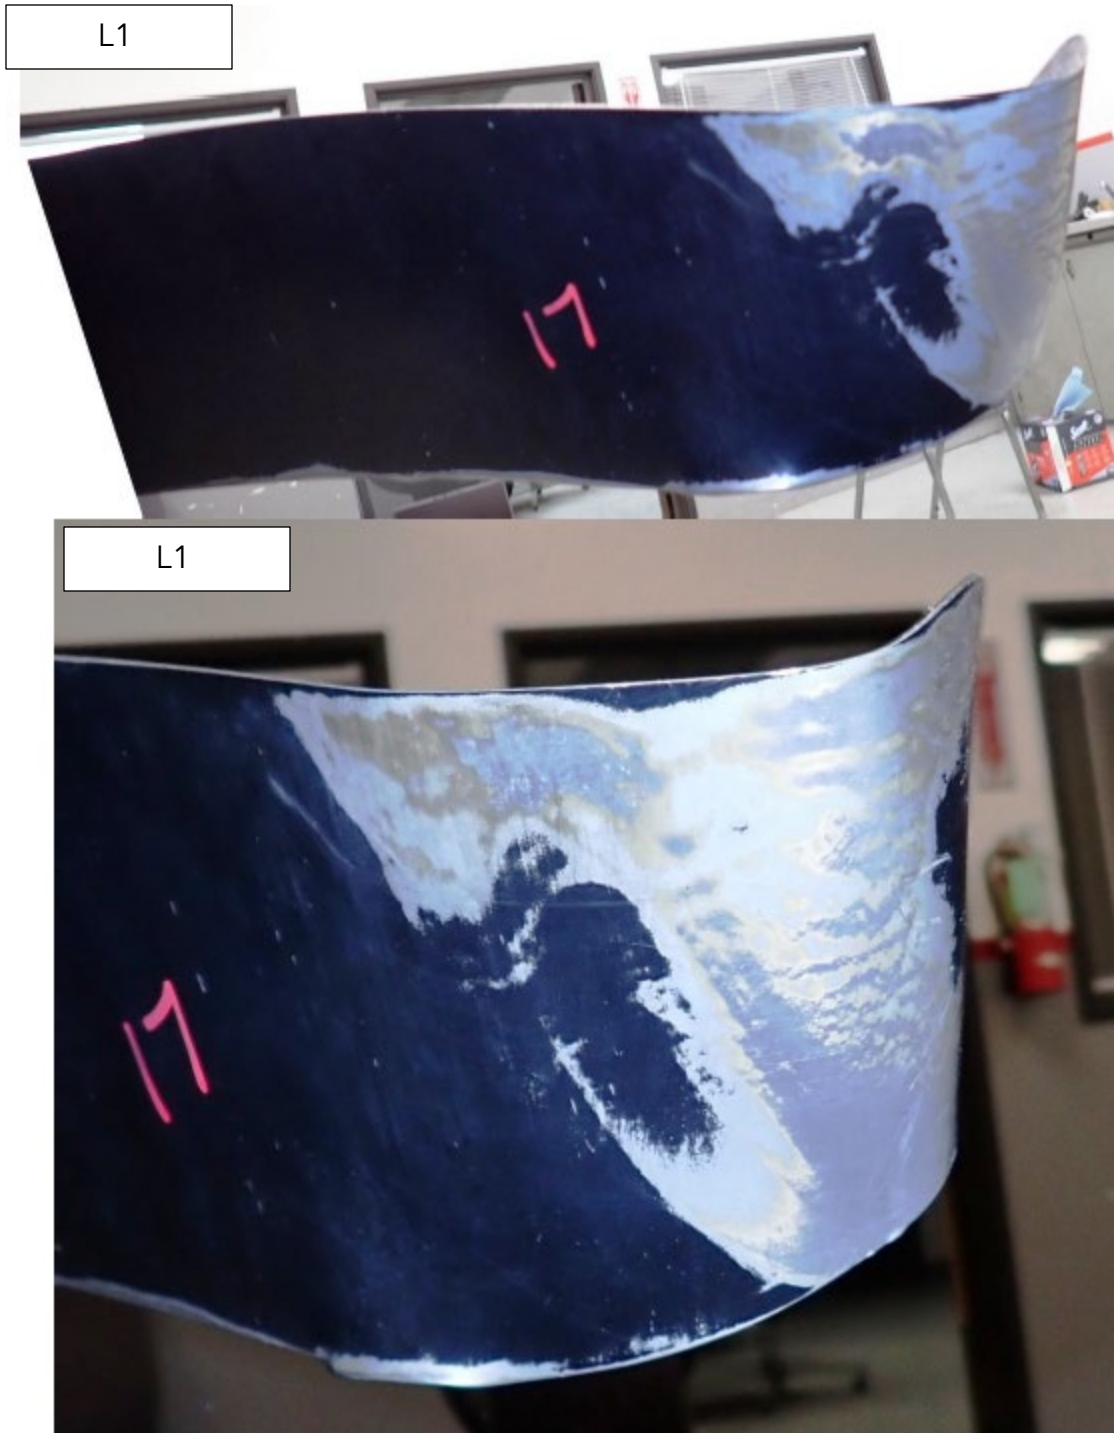
Photo 7. L1 blade face side

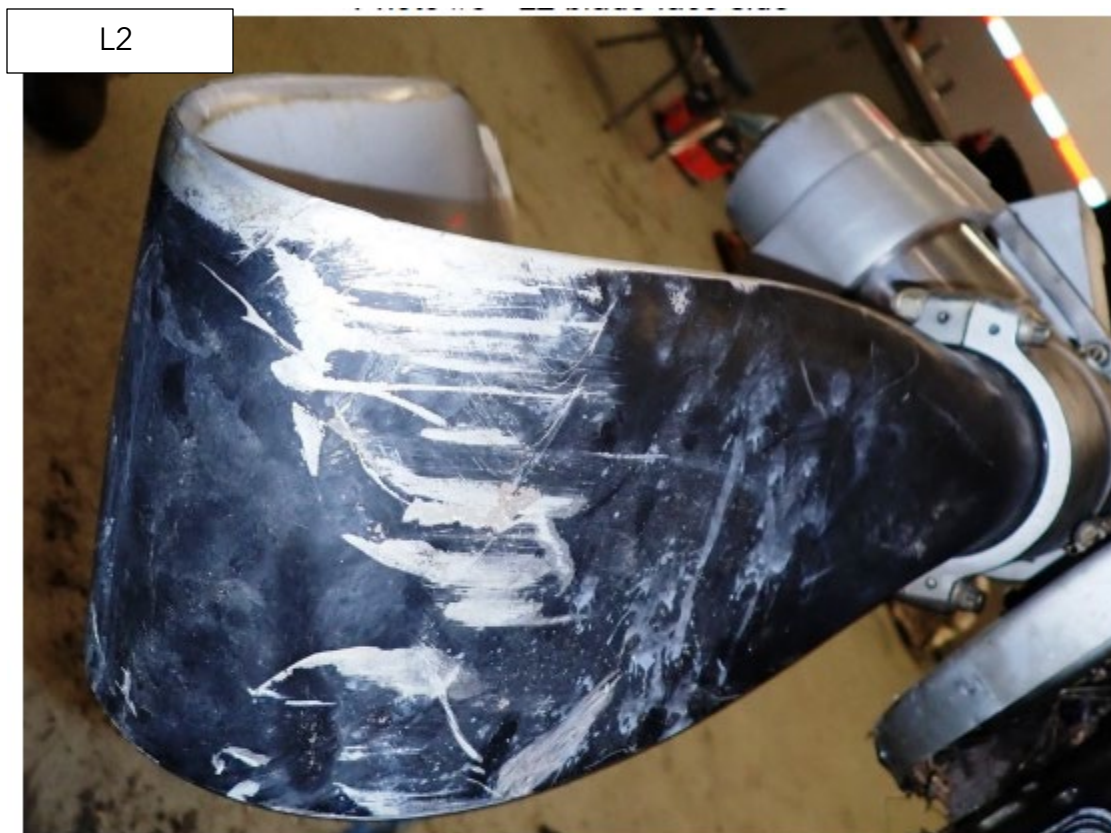
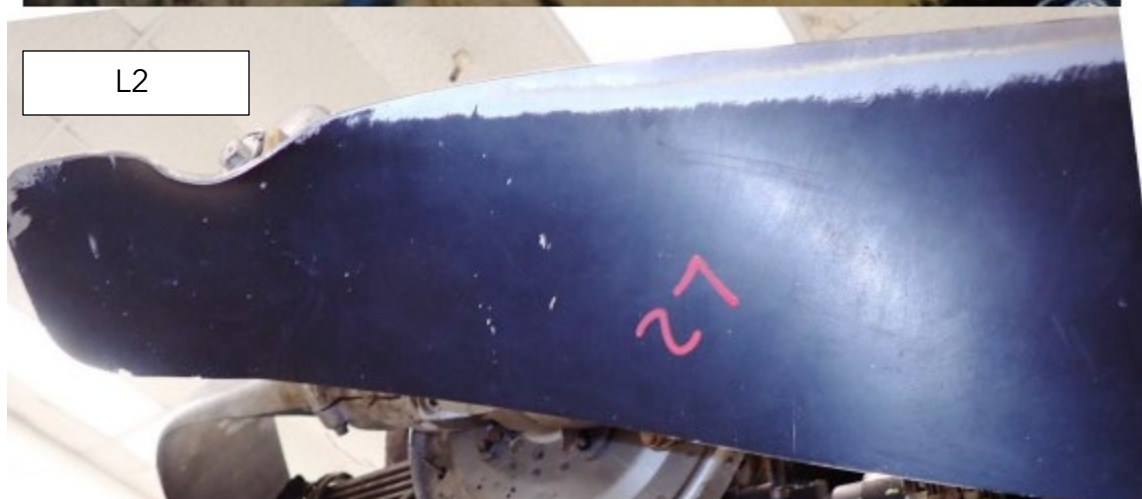
Photo 8. L2 blade face side

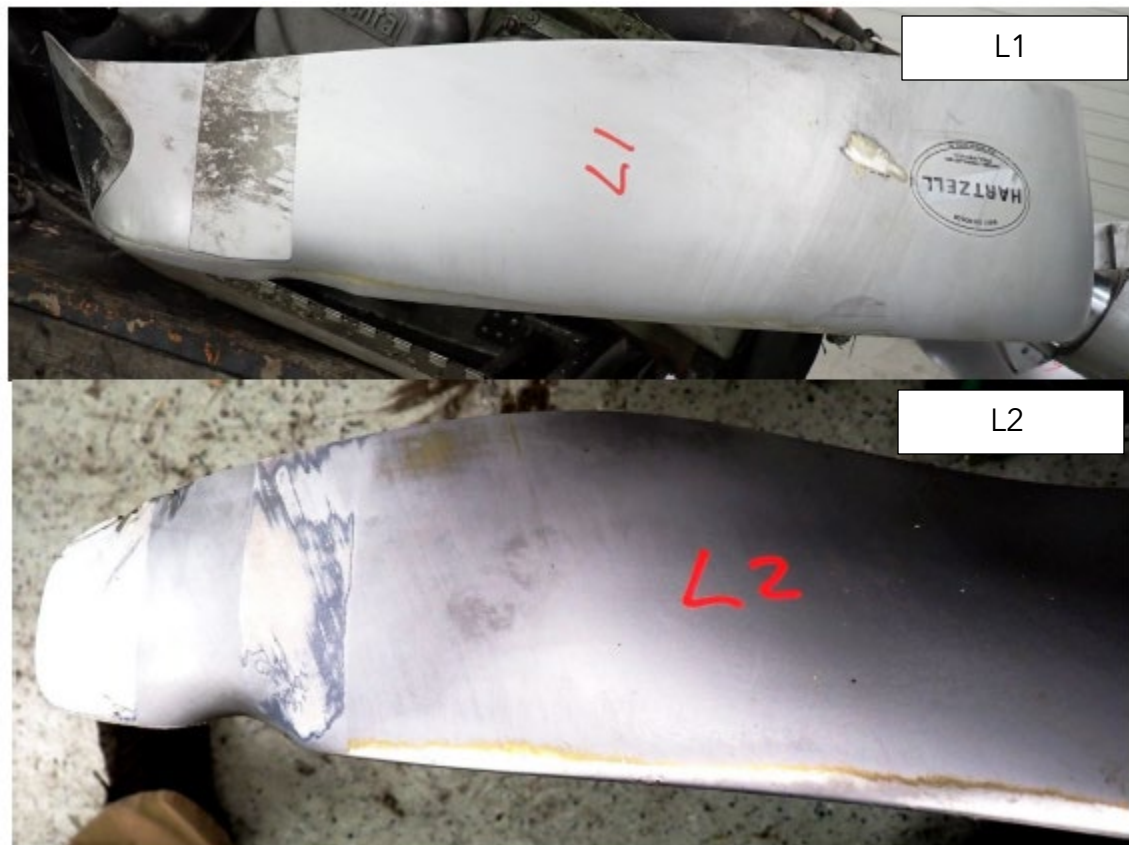
Photo 9. L1 and L2 camber sides
