# National Transportation Safety Board

CEN23FA183

## **WRECKAGE EXAMINATION SUMMARY**

Location: Brady, Texas  
Date: May 14, 2023  
Time: Exact Time Unknown  
Latitude: 31.225932° North  
Longitude: 99.358637° West  
Helicopter: Robinson R22 Beta, Registration No. N40506

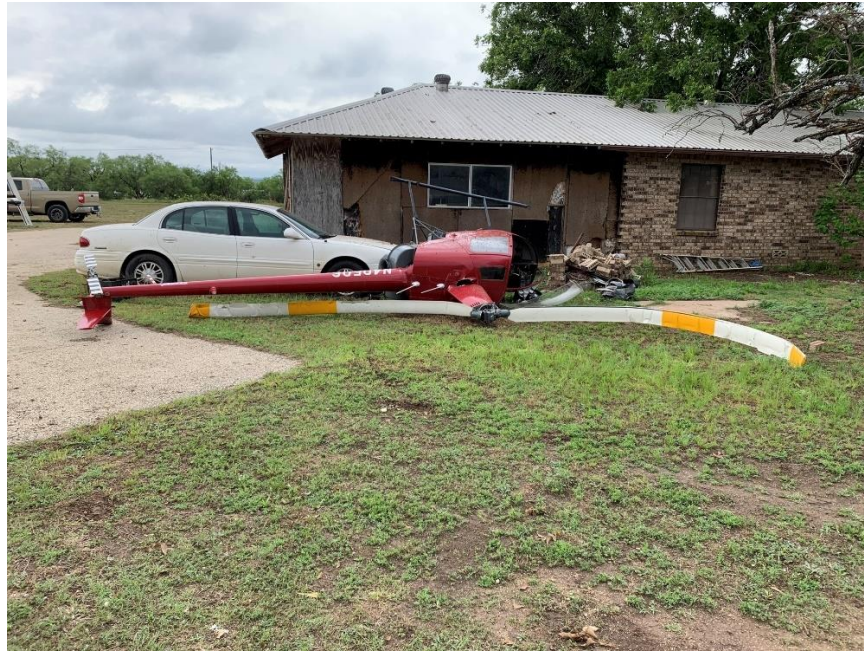
The helicopter was found on its right side, facing west, about 15 ft from the north wall of the house, as shown in Figure 1. The helicopter was about 70 ft southwest (232° true) from a concrete pad that the pilot used during ground operations, as shown in Figure 2. The helicopter's ground handling wheels and a hand truck associated with a battery charger were found beside the concrete pad, as shown in Figure 3. The battery charger and its integrated jumper cables were found about 60 ft from the concrete pad against the rear right tire of a white sedan parked beside the helicopter wreckage, as shown in Figure 4. The hood and roof of the white sedan exhibited fresh dirt deposits.

**Figure 1.** Main wreckage overview

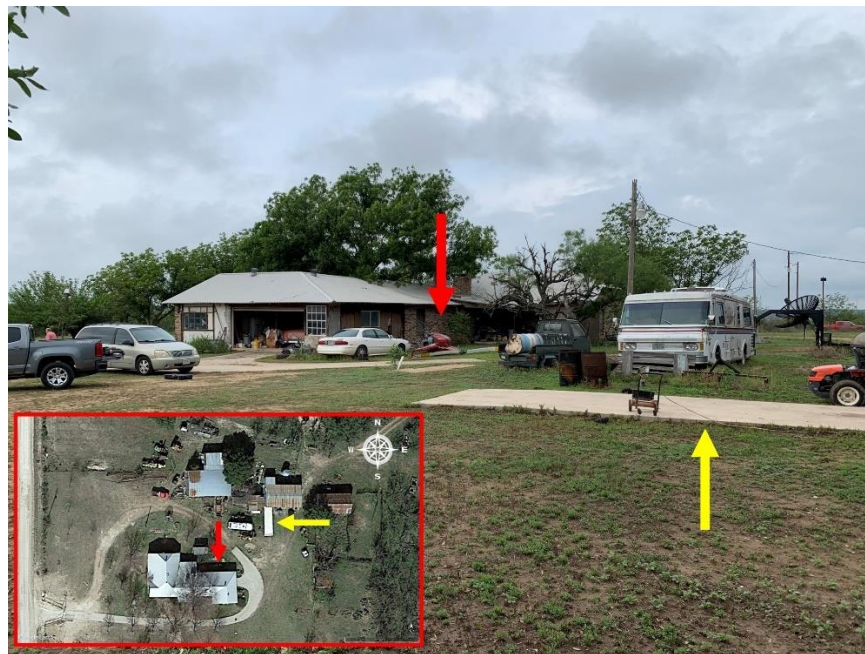
**Figure 2.** Location of main wreckage in north side yard of house (red arrows) and concrete pad (yellow arrows) with inset aerial photo depicting property layout.

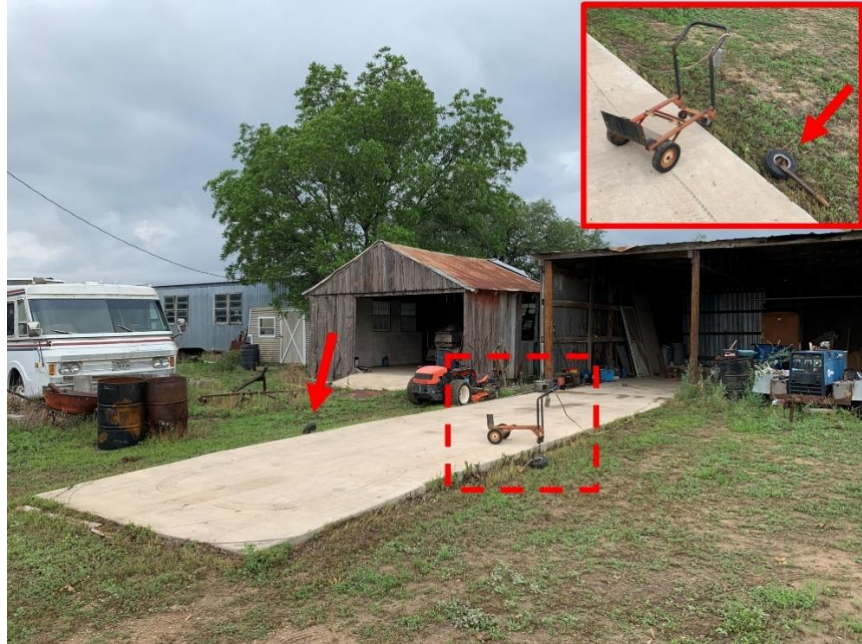
**Figure 3.** Concrete pad, hand truck used with battery charger (red boxes), and ground handling wheels (red arrows).

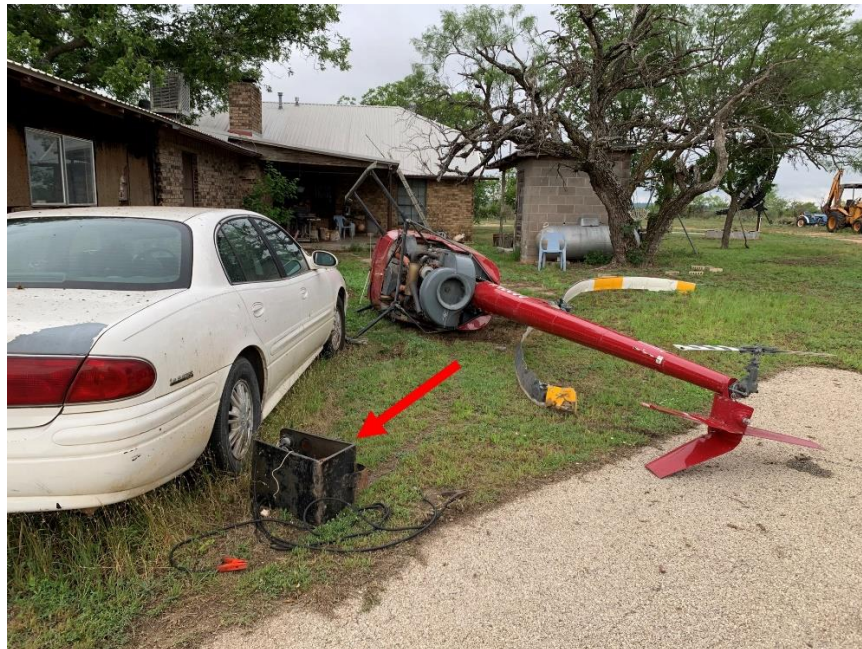
**Figure 4.** Main wreckage, sedan, and battery charger with jumper cables (red arrow).

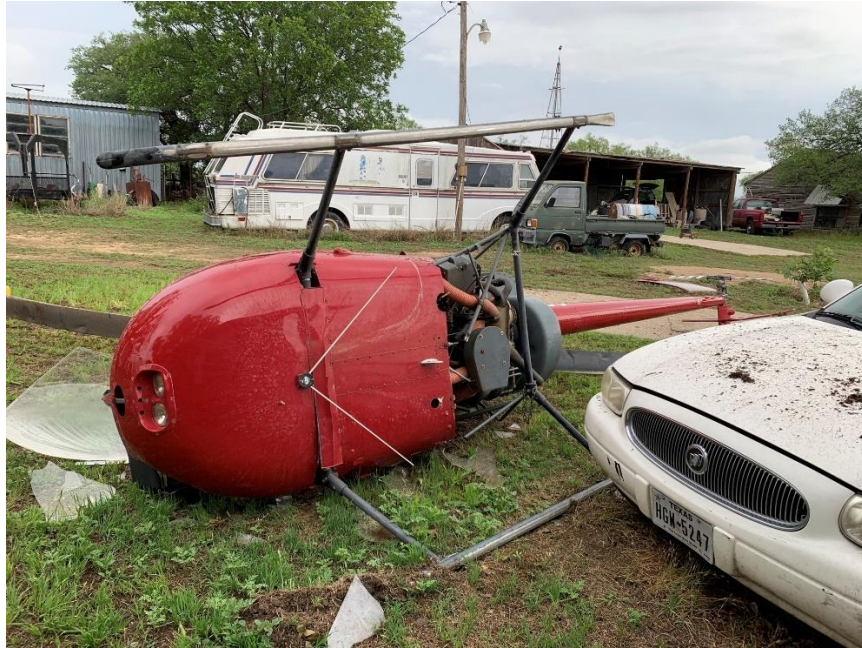
There was a small truck, full-sized recreational vehicle, and two steel drums, located between the concrete pad and the helicopter wreckage, as shown in Figure 5. Based on ground impact marks and the overall wreckage distribution, the helicopter ascended at least 7 ft to clear the obstacles before it impacted the ground near the house.

**Figure 5.** Main wreckage with obstacles along projected flight path.

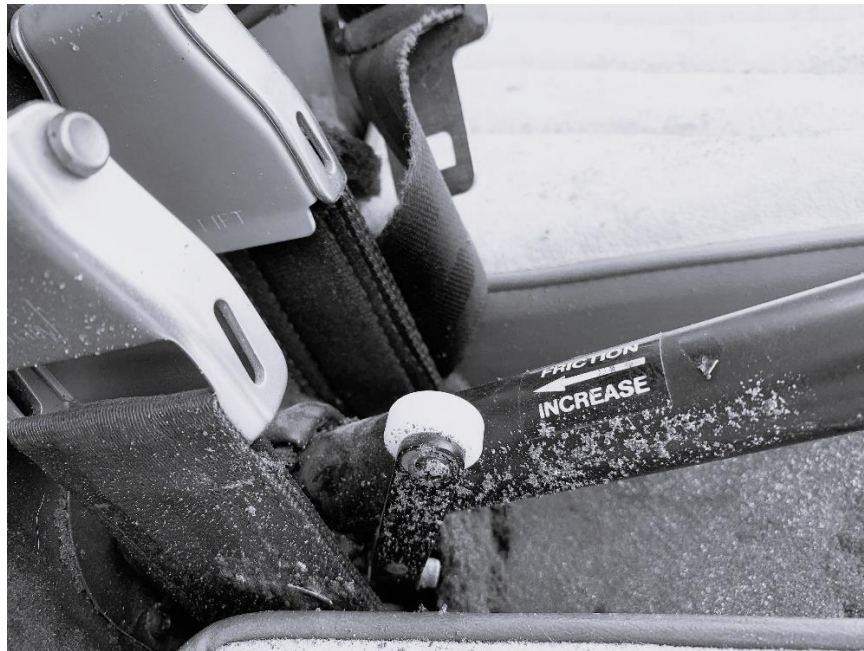
The removable flight controls were installed. The anti-torque pedals were in a neutral position. The collective was positioned mid travel and had resistance when pushed downward due to main rotor gearbox impact-related damage. The cyclic friction was on and, as shown in Figure 6, the collective friction was off.

**Figure 6.** Collective friction in off position.

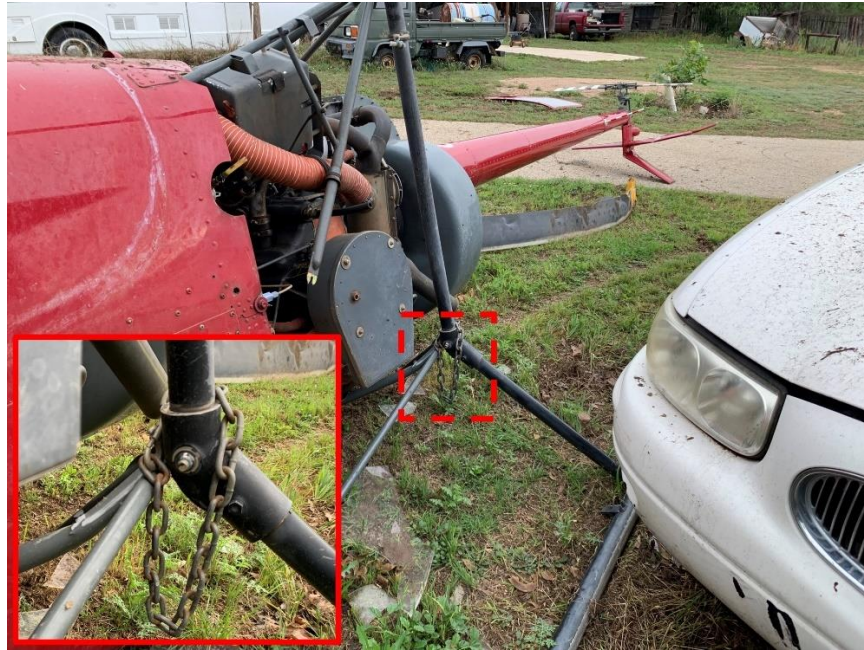
The landing skids remained attached to the airframe at three points; the forward right-side attachment point was fractured. The heel of the right skid was bent, and the toe was fractured at the strut mount. There was a short loop of chain installed on the landing skid aft cross tube, as shown in Figure 7. As previously noted, the pilot reportedly would connect an electric winch cable to the short chain loop to move the helicopter while on the ground. However, if he intended to fly, the pilot would

remove the short chain loop before the flight. The winch cable was not connected to the chain loop at the time of the crash and was found on the floor of the shed undamaged.

**Figure 7.** Chain loop around the landing gear skid aft cross tube.
