# National Transportation Safety Board

CEN23FA201

## **AIRCRAFT EXAMINATION SUMMARY**

Location: Grand Isle, LA  
Date: May 25, 2023  
Time: 1101 CDT  
Aircraft: Cessna 182T; N577TZ

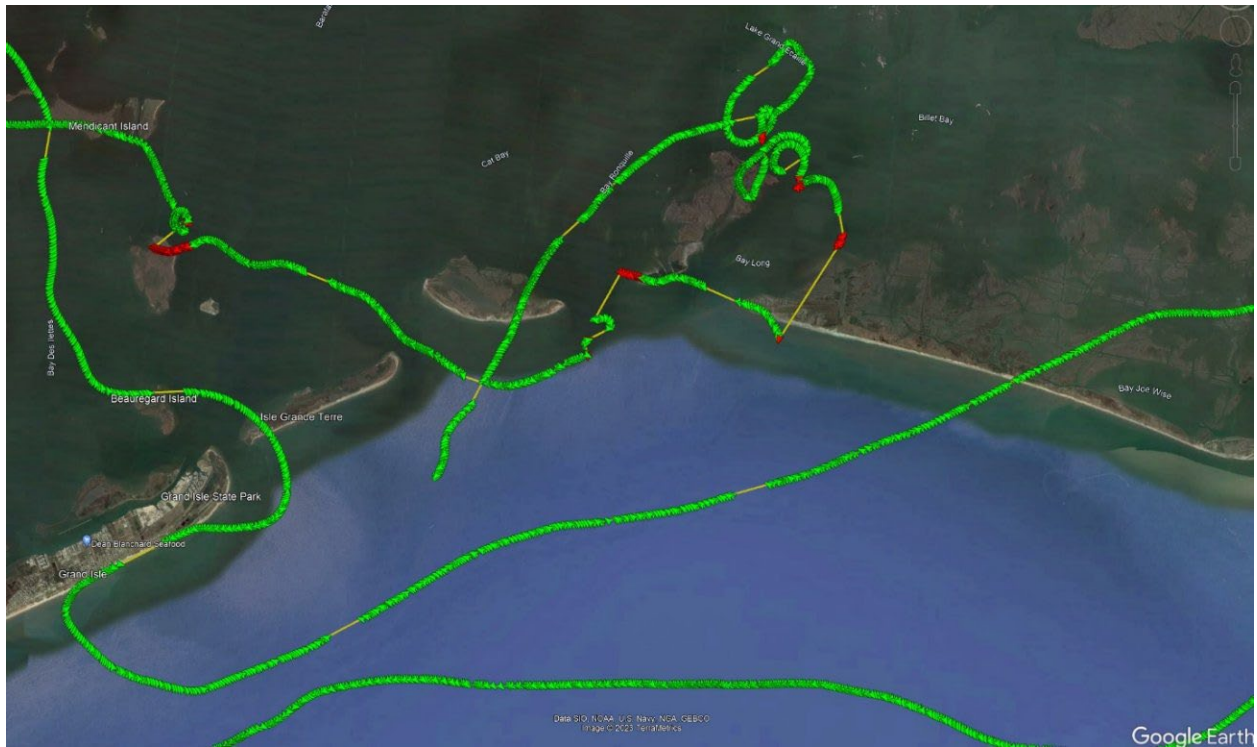
Automatic dependent surveillance-broadcast (ADS-B) data indicated that the pilot performed several low-level flight maneuvers for about 3 hours that were consistent with aerial observation for fish spotting activities. The last ADS-B contact showed the airplane about 1.8 miles offshore on a southwest heading about 175 ft above the ocean water.

ADS-B data showing the end of the flight track

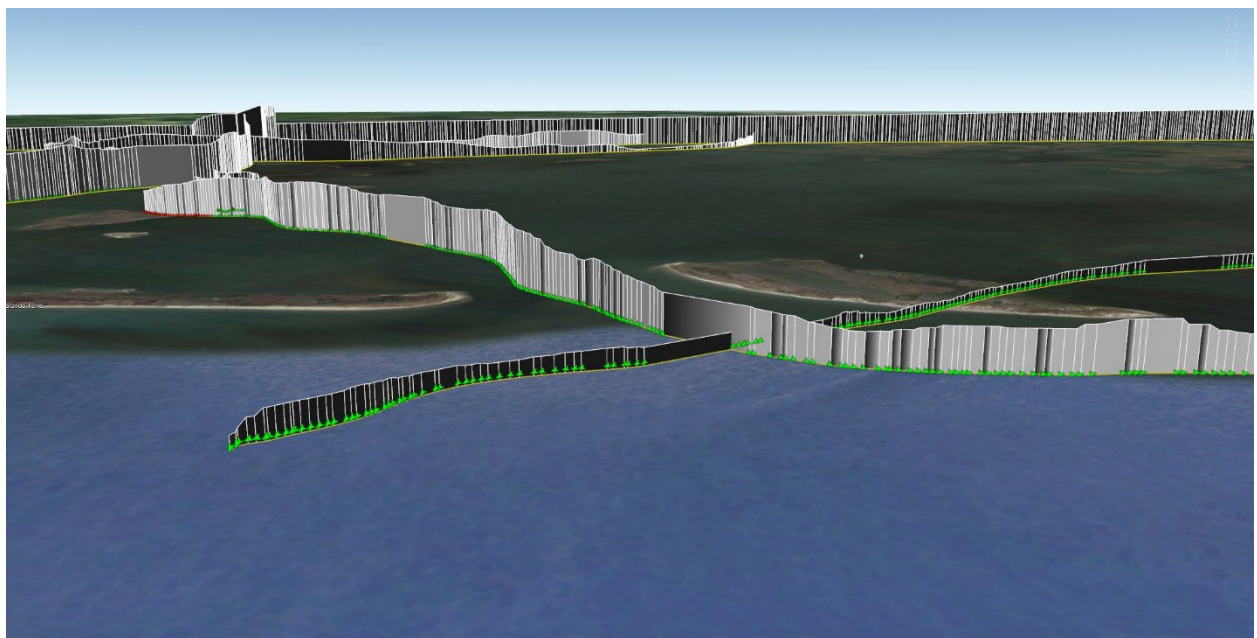
ADS-B data showing the end of the flight track

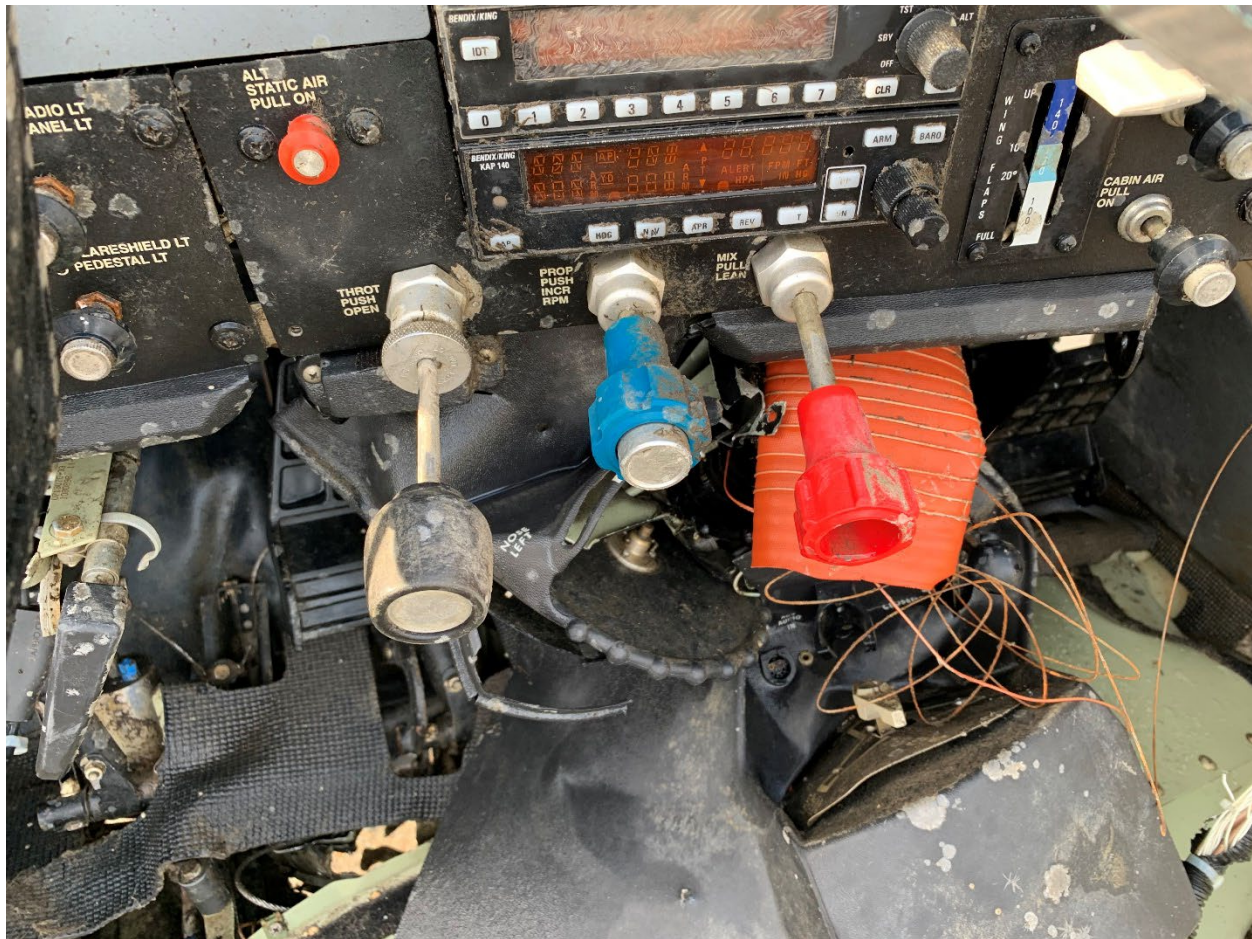
The instrument panel was intact and contained heavy deposits of ocean silt debris. The tachometer indicated 1,112.4 hours, and the HOBBS meter indicated 9,277.2 hours. All other instrument indications were unreliable due to damage. The magneto switch was in the "BOTH" position, the master switches were "ON", the avionics master switches were "ON", and the fuel pump was "OFF". The throttle lever was pulled out about 2.25", the mixture was pulled out and bent down about 1.75", and the propeller lever was pulled out about 0.25".

Engine and propeller cockpit controls

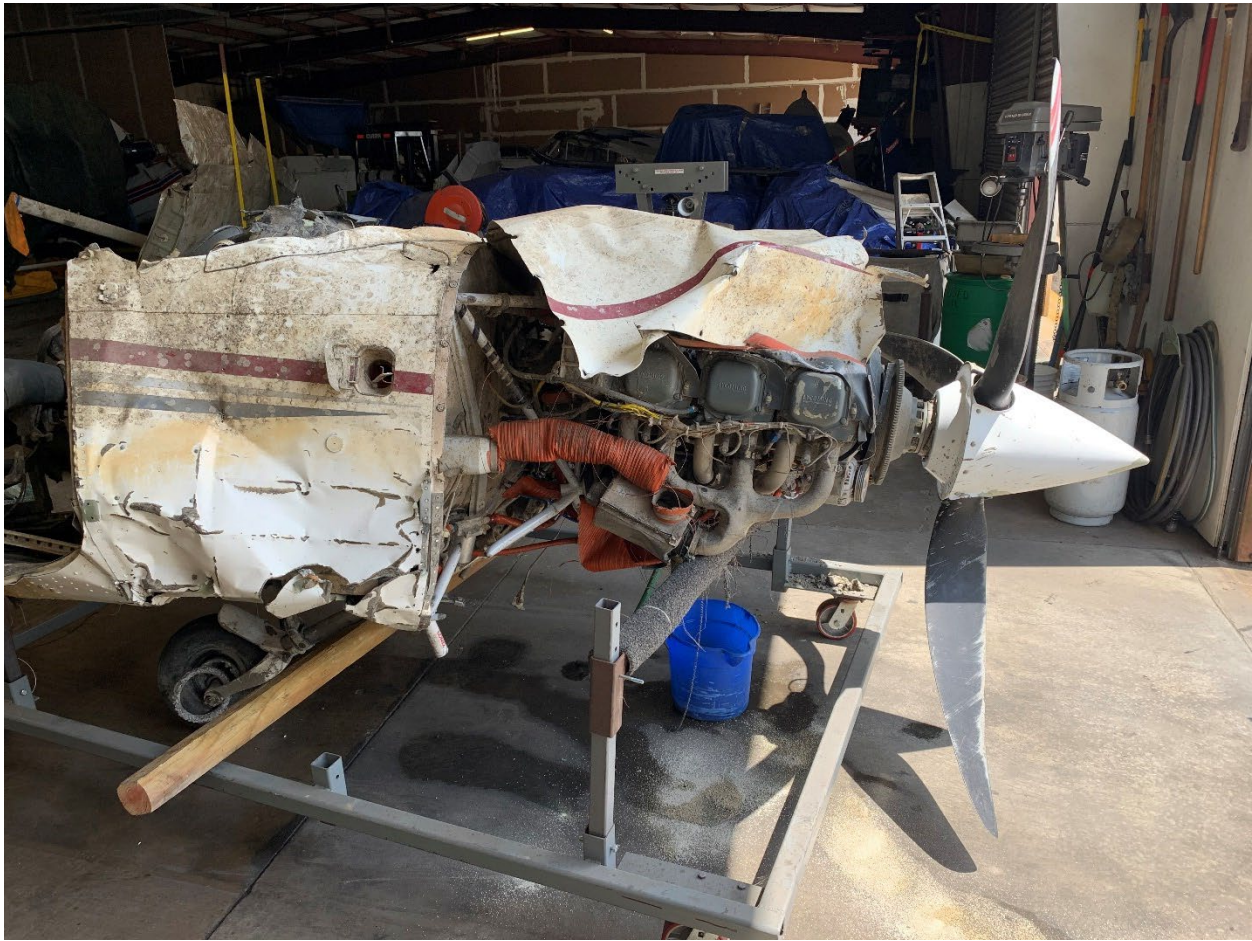
The forward fuselage, which included the engine and propeller assembly, sustained minor underside crush damage. The nose landing gear strut was bent/pushed aft about 60° into the firewall and forward fuselage floor. The nose landing gear tire remained attached. The forward fuselage floor was bent and distorted. The left and right seats remained attached to the seat rails. Both lap/shoulder harness restraints were cut during recovery, neither restraint was found secure in their respective buckle assembly.

Right side of forward fuselage, engine, and propeller assembly

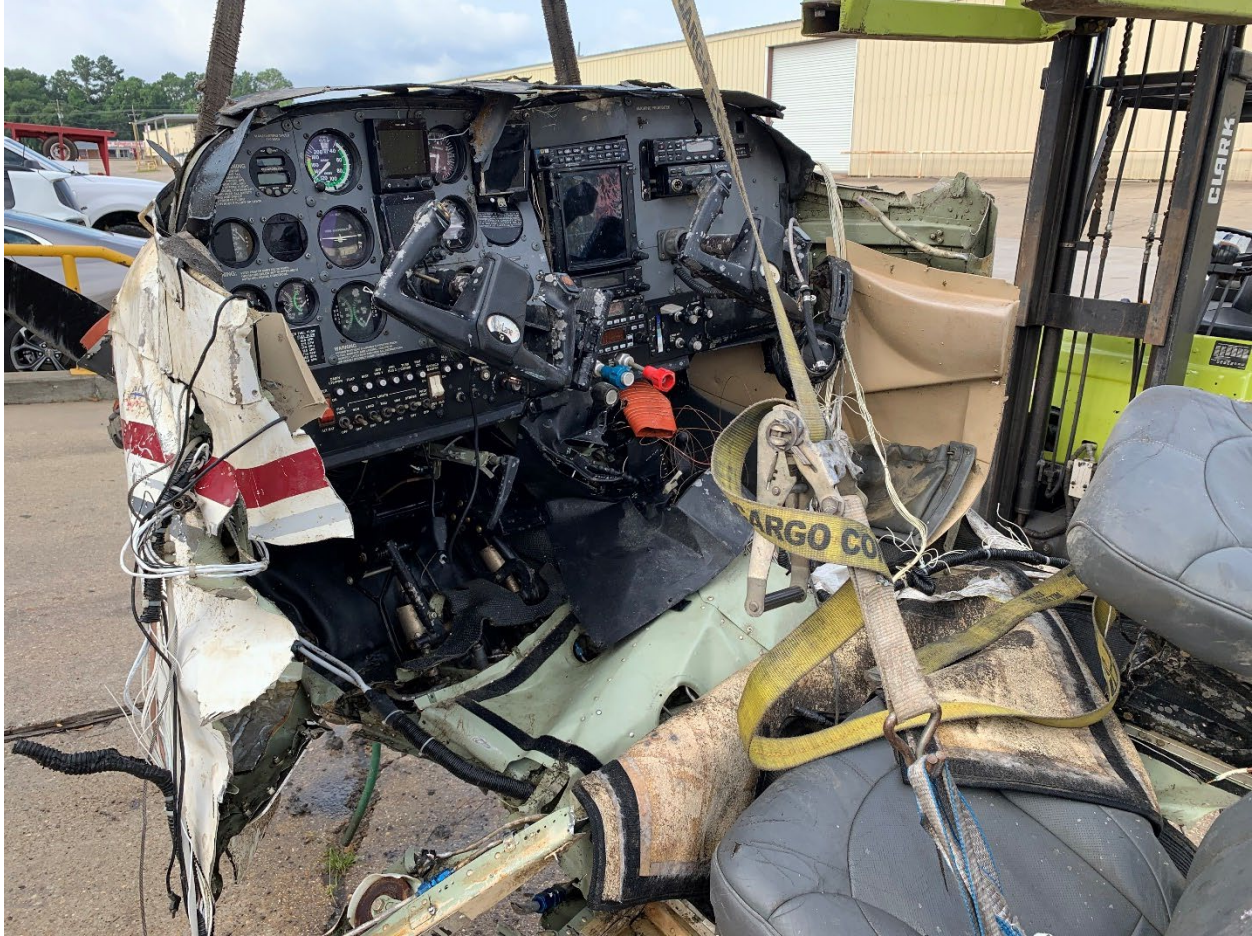
Forward fuselage cockpit and instrument panel – post freshwater wash

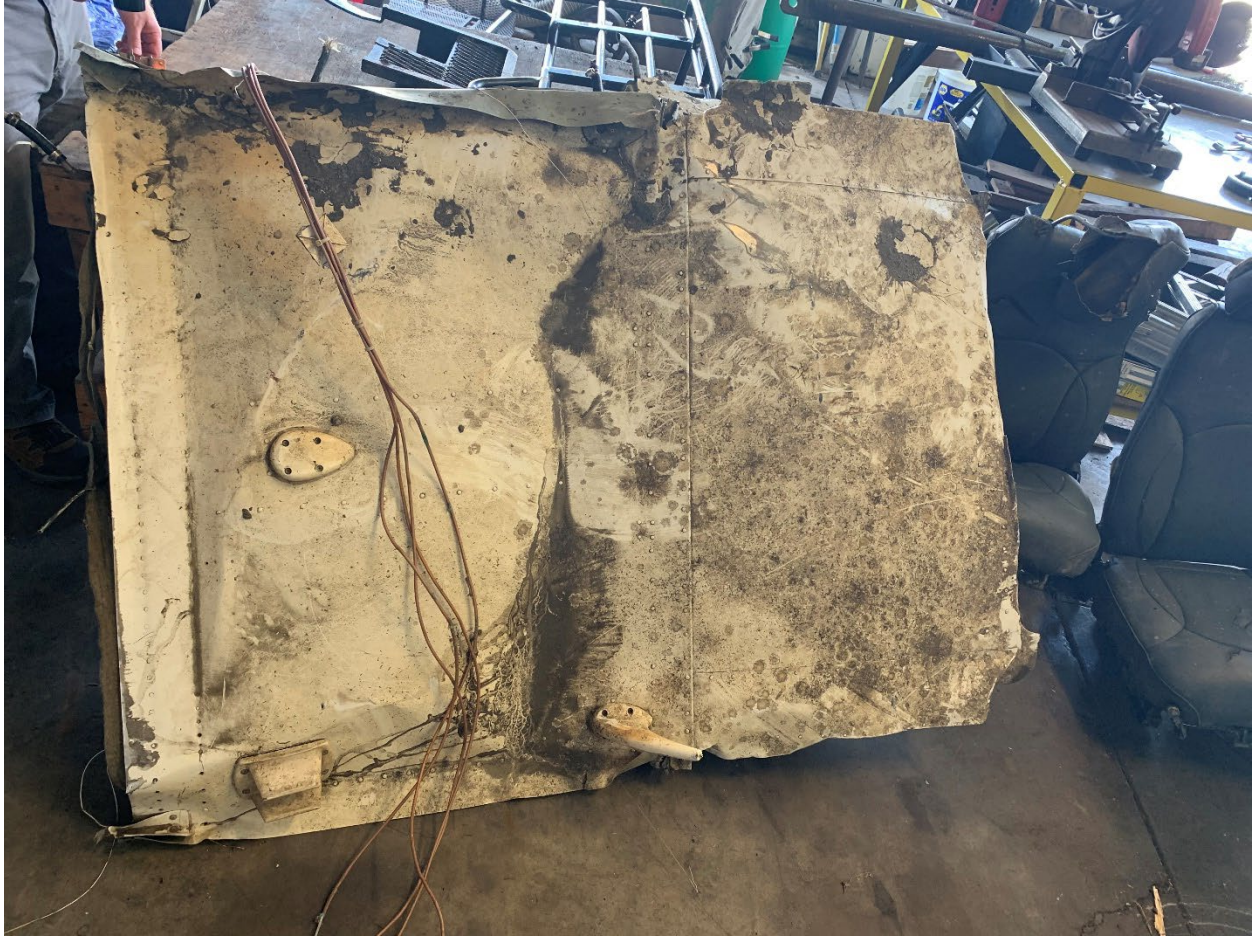
The mid-fuselage structure (rear seat area) displayed heavy distortion and bending consistent with the recovery operations. The section remained partially attached to the forward fuselage and empennage sections via aircraft wiring. The rear seats remained attached to the structure. The upper cabin roof was separated. The main landing gear struts remained attached to the fuselage. The left tire assembly and wheel pant were missing. The right tire assembly and wheel pant remained attached. The wheel pant displayed minor damage to the forward fiberglass structure. The landing gear strut fairings appeared to be hydraulic molded around the landing gear struts.

Fuselage cabin roof

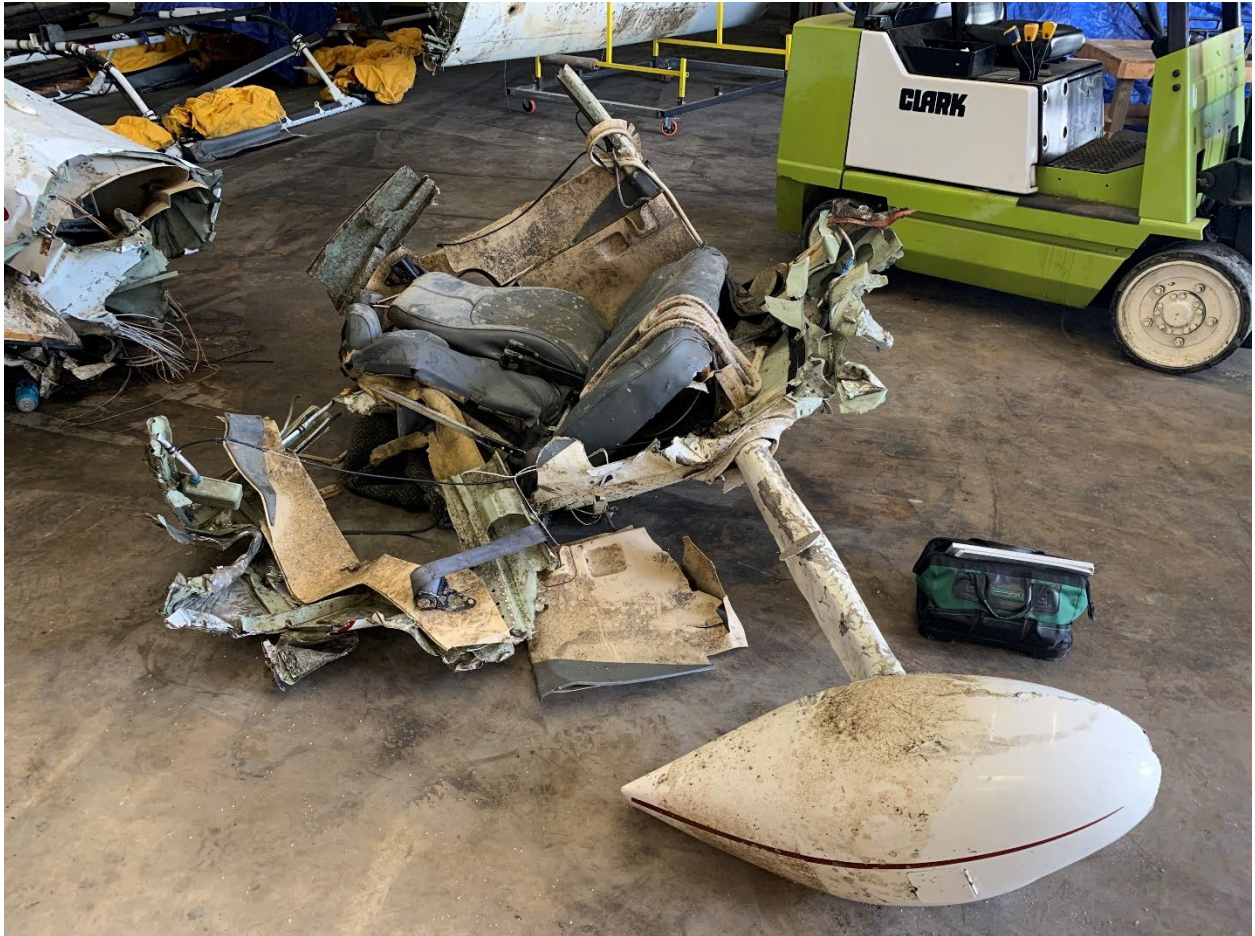
Right side of mid-fuselage section

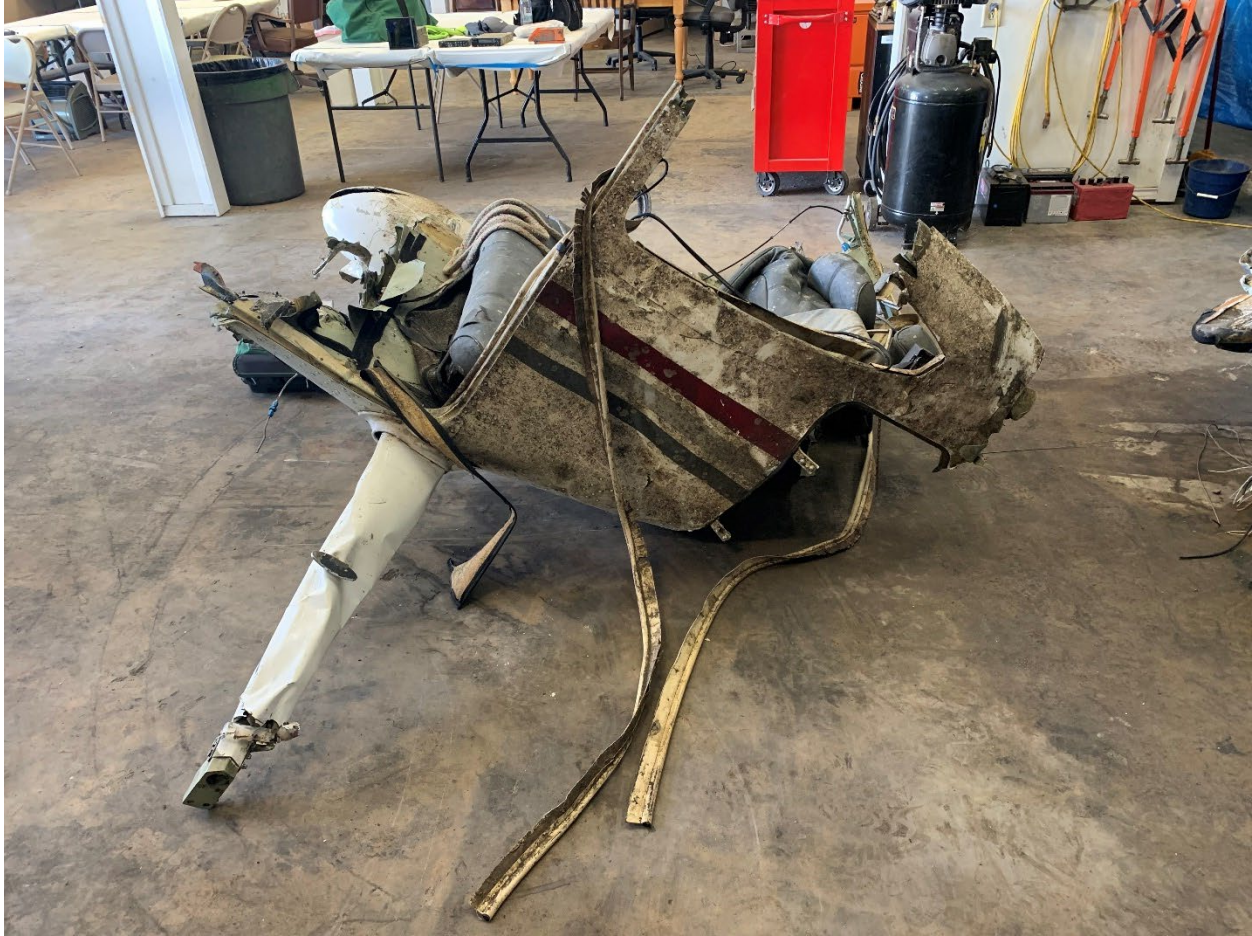
Left side of mid-fuselage section

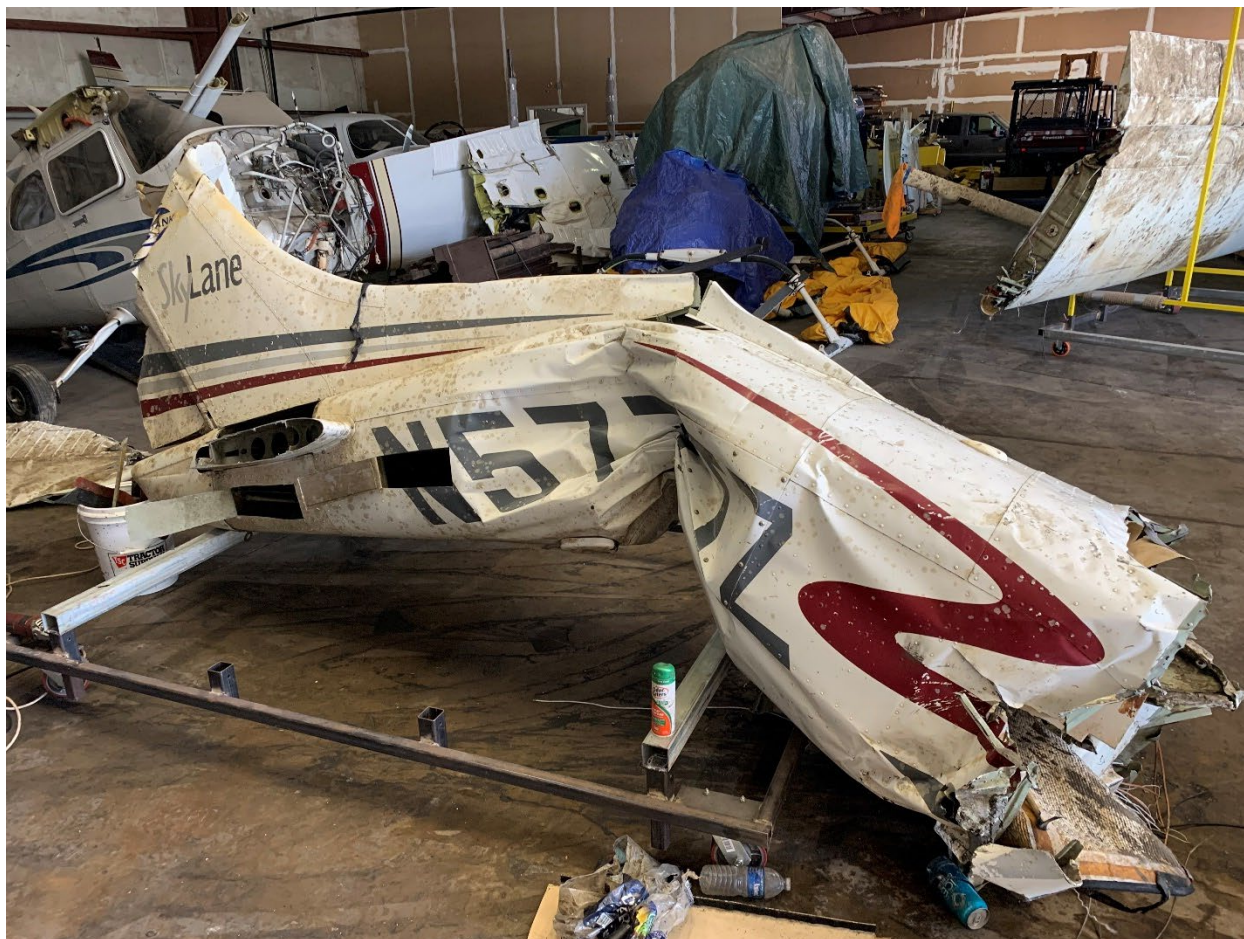
The empennage section was separated aft of the rear seats and remained partially attached via aircraft wiring. The empennage was bent and distorted during recovery operations. The horizontal and vertical stabilizers remained attached. The right horizontal and elevator were cut/separated for recovery operations. The elevators remained attached, and elevator trim tab measured about 10° tab down (nose up). The upper half of the rudder was separated and not recovered. The lower rudder section remained attached to the vertical stabilizer. Flight control cables remained attached to their respective flight control surfaces and bellcranks.

Right side of empennage section

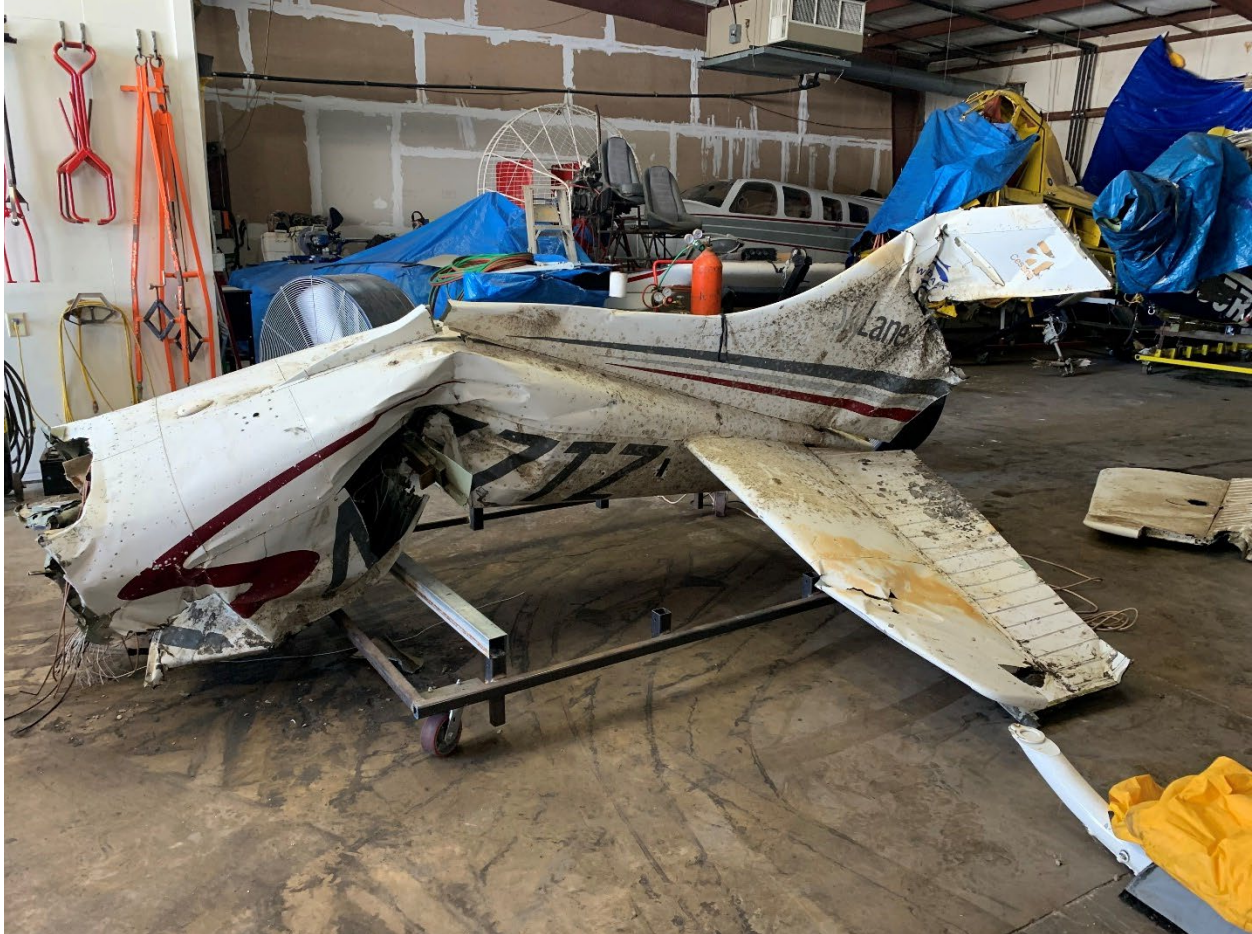
Left side of empennage section

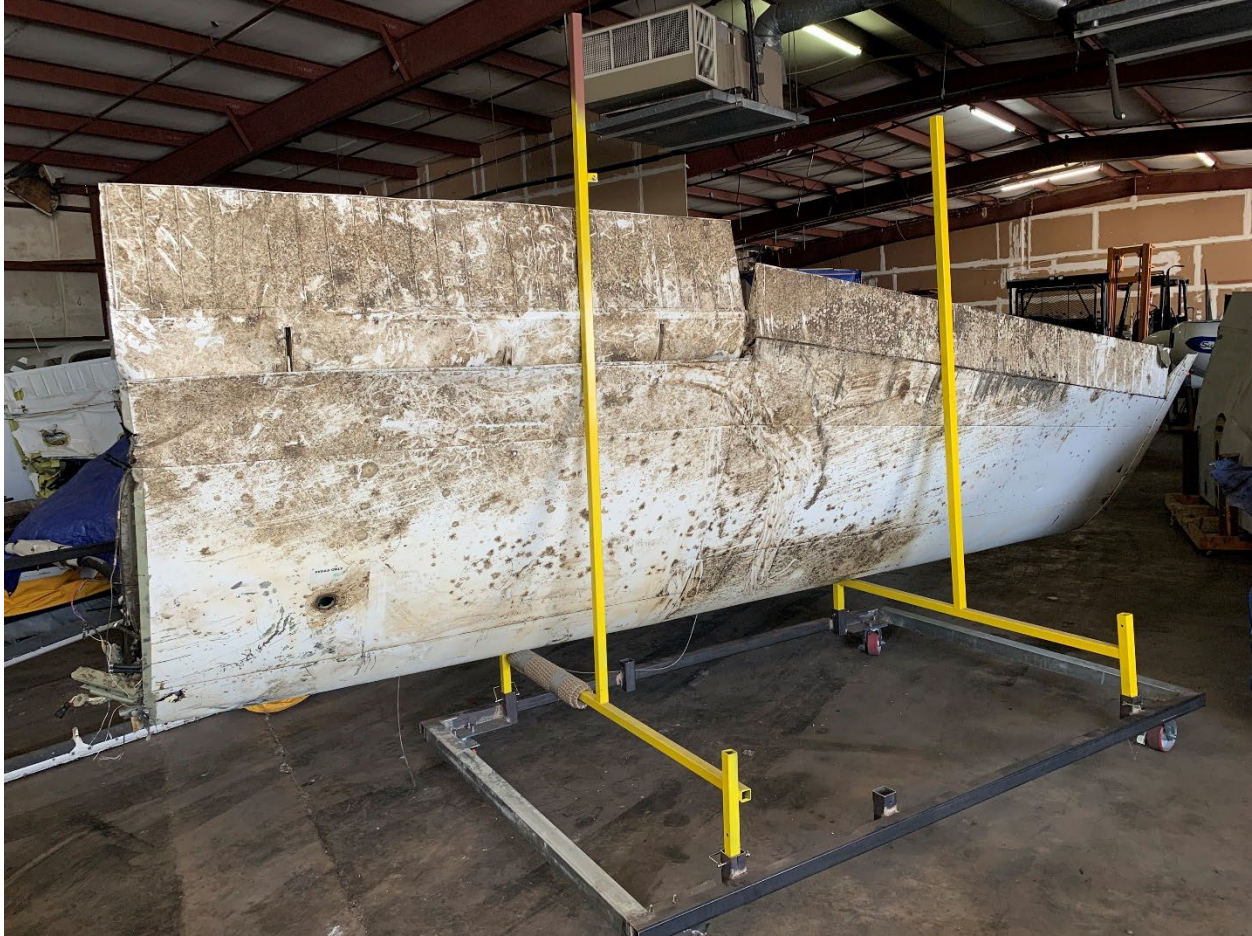
The left wing was separated from the fuselage at the wing root and strut. The left wing remained with the fuselage being entangled in the shoulder harness belts. Some minor fiberglass wing tip damage. The aileron and flap surfaces remained attached to the wing. The flap was recovered in the down/extended position. The flap push/pull rod was bent outward and prohibited the flap from retracting. The flap and aileron cables were separated near the wing root with broomstraw signatures.

Upper surface of the left wing

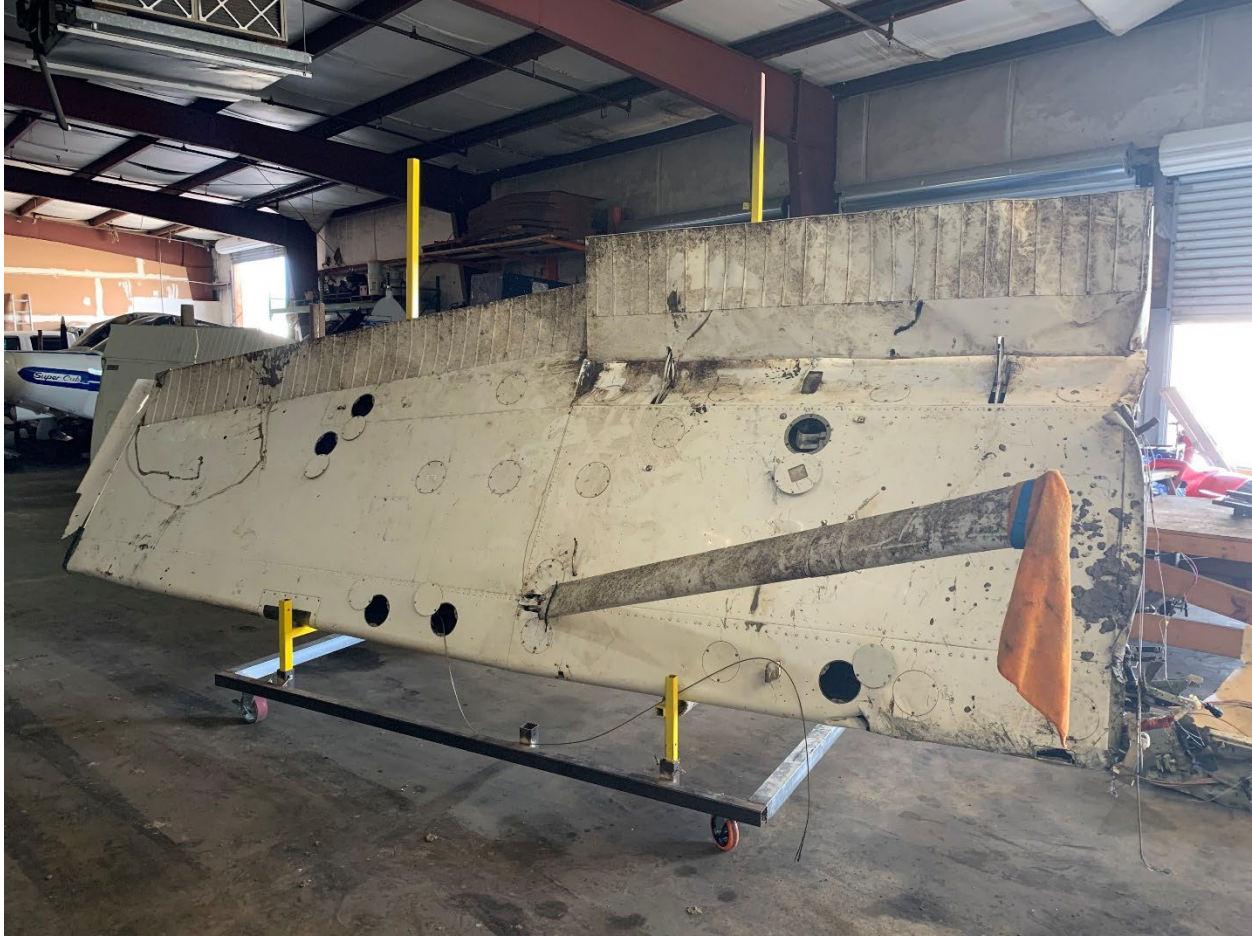
Underside of left wing

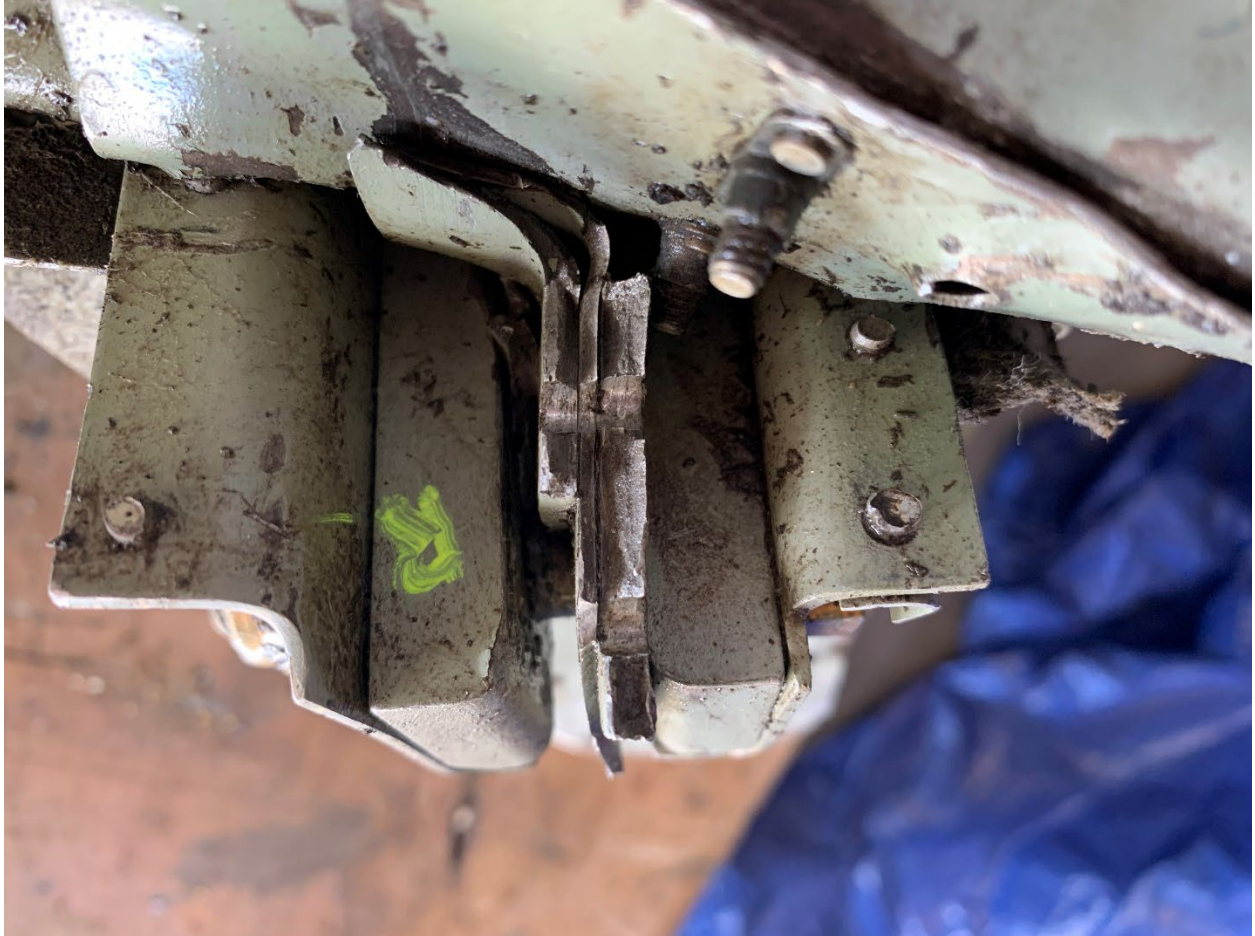
The right wing was not located in the debris field. The forward and rear spar attach points remained attached to the cabin roof structure. The attach point structure was separated and bent upward.

Right wing forward spar attach structure

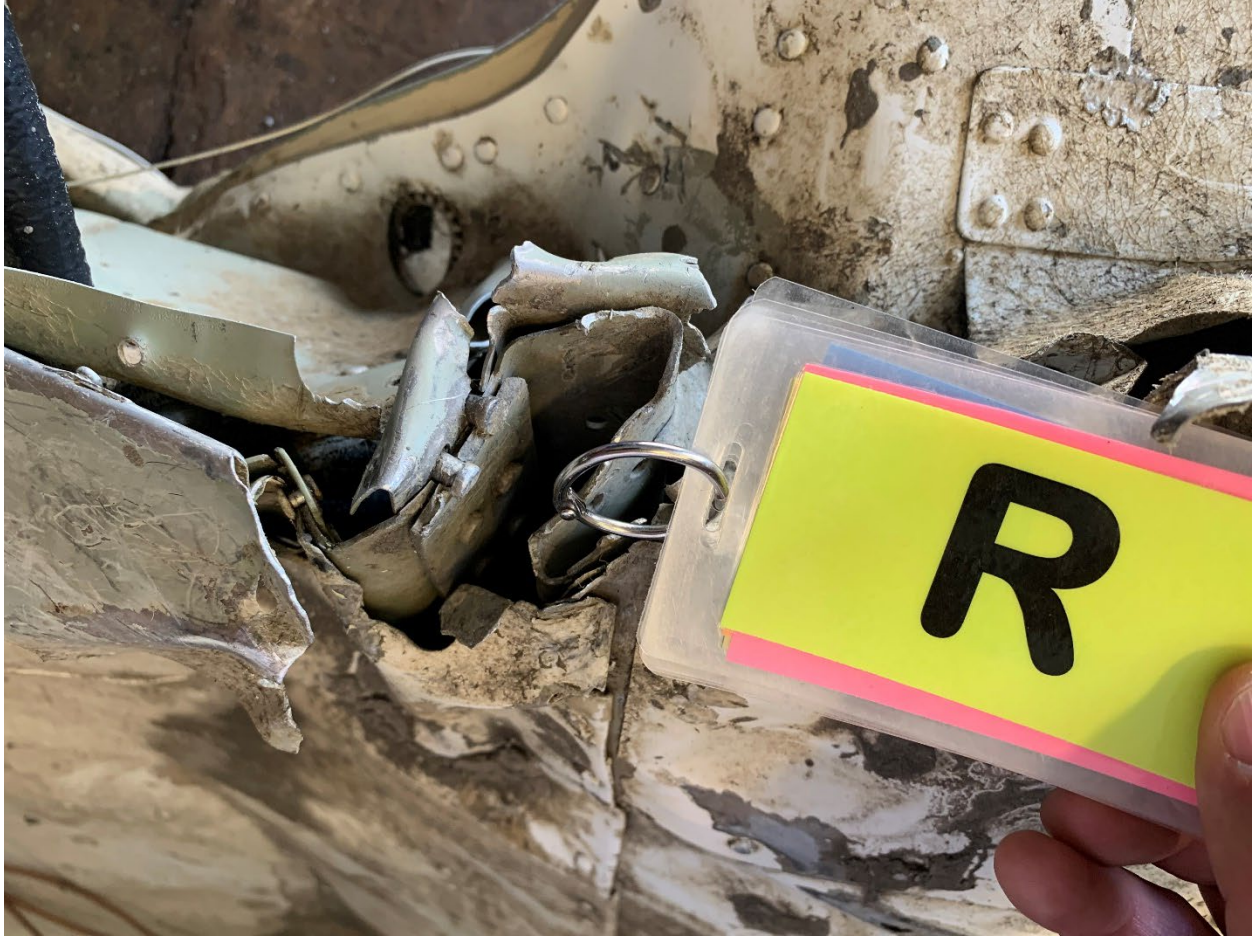
Right rear spar attach structure

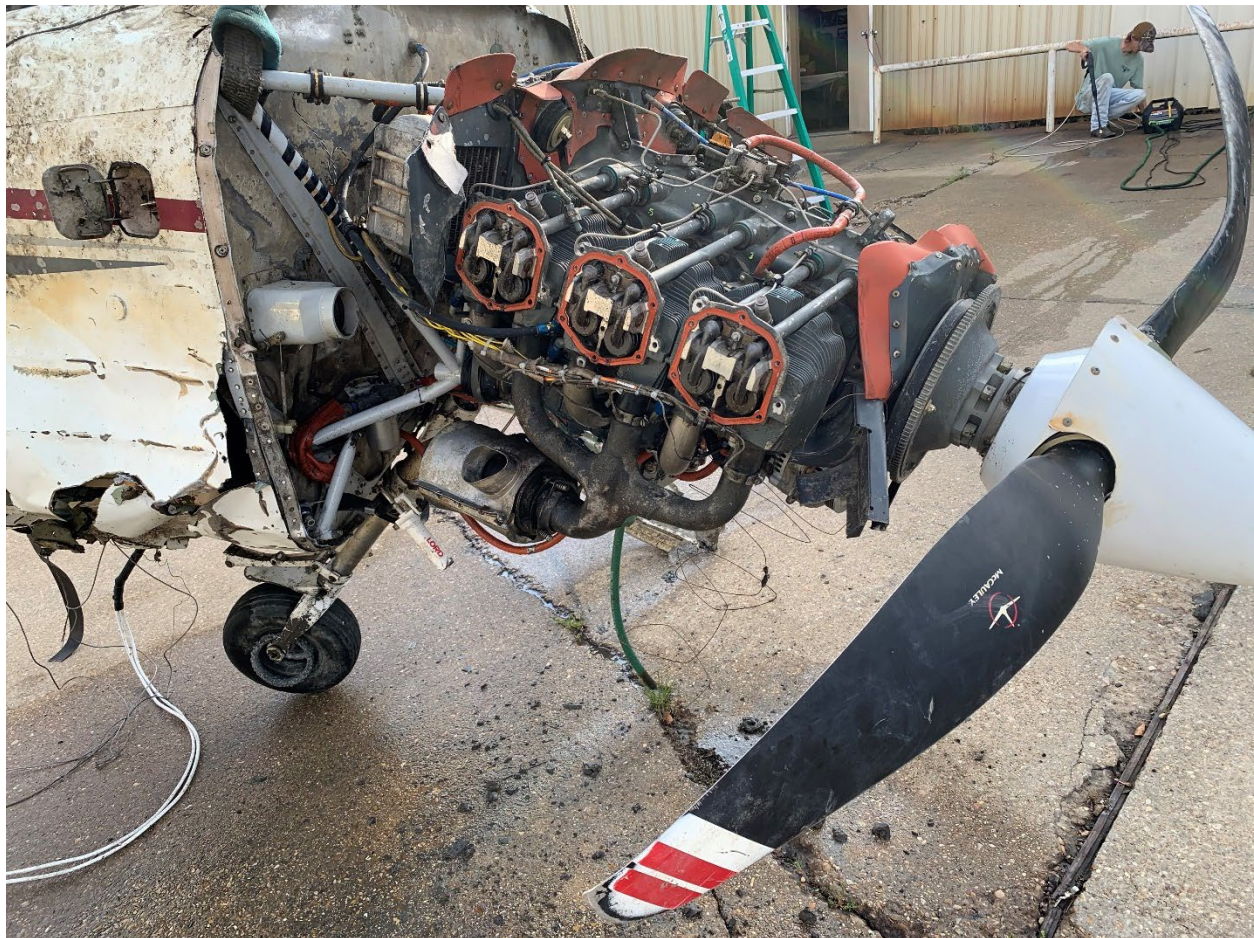
The engine remained attached to the engine mount. Corrosion and ocean silt debris was noted on the engine, and the engine data plate remained attached.

Right side of engine - post freshwater wash

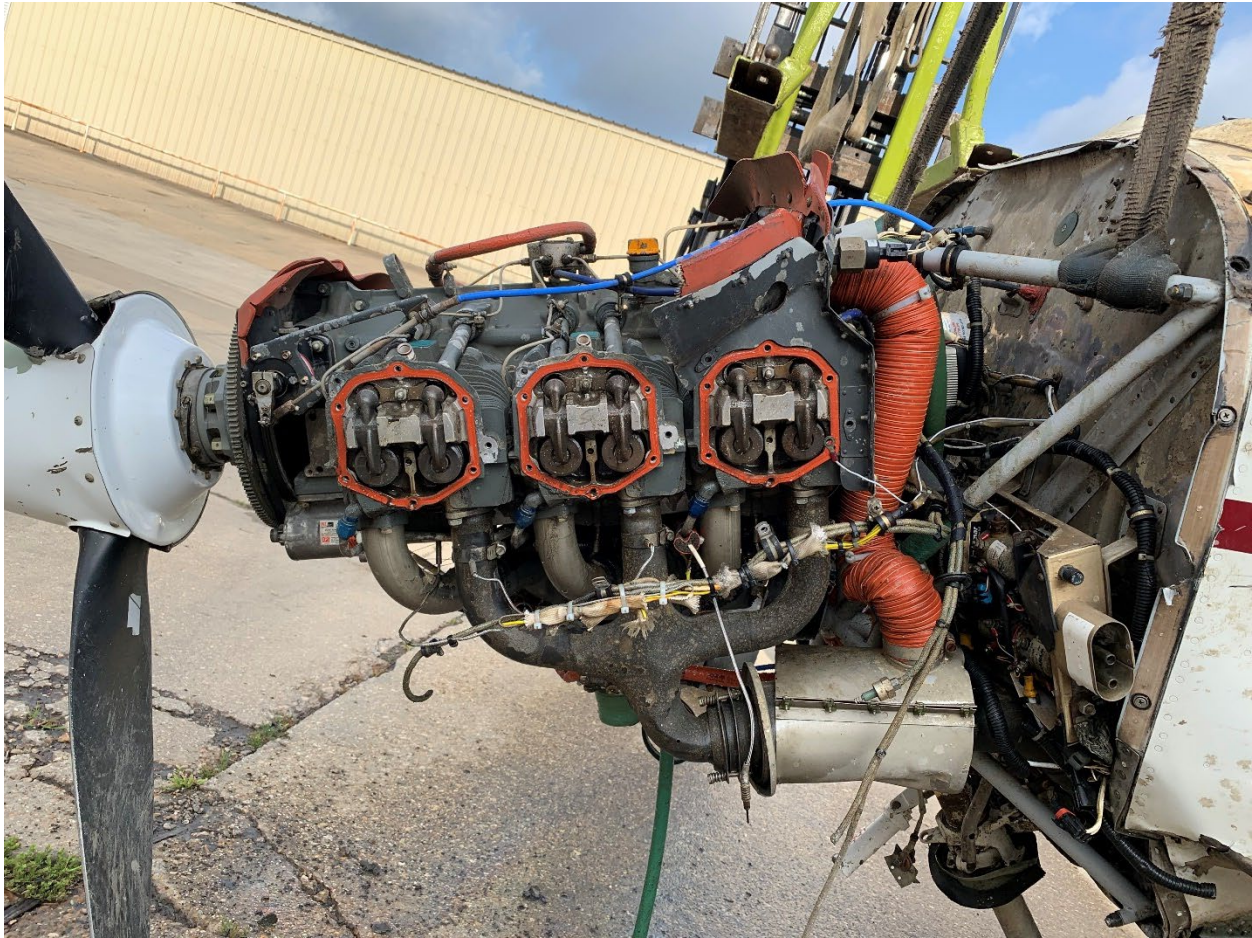
Left side of engine - post freshwater wash

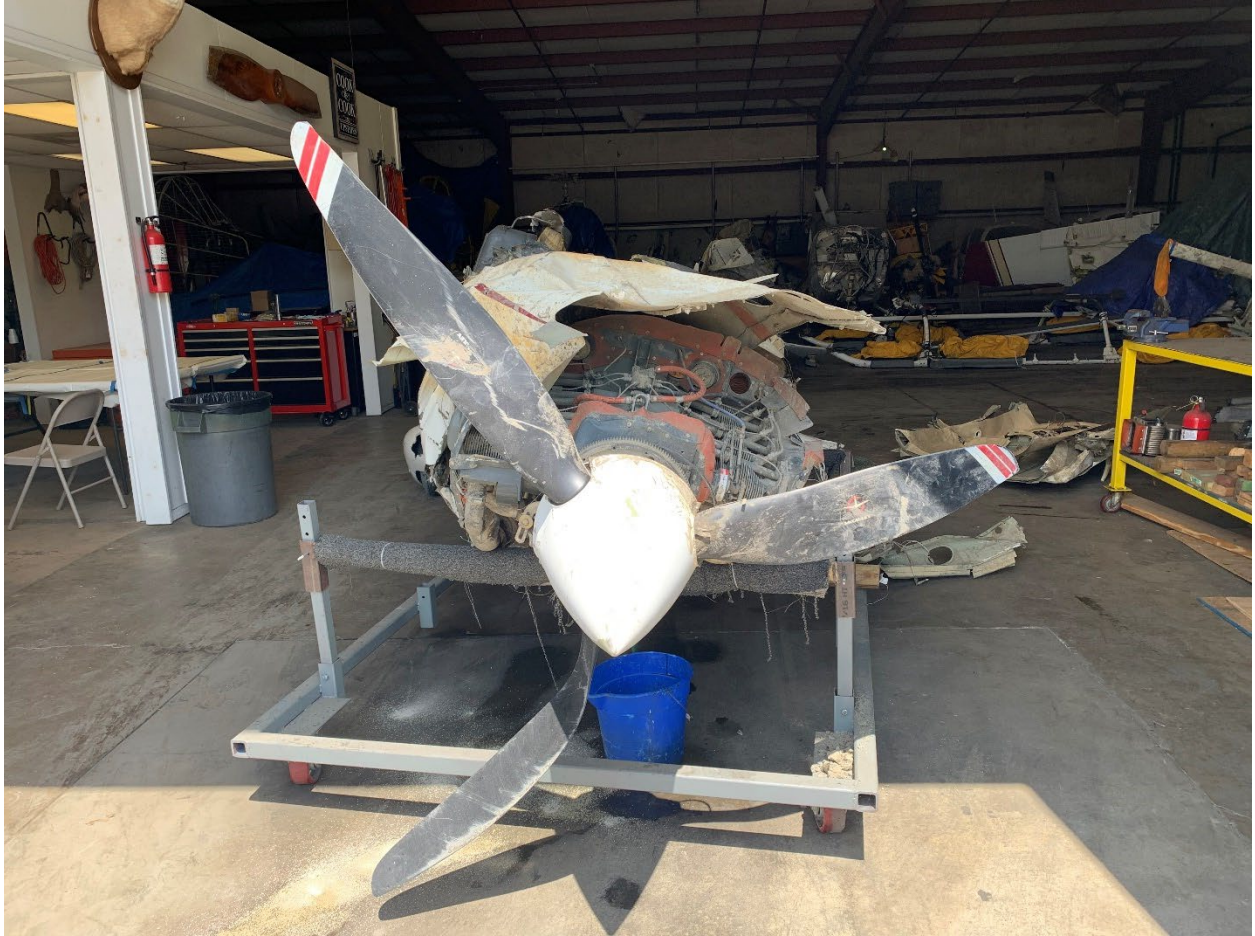
The 3-blade propeller assembly remained attached to the engine. Two blades were loose in the hub. The three blades displayed slight aft bending. Propeller spinner was unremarkable. Heavy silt deposits noted on the inside of the spinner.

Propeller assembly and spinner

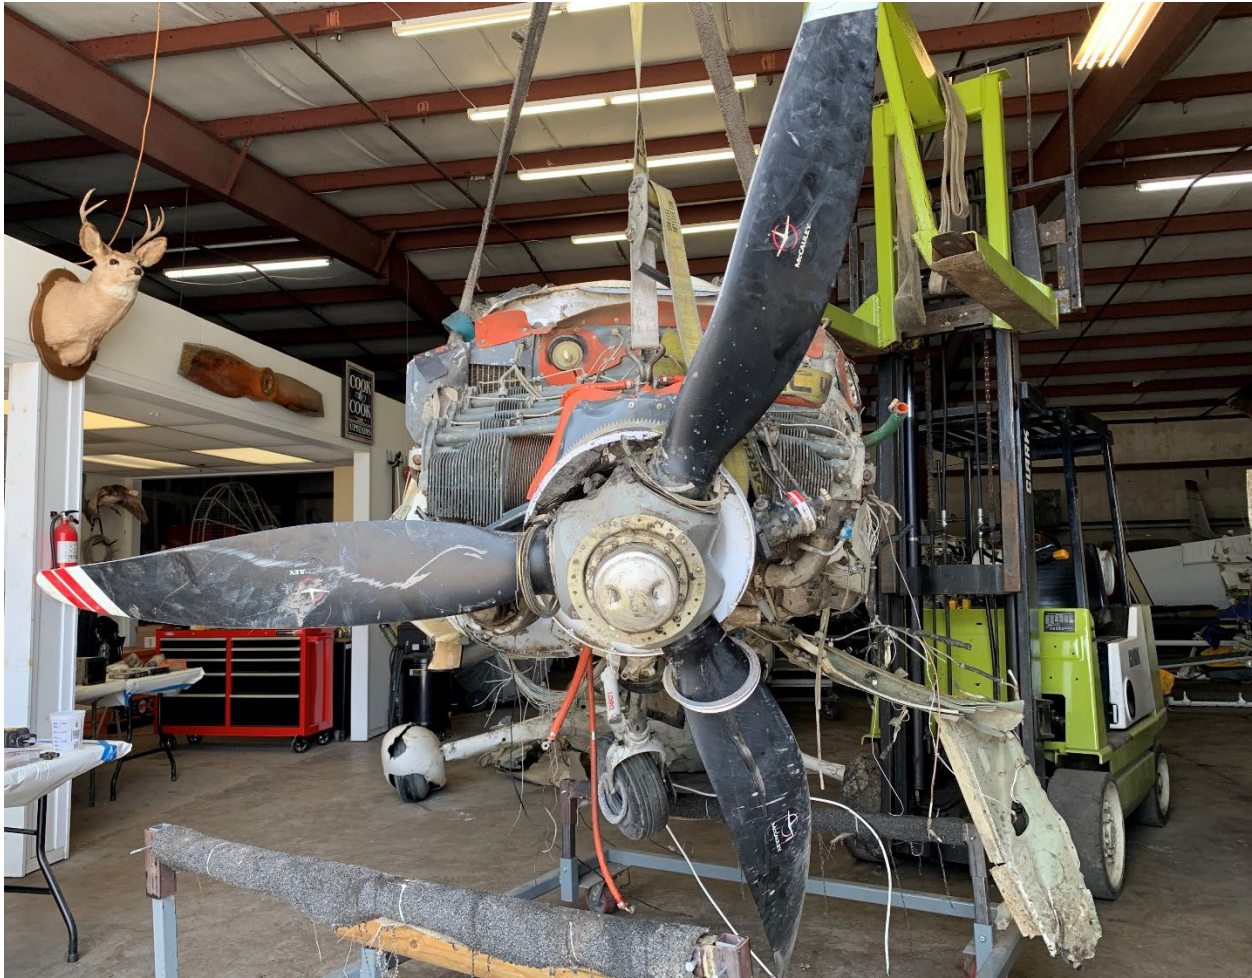
Propeller assembly with spinner removed
