# National Transportation Safety Board

CEN23FA204

## **MATERIALS LABORATORY**

Factual Report 23-077

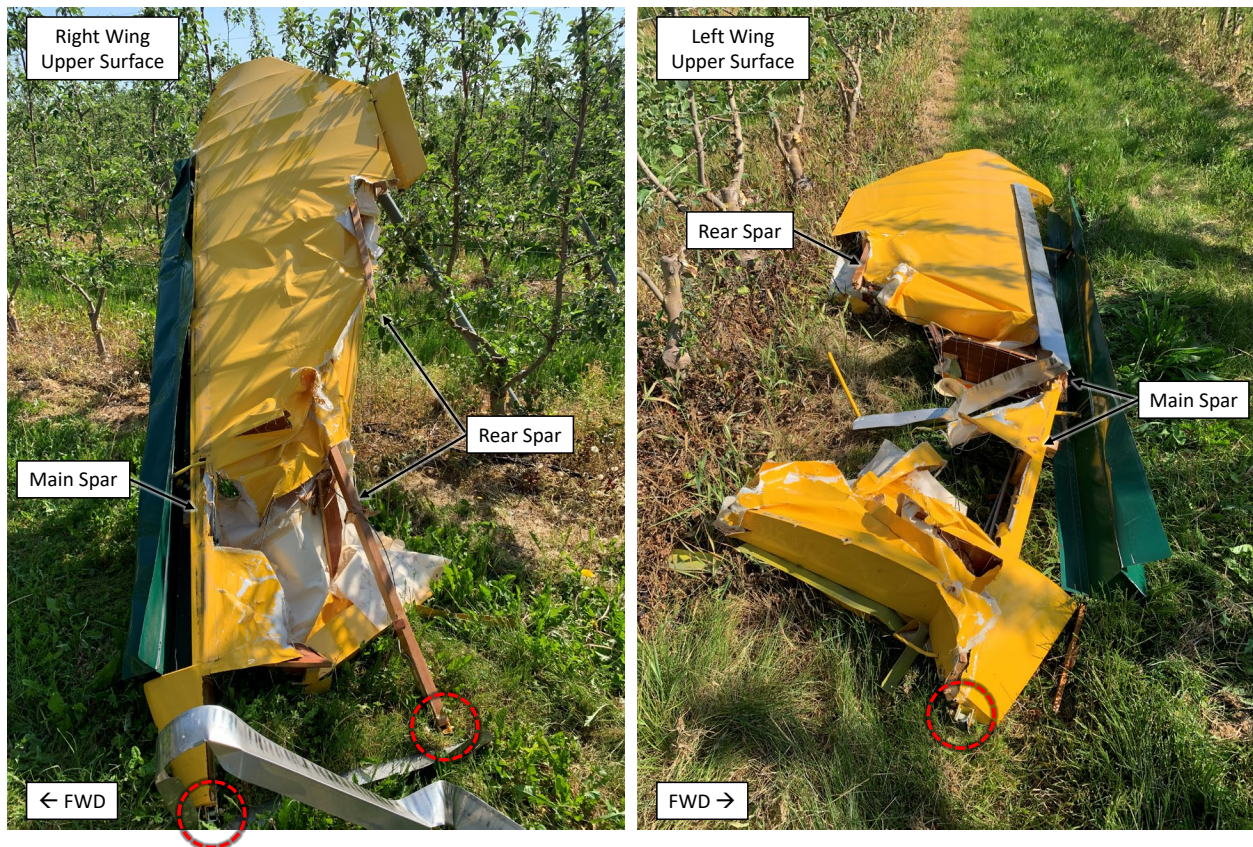
The right wing was found separated from the fuselage as shown in the left image of figure 2. The wing attachment brackets, circled in red, were fractured from the fuselage connection and retained at the main and rear spar roots where the bolted connections to the spar connector brackets were intact. The right rear spar was fractured through the location of the strut brackets as shown looking outboard in figure 3 bound by the red bracket. The fracture surface extended from the upper spar surface at the inboard end to the lower-aft spar surface at the outboard end and exhibited predominantly shear mode fracture features along the grain flow. This was consistent with predominantly torsion loading during fracture.

The left wing was found separated from the fuselage as shown in the right image of figure 2. The main spar wing attachment bracket, circled in red, was fractured from the fuselage connection and retained at the main spar root where the bolted connection to the spar connector bracket was intact. The left main spar was fractured approximately 44 inches from the root end, just outboard of the leading edge pivot arm, as shown looking inboard in figure 4. The fracture surface closer to the rear surface of the main spar was relatively flat, consistent with compressive fracture, whereas the fracture surface closer to the front surface of the main spar was more splintered, consistent with tensile fracture. This was consistent with predominantly aft bending loading during fracture.

**Figure 2.** On-scene photographs showing right wing (left image) and left wing (right image). Retained wing attachment brackets are circled in red.

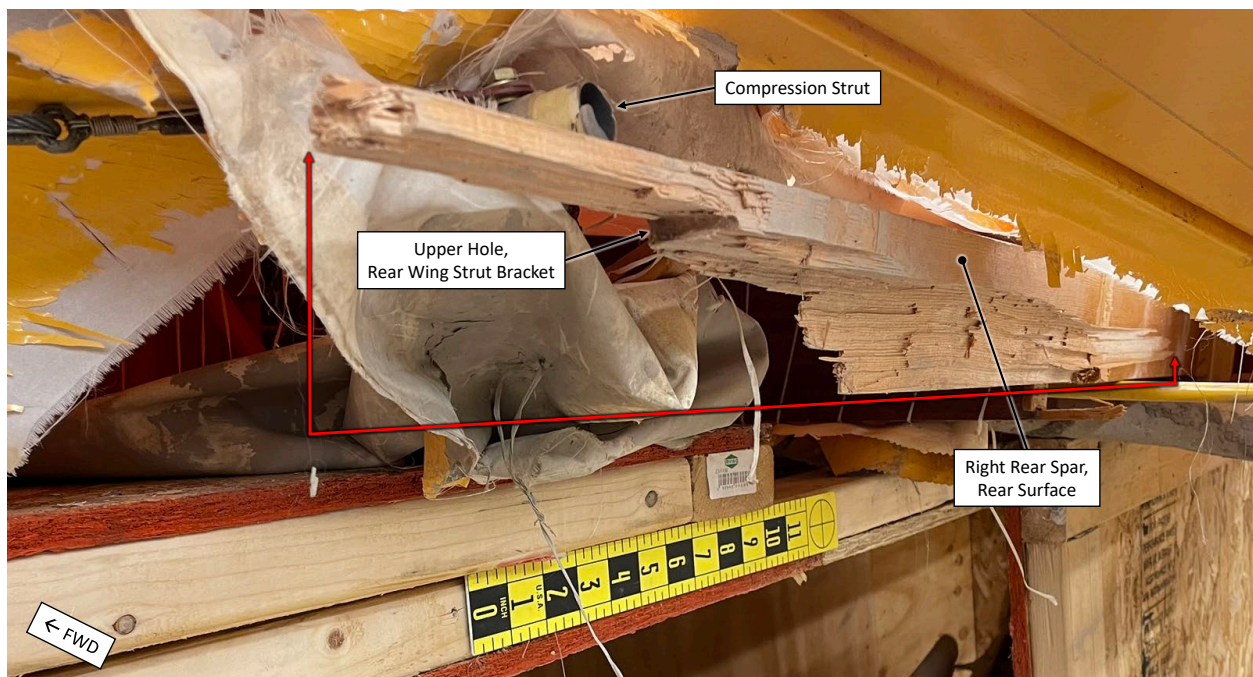
**Figure 3.** Photograph looking outboard along the fractured right rear wing spar.

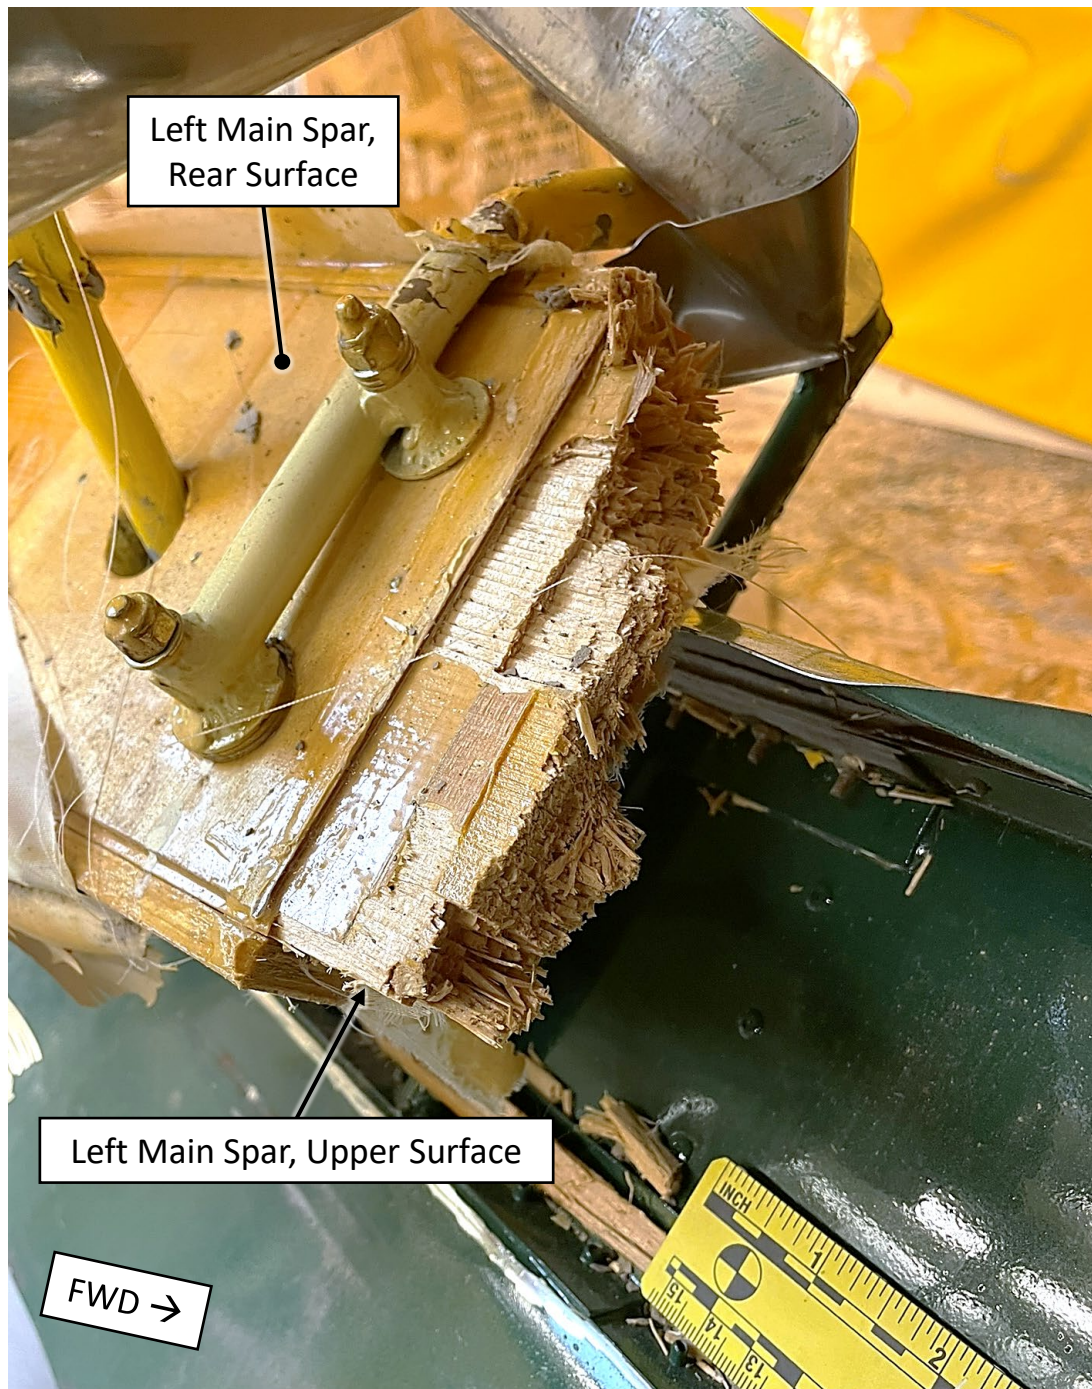
**Figure 4.** Photograph looking inboard along the fractured left main wing spar.

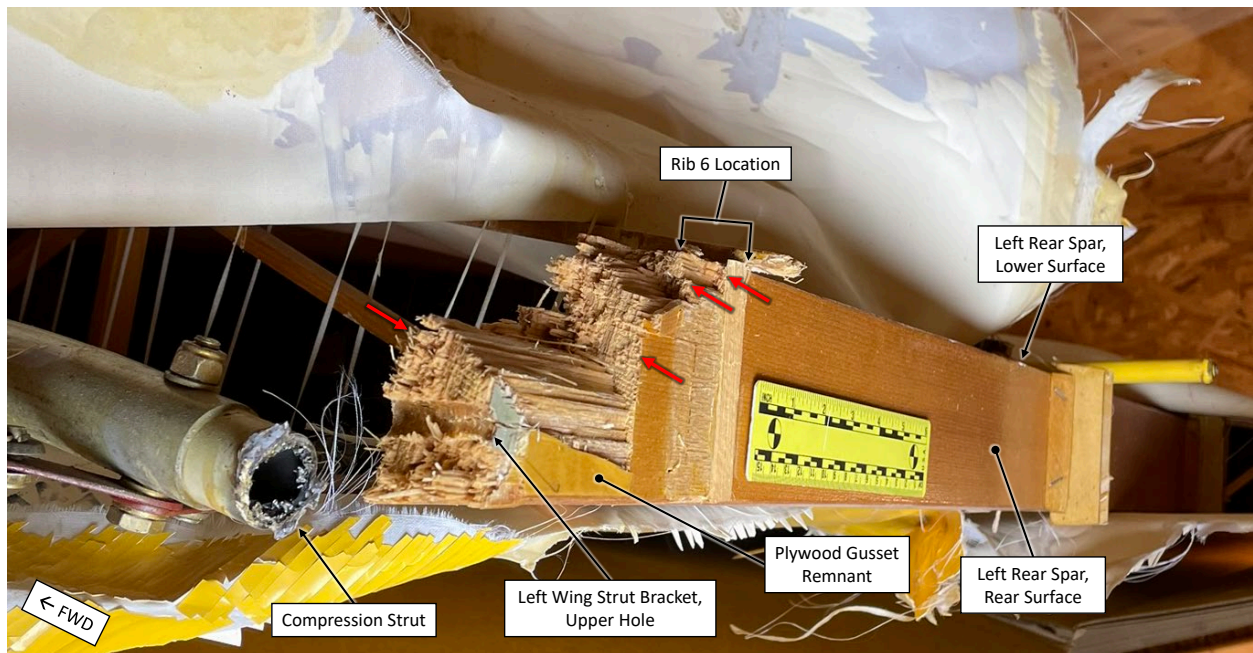
The left rear spar was fractured at the rear wing strut bracket connection as shown looking outboard in figure 5. The fracture surface was more splintered along the upper and forward edges of the left rear spar (tensile regions) with four flatter (compressive) regions 1.) at the wing strut bracket hole, 2.) at the outboard end of the rear gusset plate remnant, 3.) inboard of where Rib 6 was attached, and 4.) outboard of where Rib 6 was attached, which stepped down outboard towards the lower rear corner of the spar and are indicated by red arrows. This was consistent with predominantly downward and aft bending loading during fracture.

**Figure 5.** Photograph looking outboard along the fractured left rear wing spar.

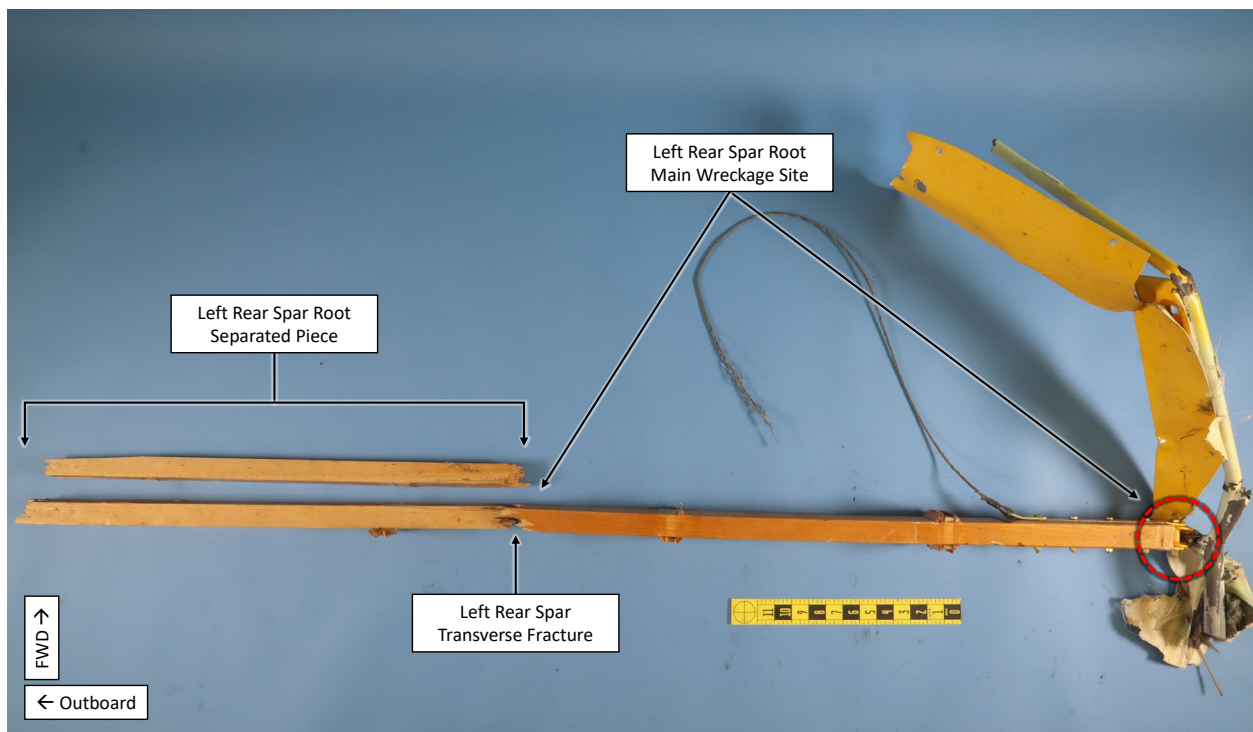
A portion of the left rear spar root approximately 37 inches long, shown in figure 6, was found in the main wreckage debris field partially attached to the

fuselage structure, as circled in red and shown more closely in figure 10. The spar connector bracket was observed still bolted to the spar root. Pieces of the left rear spar, approximately 28 inches long, which mated to the root section were fractured transversely from the spar root as shown in figure 6. This smaller piece of spar was also fractured along the longitudinal and tangential grain orientation plane at approximately mid-spar height as shown looking along the left rear spar at the transverse fracture location in figure 7. The fracture along the longitudinal-tangential grain orientation plane extended inboard along the spar as indicated by the yellow bracket. The location and orientation of this longitudinal-tangential spar fracture was consistent with torsional loading and a shear fracture mode.

**Figure 6.** Photograph of the inboard portion of the left rear wing spar.

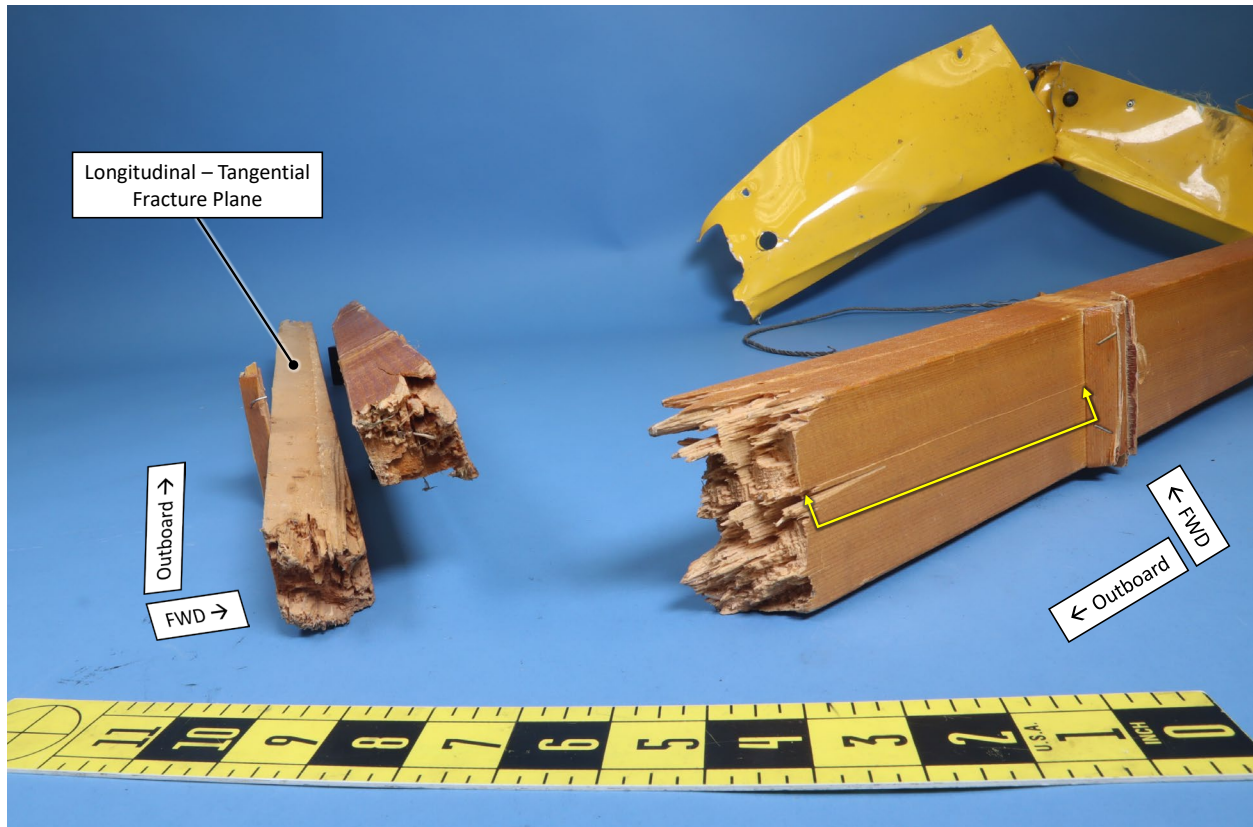
**Figure 7.** Photograph of the transverse fracture location observed on the left rear wing spar.

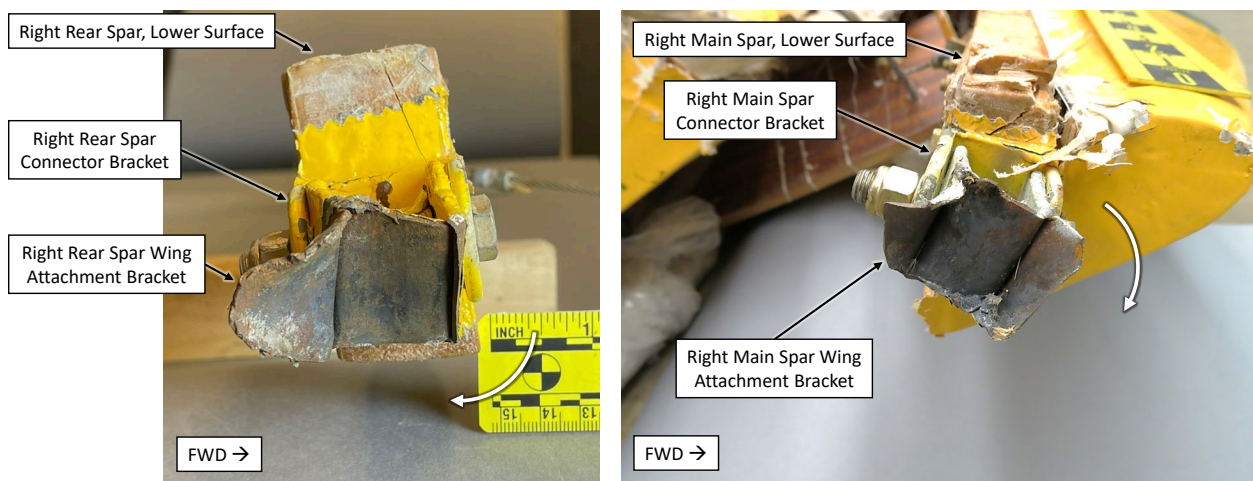
The wing attachment brackets were fractured and separated from the fuselage structure at three of the four attachment locations as shown in figures 8 - 10. The bolted connections were still intact, with the fractured portion of the wing attachment bracket retained by the respective spar connector bracket. Deformation of the fractured wing attachment brackets were consistent with upward torsional loading prior to separation as indicated by the white arrows in figures 8 and 9. Closer views of the left rear spar and wing attachment bracket are shown in figure 10 from the lower surface (left) and the upper surface (right). Partial fractures in the fuselage structure were observed near the wing attachment bracket as indicated by red arrows and this section of the left spar root was recovered from the main wreckage site, away from the wing wreckage site.

**Figure 8.** Photograph of the fractured wing attachment brackets from the right wing.

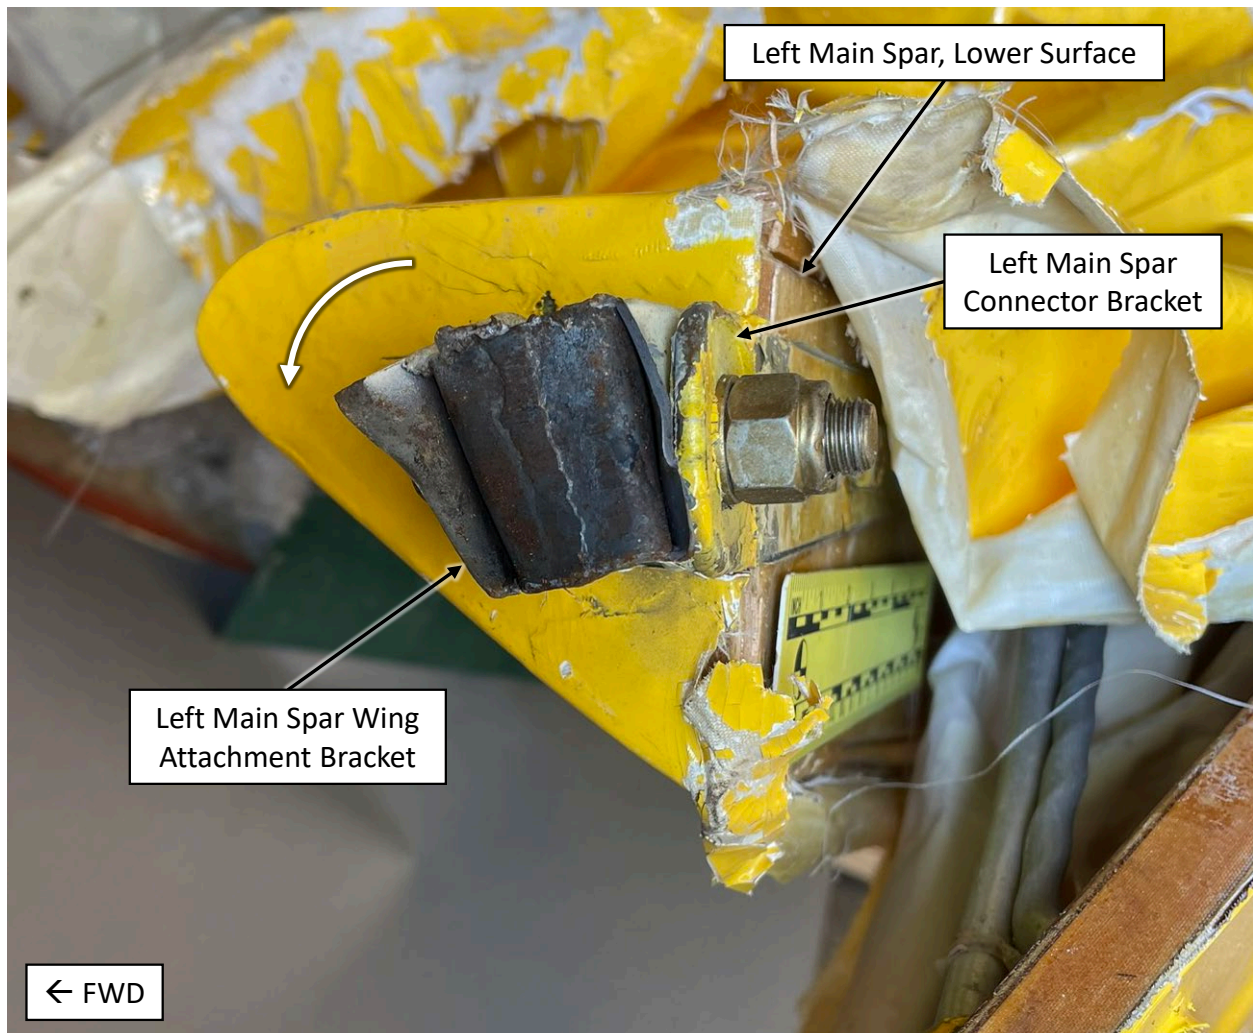
**Figure 9.** Photograph of the fractured wing attachment bracket from the left main wing spar.

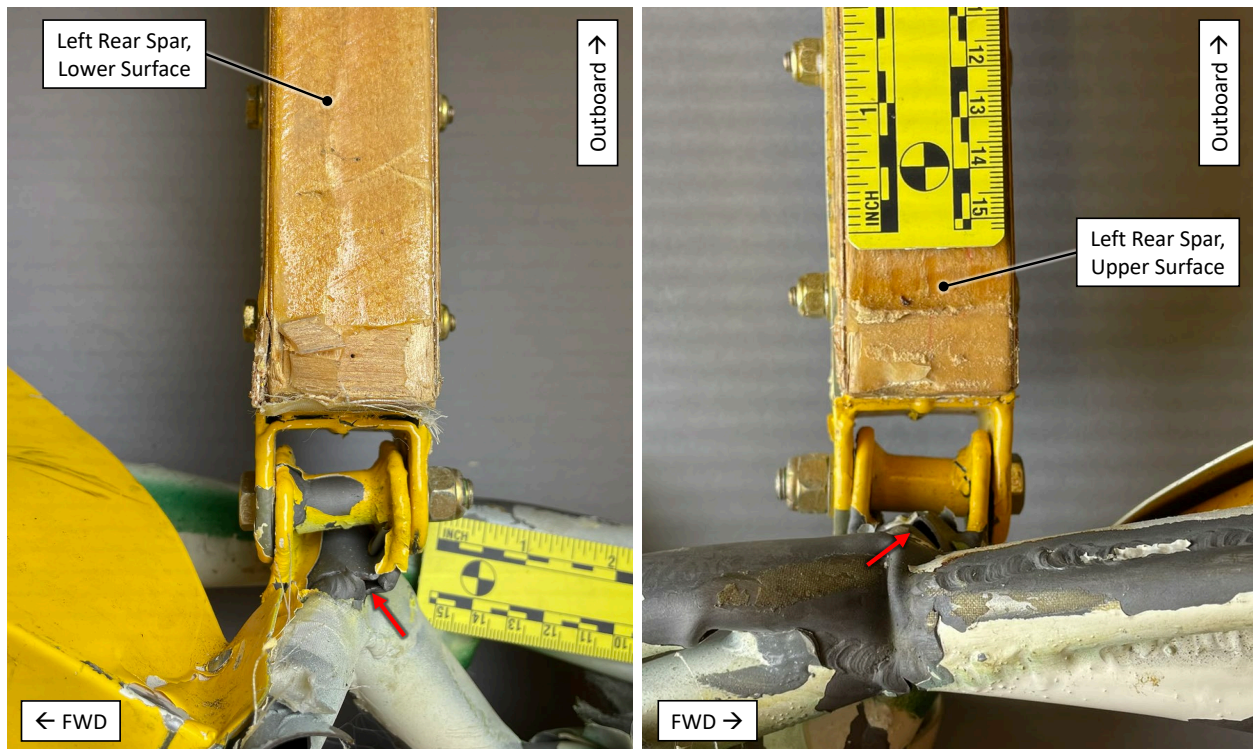
**Figure 10.** Photographs of the wing attachment bracket from the left rear wing spar still partially connected to the fuselage frame.

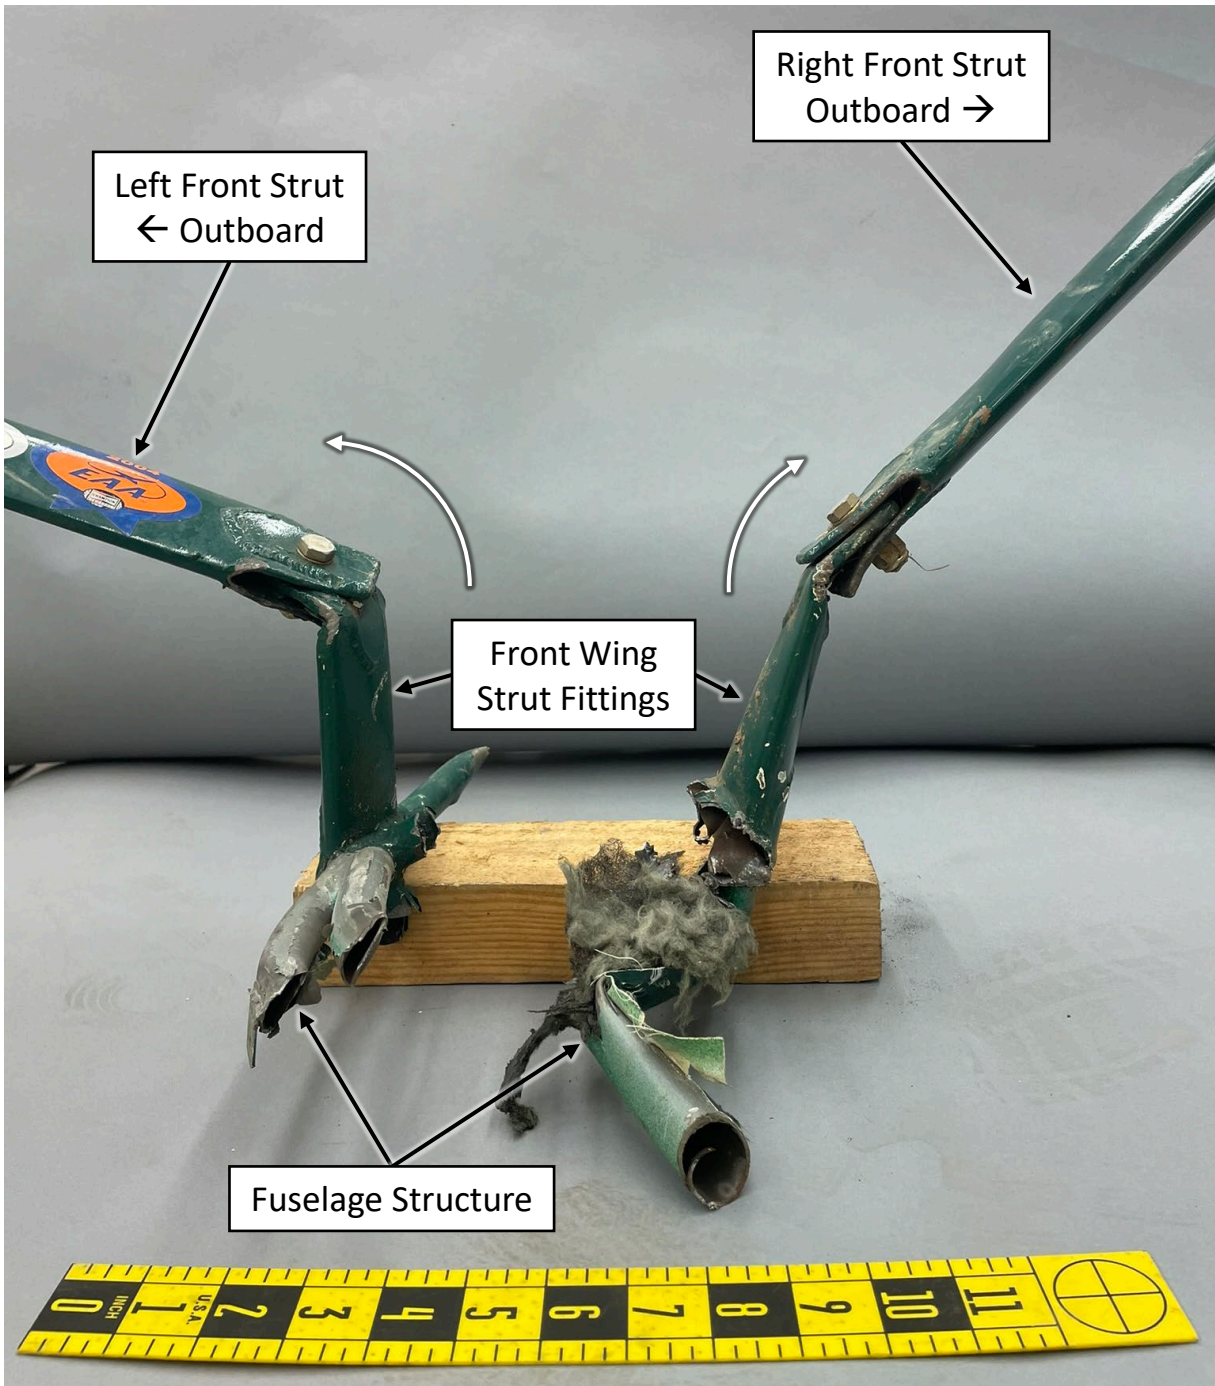
The inboard end of all four lift struts were still bolted to their respective wing strut fitting, which were all still partially attached to the fuselage structure in the main wreckage debris field. The inboard ends of the left and right front struts are shown looking forward in figure 11 and shows intact bolted connections between the struts and strut fittings and generally downward bending deformation at the connections. The front right strut was fractured approximately 41 inches away from the attachment point to the wing strut fitting as shown looking inboard in figure 12 (right). Shear lip features and deformation/buckling direction as indicated by white arrows were consistent with torsional overstress separation. A fractured wooden insert was observed inside the strut tube. The front left strut was fractured and deformed approximately 36.5 inches away from the attachment point to the wing strut fitting as shown looking inboard in figure 12 (left). The upper surface was compressed inward and the lower surface was buckled. Shear lip features and deformation direction as indicated by white arrows were consistent with predominantly upward bending and tensile overstress separation. The outboard piece of the front left strut was also buckled upward approximately 19.5 inches from the outboard fracture at the wing

**Figure 11.** Photographs of the front wing strut fittings.

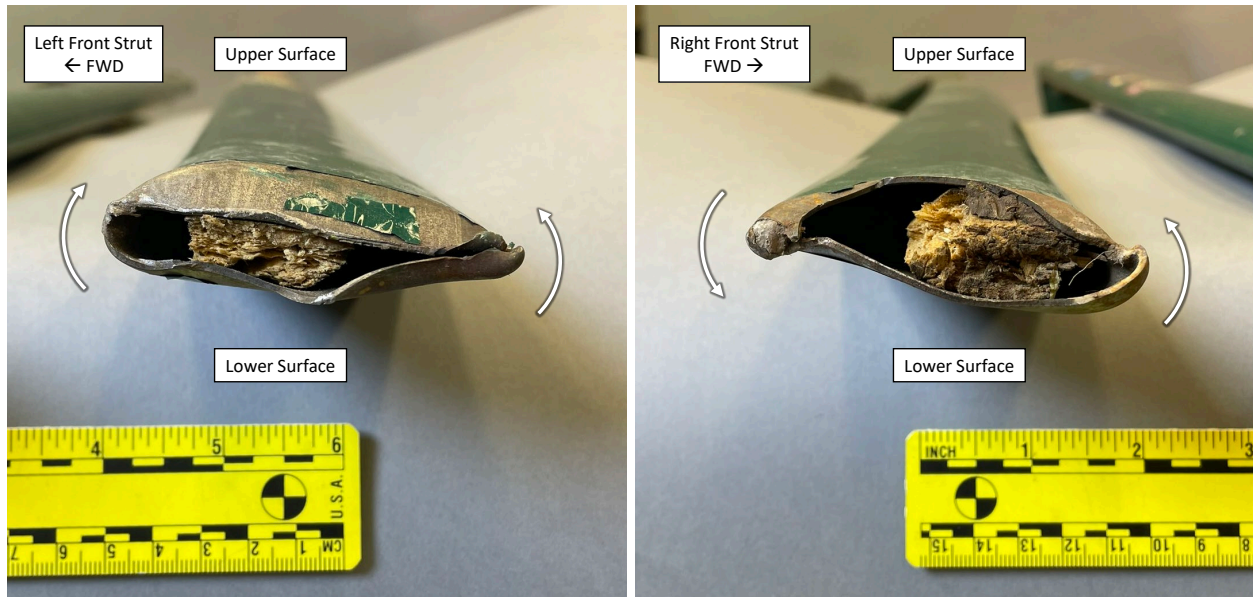
**Figure 12.** Photographs looking inboard along the front wing struts at the inboard fracture locations.

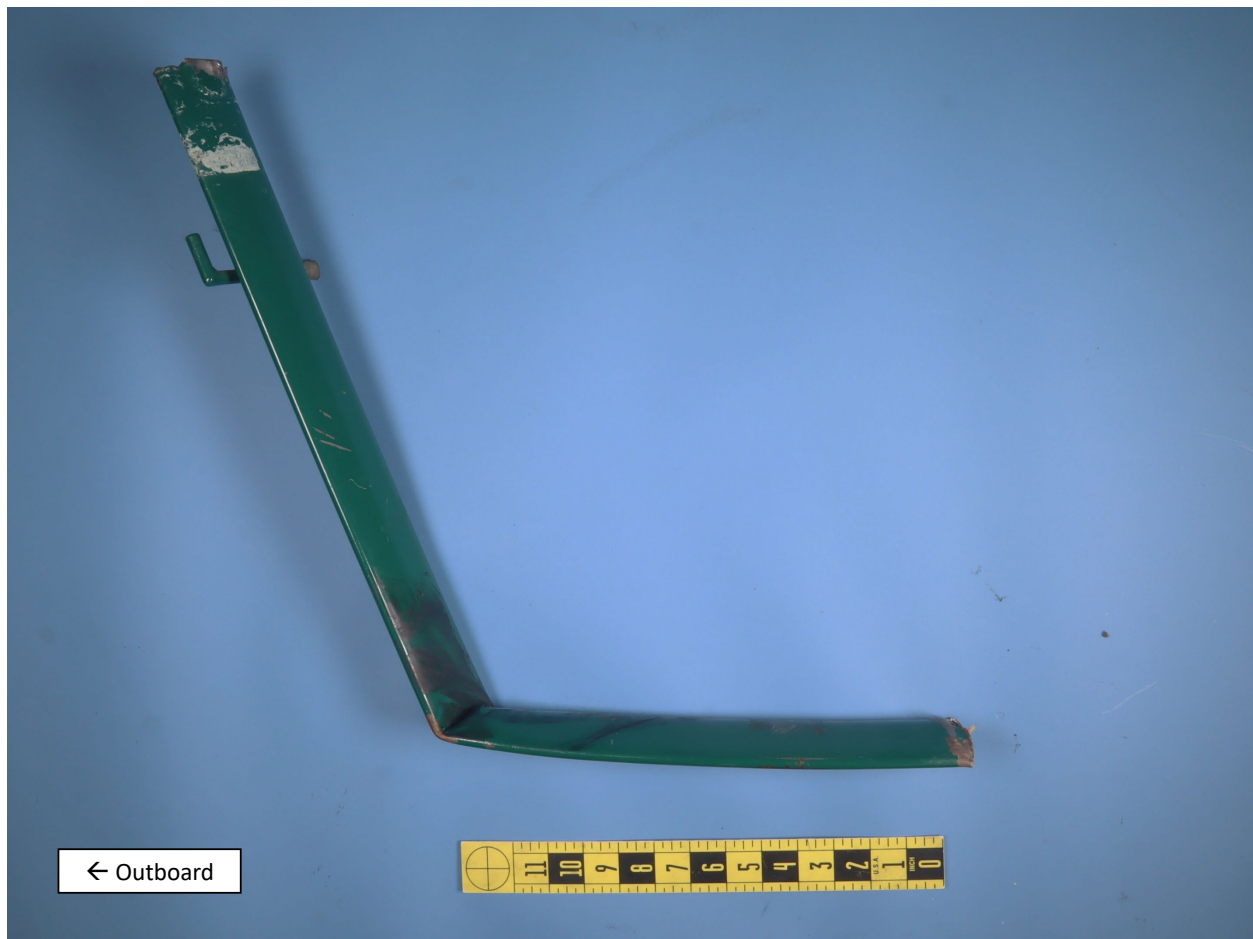
attachment fitting location as shown looking forward in figure 13. A waxy black material transfer mark was observed on the upper surface of the strut spanning the buckled area.

**Figure 13.** Photograph of the outboard end of the fractured left front wing strut. A black material transfer mark was observed on the upper surface spanning the region which was buckled upward.

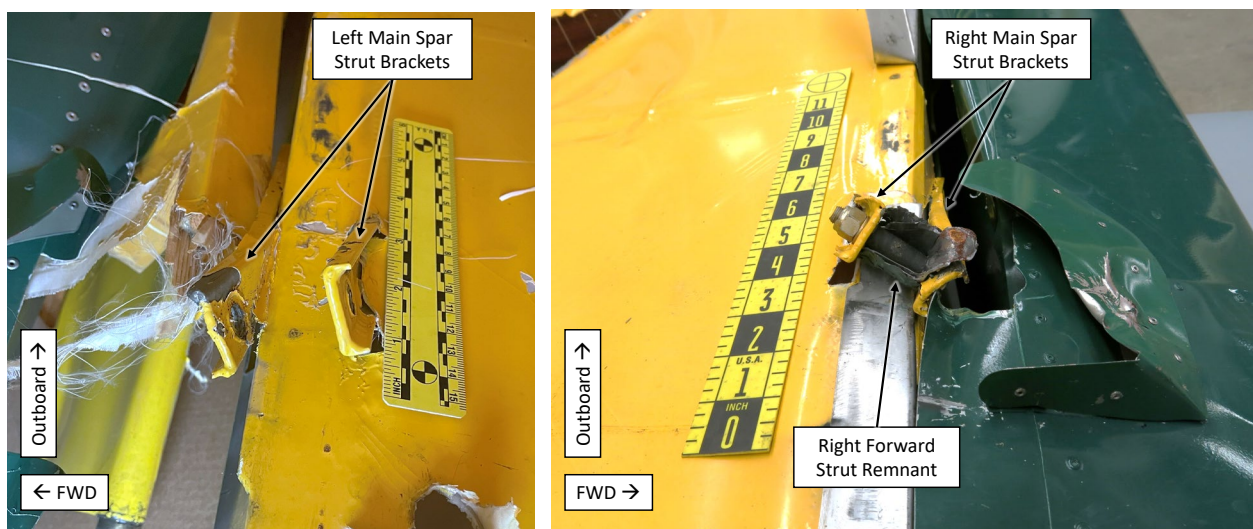
**Figure 14.** Photographs of the deformed front strut brackets on the underside of each wing.

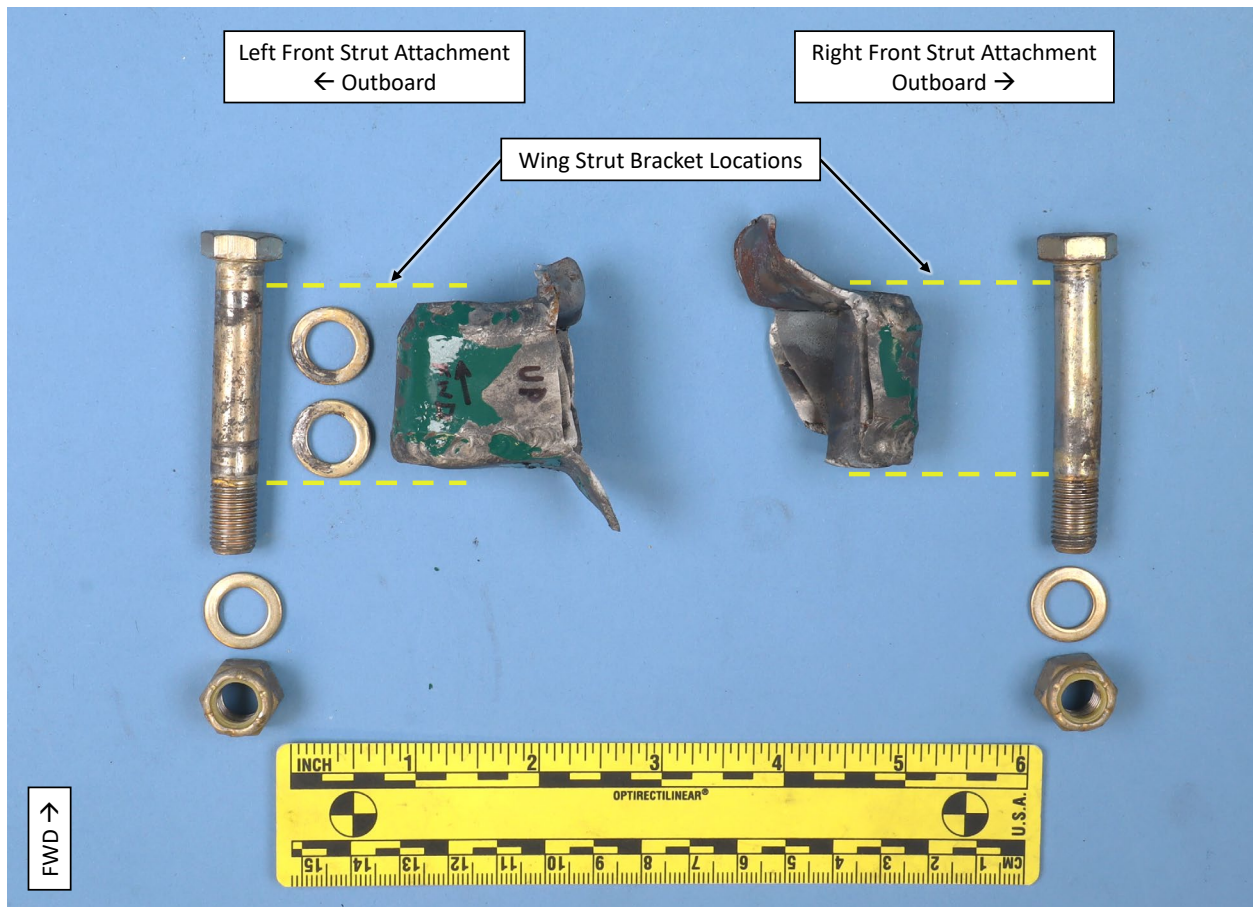
**Figure 15.** Photograph of the outboard ends of each fractured front strut and attachment hardware which was disassembled. Yellow dashed lines are representative of the strut bracket locations.

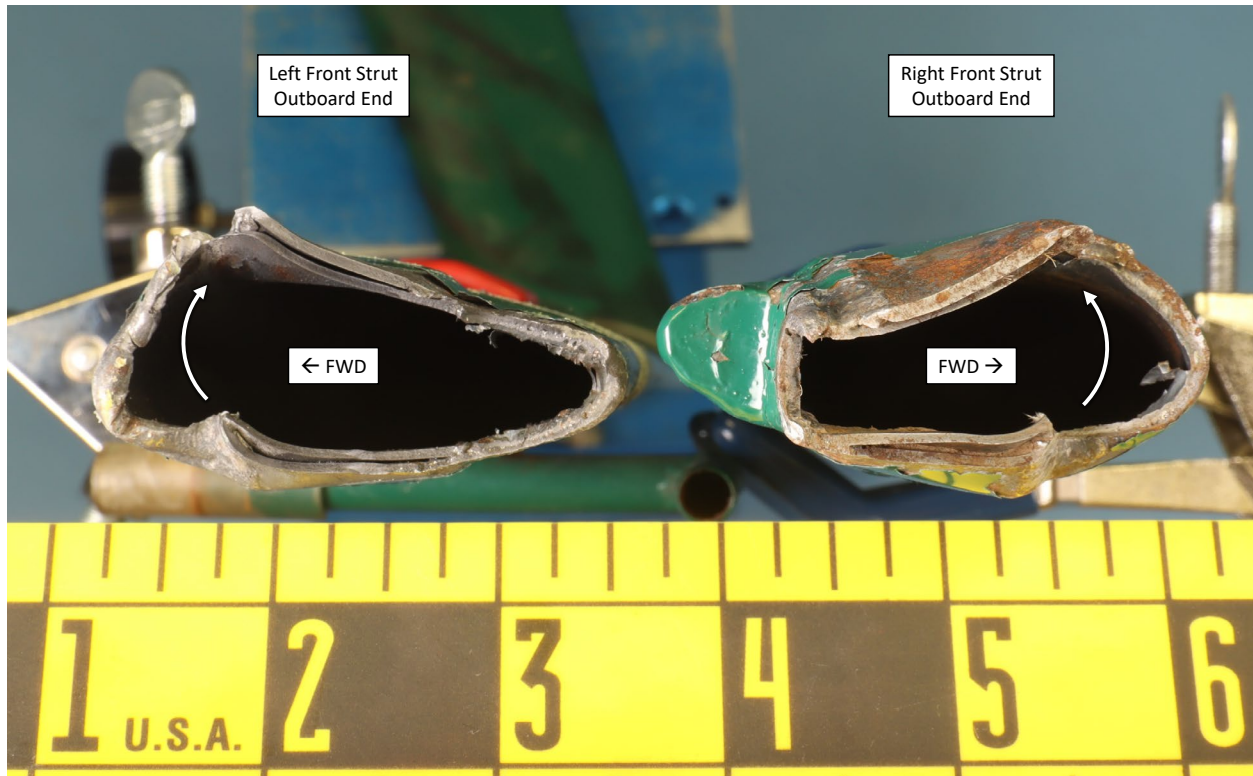
The front lift struts were also fractured at the attachment point to the main spar strut brackets. The portions of the front lift struts where the formed and welded end fittings were bolted to the wing strut brackets were retained by the main spar wing strut brackets at the wing debris site. The wing strut brackets were still bolted through the main spars. Figure 14 shows the left and right main spar strut brackets on the underside of the respective wing. The right forward strut remnant is shown as retained by the strut brackets and the left strut remnant had been disassembled in this image for closer examination. and the left forward strut remnant removed for closer examination. The main spar strut brackets were deformed in a manner consistent with wing nose-up torsional loading prior to strut separation. The fractured pieces of both front struts retained by the wing strut brackets are shown after disassembly with the associated attachment hardware in figure 15. Representative locations of the wing strut brackets are indicated by yellow dashed lines. The left front strut attachment measured approximately 1.25 inches wide between the wing strut brackets and the right front strut attachment measured approximately 1.35 inches wide. The engineering drawing specified a width of 1-3/8 (1.375) inches at this location. Two washers, each approximately 0.062 inch thick, were observed between the left front wing strut brackets and the strut upon disassembly as shown in figure 15. The mating fracture surfaces of the forward struts are shown in figure 16. Shear lip features were observed along the fractured strut and welded patch and were deformed in the direction indicated by the white arrows. Separation was consistent with torsional overstress.

**Figure 16.** Photograph showing the mating fracture surfaces of the front struts shown in the previous figure.

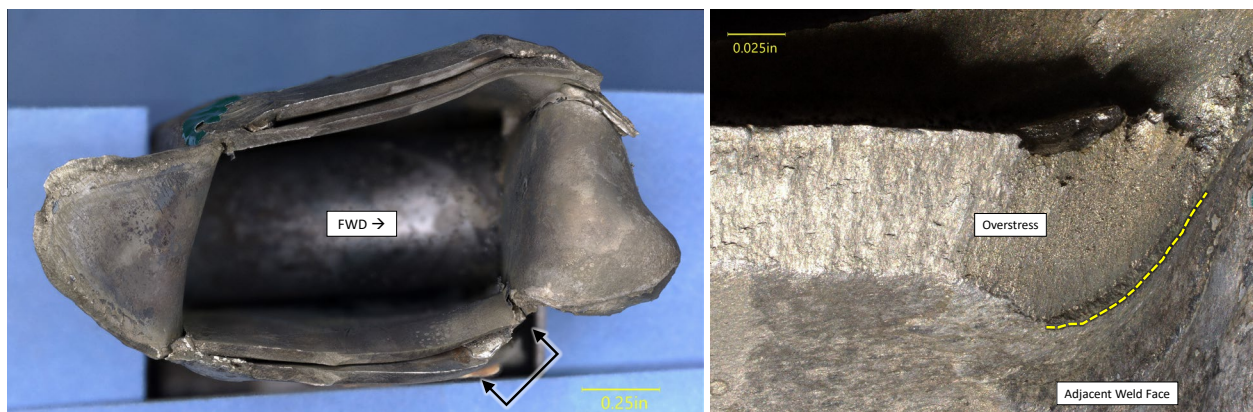
The outboard end of the fractured left front strut was examined more closely as shown looking outboard in figure 17. The bracketed area is shown more closely in the right image. A relatively flat crack was observed extending through the weld from the weld face in the area indicated by the yellow dashed line. Scanning electron microscope (SEM) images of this region are shown in figure 18 with the flat crack region bounded by yellow dashed lines. Above this region, dimpled fracture features were observed, consistent with overstress separation. A closer view of the flatter fracture region is shown in the right image. Faint fracture features which resembled fatigue striations were observed at higher magnification and are oriented horizontally in this image, typical examples indicated by yellow arrows, and the general direction of fracture from bottom to top.

**Figure 17.** Digital microscope images of the left front strut fracture location near the strut bracket connection. A closer view of the bracketed region is shown on the right. A relatively flat crack was observed extending through the weld from the weld face in the area indicated by the yellow dashed line.

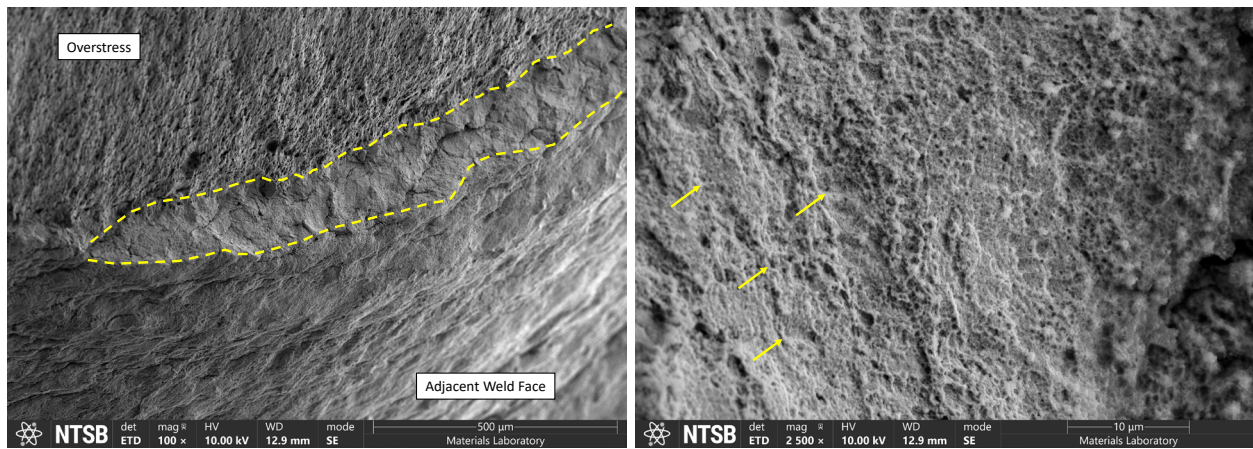
**Figure 18.** Scanning electron microscope images of the relatively flat fracture region identified in the previous figure. Faint horizontal features resembling fatigue striations are indicated by yellow arrows with the crack growth direction from bottom to top in this image.

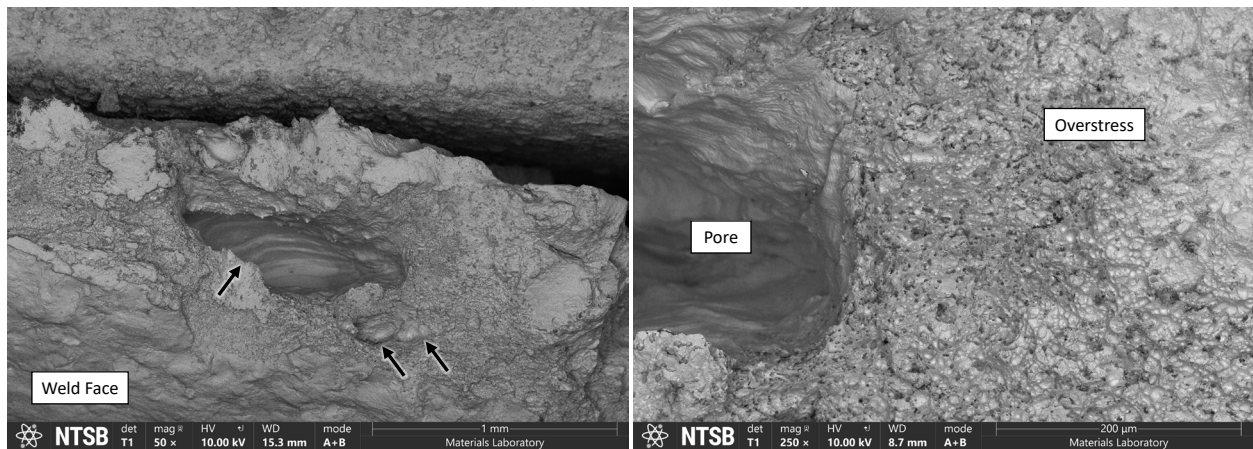
Figure 19 shows SEM images of the fractured welds near the outboard end of the left lift strut. Some weld porosity was observed as indicated by black arrows in the left image with the largest observed pore being approximately 0.04 inch by 0.02 inch. Fractured weld material adjacent to the pores exhibited dimpled fracture features consistent with overstress separation.

**Figure 19.** Scanning electron microscope images of fractured weld material from the left front strut fracture surface near the strut bracket connection showing weld porosity.

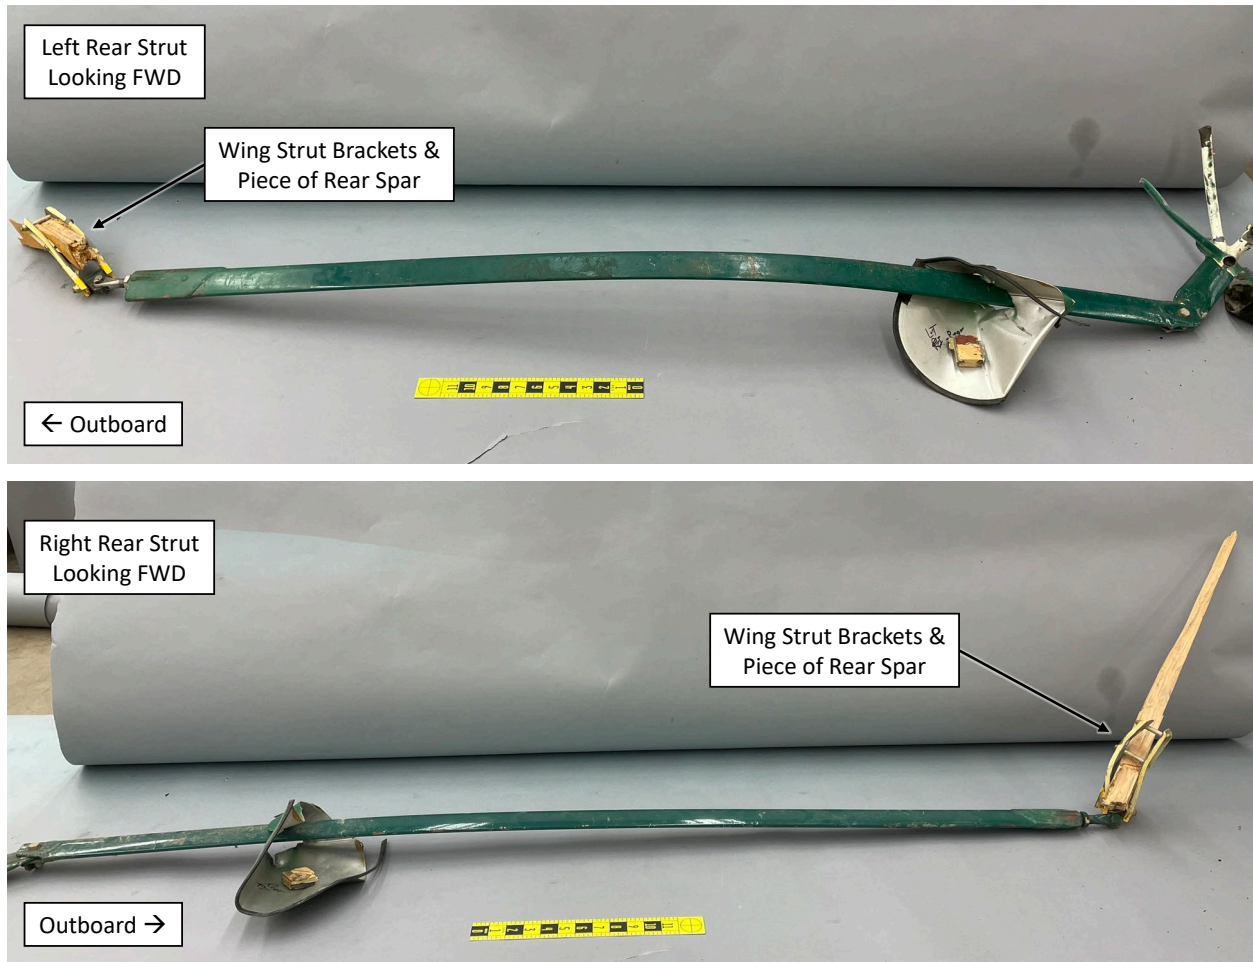
The rear lift struts were generally bent downward along the span as shown in figure 20, with a greater degree of bending deformation observed on the left rear strut. The rear struts were still attached to their respective wing strut brackets with pieces of the fractured rear spar retained between the brackets as shown more closely in figure 21. The bolts which secured the brackets to the rear spars were retained by the brackets. The rear wing strut brackets were deformed in a manner consistent with aft bending loading prior to spar fracture. Figure 22 shows the forward facing rear wing strut brackets at the location where the compression strut attached. Local deformation of the bracket was observed in the areas indicated as well as separated, torn, and deformed material consistent with ductile tensile overstress separation of the compression strut from the strut brackets.

**Figure 20.** Photographs of the rear strut brackets as viewed looking forward showing generally downward bending deformation.

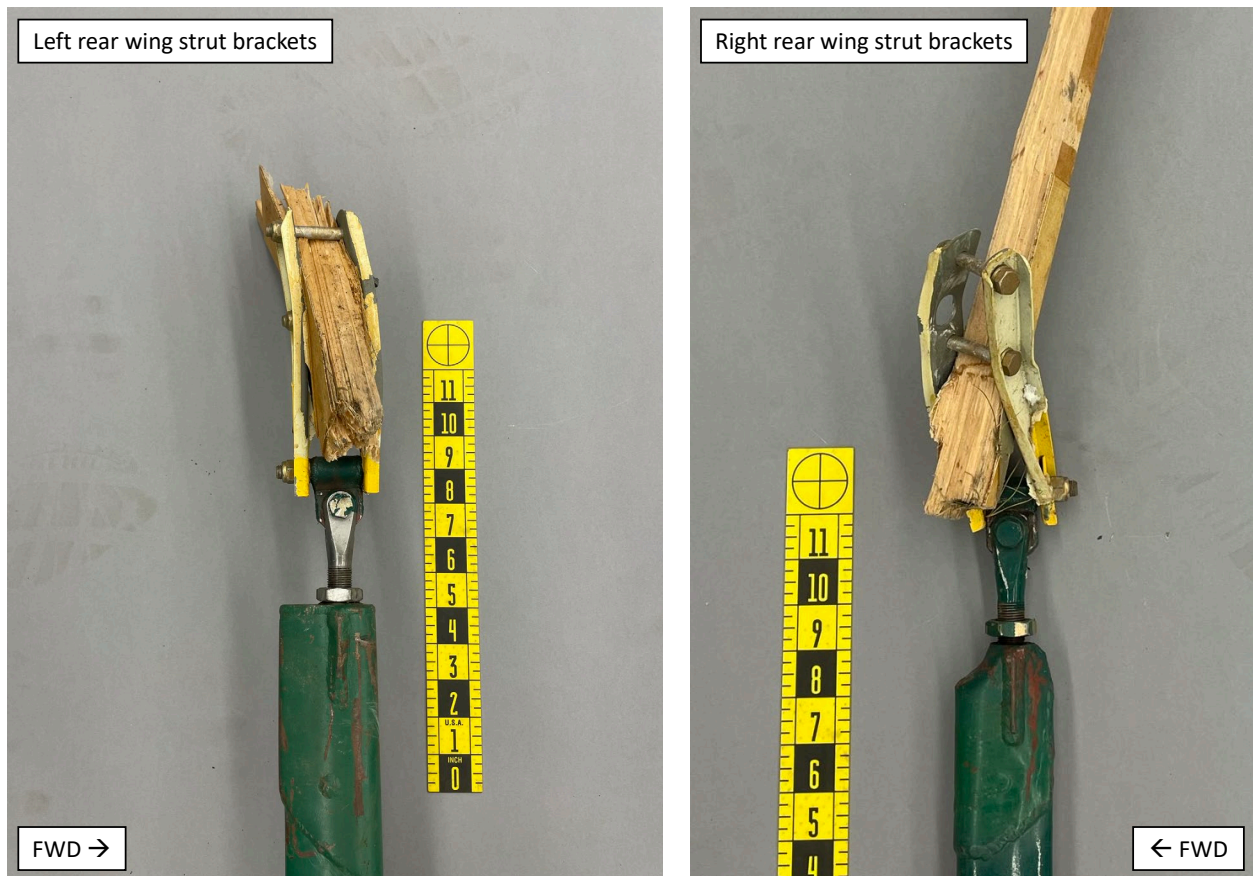
**Figure 21.** Photographs of the rear strut brackets as viewed looking down showing torsional bending deformation and pieces of retained rear spar.
