# National Transportation Safety Board

CEN23FA204

## **MATERIALS LABORATORY**

Factual Report 23-077

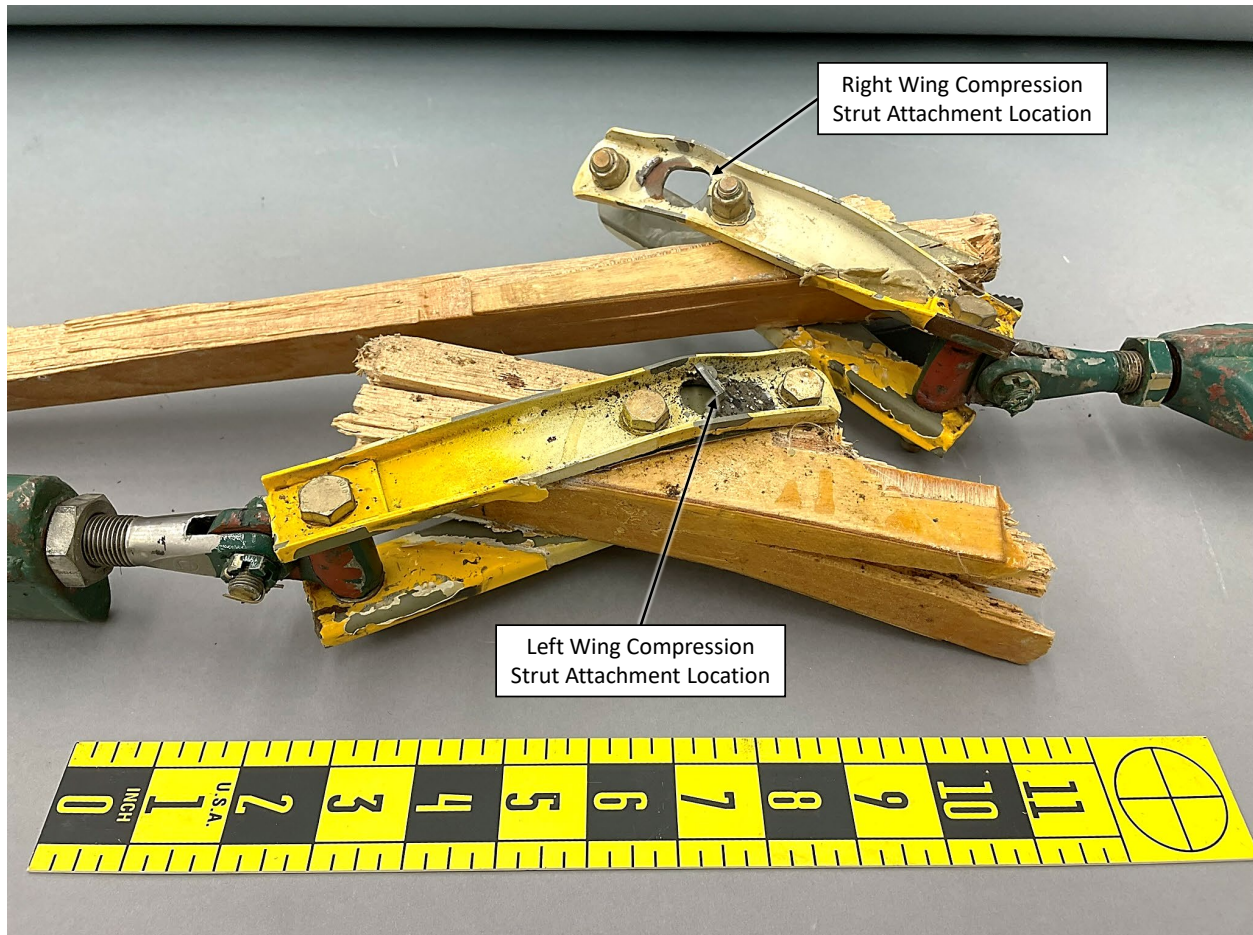
**Figure 22.** Photograph of the forward sides of the rear strut brackets with compression strut attachment locations identified where local deformation and separated/torn material was observed.

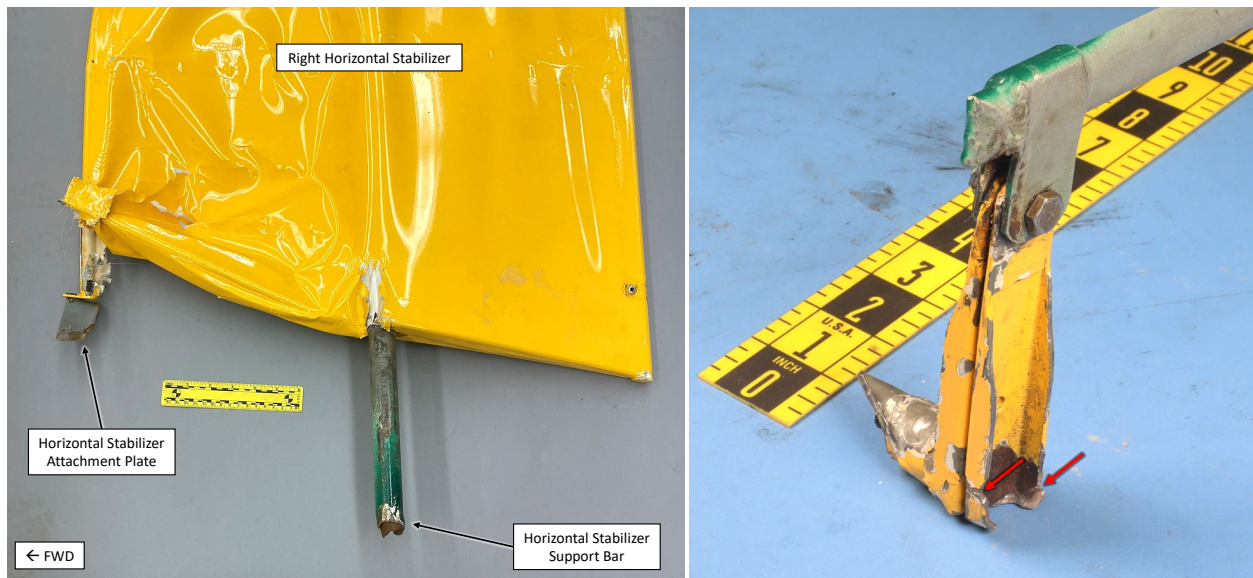
The right horizontal stabilizer was reportedly found at a location between the wing wreckage and the main wreckage debris fields. The right horizontal stabilizer support bar was fractured approximately 8.5 inches from the inboard edge of the horizontal stabilizer as shown in the left image of figure 23. The fractured end of the bar was bent slightly aft and downward, and the fracture surface exhibited shear lip features, consistent with bending or torsional loading and tensile overstress separation of steel tubular structures. The forward end of the horizontal stabilizer attached to a bracket which was welded to the steel frame. A portion of the bracket was retained by the right horizontal stabilizer and was deformed away from the inboard side of horizontal stabilizer. The right elevator remained attached to the horizontal stabilizer and was fractured at the connection to the elevator horn, shown in the right image. Secondary cracks were observed where the elevator tube attached to the elevator horn as indicated by red arrows.

**Figure 23.** Photographs of the separated right horizontal stabilizer (left) and fractured right elevator horn attachment location (right).

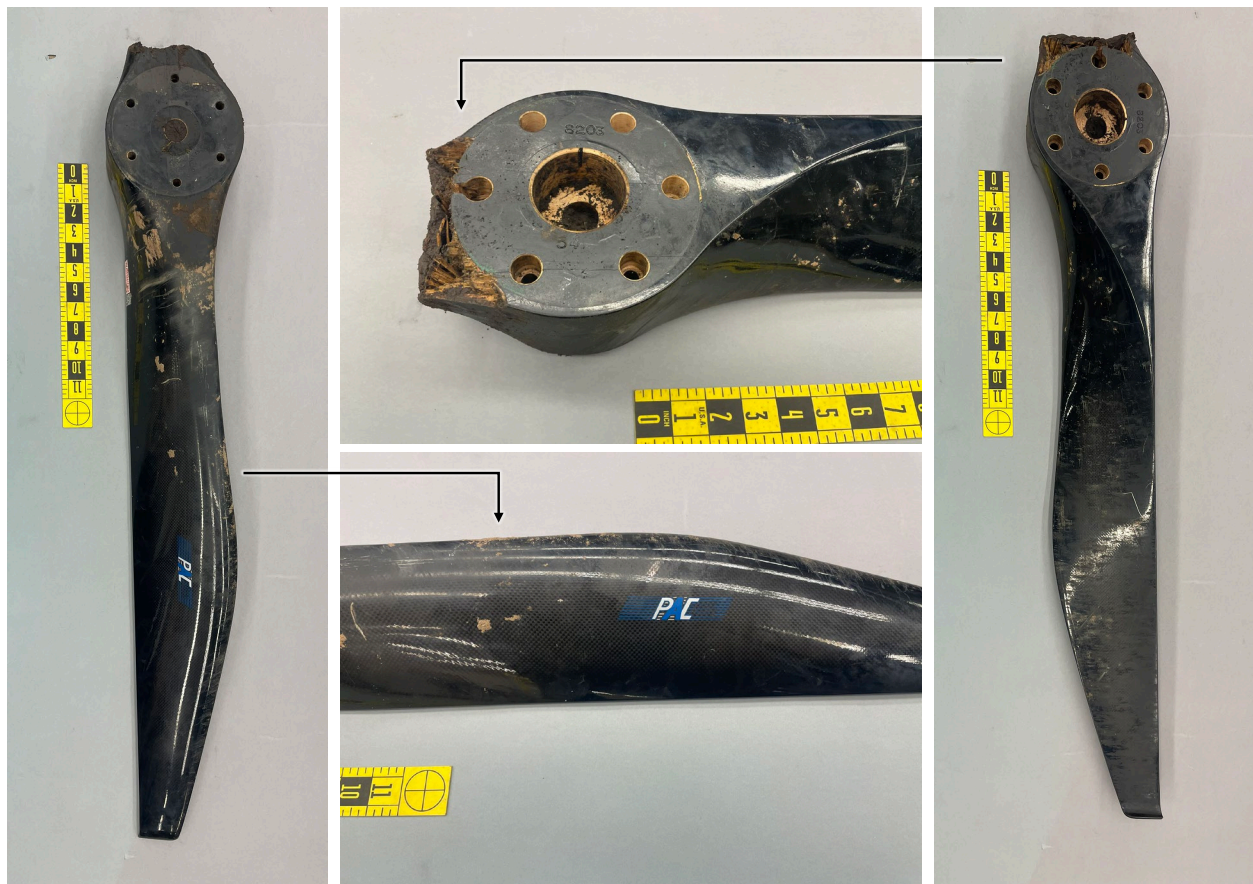
One blade of the recovered propeller was fractured near the hub as shown from the forward and aft sides in figure 24. The logo for Prince Aircraft Company (Whitehouse, Ohio) was observed on one side of the intact blade and the construction was consistent with a wooden core with a woven carbon fiber reinforced polymeric outer layer. The numbers "8203" and "54" were molded into the hub as shown in the upper central image. The distance from the center of the hub to the end of the intact blade was approximately 35 inches, consistent with a 70-inch propeller diameter. The engineering drawing specified a 66-55 propeller with a O-200 (100 horsepower) engine model.

**Figure 24.** Photographs of the fractured propeller.
