CEN23FA220

## INVESTIGATION PHOTOGRAPHS

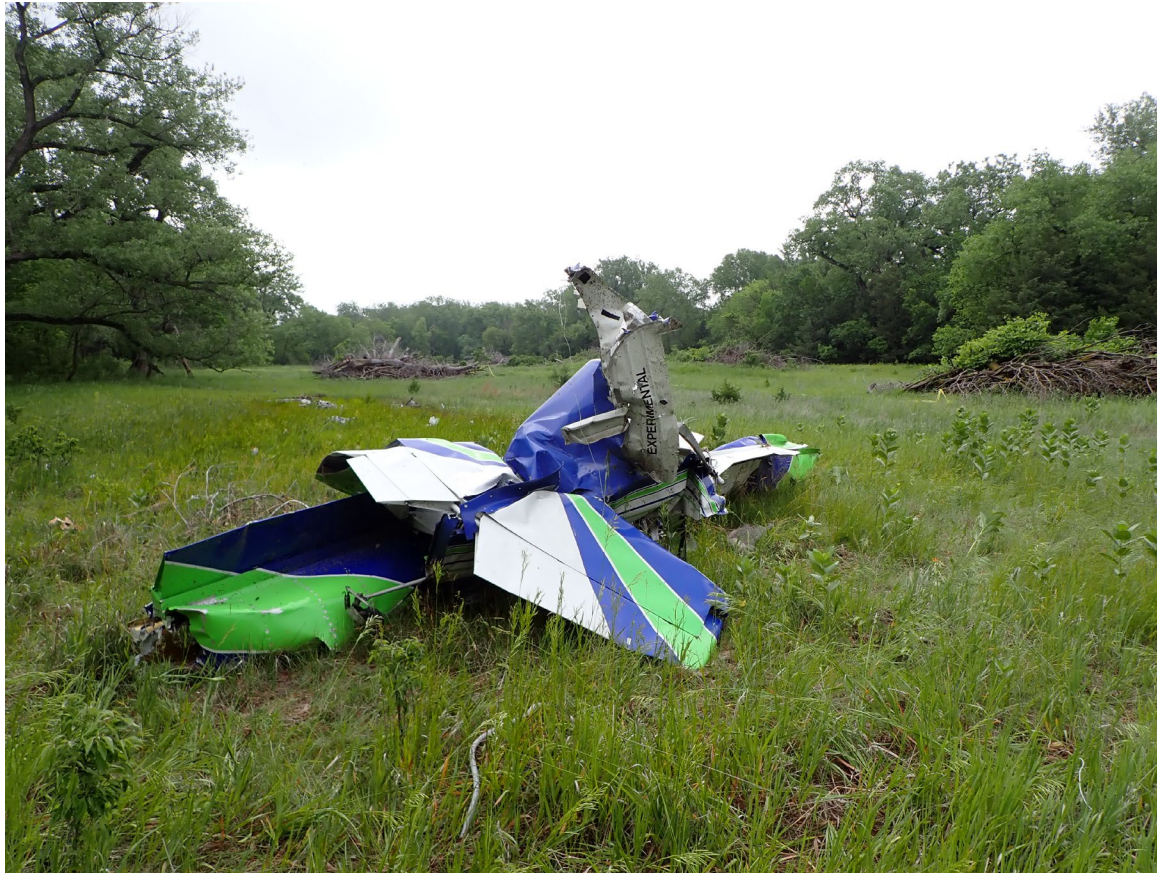
**Photograph 1 - Main wreckage**

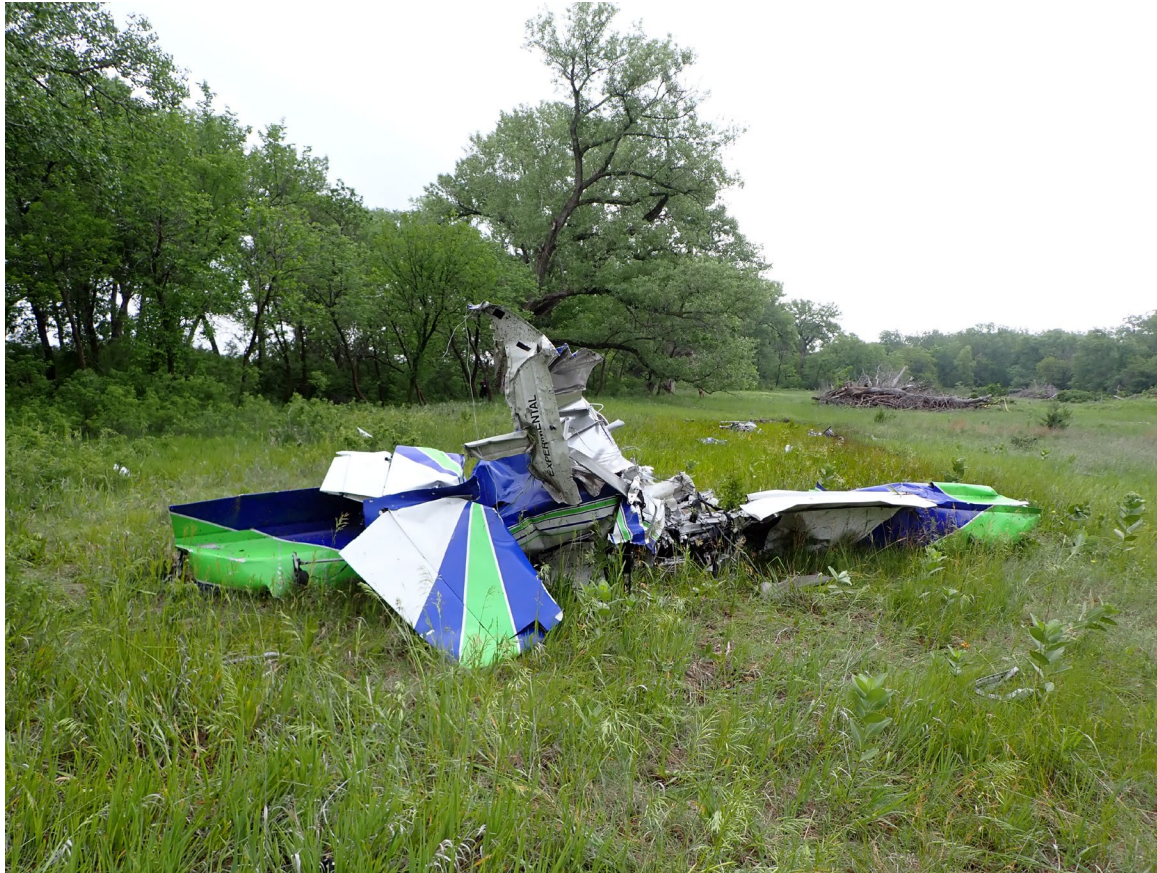
**Photograph 2 - Main wreckage**

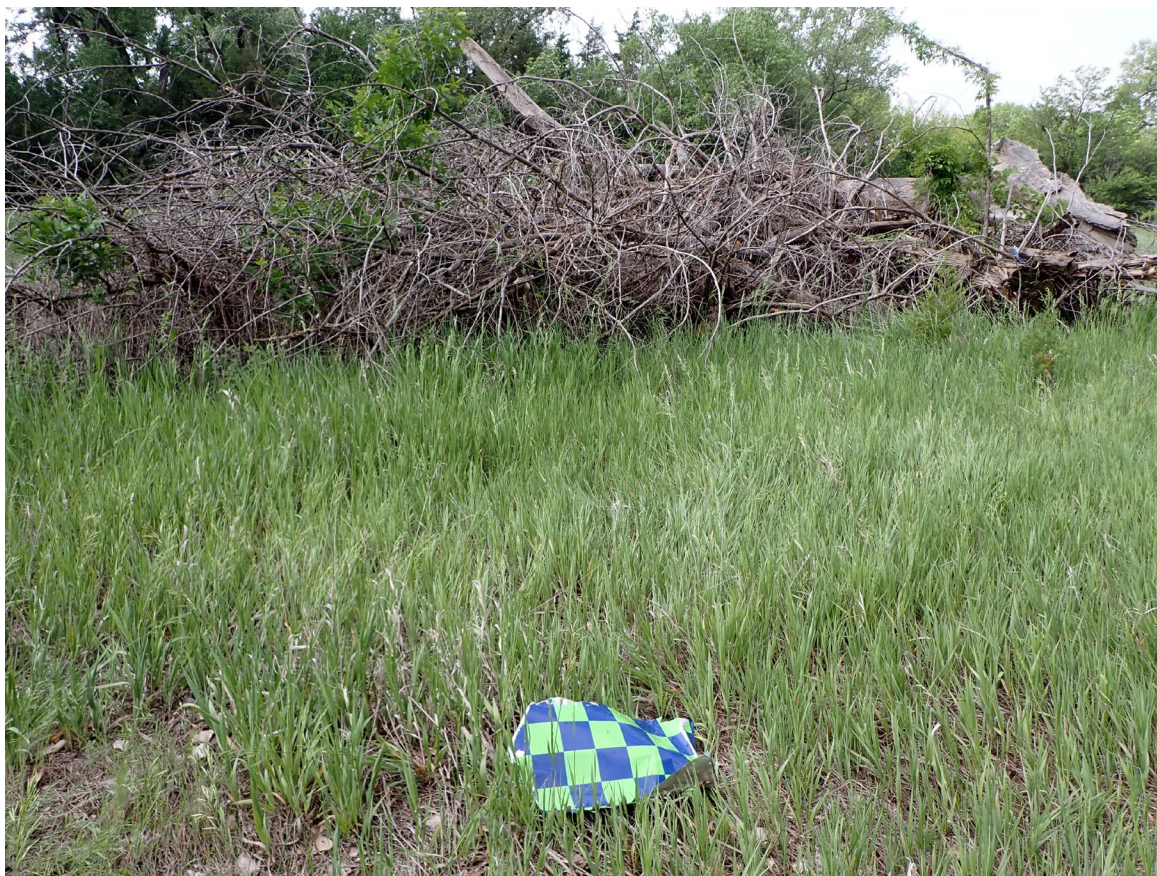
**Photograph 3 - Piece of rudder found before impact site**

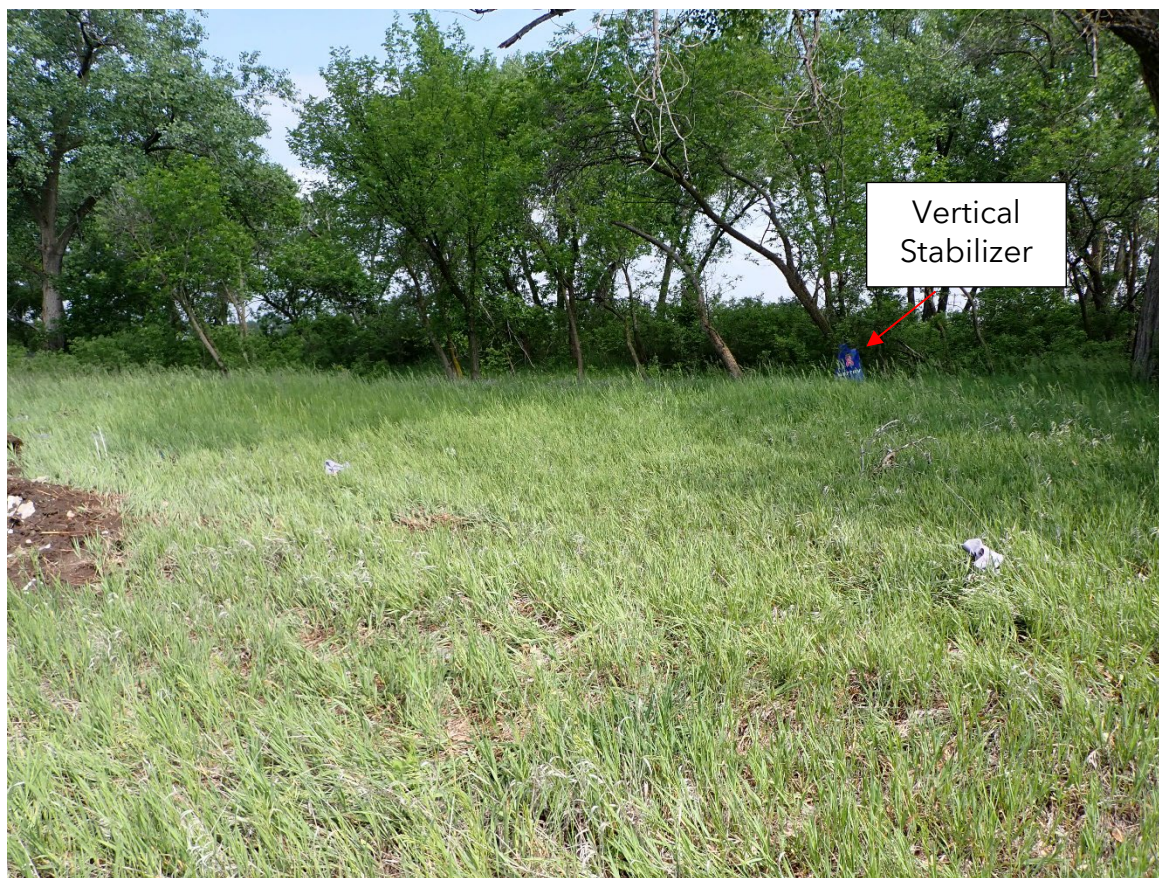
**Photograph 4 - Vertical stabilizer found under tree**

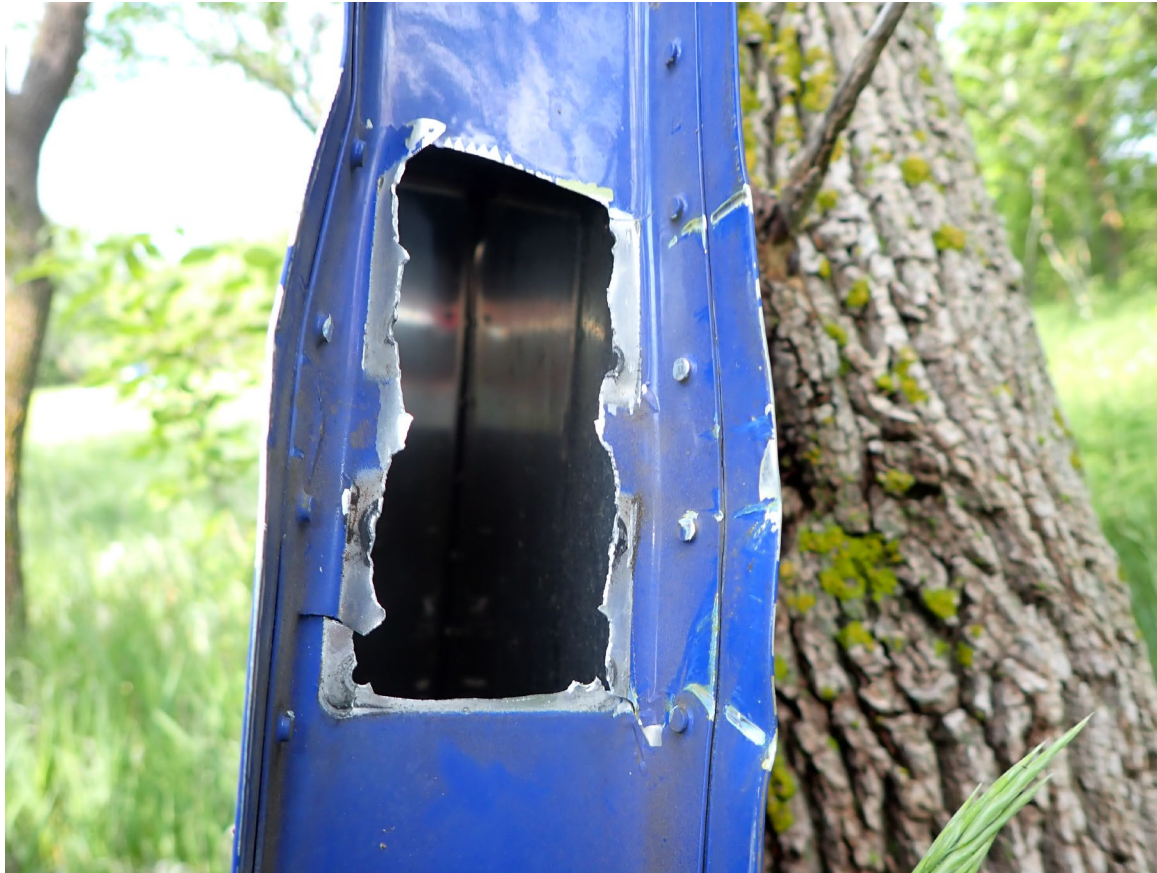
**Photograph 5 - Vertical stabilizer where rudder hinge was torn away**

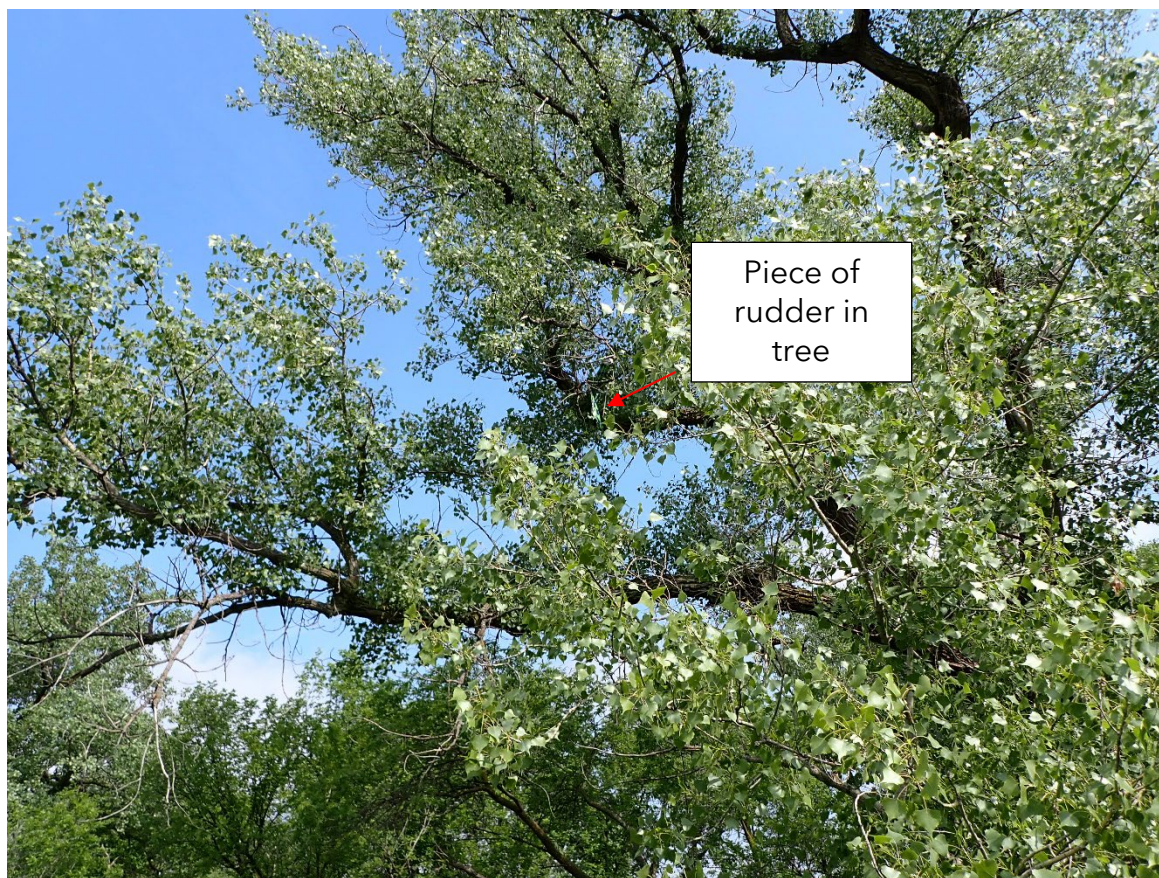
**Photograph 6 - Piece of rudder in the tree**

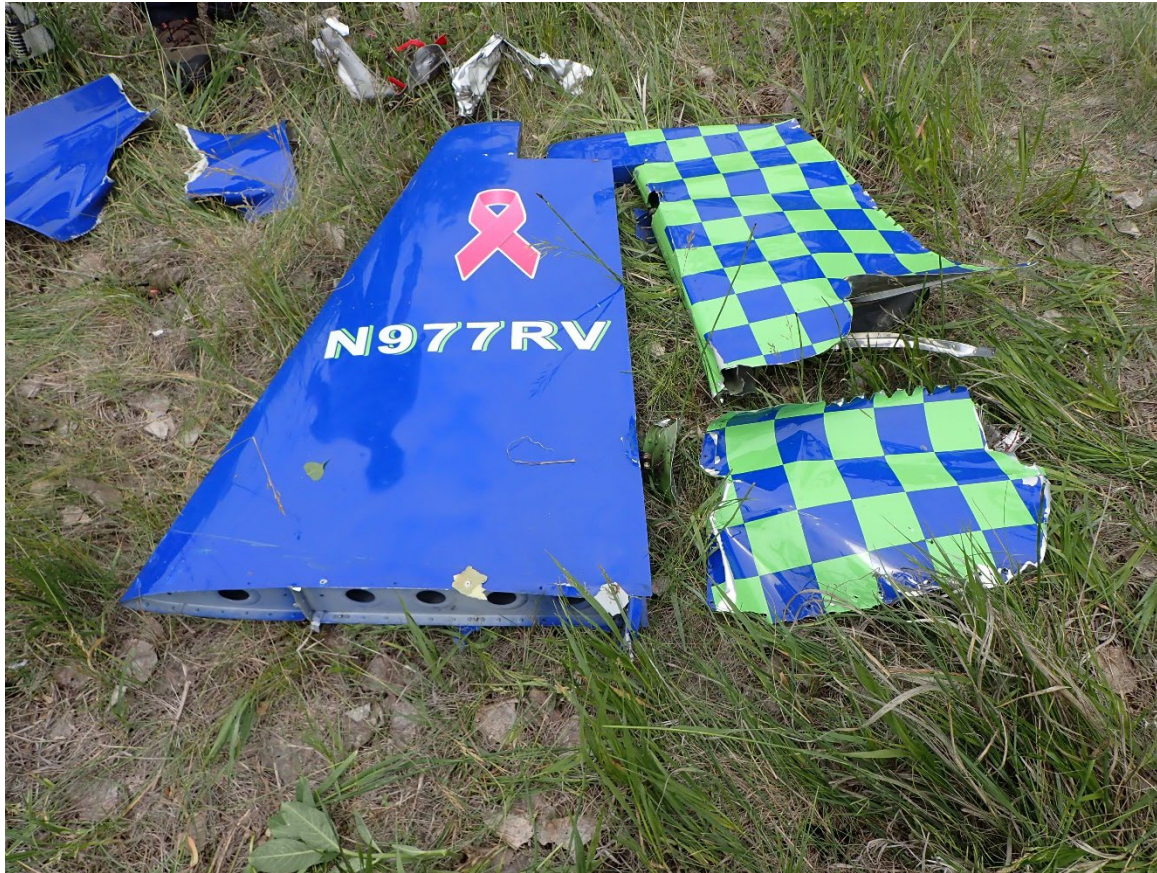
**Photograph 7 - Vertical stabilizer and rudder**
