# National Transportation Safety Board

CEN23FA239

## **WRECKAGE EXAMINATION SUMMARY**

Location: Watertown, Wisconsin  
Date: June 14, 2023  
Time: 0903 central daylight time  
Airplane: Mooney M20R, Registration No. N1025C

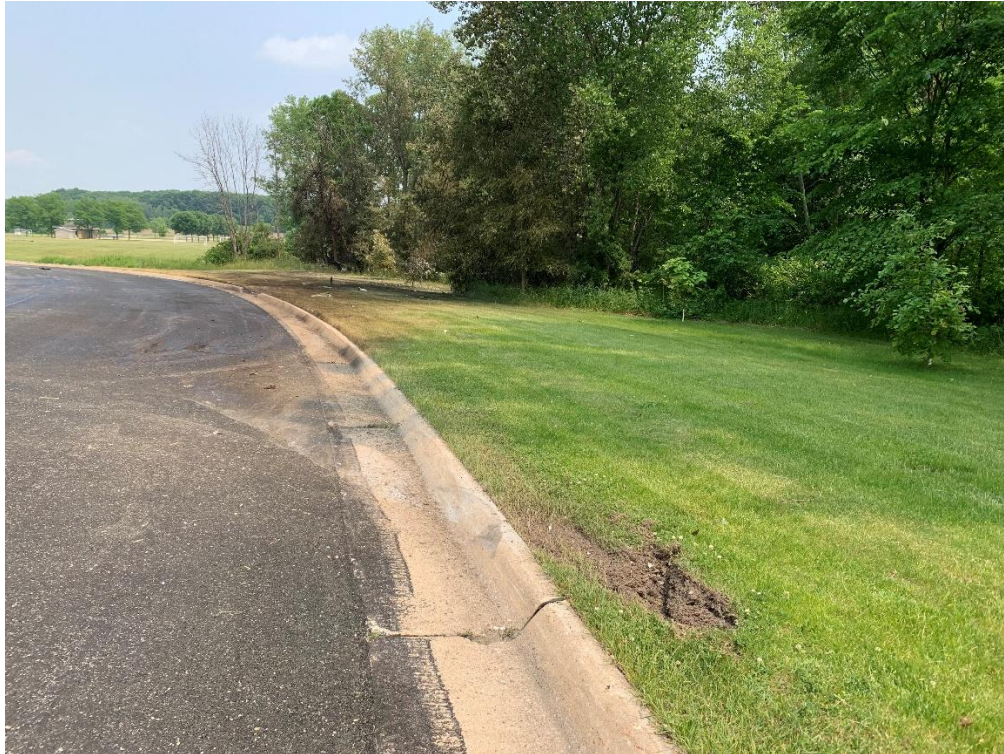
The accident site was surveyed with a GPS before the wreckage was recovered. The initial impact point was a concrete curb and asphalt road in Brandt-Quirk Park, as shown in figure 1. The local police department used a total station to identify the initial impact point as 43.2082471° North Latitude, 88.7489094° West Longitude, and 857.7 ft msl. The Google Earth application indicated that the elevation of the initial impact location was 853 ft msl. The wreckage energy/debris path projected to the east. The initial impact included multiple propeller strike gouges and linear scratches in the asphalt road, as shown in figure 2. The main wreckage was in a wooded area situated along a creek about 260 ft from the initial impact point, as shown in figure 3. Additional debris, including but not limited to the engine and both main landing gear wheels/tires, were found in a grass soccer field east of the main wreckage. The furthest wreckage was recovered about 739 ft east of the initial impact point.

**Figure 1.** Initial impact location at concrete curb and asphalt road

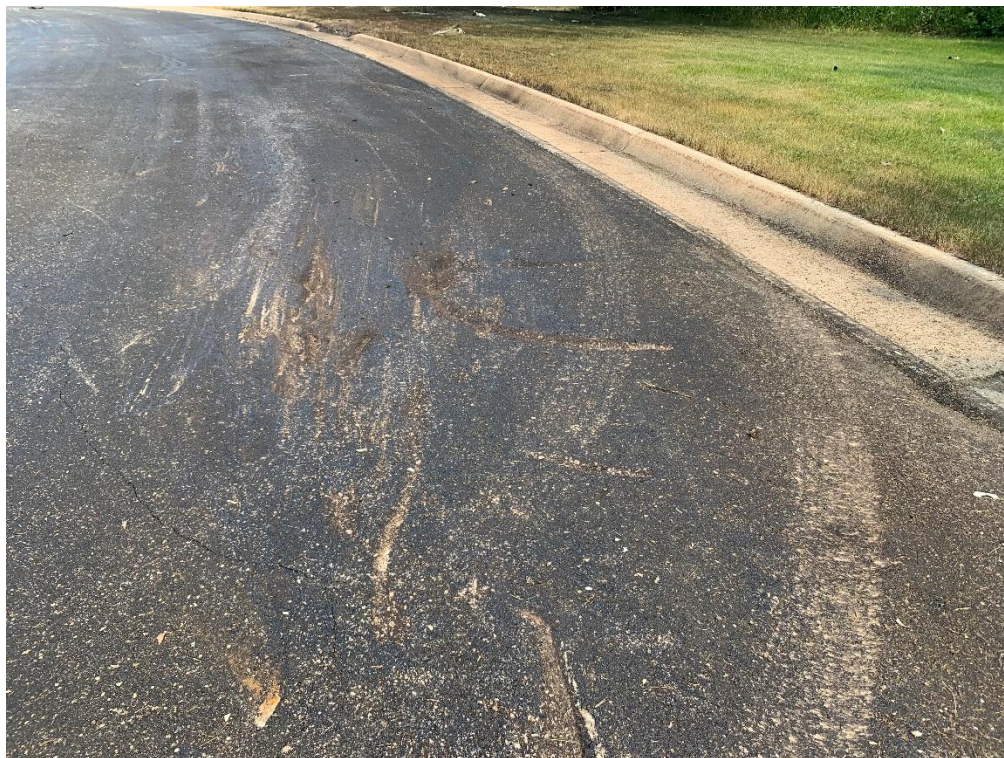
**Figure 2.** Airplane impact with road and propeller slash marks

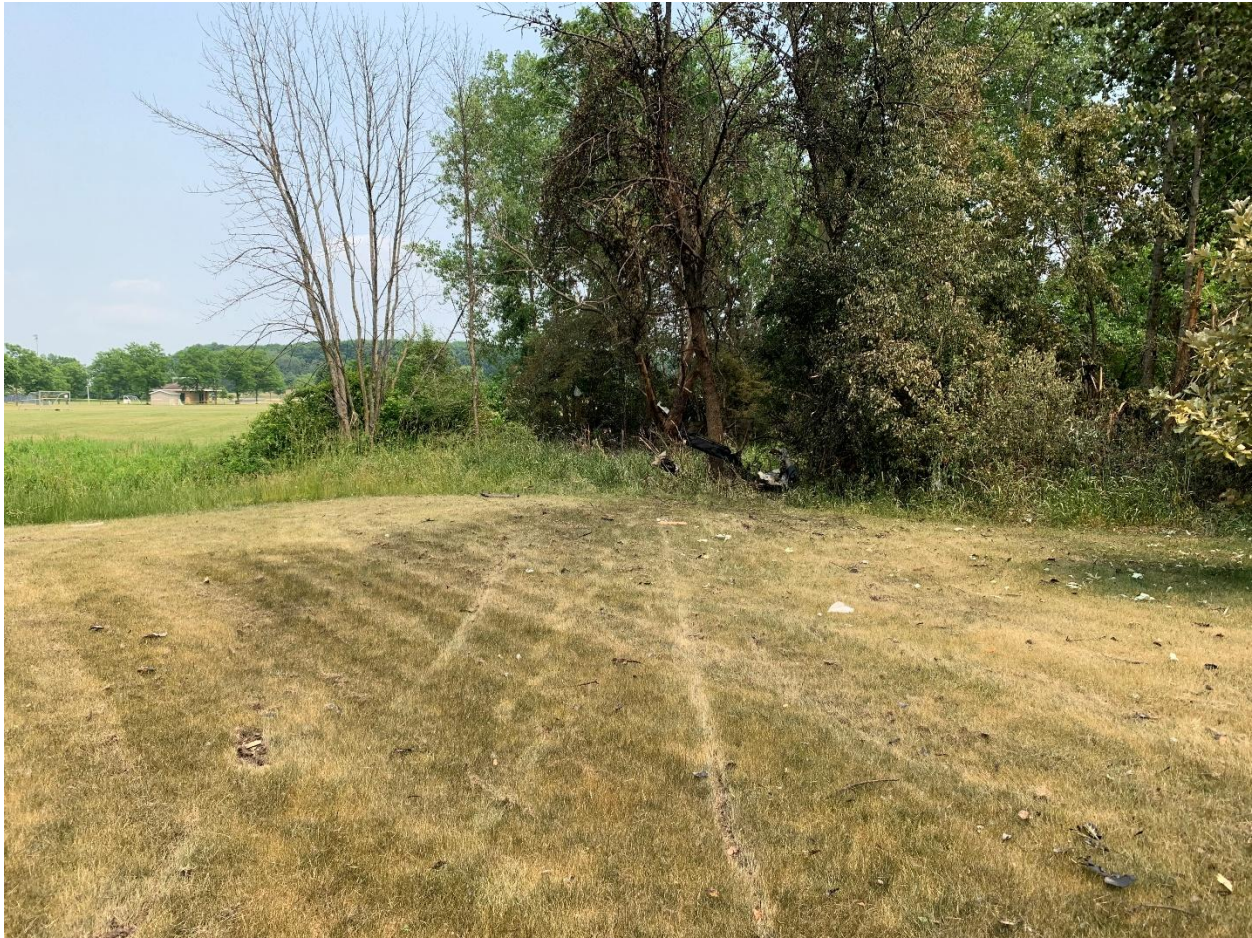
**Figure 3.** Airplane wreckage debris trajectory toward wooded area

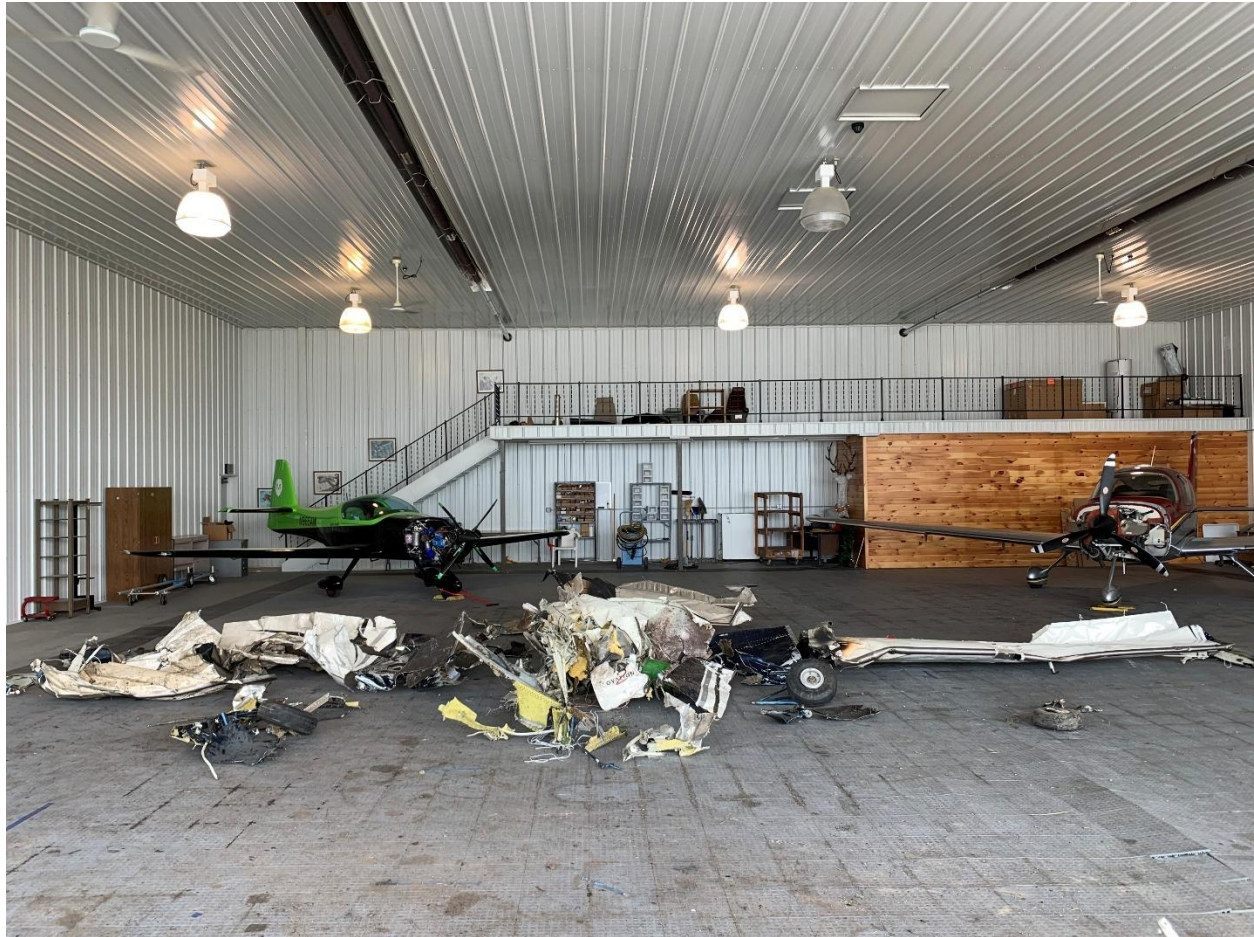
A wreckage layout confirmed that all major structural components were accounted for at the accident site, as shown in figure 4. The airframe, cabin, cockpit, and right wing fragmented during impact. The forward fuselage tubular structure was highly fragmented, as shown in figure 5. The ailerons, flaps, rudder, elevator, and speed brakes were identified. Flight control continuity could not be confirmed due to extensive impact-related damage. The recovered flight control push-pull tubes were highly segmented and exhibited overstress features that were consistent with impact-related damage. The left wing remained intact and relatively undamaged, as shown in figure 6. The left aileron remained attached to the left wing. The left flap was found in multiple pieces, but the entire span was identified. The right wing structure was highly fragmented, as shown in figure 7. The entire right flap separated from the right wing. The right aileron separated from the wing and was found in two pieces. Both horizontal stabilizers exhibited impact-related damage with leading edge crushing, as shown in figure 8. The left elevator remained attached to the left stabilizer. The right elevator separated from the right horizontal stabilizer and was found in two pieces. The vertical stabilizer and rudder were relatively undamaged. The rudder

**Figure 4.** Airplane wreckage layout in a hangar

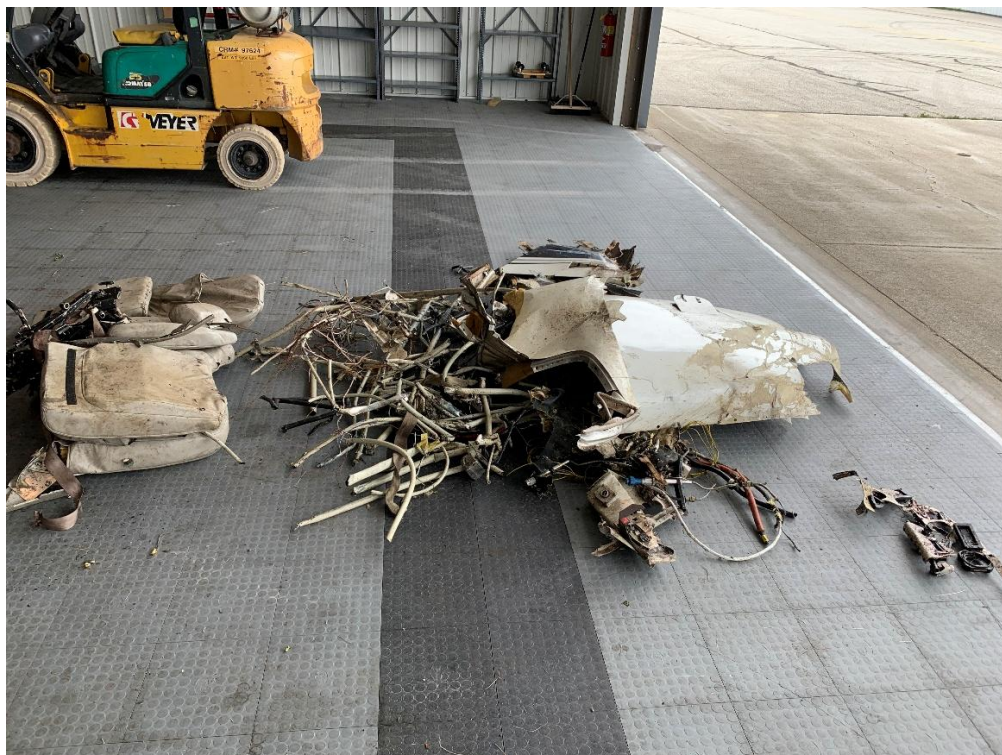
**Figure 5.** Forward fuselage of the airplane

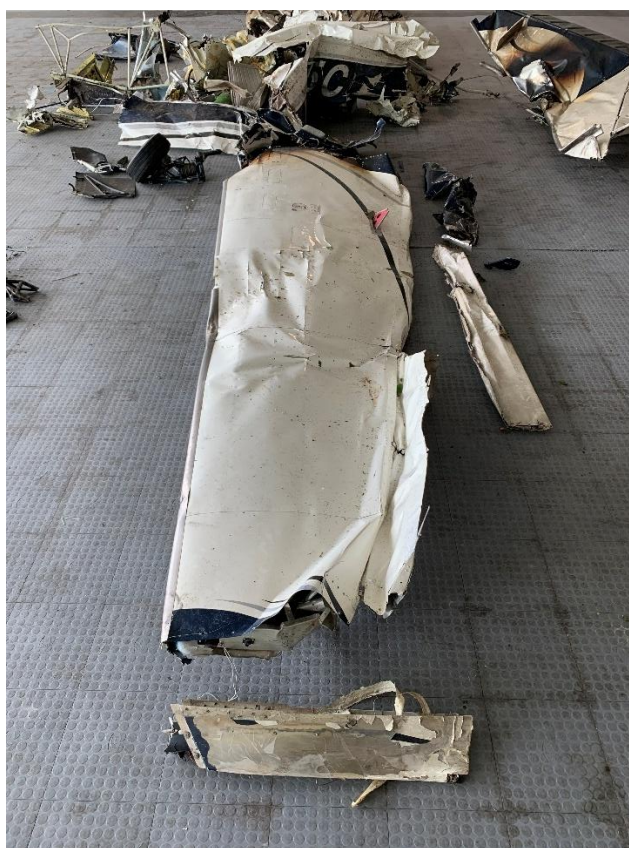
Most of the airplane wreckage was in a wooded area on the east side of the creek. The left wing separated from the fuselage near the wing root and was found relatively intact. The highly fragmented components of the cabin, cockpit, seats, aft fuselage, empennage, and right wing were found scattered throughout the wooded area on the east side of the creek.

**Figure 6.** Left wing

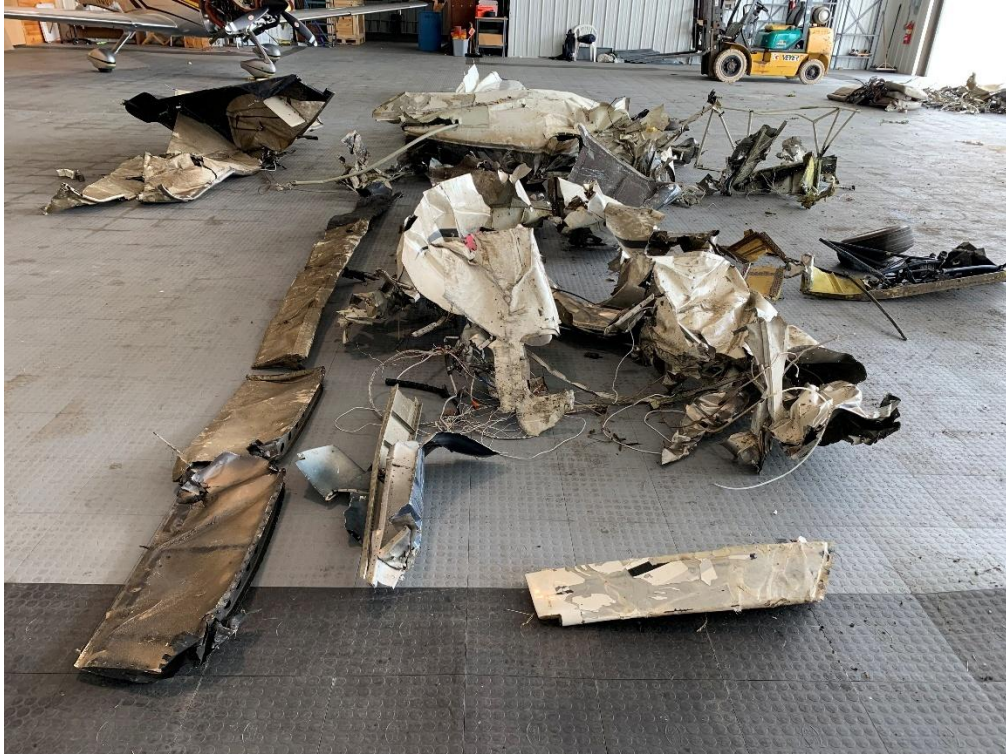
**Figure 7.** Right wing

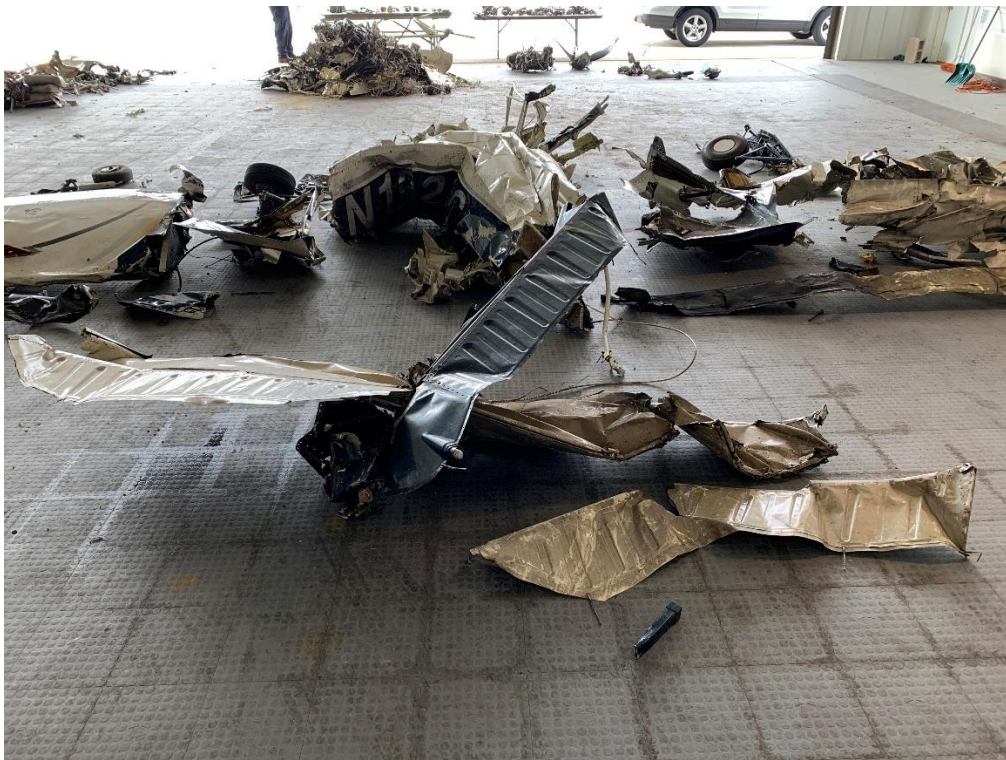
**Figure 8.** Empennage

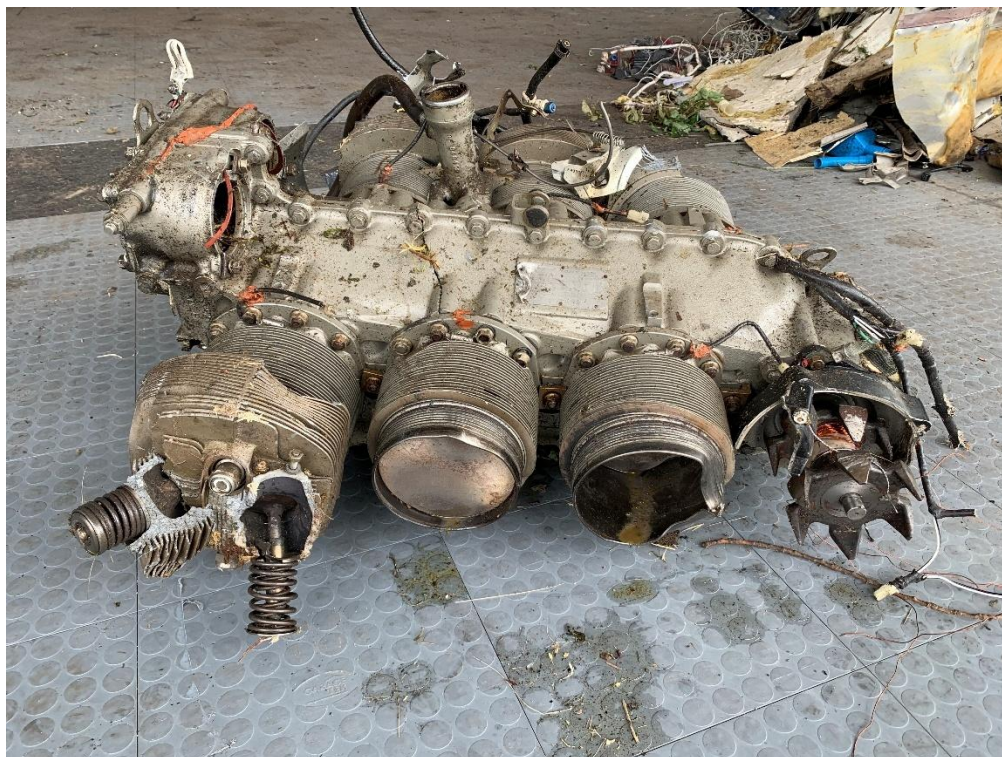
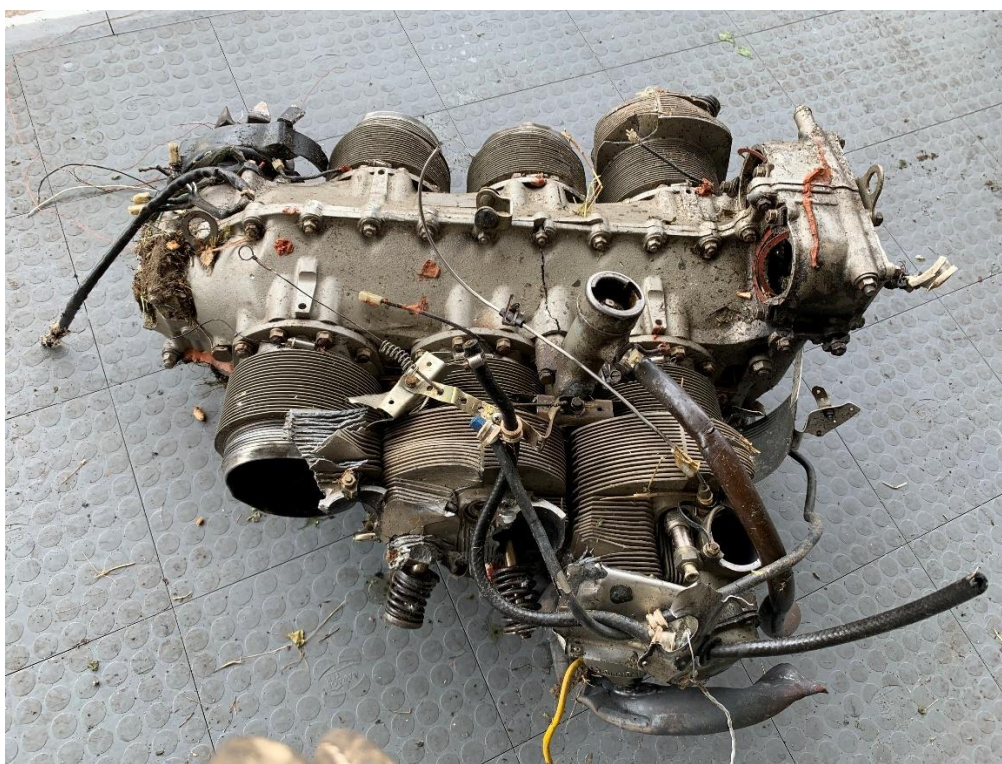
The engine exhibited extensive impact-related damage that prevented the crankshaft being rotated, as shown in figure 9 and figure 10. All four engine mounts exhibited impact related damage. The upper crankcase exhibited a large crack between cylinder Nos. 2 and 3. Three of the six cylinder heads separated during impact. The remaining three cylinder heads exhibited extensive impact-related damage. There were numerous cylinder head fragments recovered from the debris path. There were multiple intake and exhaust valves found separated from their respective cylinder heads. All six pistons remained in their respective cylinders. The propeller flange and crankshaft exhibited features consistent with an overload separation, as shown in figure 11. All engine accessories separated from the engine crankcase during impact. Portions of the left and right magnetos exhibited extensive impact-related damage and could not be tested. The engine-driven fuel pump and propeller governor exhibited impact-related damage and were not tested. The fuel manifold and injector lines separated from the top of the engine crankcase. The oil filter separated from the engine. The engine oil sump separated from the crankcase. The rear of the engine crankcase was missing, exposing the aft accessory gears. The intake, exhaust, and muffler separated from the engine and was fragmented and/or crushed.

**Figure 9.** Right side of engine

**Figure 10.** Left side of engine

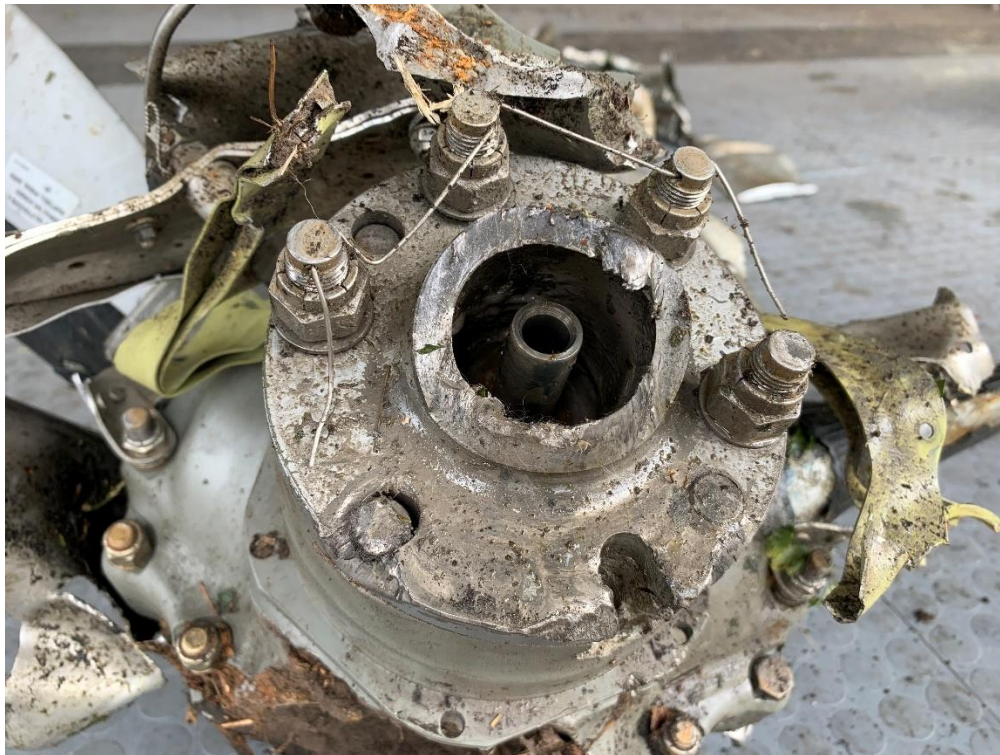
**Figure 11.** Engine propeller flange and portion of crankshaft

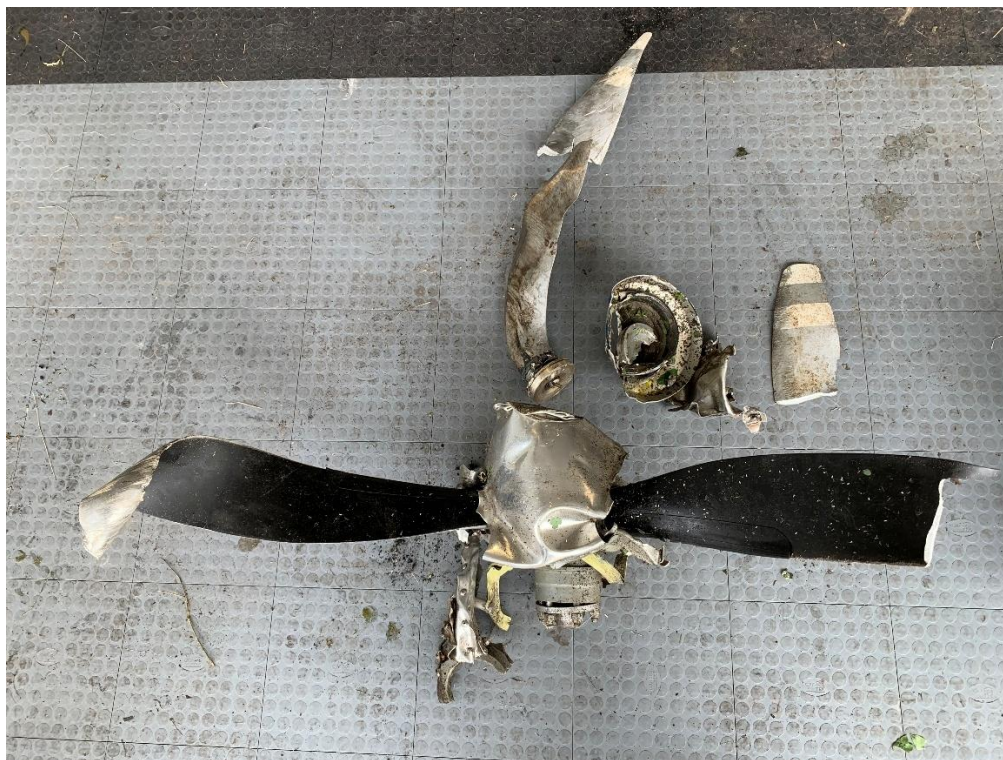
The propeller hub with two blades separated from the engine crankshaft, as shown in figure 12. The remaining propeller blade separated from the hub and was found in two pieces. All three propeller blades exhibited extensive impact-related damage, including spanwise bending, blade fractures, blade twisting, chordwise scratching, and leading-edge damage.

**Figure 12.** Propeller

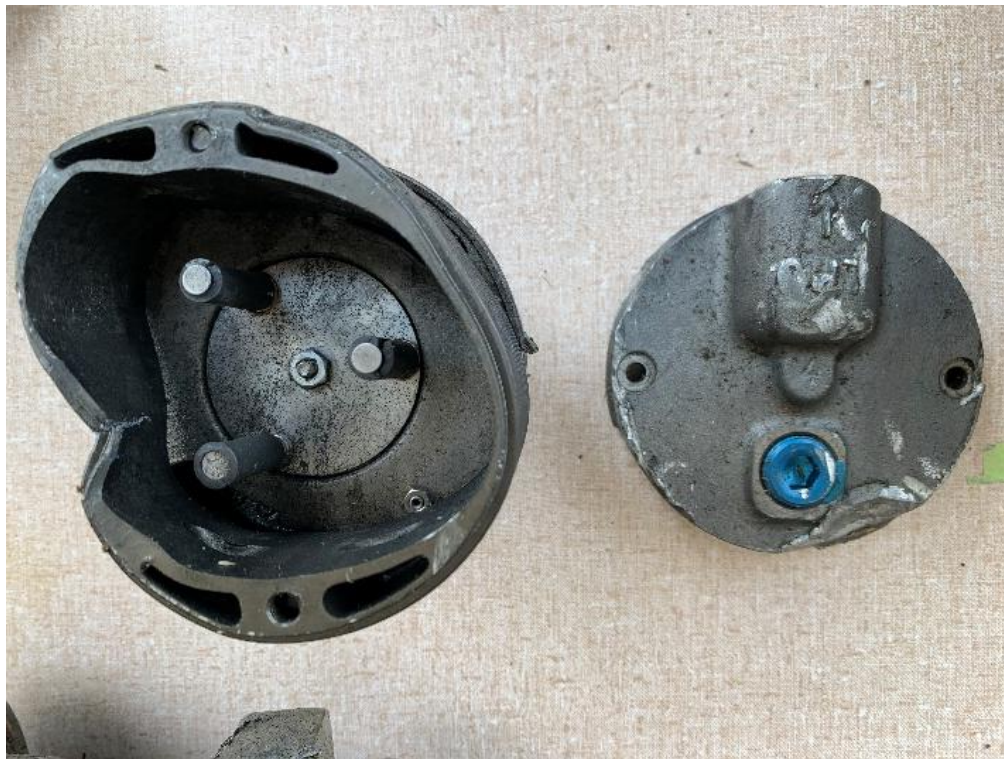
**Figure 13.** Vacuum pump

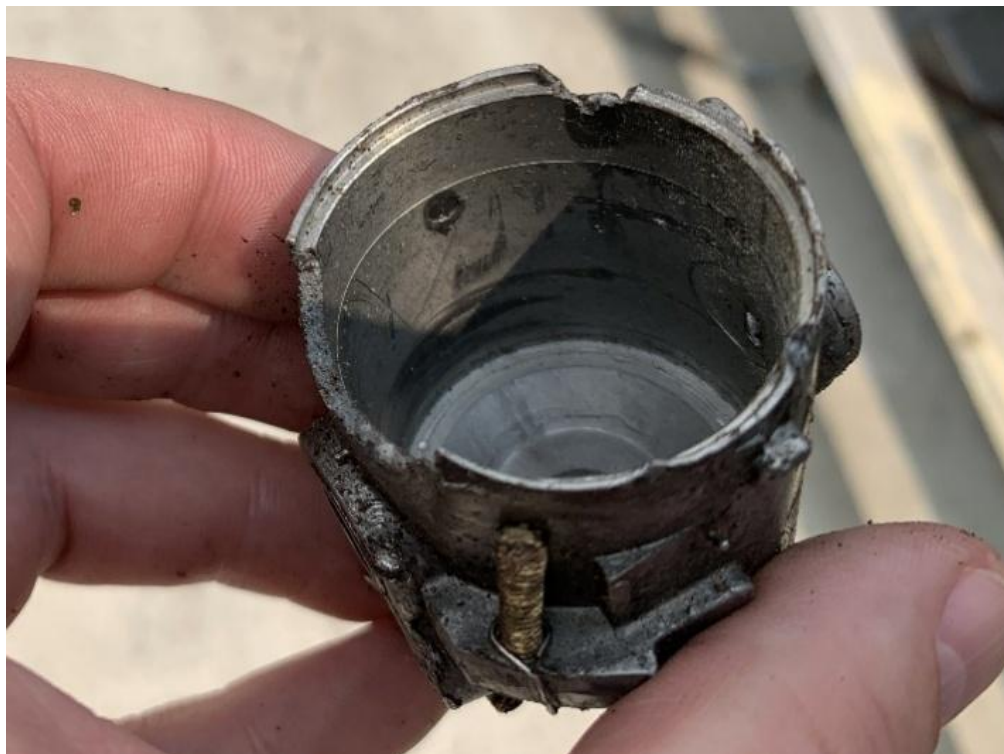
The vacuum pump separated from the engine and exhibited impact-related damage, as shown in figure 13. The vacuum pump rotor/vanes were not recovered. A separated gyro housing was recovered and exhibited impact-related damage. The interior surface of the gyro housing exhibited rotational scoring, as shown in figure 14. The gyro rotor was not recovered.

**Figure 14.** Gyro housing
