# National Transportation Safety Board

CEN23FA239

## **ACCIDENT FLIGHT DATA SUMMARY**

Location: Watertown, Wisconsin  
Date: June 14, 2023  
Time: 0903 central daylight time  
Airplane: Mooney M20R, Registration No. N1025C

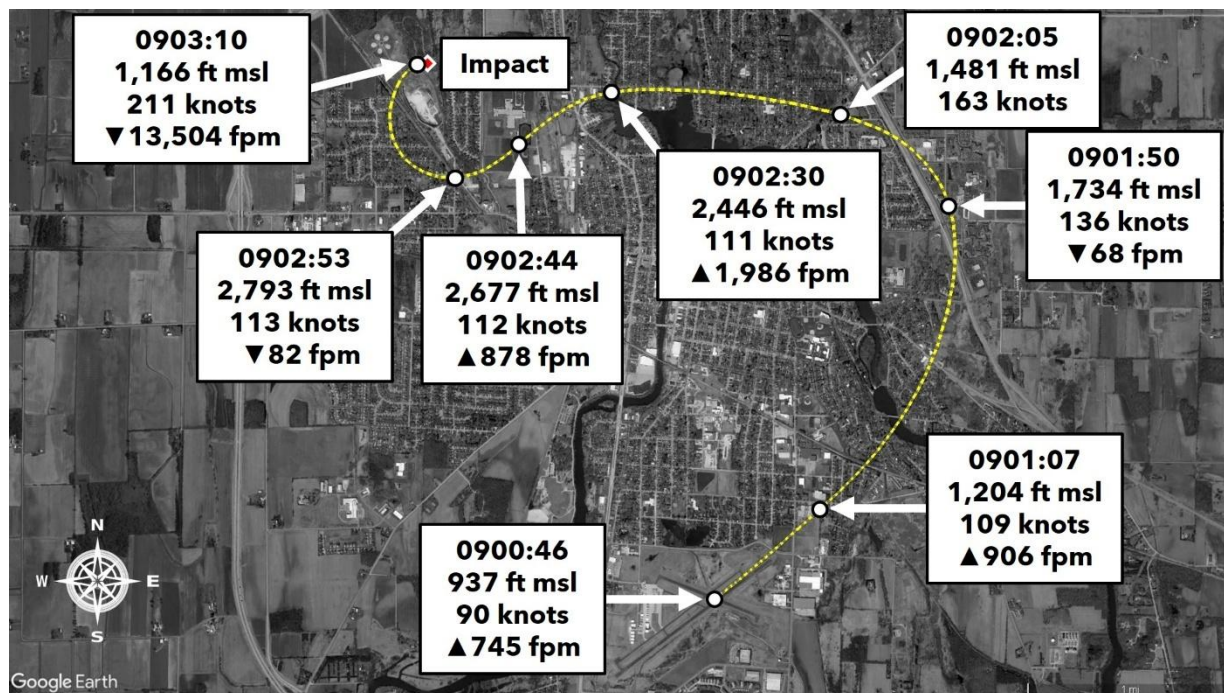
According to automatic dependent surveillance-broadcast (ADS-B) data, at 0900:46, the airplane was on initial climb from runway 5 at RYV, as depicted in figure 1. An airport surveillance video camera at RYV captured the airplane climbing wings level into an overcast ceiling. The RYV weather station reported an overcast ceiling at 300 ft above ground level (agl). Based on several pilot reports, the reported cloud tops were about 3,000 ft mean sea level (msl).

**Figure 1.** Plot of airplane flight track data.

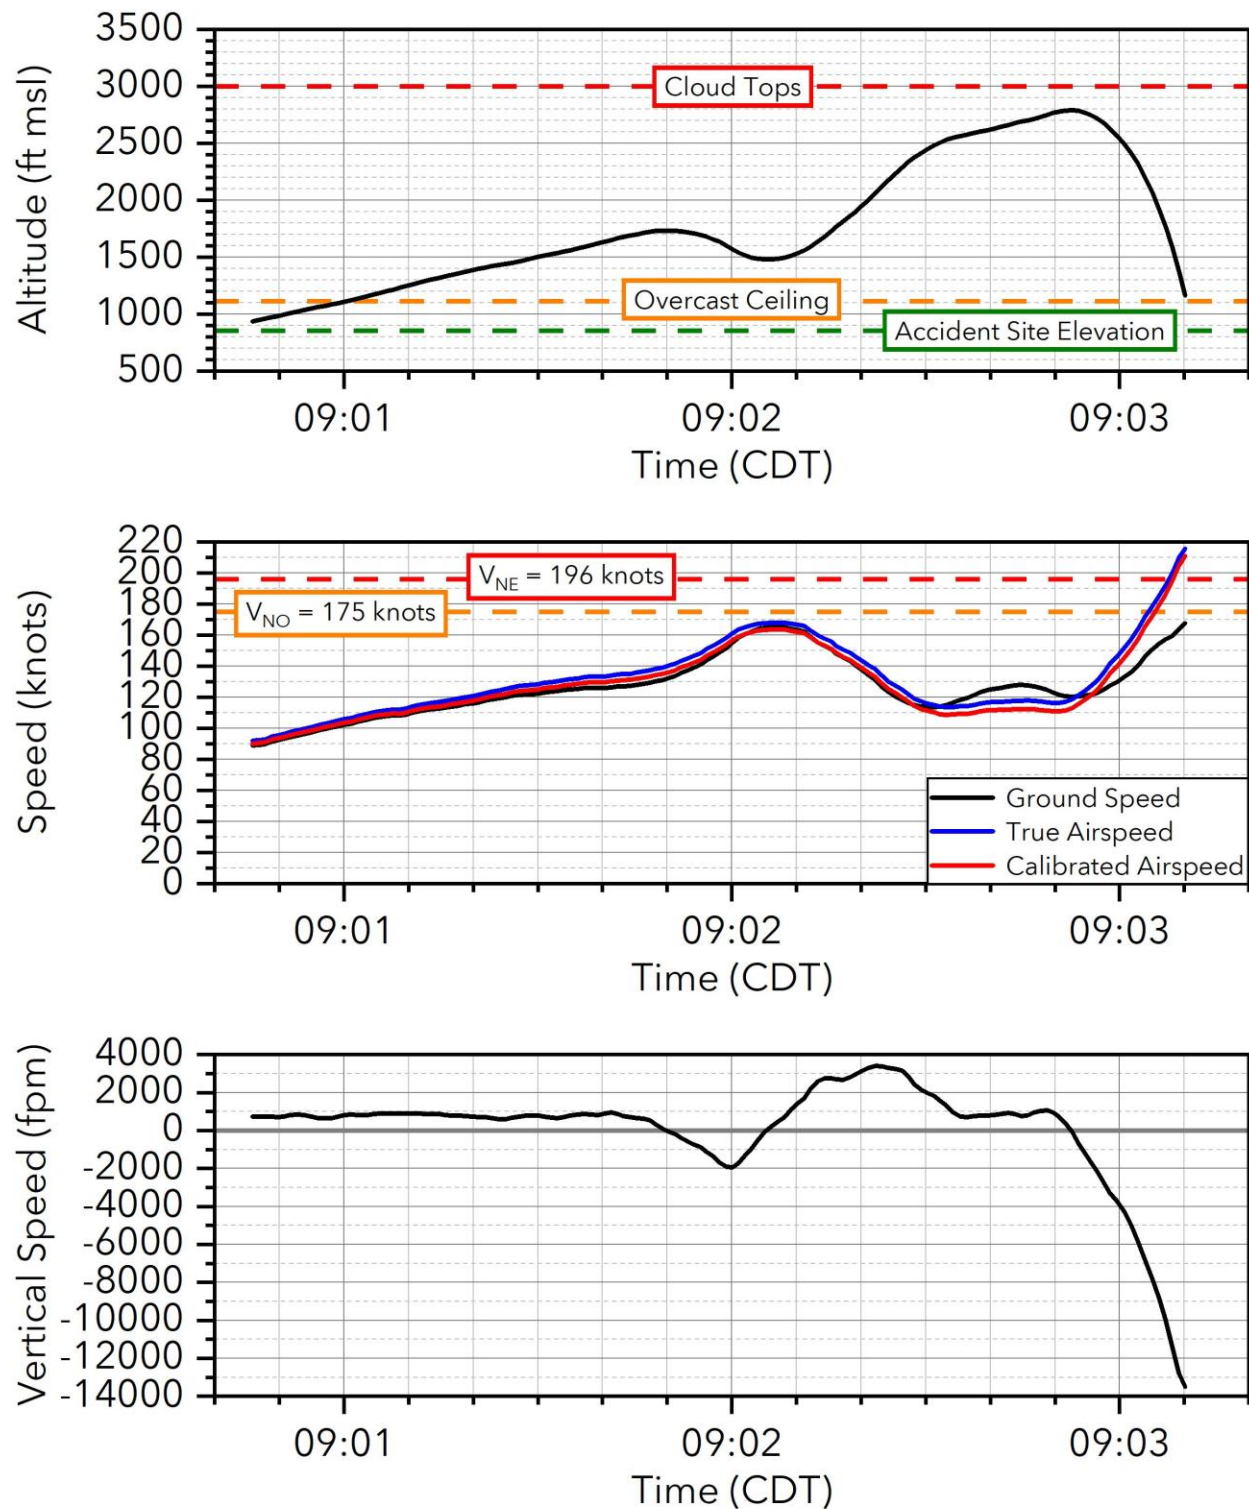
At 0901:07, the airplane entered a climbing left turn toward west-northwest, as depicted in figure 2 and figure 3. At 0901:50, the airplane entered a descent from 1,734 ft msl while still in the left turn. At 0902:00, the airplane was descending at 1,941 feet per minute (fpm) with a 30° left-wing-down roll angle. About 5 seconds later, the airplane entered a climb from 1,481 ft msl while in a left turn toward west-northwest at 163 knots calibrated airspeed (KCAS).

At 0902:44, the airplane entered a climbing right turn toward north. At 0902:53, the airplane entered a descending right turn from a maximum altitude of 2,793 ft msl. About 15 seconds later, the airplane's roll angle was about 80° right-wing-down as the airplane descended at 11,411 fpm in a right turn toward northeast.

At 0903:10, the final recorded ADS-B data point, the airplane was flying at 211 KCAS as it descended 13,504 fpm with a 56° right-wing-down roll angle. According to the Mooney M20R Pilot Operating Handbook, the never exceed airspeed ( $V_{NE}$ ) for the airplane was 196 KCAS. The final track point was at 1,166 ft msl and about 255 ft east-northeast of the initial impact with the ground.

**Figure 2.** Plots of airplane altitude, ground speed, true airspeed, calibrated airspeed, and vertical speed.

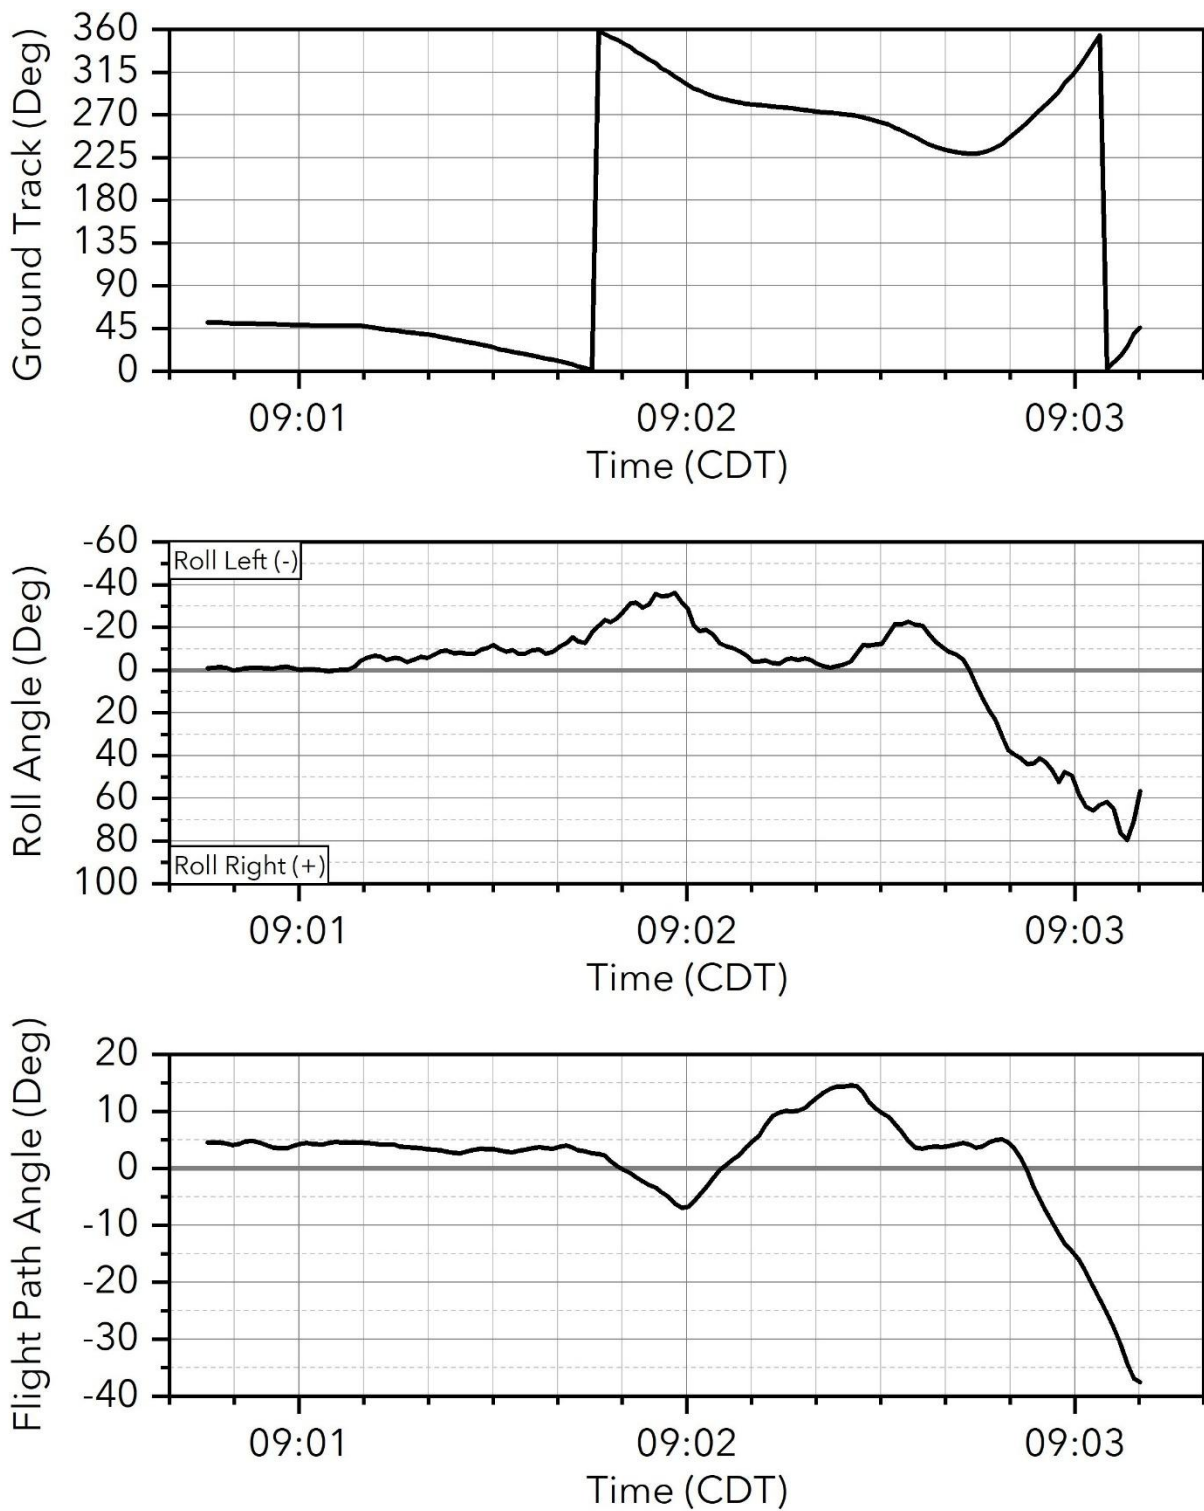
**Figure 3.** Plots of airplane ground track, roll angle, and flight path angle.
