# National Transportation Safety Board

CEN23FA248

## INVESTIGATION SUMMARY

Location: Duluth, Minnesota  
Date: June 21, 2023  
Time: 0719 central daylight time (CDT)  
1219 coordinated universal time (UTC)  
Airplane: N308ED, Aeronca 7CCM

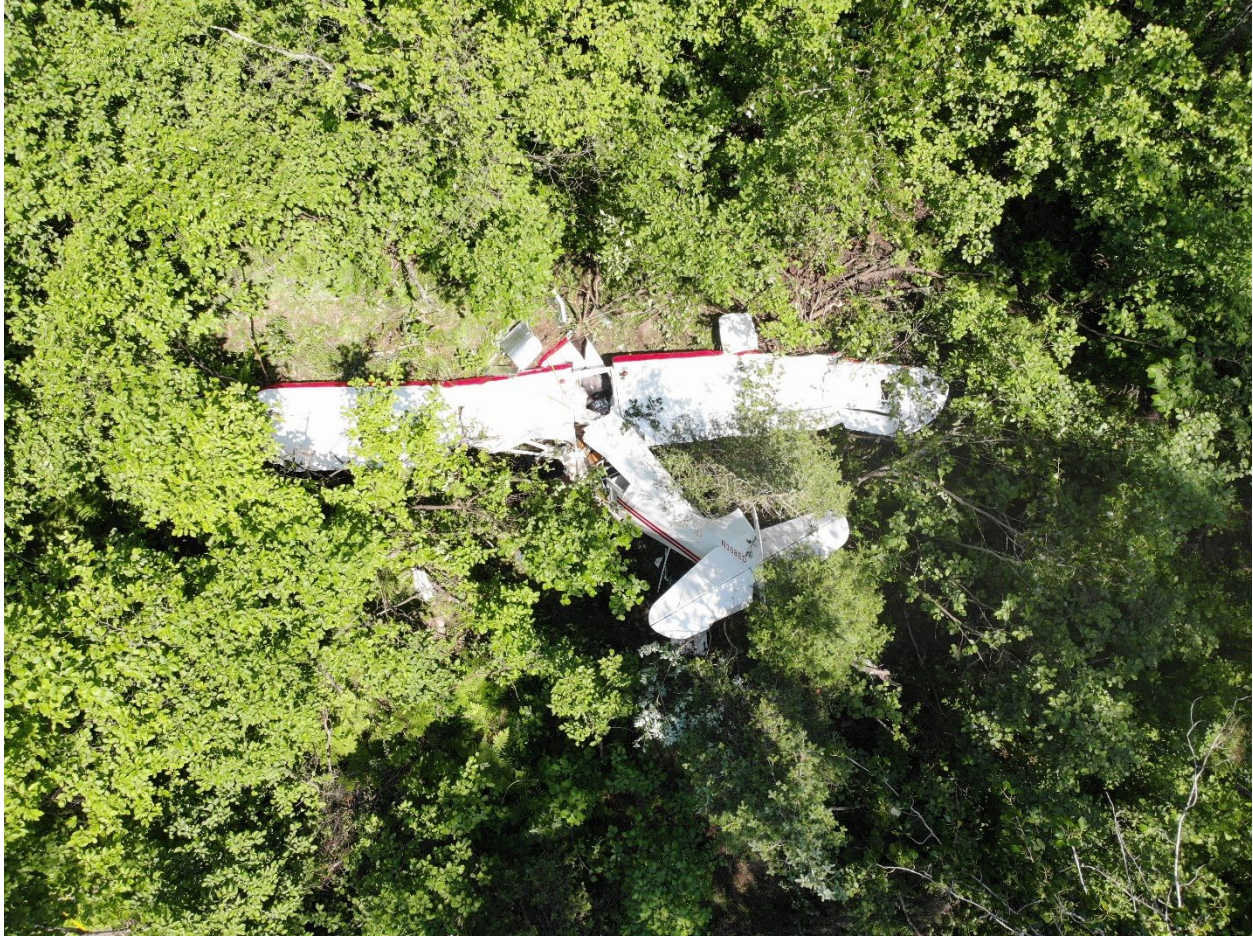
Figure 2. Aerial image of the accident site (Source: St. Louis Co. Sheriff's Office)

The airplane was located about 30 yards into a densely wooded area. There was no damage noted to the surrounding trees or the canopy.

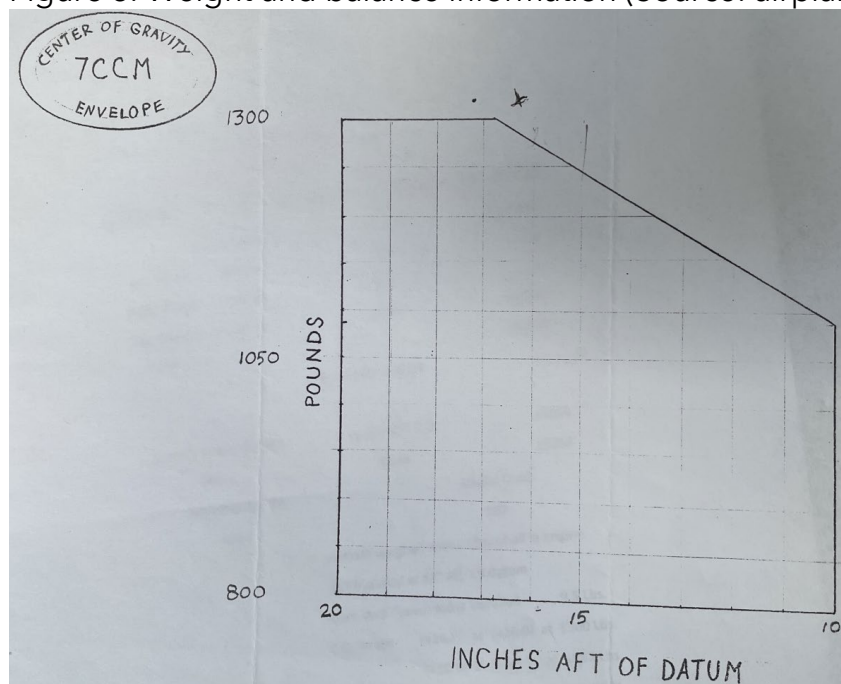
Figure 4. Center of gravity envelope (Source: airplane owner)

Assuming full fuel (13-gals main tank) at departure, and about 11 gals at the time of the accident, with a fuel burn of 4.24 gph, the airplane would have used about 2 gals for startup, taxi, takeoff, climb, cruise, and one fly over the private strip. Arms are directly from TCDS, weights are from the police report, and there was no appreciable baggage. Airplane owner was not sure if aux tanks were at 1.5 gals each, which is a rule in the flight club manual. However, since 2.5 gals were drained from the right aux tank, the calculations below will assume 5 gals total for both aux tanks. The owner was also not sure how much was in the main tank on takeoff. Since the pilot had just completed the annual inspection and no one had flown it since May 31, 2023, the amount of fuel in the main tank was unknown.

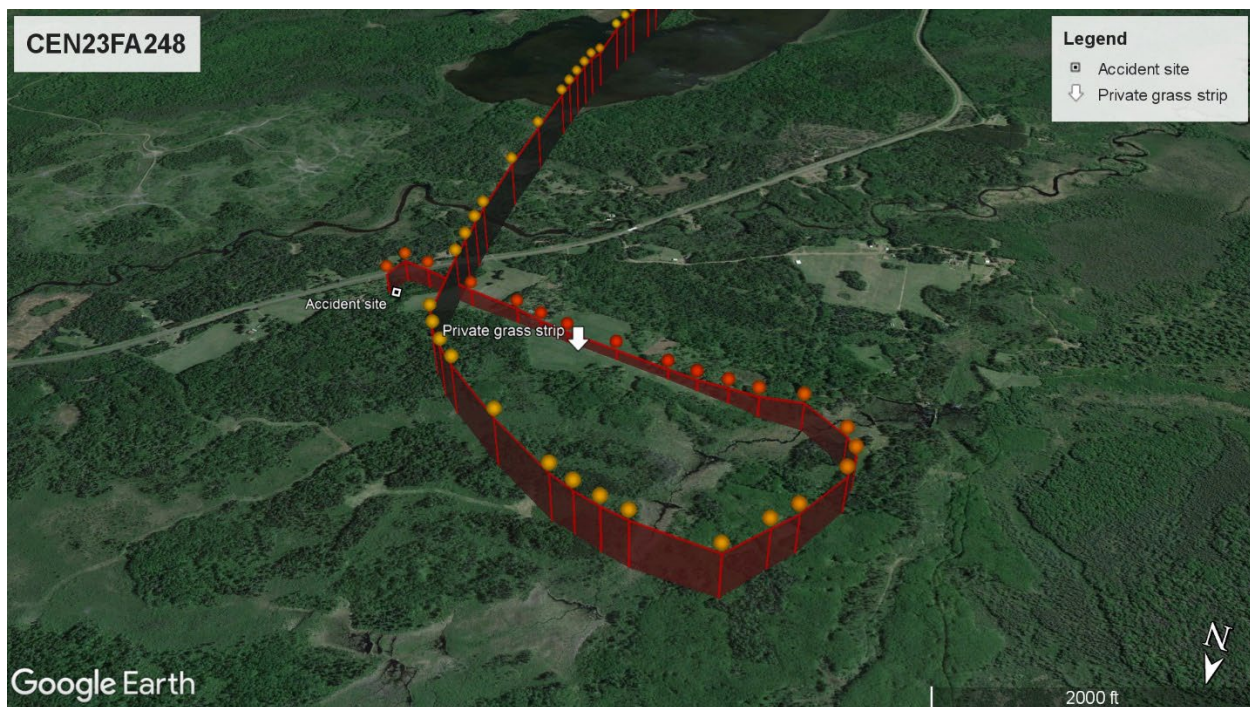
Figure 5. Grass strip and accident site location with the accident flight track

The tabular data revealed that the airplane departed DLH at 0659 and proceeded northeast. The airplane approached the private grass strip from the south and entered a left downwind for the east runway. The airplane continued in the left pattern and descended to about 100 ft AGL and flew the runway easterly heading at 58 MPH. While continuing on the runway heading, the airspeed increased to 64 MPH, then decelerated to about 60 MPH during the initial climb out. The airspeed continued to decrease during the climb to 54 MPH. The airplane made a left turn at 220 ft AGL and 54 MPH. The final recorded GPS point was 45 yards southeast of the accident site.
