CEN23FA257

## INVESTIGATION PHOTOGRAPHS

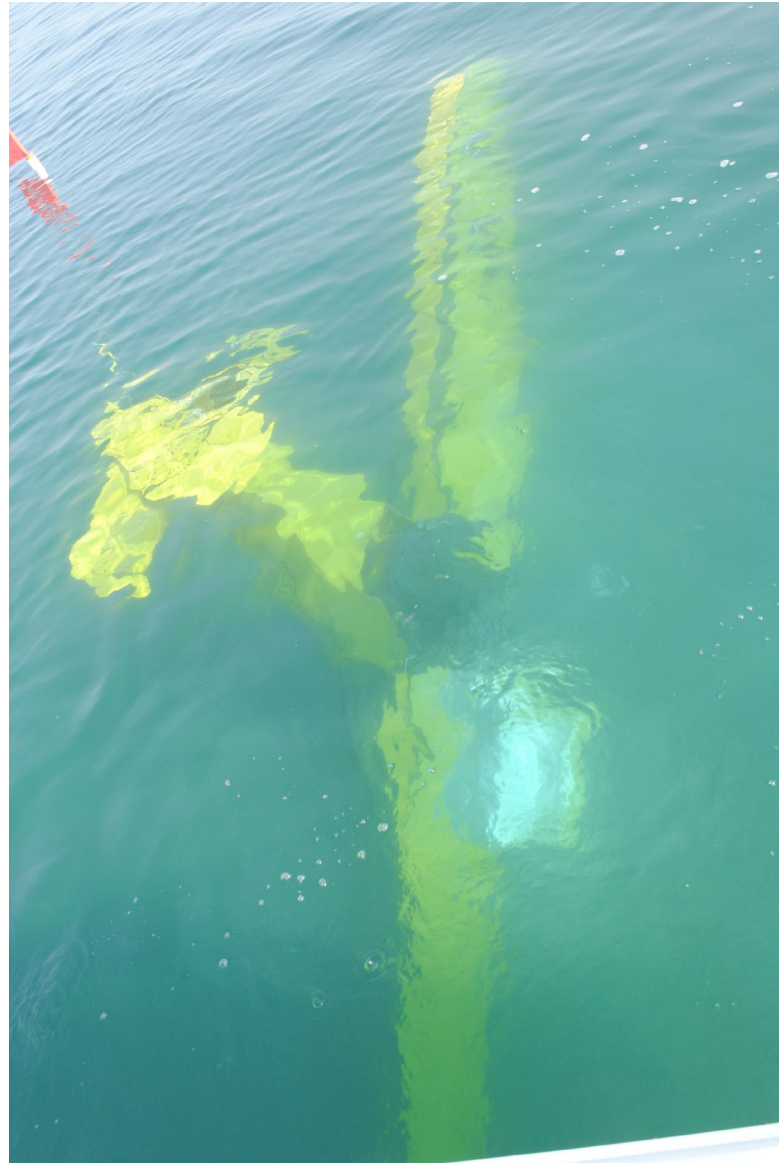
**Photograph 1 - Accident Scene (Courtesy of LEO)**

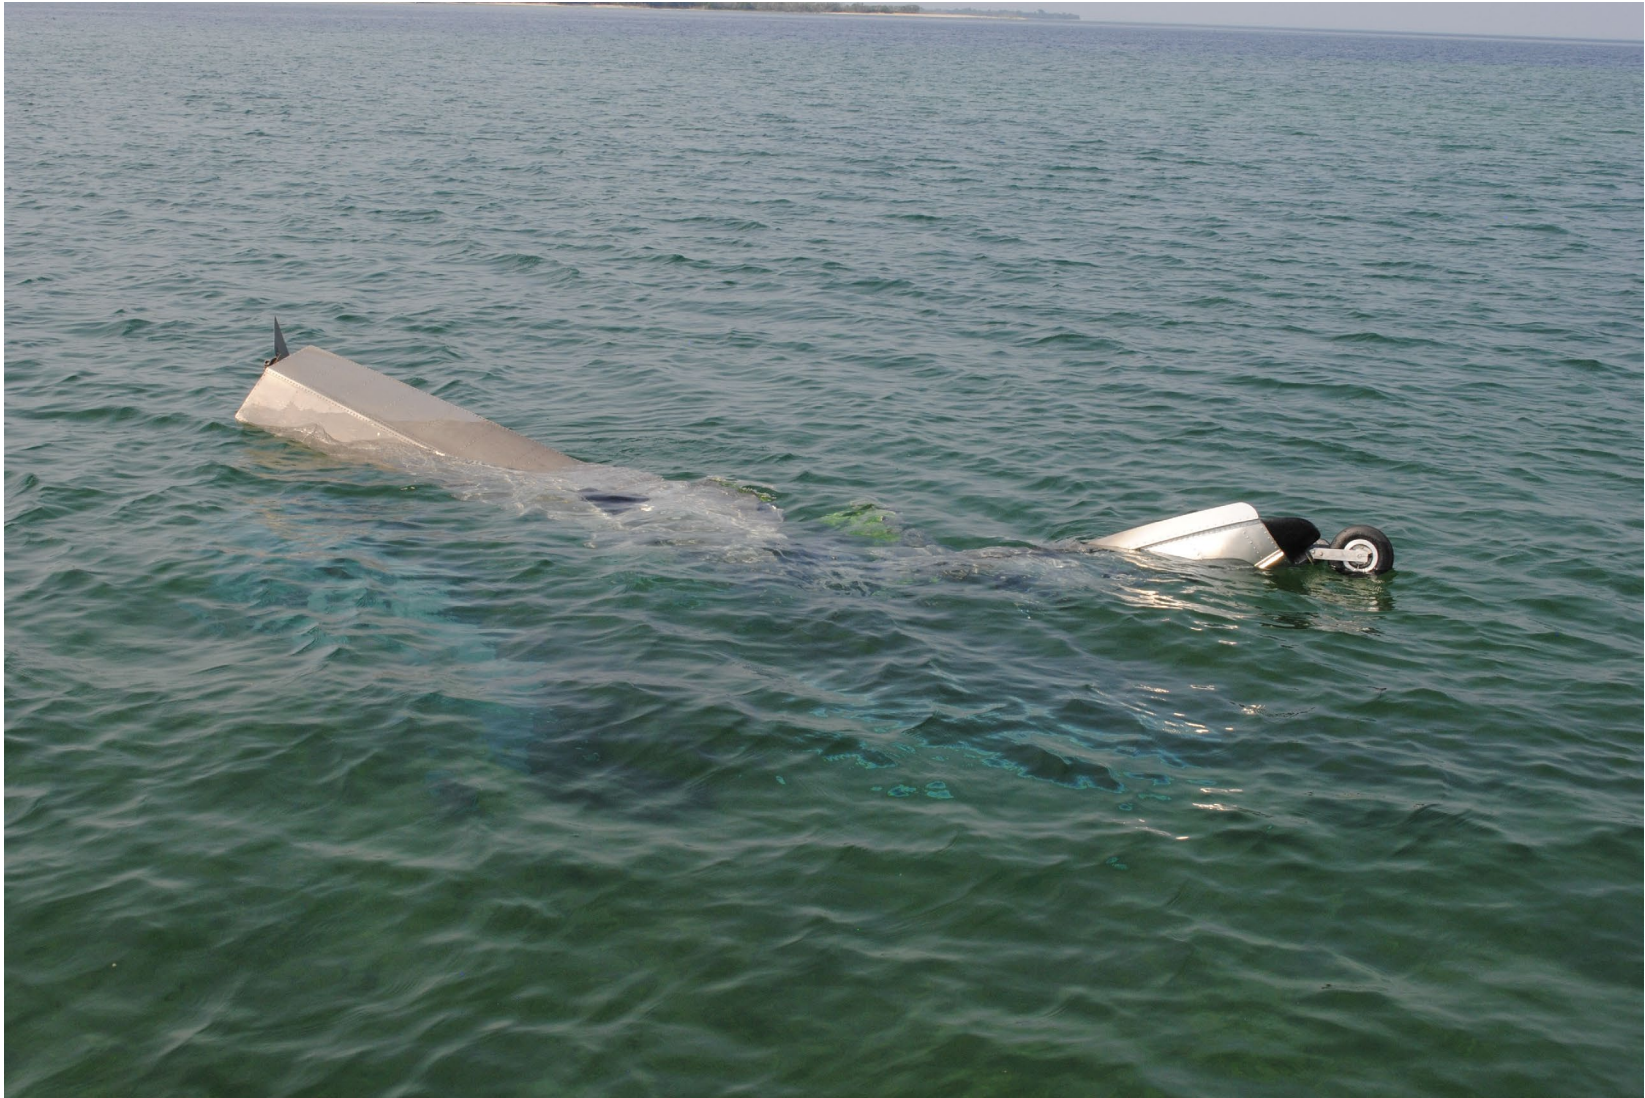
**Photograph 2 - Airplane floats separated from airplane. (Courtesy of LEO)**

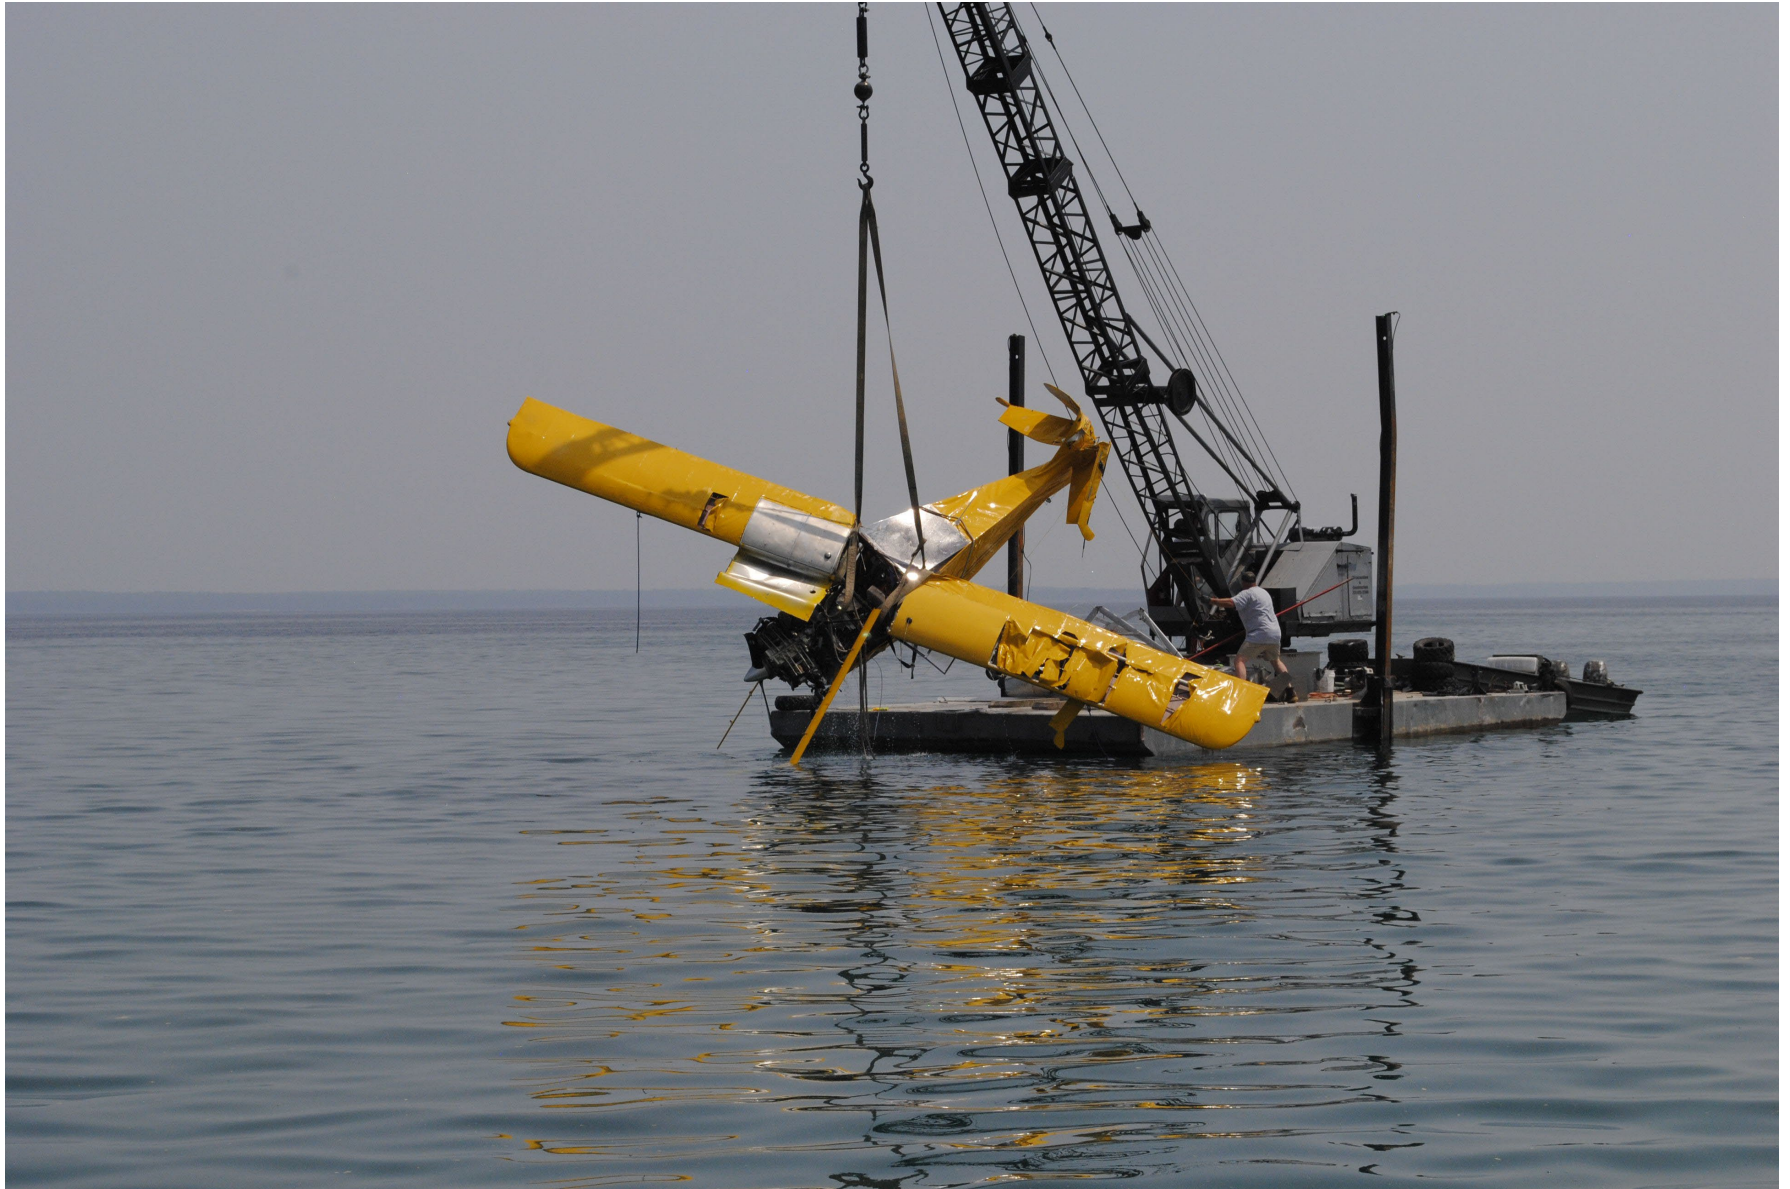
**Photograph 3 -Recovery of accident airplane (Courtesy of LEO)**

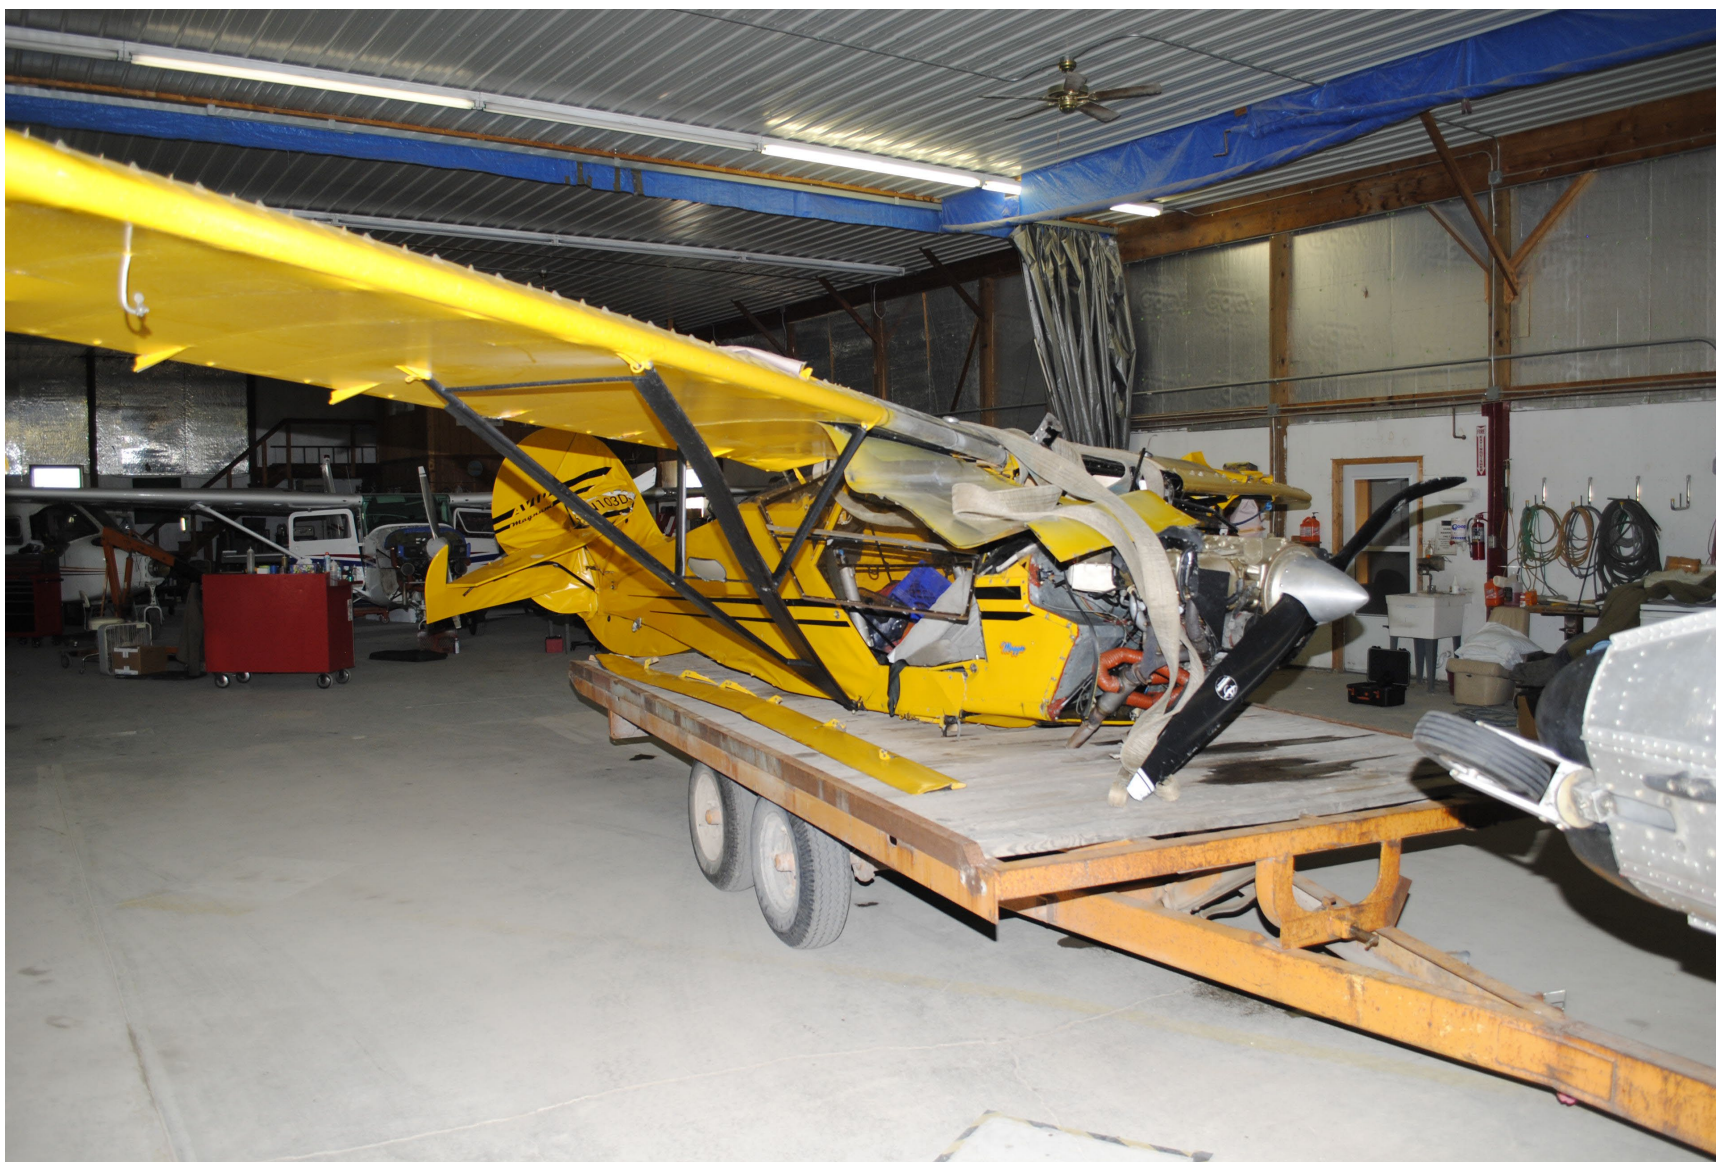
**Photograph 4 - Accident airplane post recovery (Courtesy of LEO)**

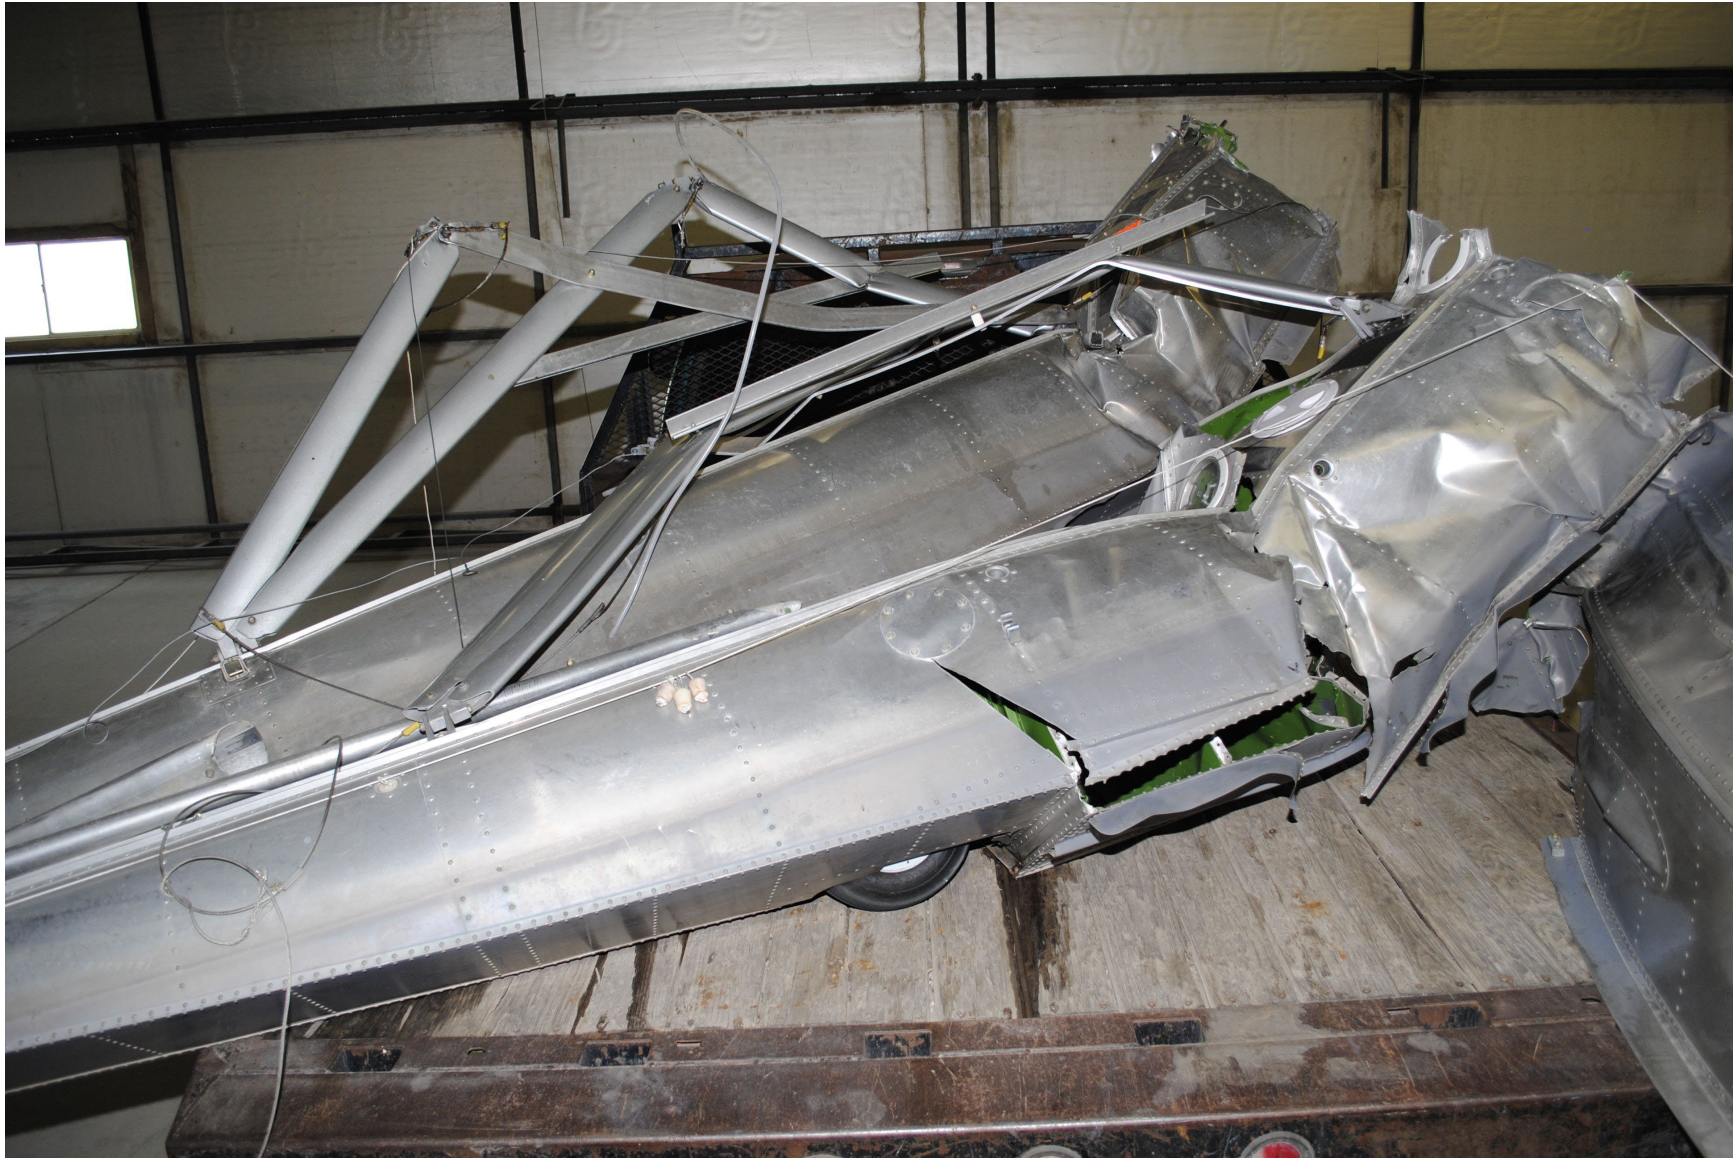
**Photograph 5 - Floats exhibiting significant crush damage (Courtesy of LEO)**

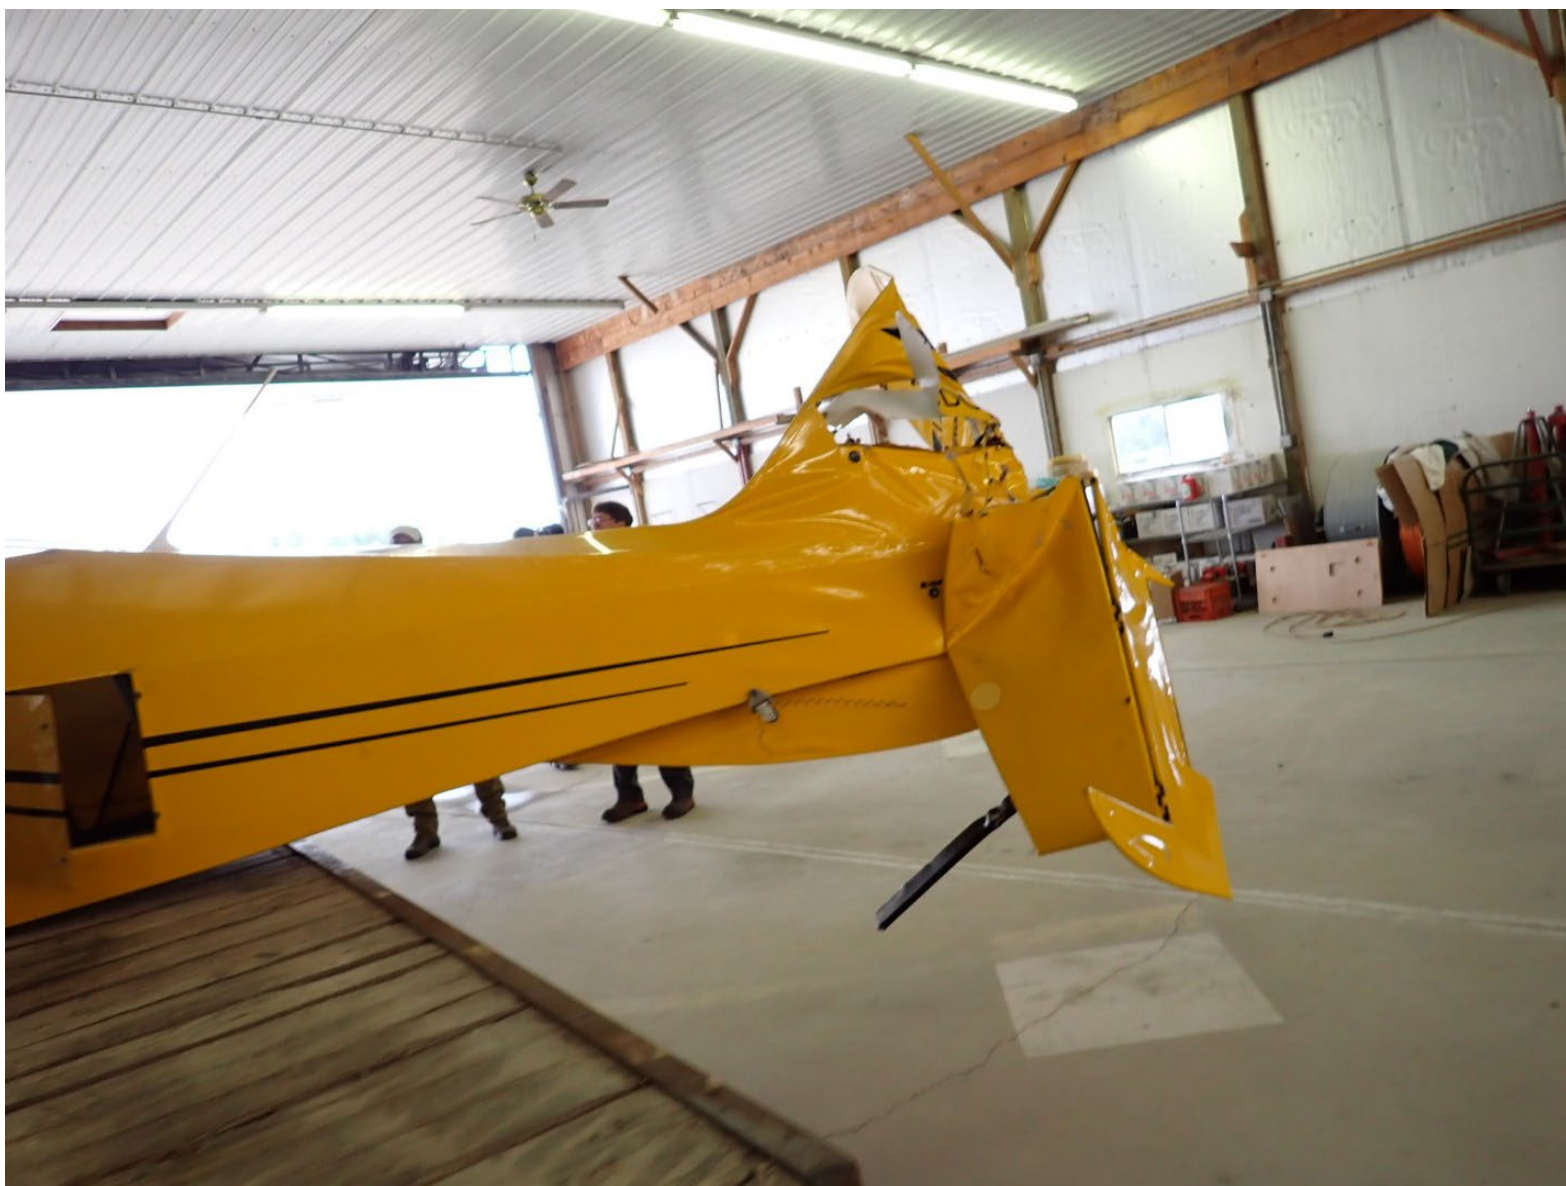
**Photograph 7 - Damaged Empennage**

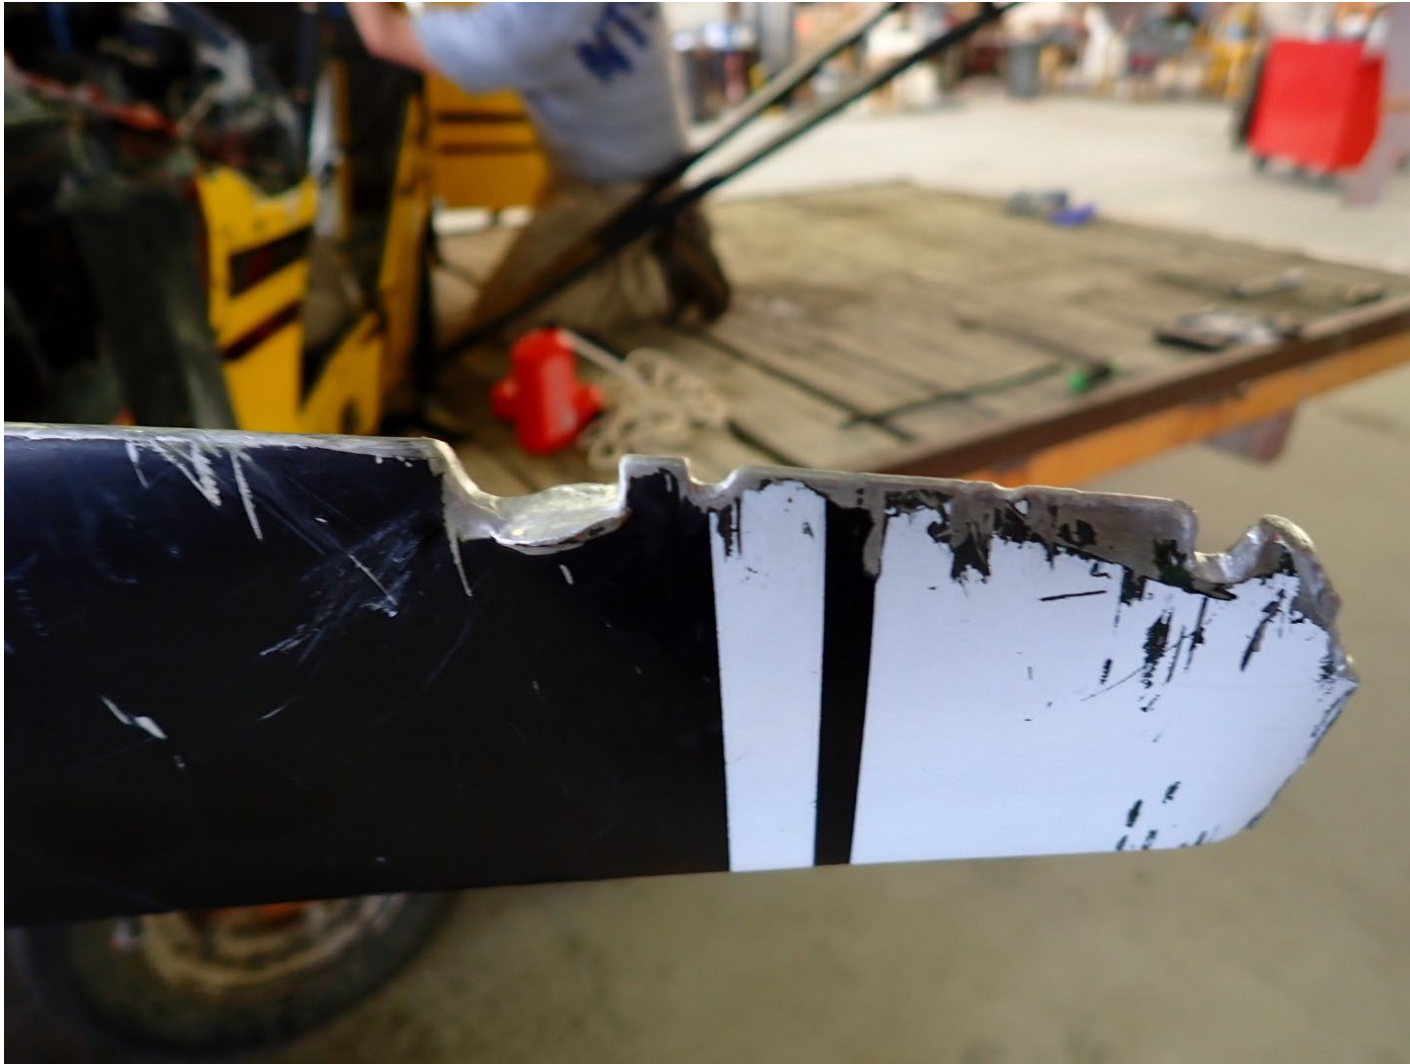
**Photograph 8 - Propeller Damage**

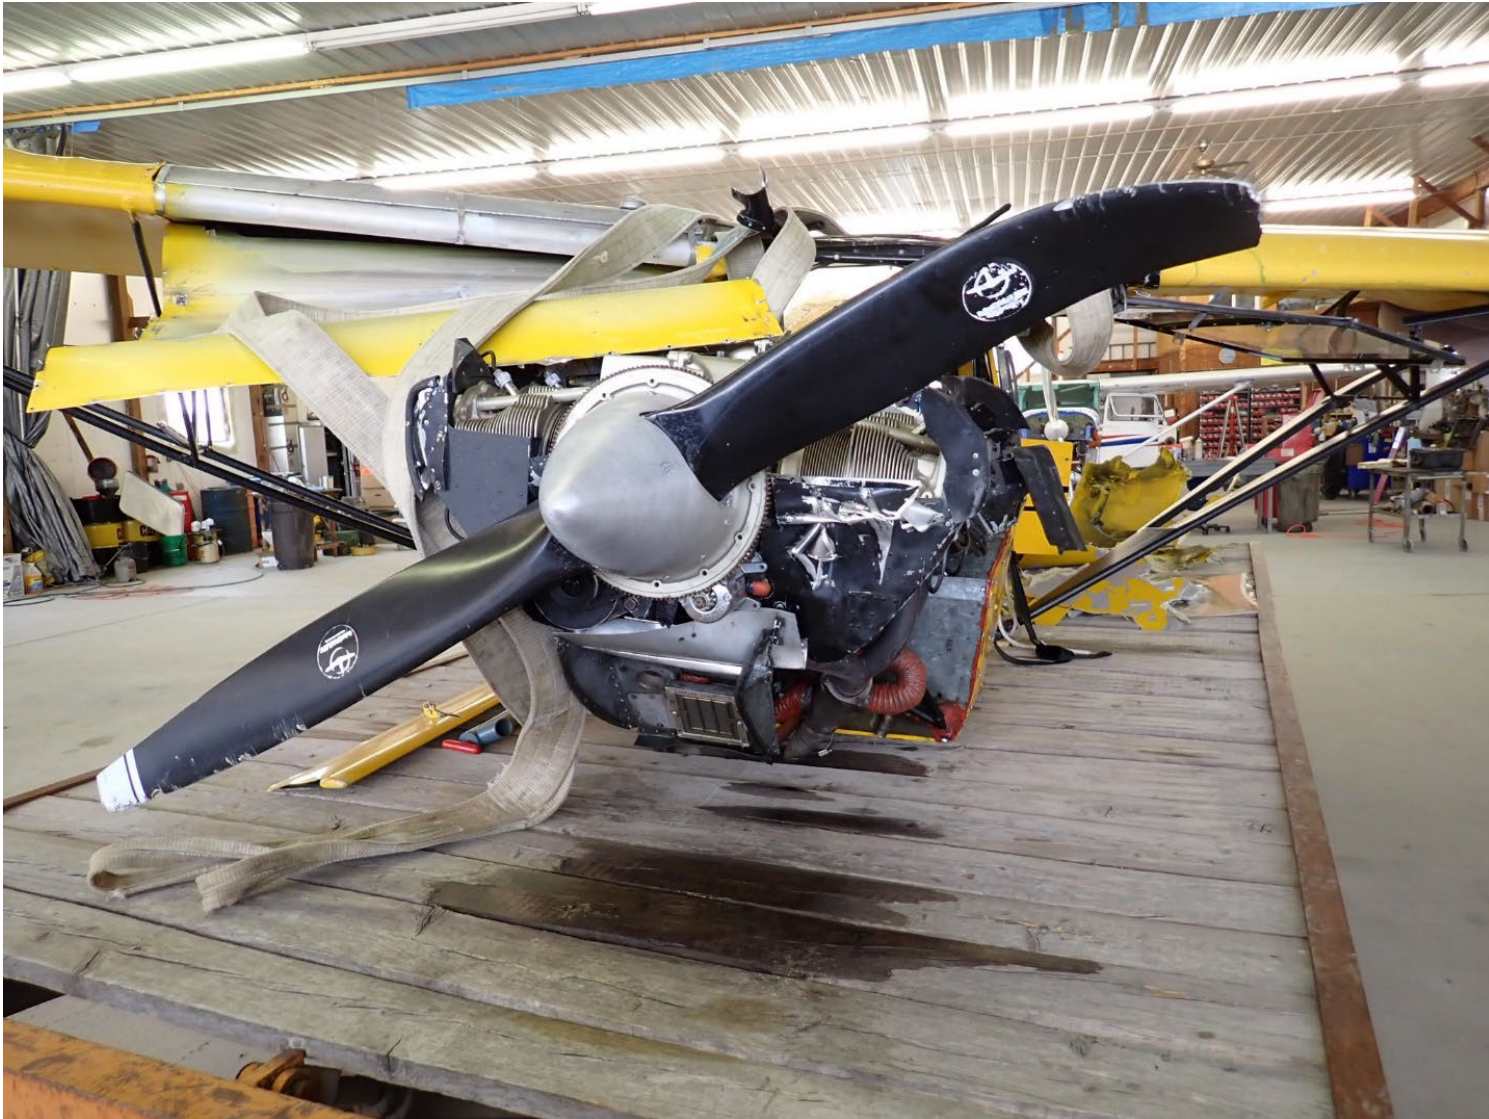
**Photograph 9 - Head-on view of the accident airplane**
