# National Transportation Safety Board

CEN23FA258

## **FLIGHT TRACK DATA SUMMARY**

Date: June 26, 2023  
Time: 0805 central daylight time  
Location: Hot Springs, Arkansas  
Airplane: Cessna 177  
Registration: N3138T

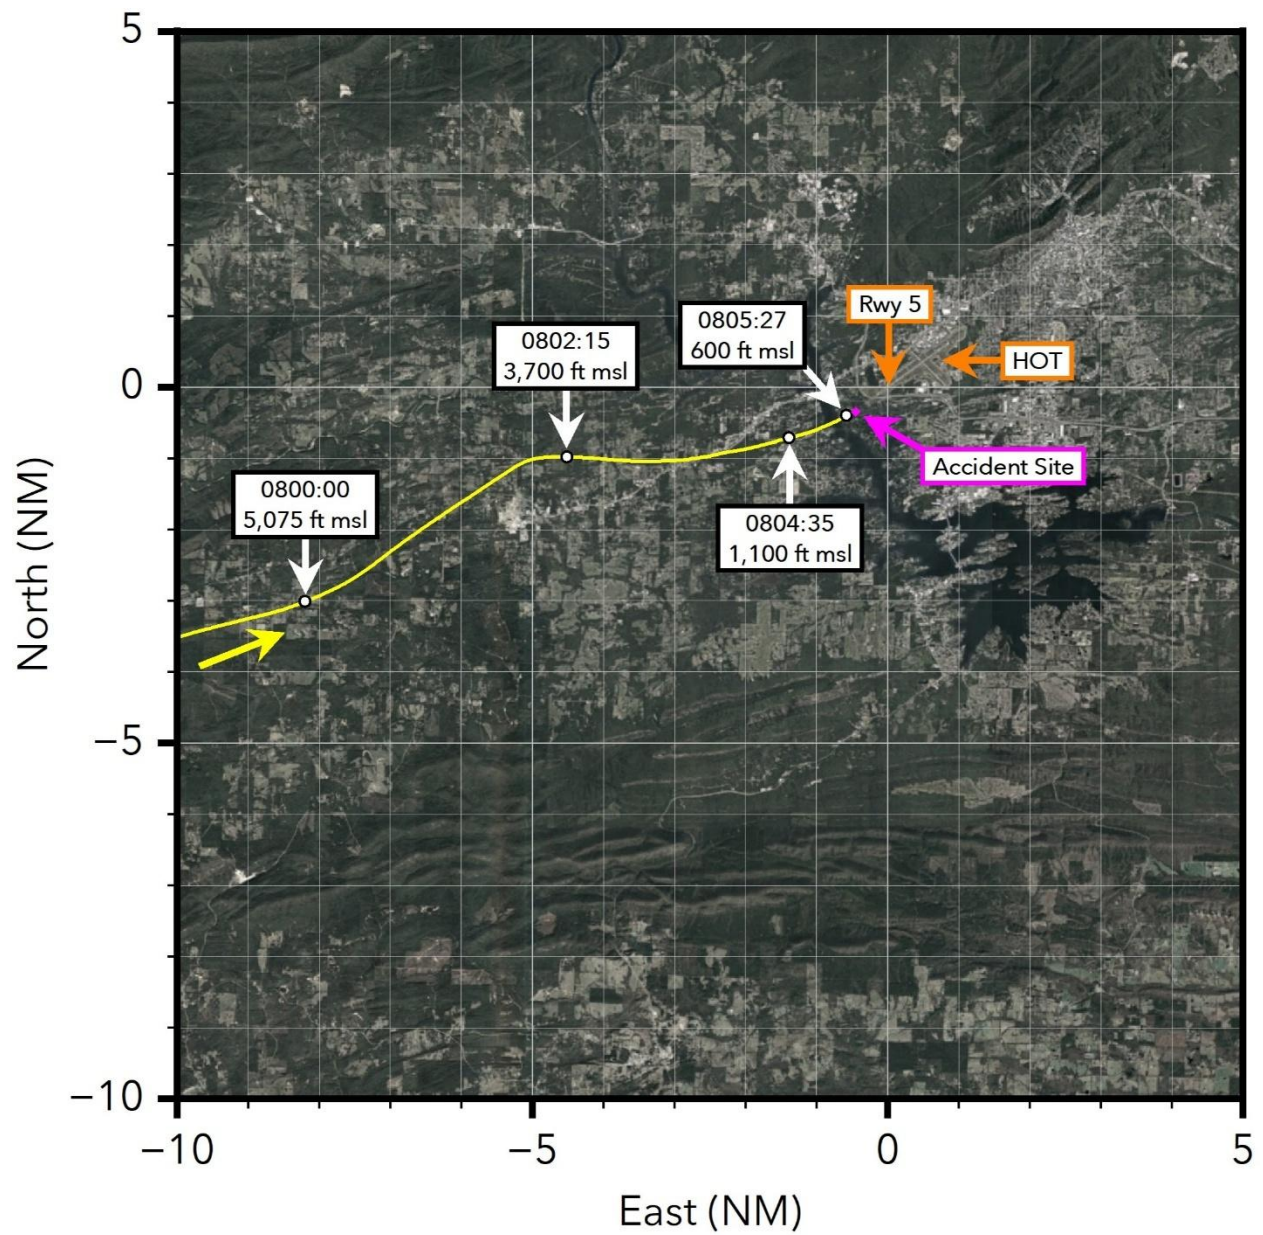
airport and that he intended to make a full stop landing on runway 23. At that time, the airplane was approaching HOT from the southwest, as depicted in figure 1.

**Figure 1.** Plot of airplane flight track data.

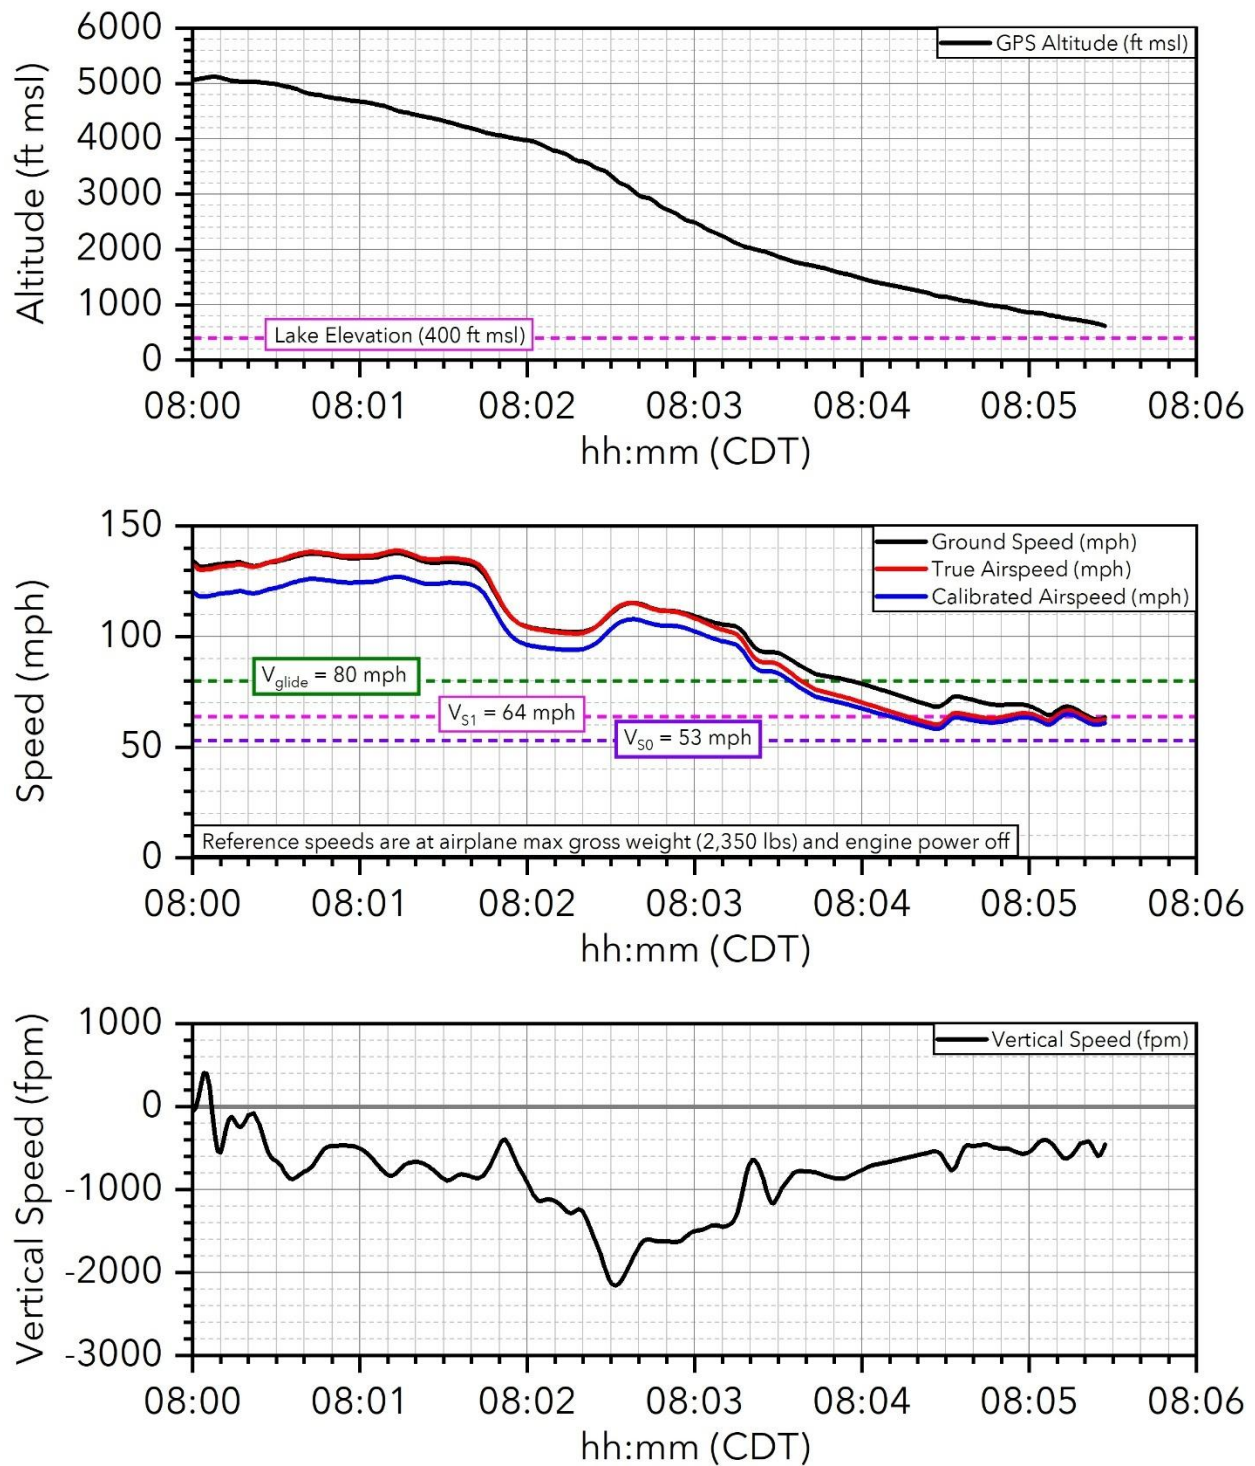
At 0804:35, the pilot transmitted, "... engine out, coming in runway five, engine out." At that time, the airplane was about 1,100 ft msl, or about 600 ft above the runway 5 threshold elevation, and 1.8 sm west-southwest of the runway. Airplane performance calculations using ADS-B flight track data indicated that the airplane's calibrated airspeed was about 63 mph when the pilot transmitted that the airplane had a loss of engine power, as depicted in figure 2.

At 0805:27, the final recorded ADS-B track point was about 600 ft msl (200 ft above ground level) and 0.8 sm from the runway 5 threshold. The airplane was about 0.16 sm west-southwest of the point-of-impact with the lake. Airplane performance calculations using ADS-B track data indicated that the airplane was at a calibrated airspeed of about 61 mph, descending about 450 feet per minute (fpm), and was nearly wings level, as depicted in figure 2 and figure 3.

**Figure 2.** Plots of airplane altitude, ground speed, true airspeed, calibrated airspeed, and vertical speed.

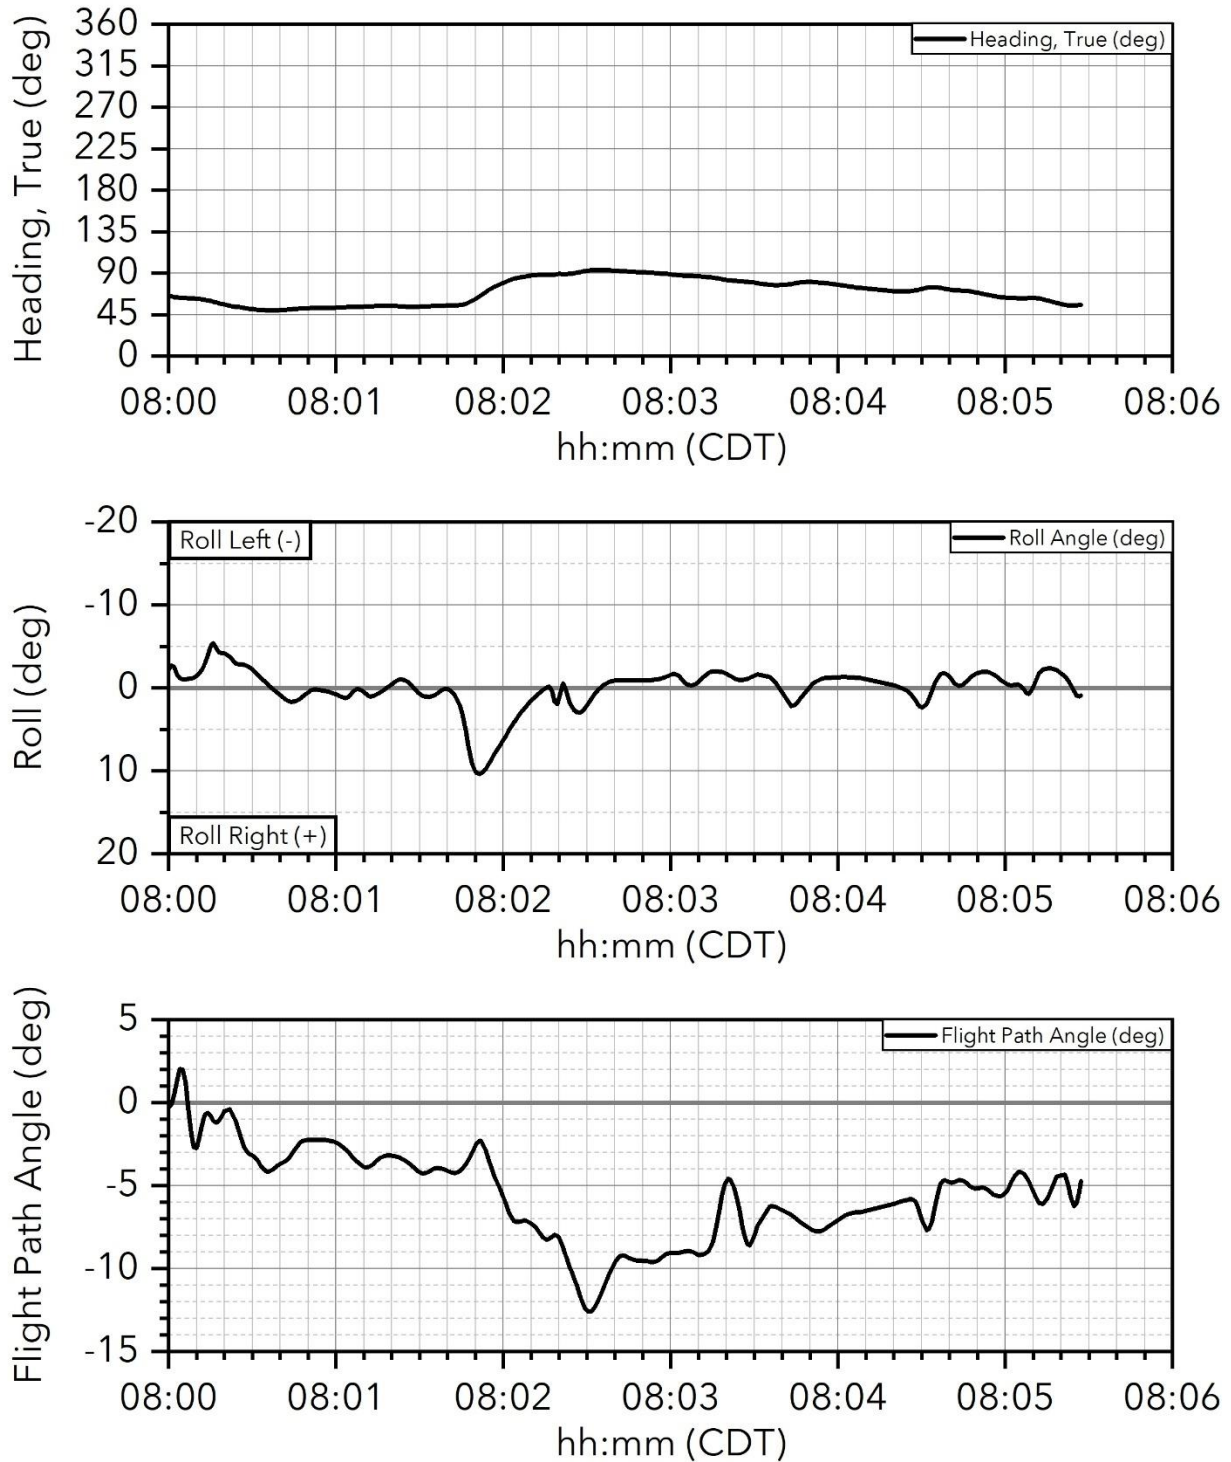
**Figure 3.** Plots of airplane heading, roll angle, and flight path angle.
