# National Transportation Safety Board

CEN23FA258

## **WRECKAGE EXAMINATION SUMMARY**

Date: June 26, 2023  
Time: 0805 central daylight time  
Location: Hot Springs, Arkansas  
Lat/Lon: 34.46725, -93.11536  
Airplane: Cessna 177  
Registration: N3138T

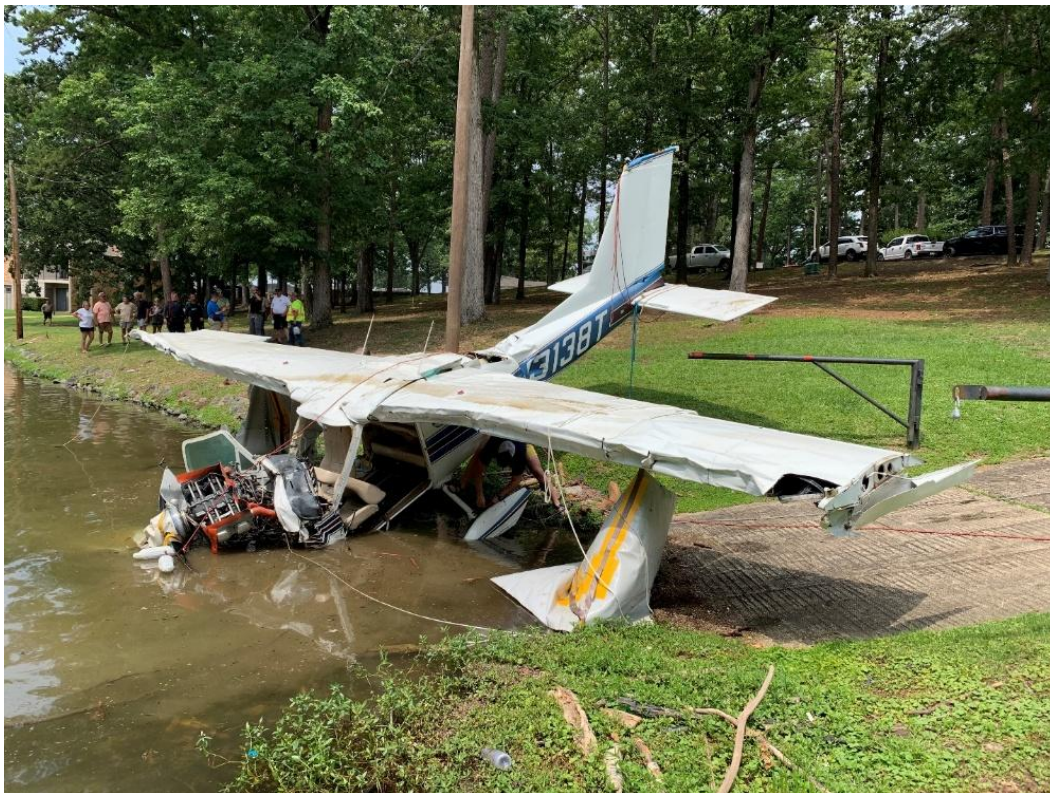
The airplane sustained substantial damage when it impacted lake water in a near vertical nose down pitch attitude. The airplane sank and was found inverted in 7 to 13 ft of water. The accident site was about 0.66 sm west-southwest of the runway 5 threshold at Memorial Field Airport (HOT), Hot Springs, Arkansas. On June 27, 2023, recovery crews floated the aircraft to the surface and towed it to a public boat launch where it was recovered to shore, as shown in figure 3.

**Figure 3.** Airplane wreckage after it was recovered to a boat launch.

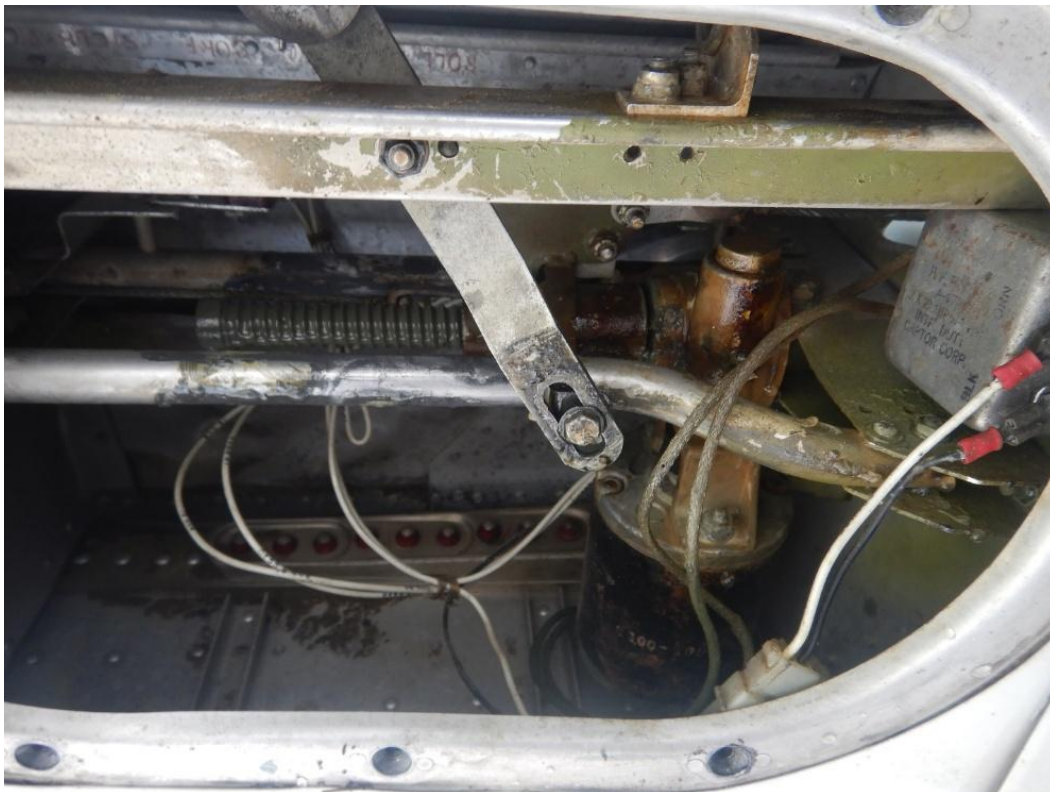
The left- and right-wing flaps remained attached to their respective attachment points. The flap handle in the cockpit was found at the "¼" detent. The flap handle panel was bent forward beginning about midway down the panel. The flap actuator jackscrew was found fully extended, as shown in figure 4, consistent with the wing flaps fully extended at impact.

**Figure 4.** Flap motor/actuator.

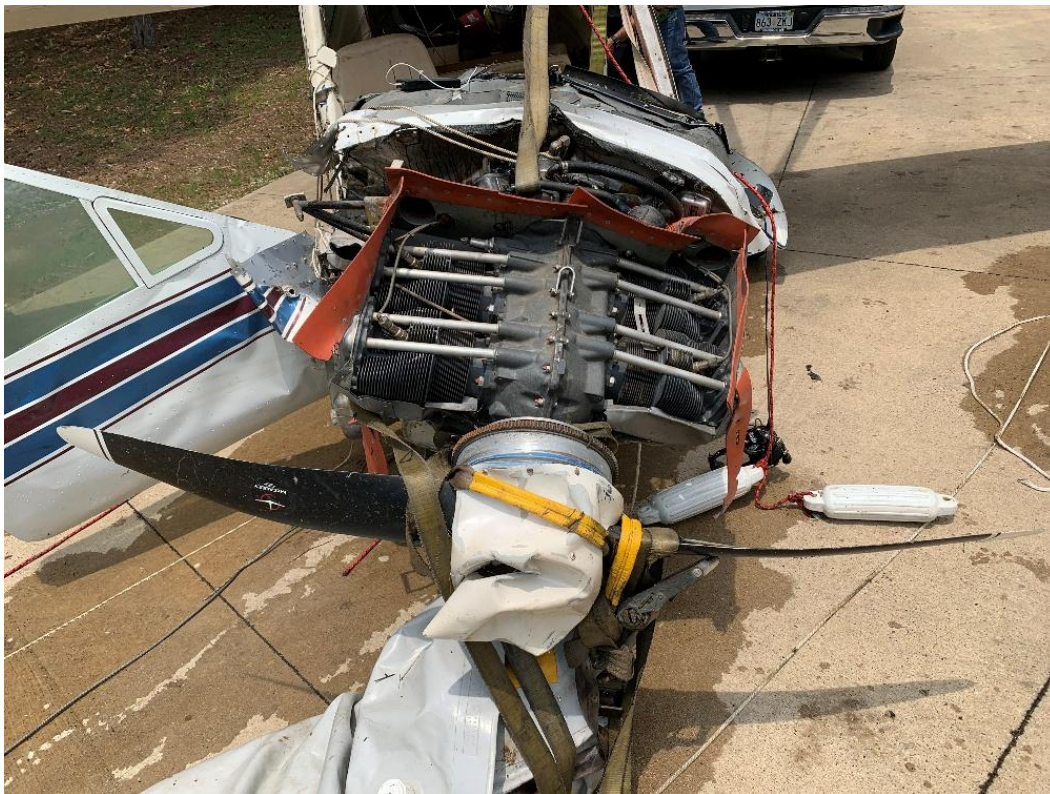
The engine remained attached to the airframe mounts but was displaced aft and down, as shown in figure 5. Internal engine continuity and valve train continuity were confirmed while the crankshaft was rotated. Cylinder compression was confirmed by placing a finger over the open spark plug holes and feeling suction and expelled air from each cylinder while the crankshaft was rotated. Borescope examination of each cylinder did not reveal any anomalies with the cylinders, pistons, valves, or valve seats.

**Figure 5.** Engine and propeller.

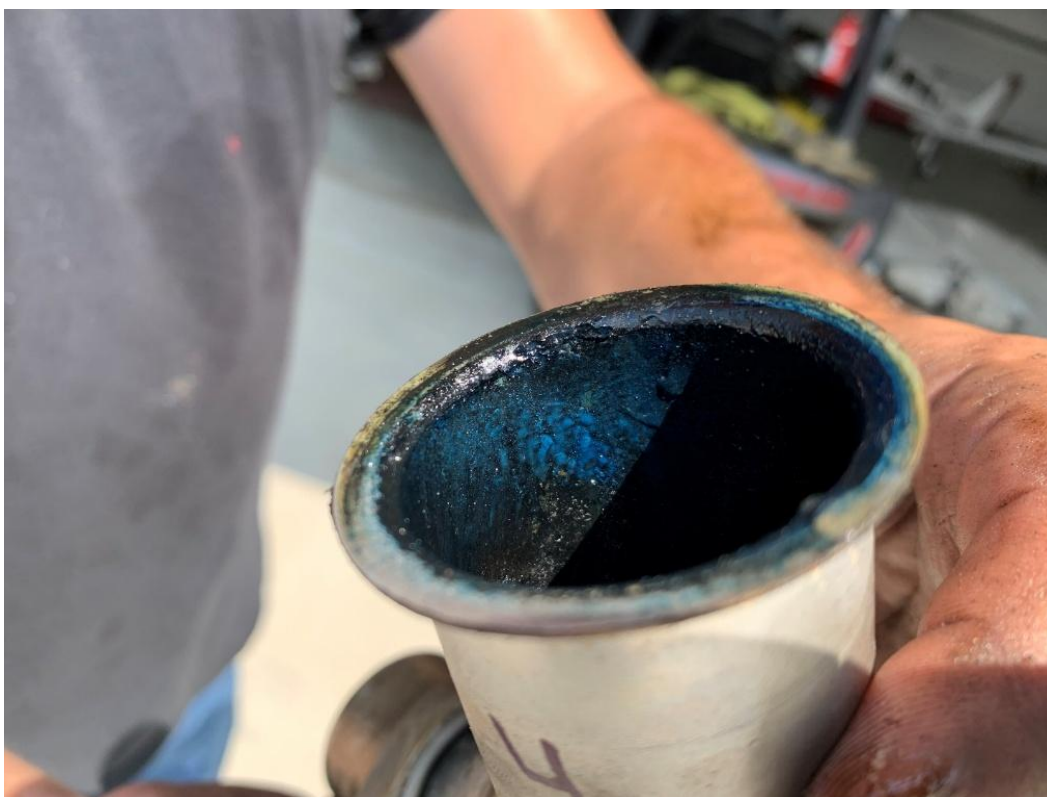
The exhaust and intake tubes were removed to facilitate the engine examination. Sediment was found in one exhaust riser, but no exhaust obstructions were observed. The intake tubes exhibited excessive fuel staining and black deposits in each pipe, an example is shown in figure 6. Fuel staining was also observed on the exterior of the No. 2 cylinder tube at the mounting gasket to the cylinder.

**Figure 6.** Intake tube with fuel staining.

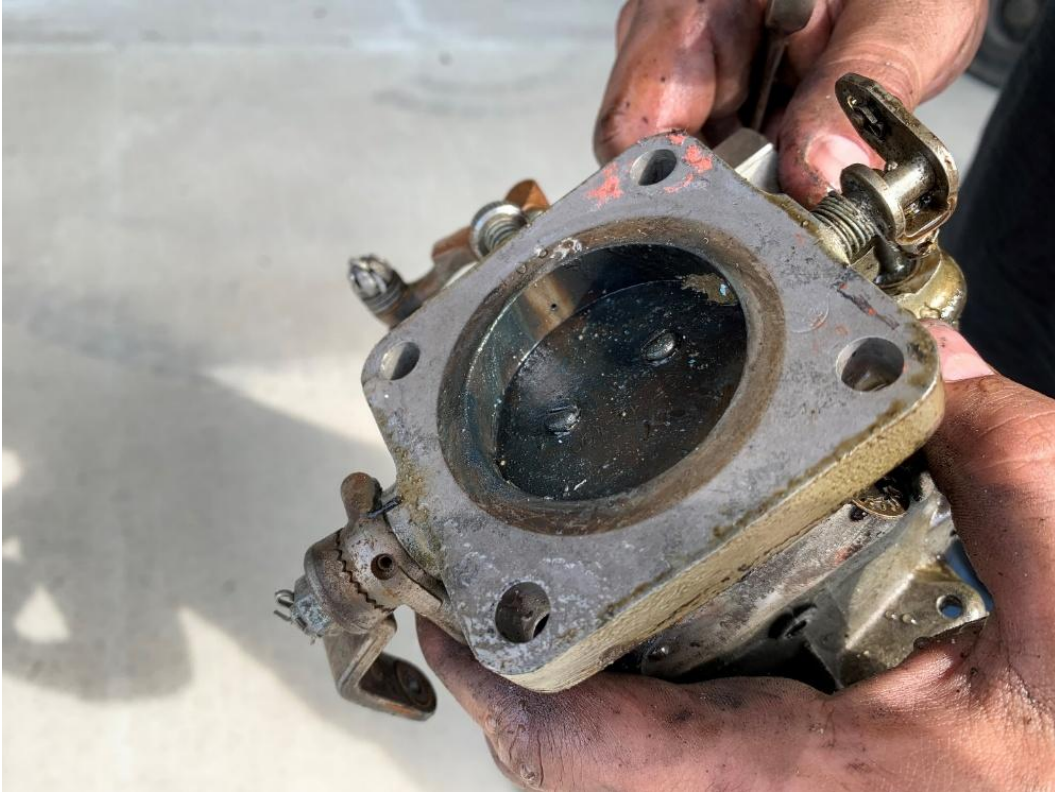
The carburetor was removed for further examination. The throttle plate was mostly closed and had evidence of fuel staining on the back side (engine sump side) of the plate, as shown in figure 7. Fuel staining was only observed on the engine side of the throttle plate. The accelerator pump jettisoned water into the carburetor throat when the throttle arm was actuated. The carburetor fuel inlet screen contained organic debris; however, the fuel inlet line fitting had sheared and exhibited impact-related damage. The metal floats in the fuel bowl exhibited metal hydraulic deformation, as shown in figure 8.

**Figure 7.** Fuel staining on throttle plate and carburetor throat.

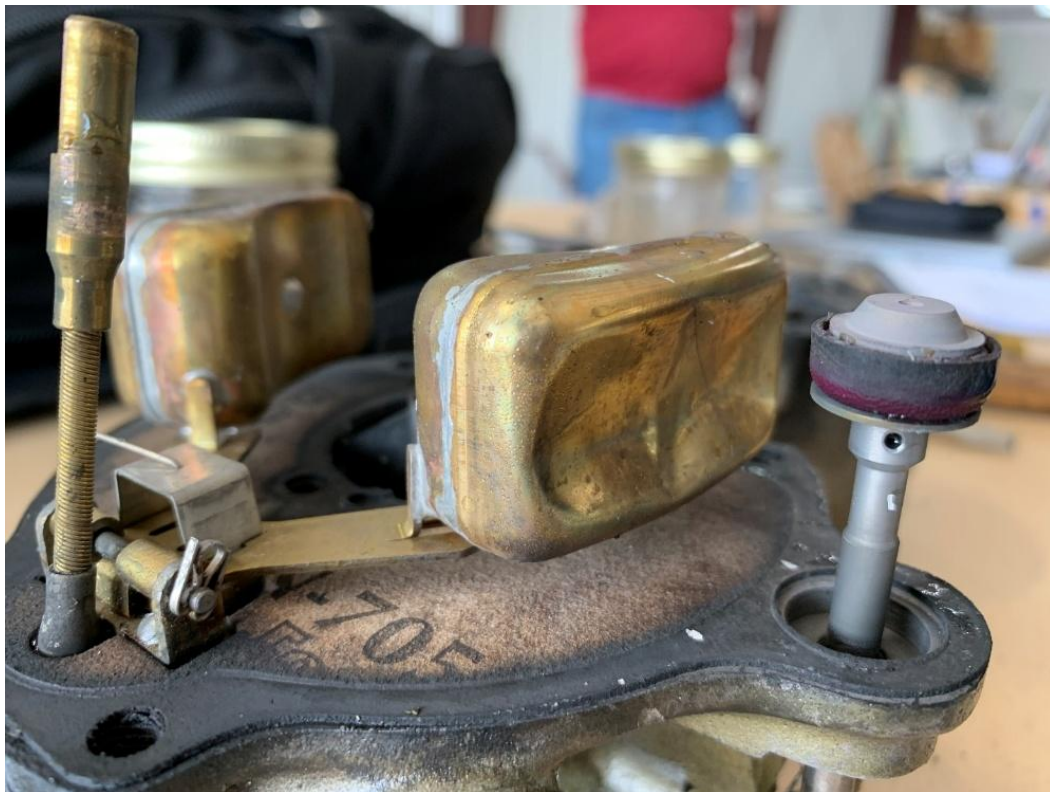
**Figure 8.** Hydraulic deformation to carburetor float.

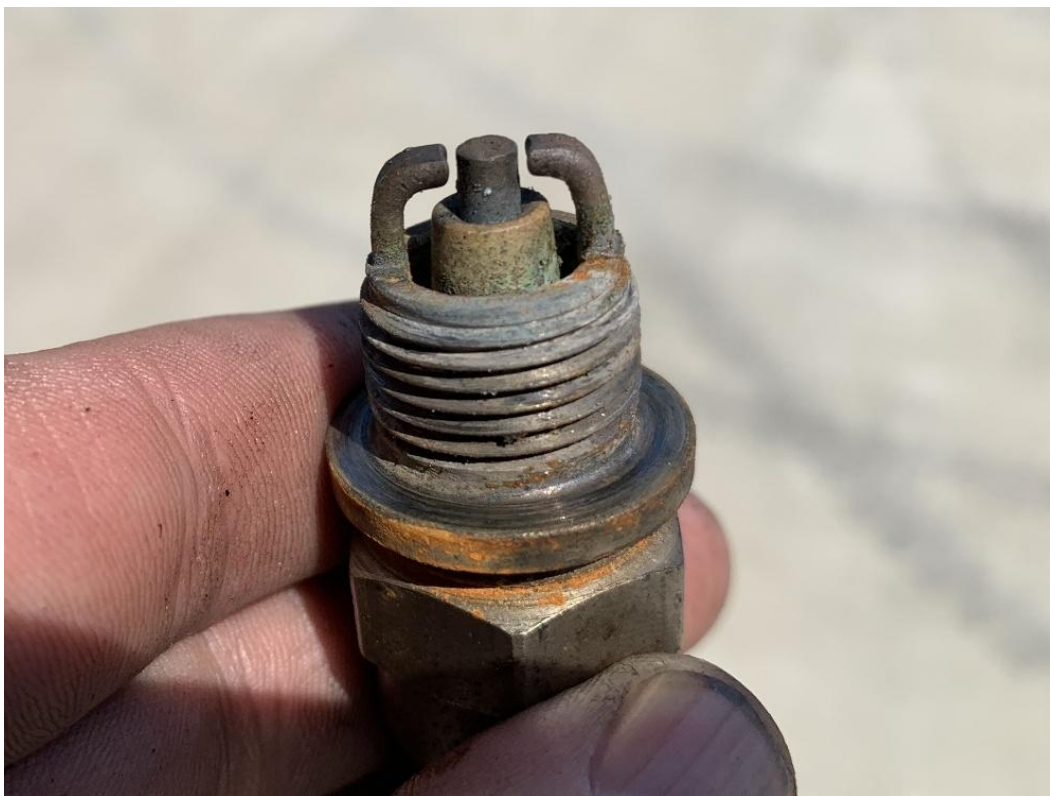
The bottom spark plugs were removed upon the wreckage recovery to the shore on June 27, 2023, to allow water to drain from the cylinder heads. The cylinder No. 3 top spark plug exhibited blue staining on the insulating ceramic, as shown in figure 9. The remaining spark plugs exhibited features consistent with normal engine operation.

**Figure 9.** Cylinder No. 3 top spark plug.

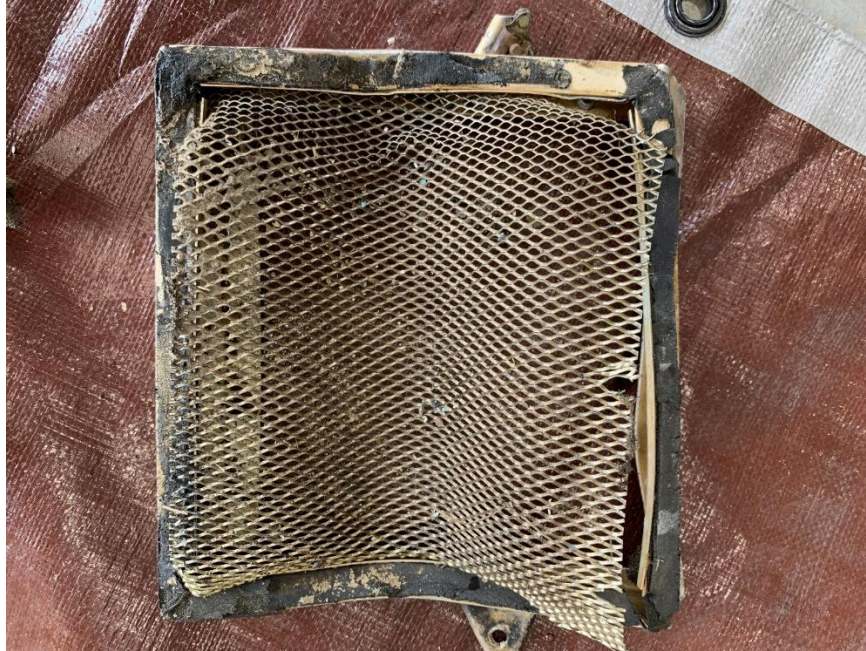
The airplane air filter appeared deteriorated and dirty. The filter was removed and the sealing gasket of the airbox was deteriorated and missing sections of gasket material, as shown in figures 10 and 11.

**Figure 10.** Engine induction filter box and gasket.

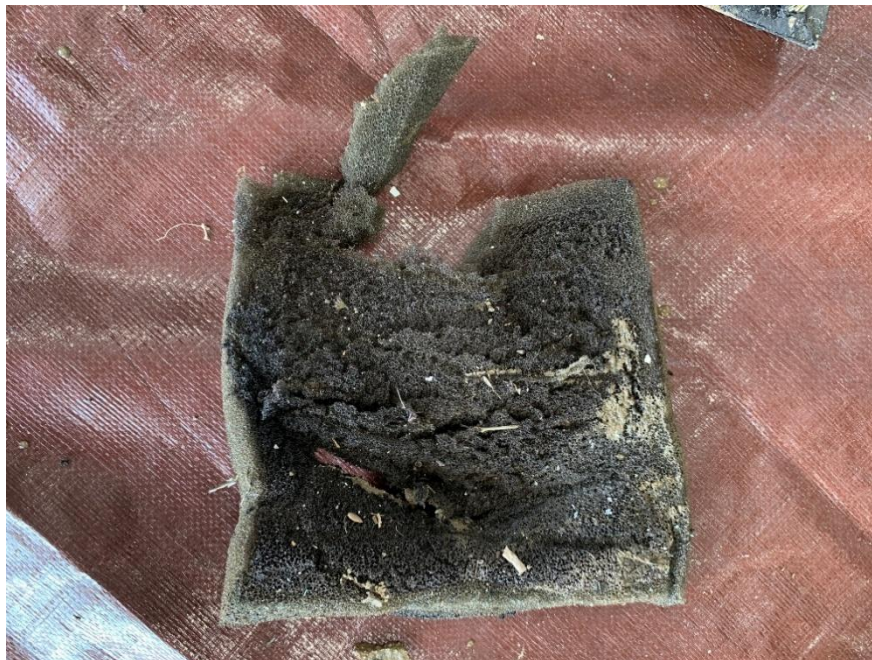
**Figure 11.** Engine induction filter element.

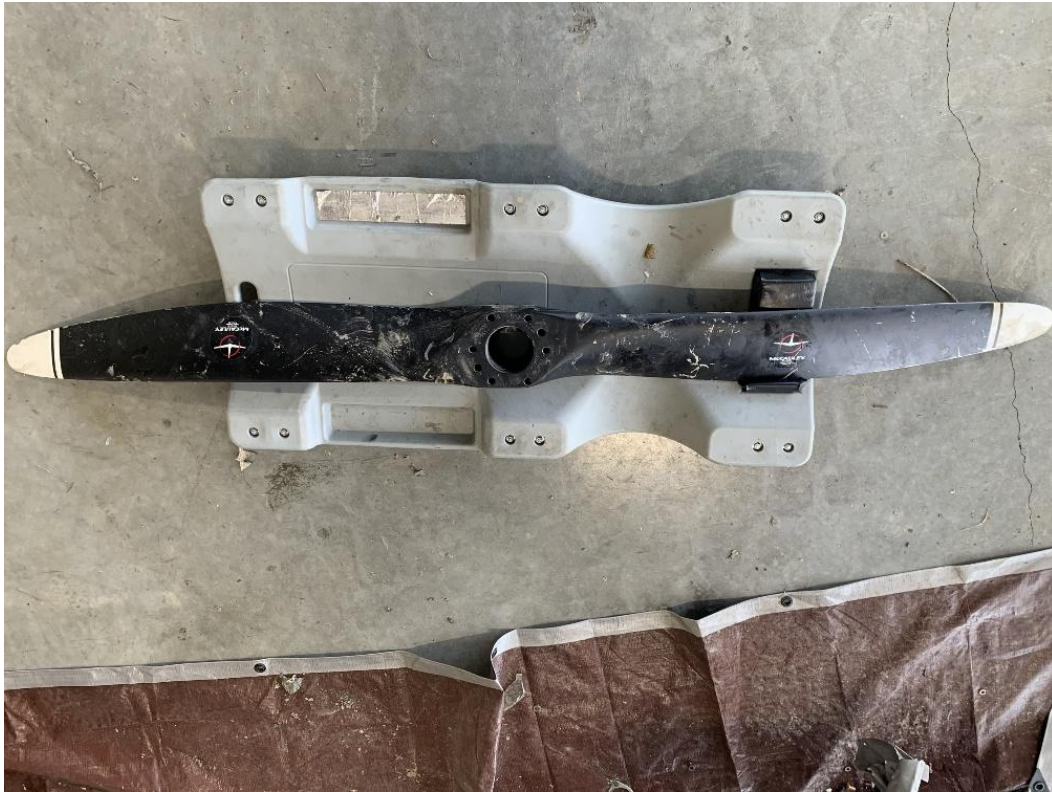
The propeller remained attached to the crankshaft flange and spacer. The spinner displayed fore-to-aft crush damage. The propeller blades exhibited slight twist and light chordwise scratch marks, as shown in figure 12. The leading edge of both propeller blades exhibited minor scratches.

**Figure 12.** Propeller.
