# National Transportation Safety Board

CEN23FA283

## **AIRCRAFT EXAMINATION**

Airplane: Beech A36, N15RP

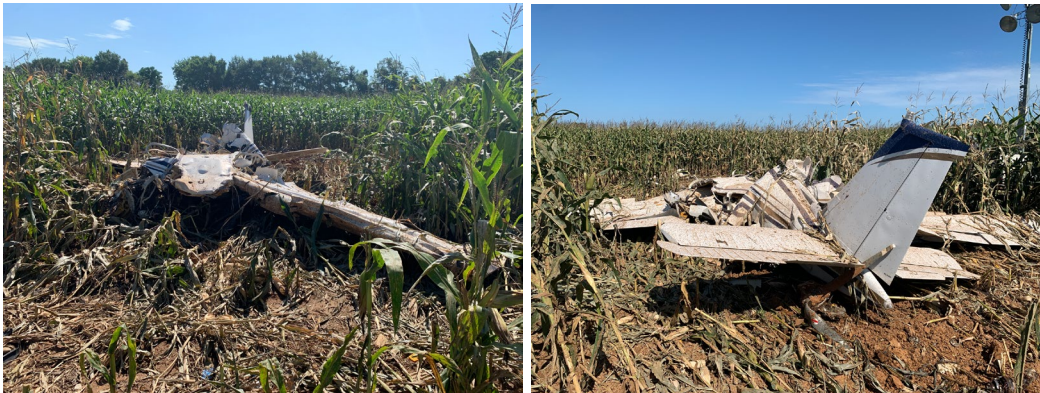
**Figure 1 - Aircraft Wreckage at the Accident Site**

The airplane wreckage was located about 1 mile south of M79 and was destroyed by impact forces shown in Figure 1. The airplane's tail to nose heading was about 268°. Ground scarring and airplane damage was consistent with a nose-down, high-speed impact. Ground scarring began with two main landing gear wheel impressions separated by 7 ft and immediately forward was the impression of the wing leading edges. A 3 ft deep hole followed and preceded the aircraft tail by about 8 ft. The airframe was upright. The nose wheel strut and wheel were found in the hole. Wreckage debris extended about 50 ft forward of the aircraft nose and contained windscreen pieces and avionics.

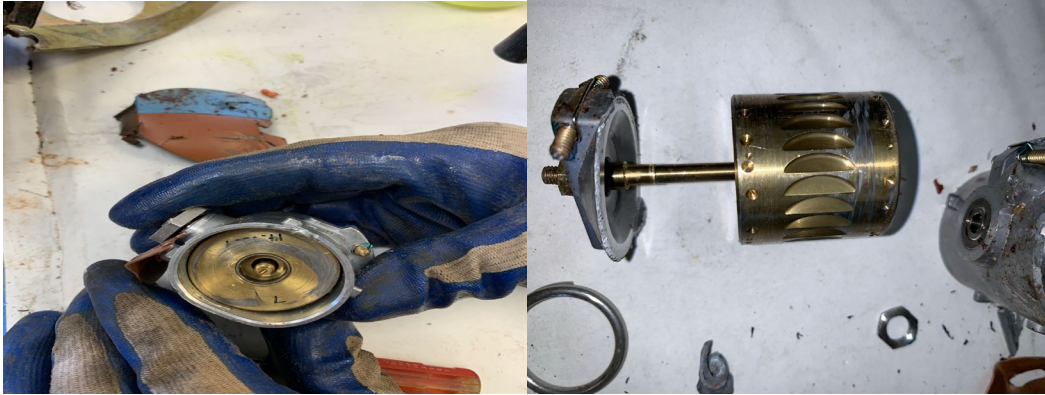
**Figure 2 - Attitude Indicator Housing and Gyro**

The instrument panel and flight and engine instruments sustained accident impact damage. The attitude indicator gyro housing was crushed inward onto the gyro which displayed circumferential scoring consistent with rotation shown in Figure 2.

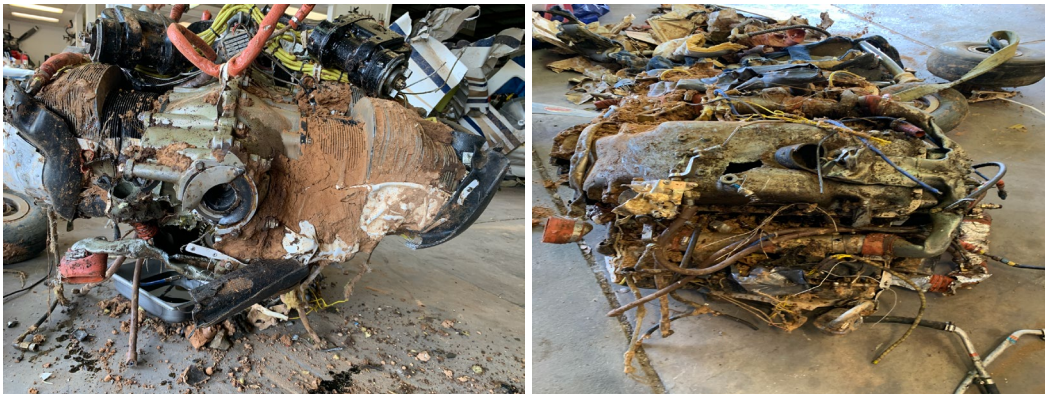
**Figure 3 - Accident Damage to the Engine**

The engine remained attached to the aircraft fuselage and sustained accident impact damage that included damage to the engine oil pan, front portion of the engine case, and both magnetos, which were separated from the engine with their ignition harness attached, shown in Figure 3.

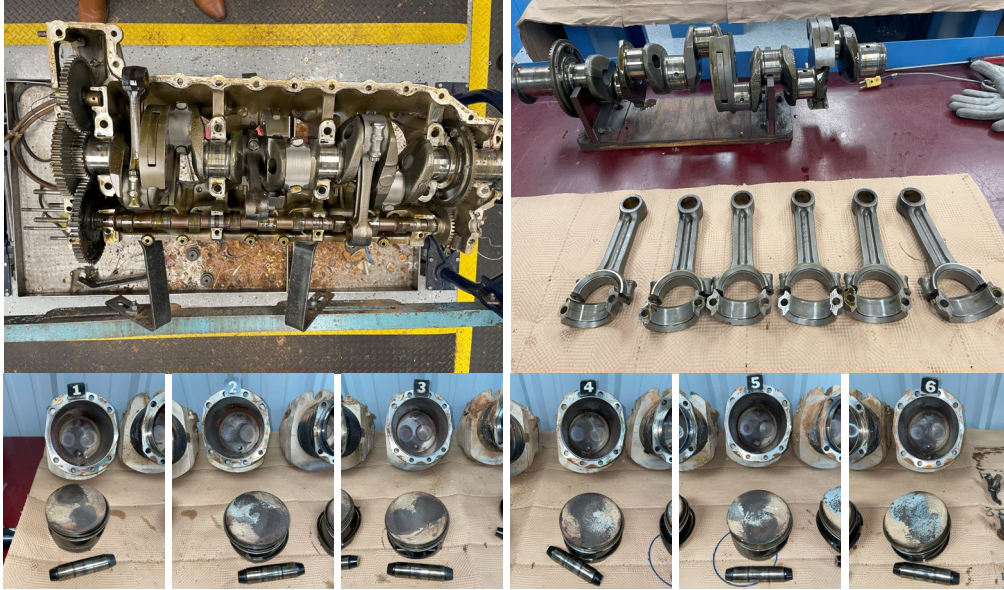
**Figure 4 - Internal Engine Components**

The engine underwent disassembly examination at Continental Aerospace, Mobile, Alabama, under the supervision of the NTSB Accident Investigator-in-Charge. The engine drive train and valve train components were in place and connected, shown in Figure 4. The drive and valve train components did not display features of abnormal engine operation. The top spark plugs, shown in Figure 5, displayed features of normal operation. Both magnetos were tested on a magneto test stand and produced electrical spark in proper sequence. The engine driven fuel pump drive coupling was intact and unbroken and rotated freely without anomaly.

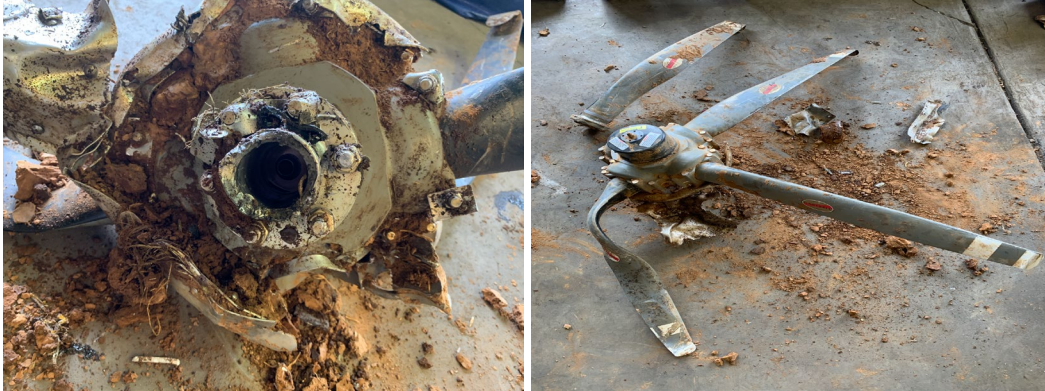
**Figure 4 - Propeller Flange and Blades**

The propeller was separated from the propeller flange and that separation exhibited features of overload separation. The blades display S-shaped twisting and propeller tip curl consistent with engine power production, shown in Figure 4
