**NTSB File No.:** CEN23FA285

**Aircraft:** Piper PA-60-601P Aerostar

## PROPELLER EXAMINATION REPORT

**Aircraft Accident/Incident report No.: 230706**

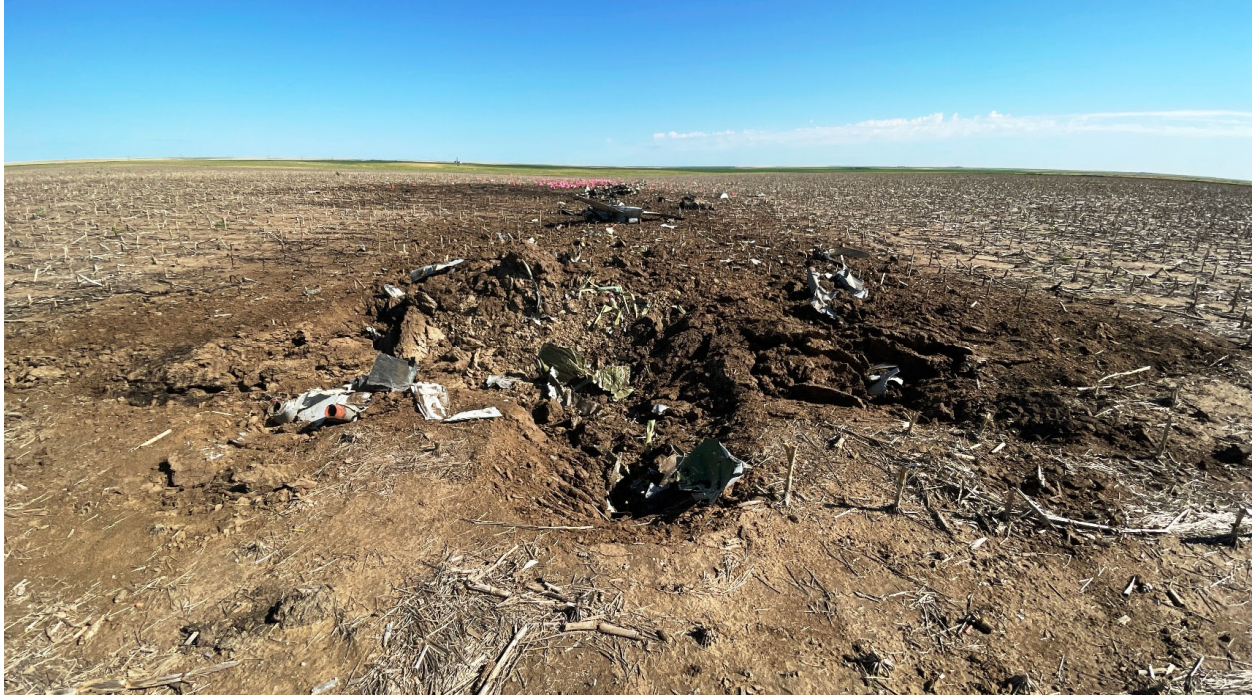
The aircraft impacted into flat, dry, hard-packed, farm field soil (Photo #1). Both propellers separated from their engines at the crankshaft flange during the impact sequence.

Photo #1 – Aircraft impact site and debris field  
(Photo Courtesy of NTSB)

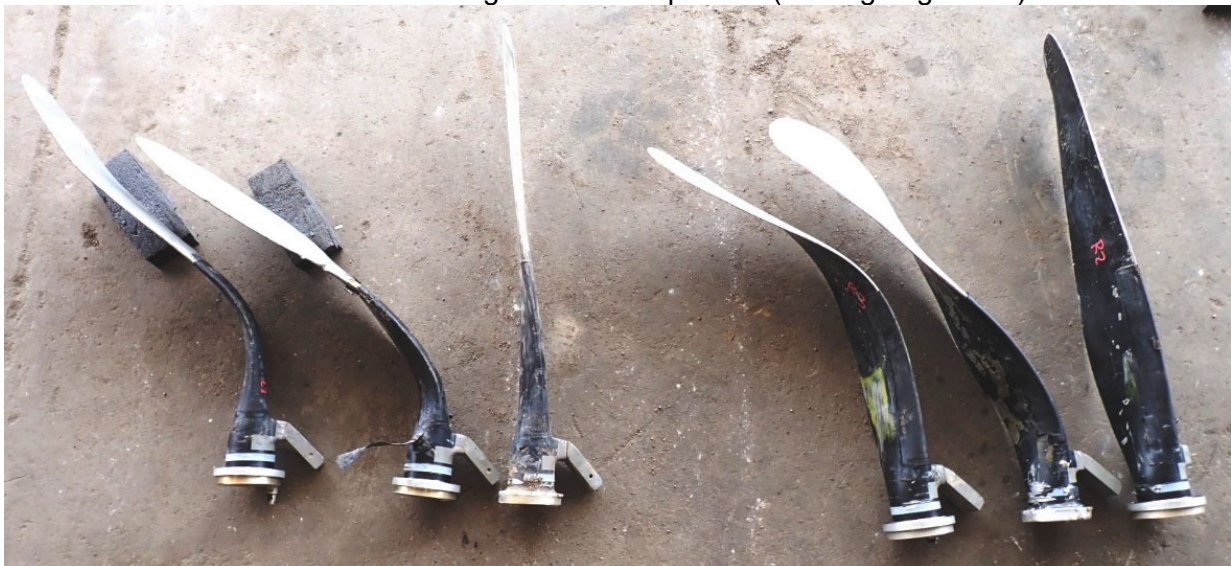
Photo #2 and #3 show a comparison left and right propeller blade bend and twist damage when looking from a leading edge and trailing edge perspective. The blade damage patterns and severity are similar for both propellers suggesting a somewhat symmetrical power condition. Internal impact signatures on both propellers indicated they were operating in a blade angle

Photo #2 - Left vs. Right blade comparison (leading edge view)

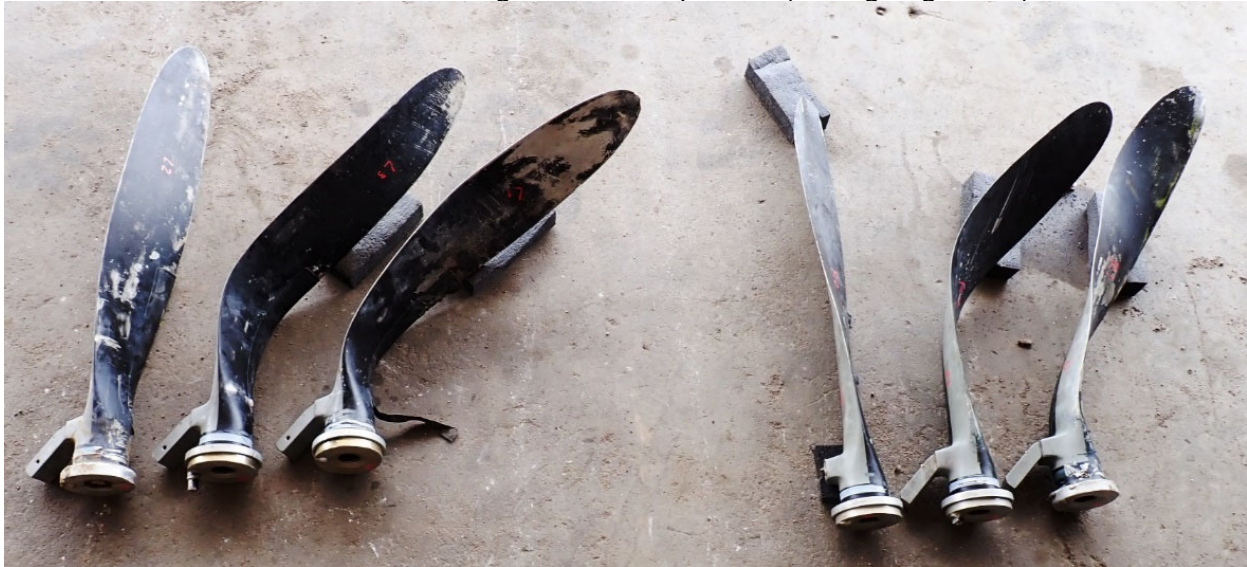
Photo #3 - Left vs. Right blade comparison (trailing edge view)

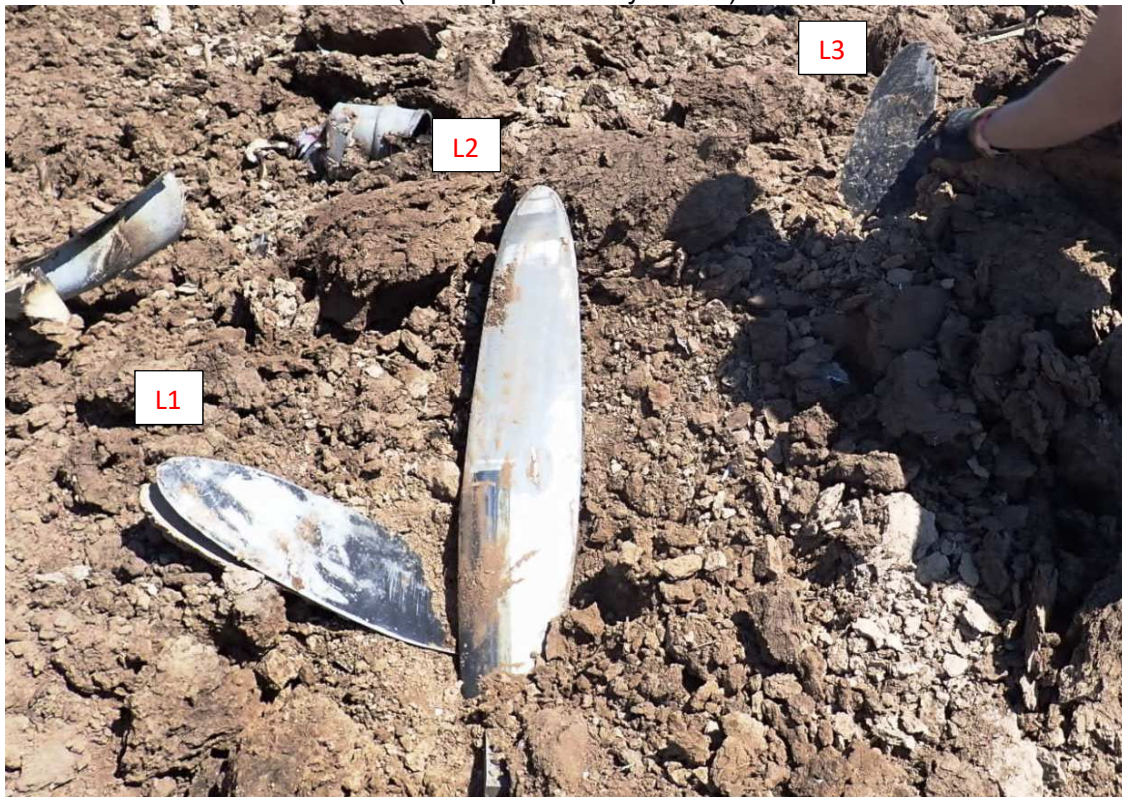
**As Received Condition:** The propeller assembly impact-separated from the engine crankshaft flange during the impact sequence and was found partially buried in terrain near the main impact crater (Photo #4). One blade (L2) impact-separated from the propeller hub and was found lying on the terrain surface near the main propeller assembly. The hydraulic unit (cylinder, piston, feathering spring and pitch stops) also impact-separated and was found on the terrain surface further along the debris field. The spinner dome was impact-separated/torn from the assembly. All six mounting studs remained in the engine crankshaft flange. The propeller was presented for examination as shown in Photo #5. All three blades exhibited chordwise/rotational scorning and leading edge gouging. Blades L1 was bent aft, twisted toward low pitch with remarkable leading edge gouging, and had a remarkable impact mark in the shank trailing edge area where it exits the hub aperture. Blade L3 exhibited S-bending with chordwise/rotational scoring on the face side in the tip region. The blade retention pocket for blade L2 was fractured in the aft direction and the L2 bearing retention lip was partially fractured. The L2 pitch change knob was also fractured from the butt of the blade. All three counterweights remained attached to their respective blades.

Photo #4 - Left propeller in-situ  
(Photo provided by NTSB)

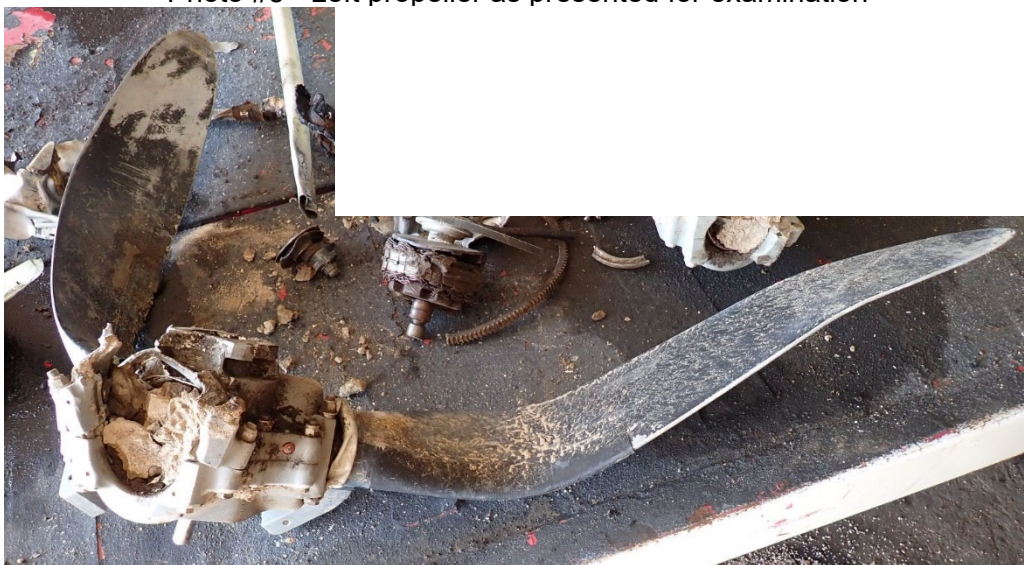
Photo #5 - Left propeller as presented for examination

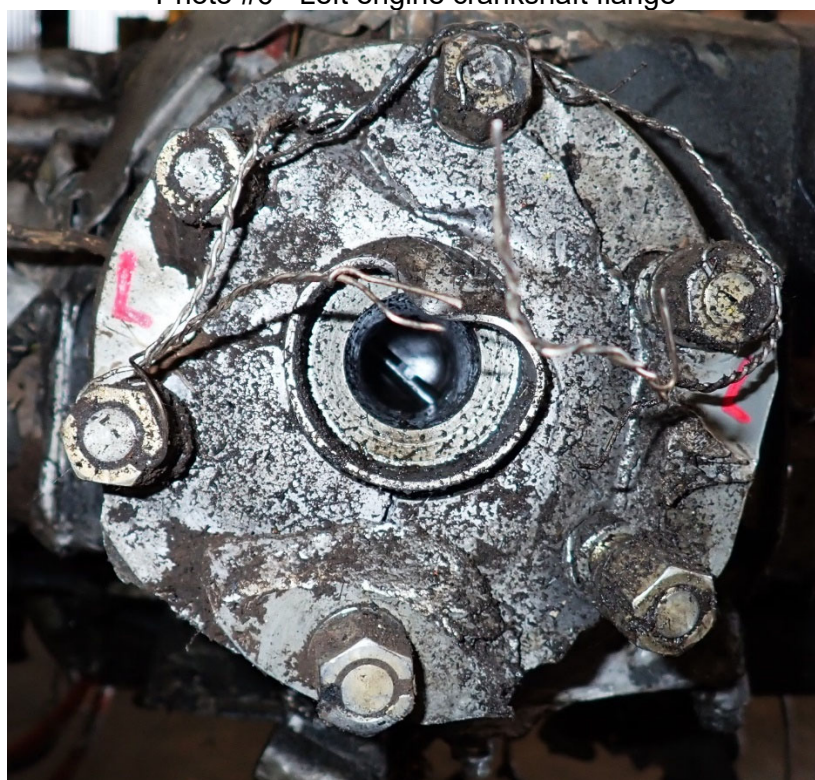
**Engine/Propeller Mounting:** The engine crankshaft flange remained attached to the crankshaft with all six propeller mounting studs attached (Photo #6). The crankshaft pilot bore lip was bent. The propeller hub mounting flange feet were fractured from the hub (Photo #7).

Photo #6 - Left engine crankshaft flange

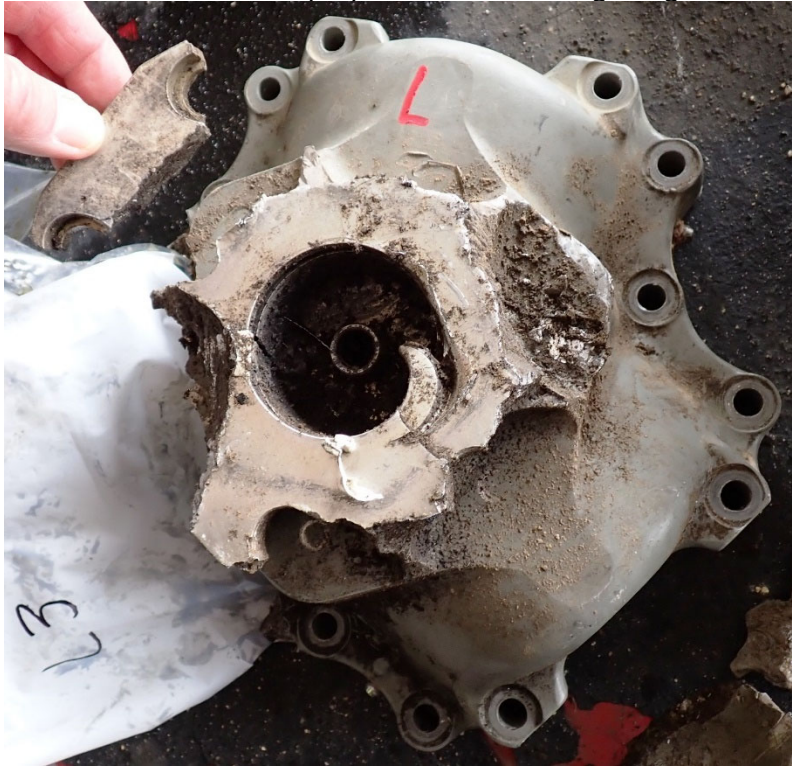
Photo #7 - Left propeller hub mounting flange

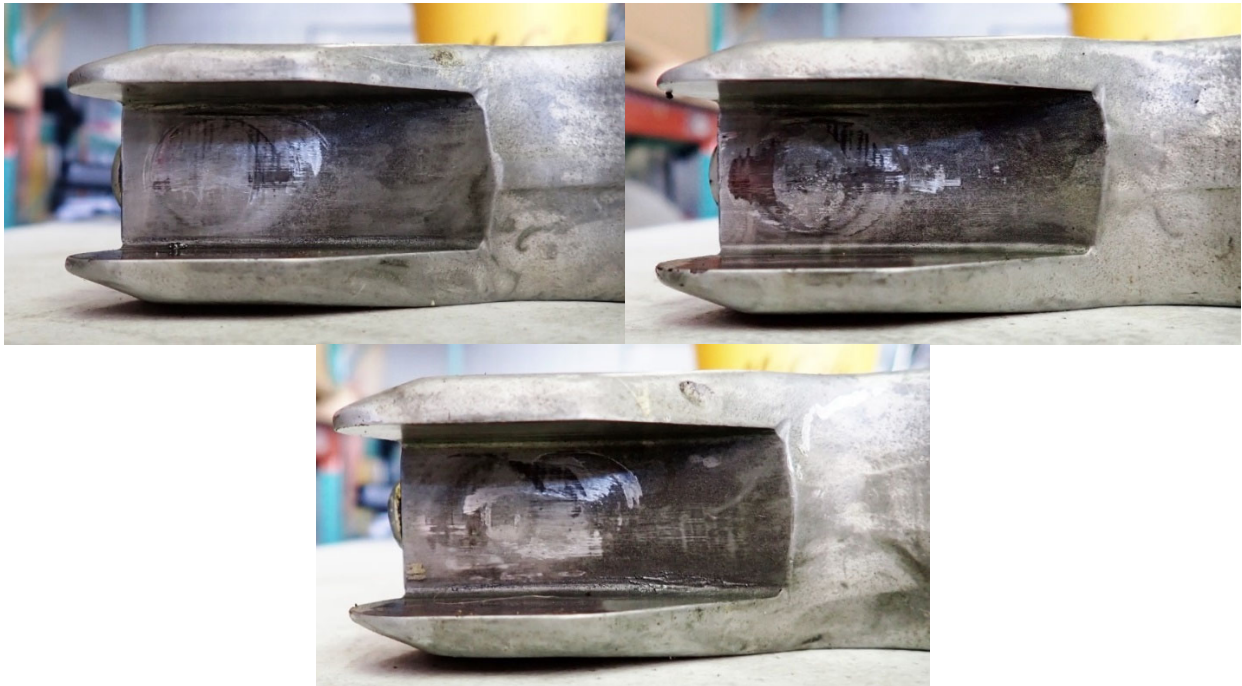
**Fork:** The fork was found loose in the hub. The pitch change rod had fractured from the fork on both the forward and aft sides. The fork was intact with no remarkable fractures seen in the slots/tangs. There were pitch change knob block marks in all three slots representative of blade angles in normal range of operation (Photo #8).

Photo #8 - Left fork slots

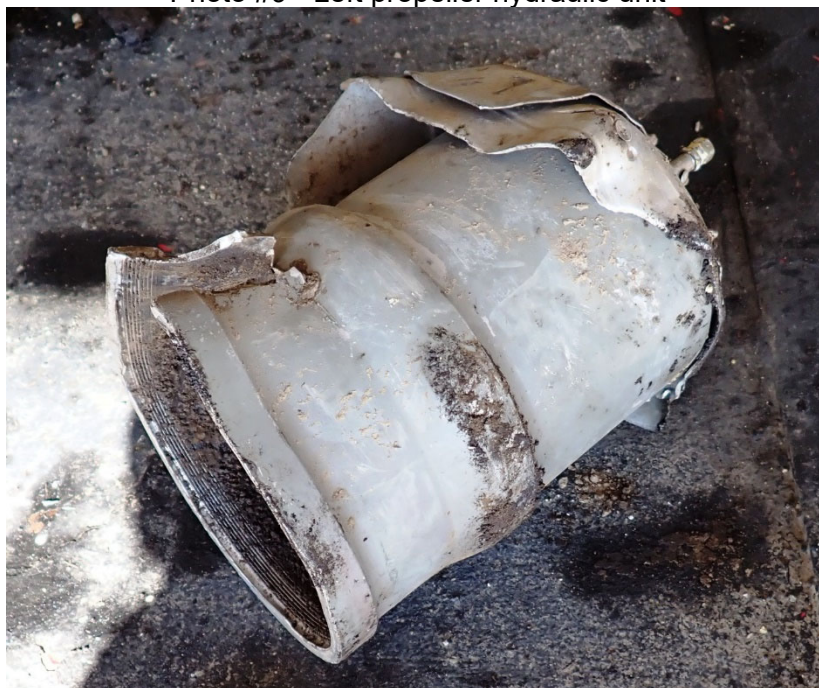
**Cylinder:** The cylinder impact-separated from the propeller assembly and the threaded area was bent and partially torn (Photos #9 and #10). The piston, feathering spring and pitch stop

Photo #9 - Left propeller hydraulic unit

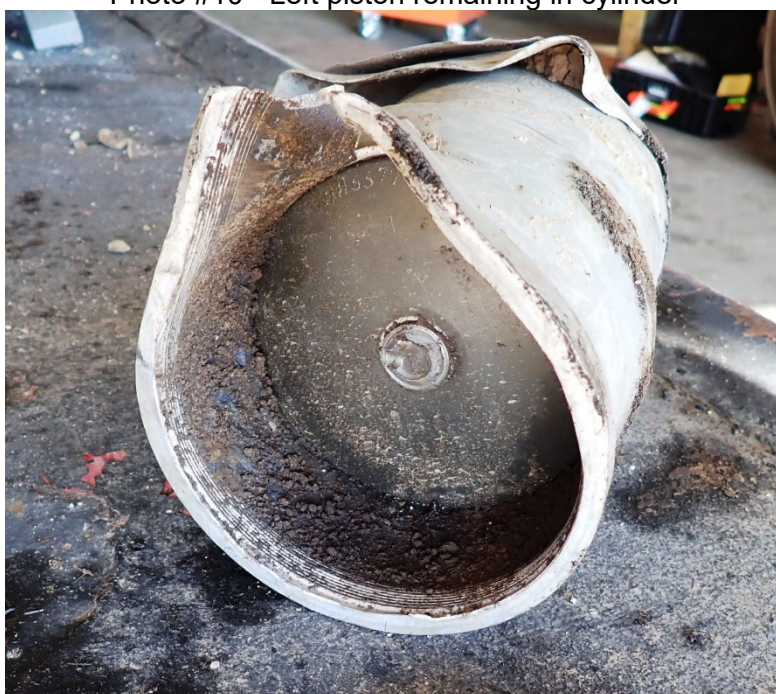
Photo #10 - Left piston remaining in cylinder

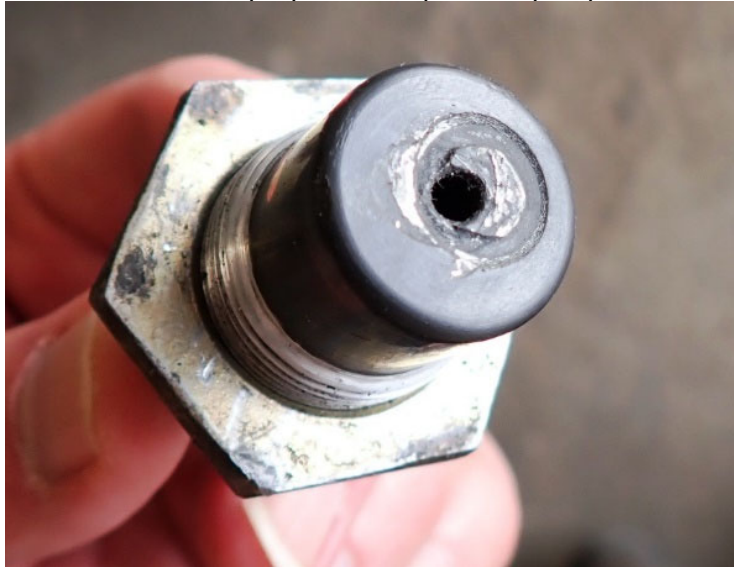
| <b>Low Pitch Stop:</b> | The low pitch stop assembly was intact with the air valve and cap still attached. The face of the low pitch stop exhibited contact damage from the cap screw (Photo #11). The pitch stop stack appeared intact and secure when viewed through the low pitch stop hole (Photo #12) |

Photo #11 - Left propeller low pitch stop impact mark

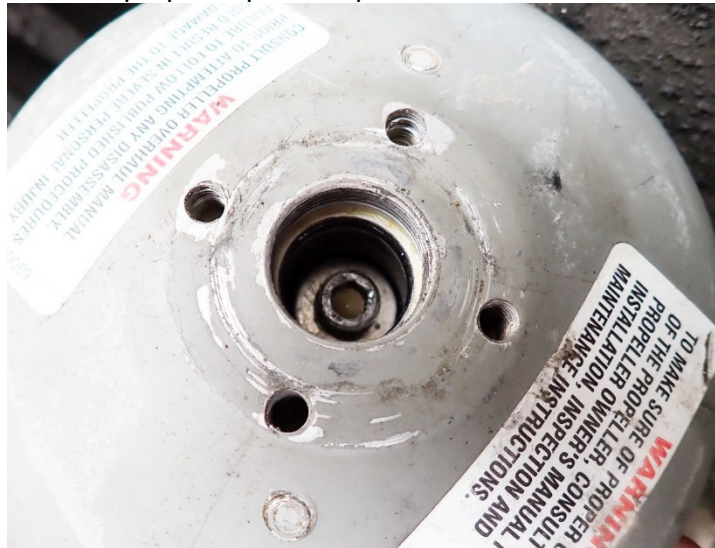
| <b>Feather Stop:</b> | The hydraulic unit was not disassembled due to damage and safety concerns. The feather stop washer appeared intact (Photo #12). |
| <b>Start Lock:</b> | The forward pitch change rod with the pitch stop stack appeared loaded on the start lock assembly and sleeve when viewed through the low pitch stop hole (Photo #12). |

Photo #12 - Left propeller pitch stop stack intact and near the start lock

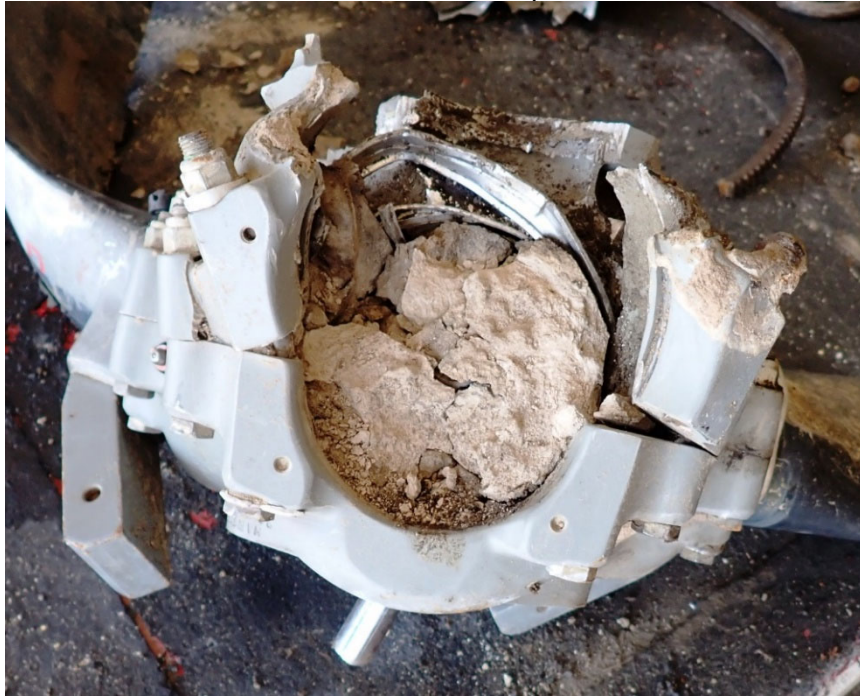
**Hub Assembly:** The hub assembly was fractured at the mounting flange, the L2 blade retention pocket and the cylinder mounting boss were fractured (Photos #13 through #16). All of the hub thru-bolts were present but those around the L2 retention arm were bent (Photos #14 and #15). The preload shelves and webs of all three blades were marred and/or fractured. The bearing retention radius for L2 on the forward hub was fractured. There was a crack in the aft hub wall between the L2 and L3.

Photo #13 - L2 blade retention pocket fractured

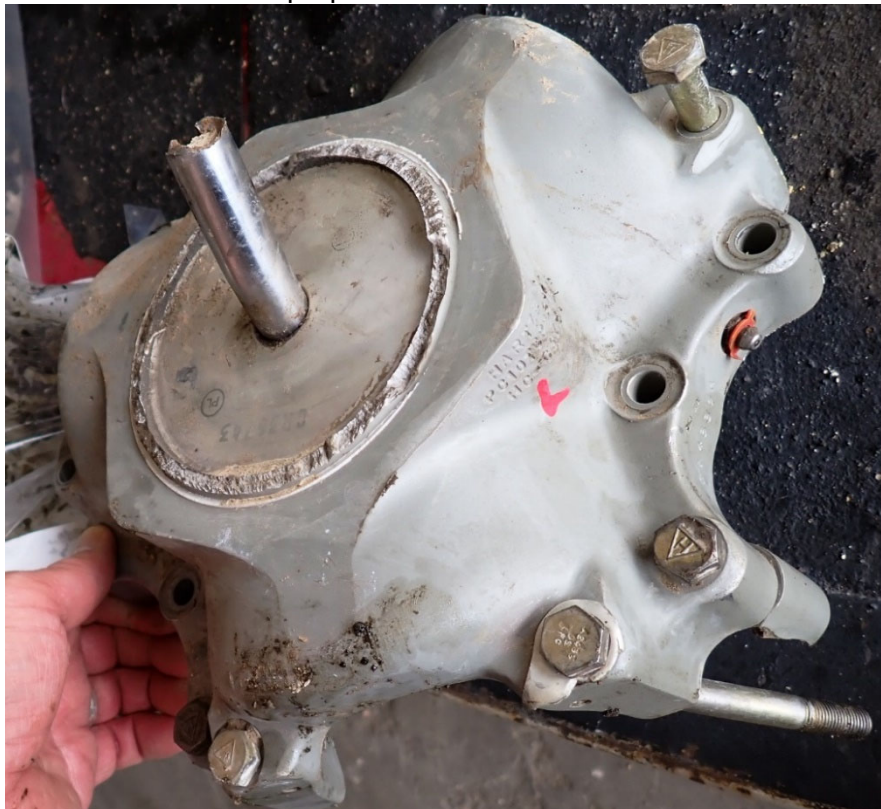
Photo #14 - Left propeller forward hub half – external view

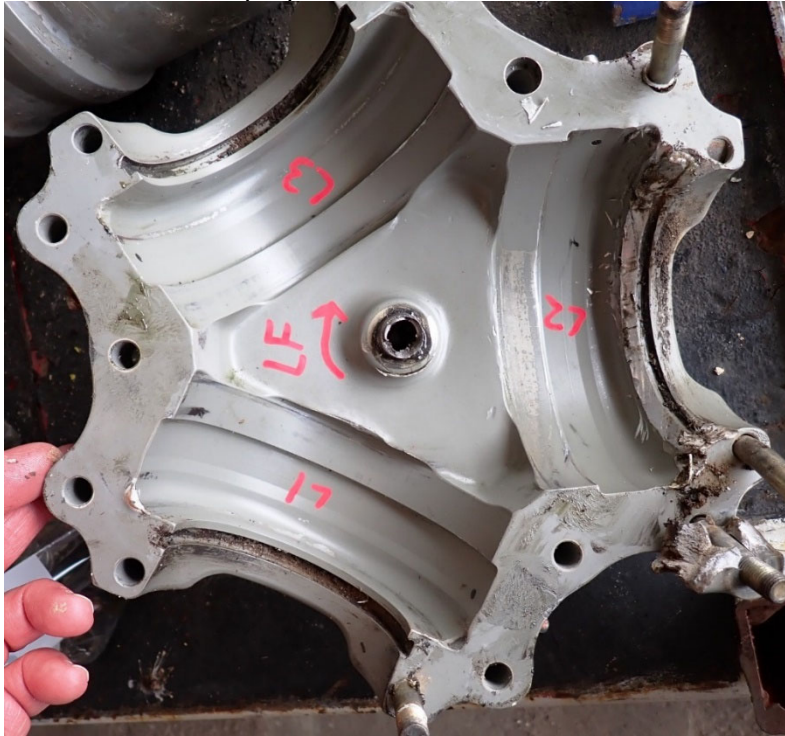
Photo #15 - Left propeller forward hub half – internal view

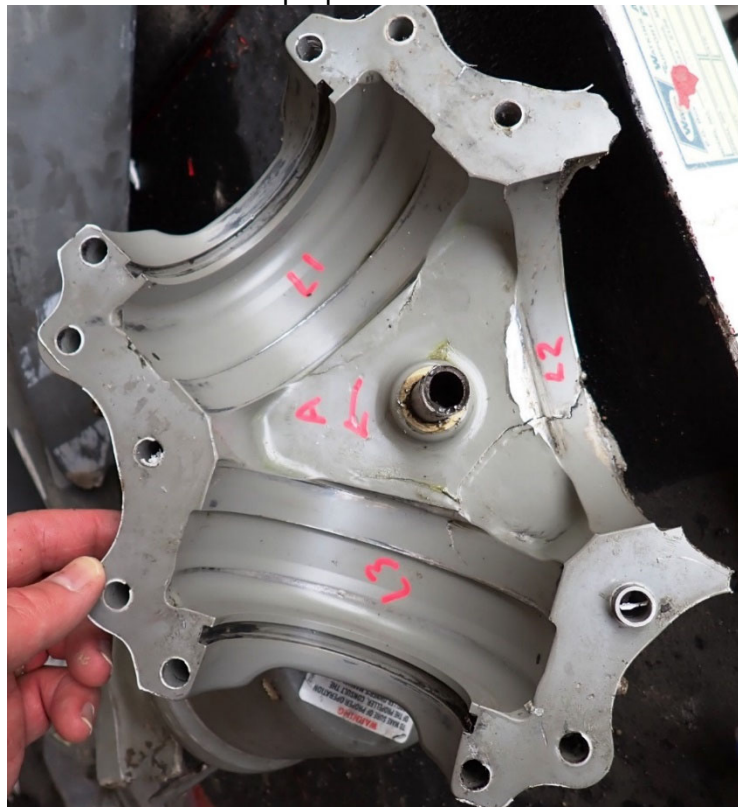
Photo #16 - Left propeller aft hub – internal view

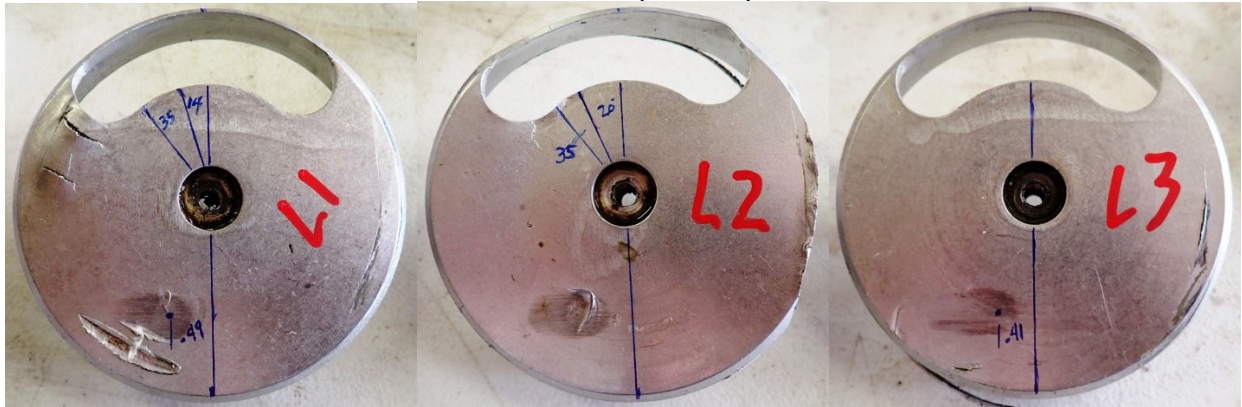
**Preload Plates:** For this propeller model, when the blade knob is aligned with the hub parting line, the blade angle at the reference station is approximately  $48.5^\circ$  (knob  $12^\circ + 36^\circ$  constant + 3-blade delta of  $0.5^\circ = 48.5^\circ$ ). All three preload plate lips were sheared and smashed and had impact damage on the aft/face side where the plate rests against the aft hub web. All three plates had fork impact marks in the lower ( $<48^\circ$ ) blade angle range of normal operation (See Table below and Photo #17).

| Preload Plate | Condition |
|---|---|
| L1 | The forward/low pitch end of the knob slot was fractured by the remnants of the pitch change knob forcefully rotated under the plate. There were pitch change knob marks in the slot at 35° and 14° forward of the split line. There was a circular, fork bumper mark at 0.49" forward of the split line. |
| L2 | The plate was distorted and aft sidewall of the plate was fracture-separated. The forward/low pitch end of the knob slot was fractured by the remnants of the pitch change knob forcefully rotated under the plate. There were pitch change knob marks in the slot at 35° and 20° forward of the split line. |
| L3 | There was a circular, fork bumper mark at 0.41" forward of the split line. |

Photo #17 - Left preload plates

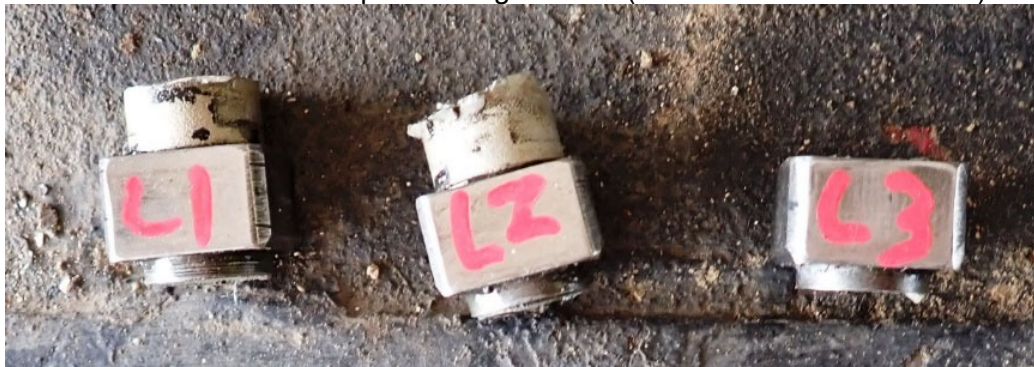
| Knob condition | Fractured (Photo #18) |

| Knob condition | Fractured (Photo #18) |

Photo #18 - Left blade pitch change blocks (L1 and L2 knobs fractured)

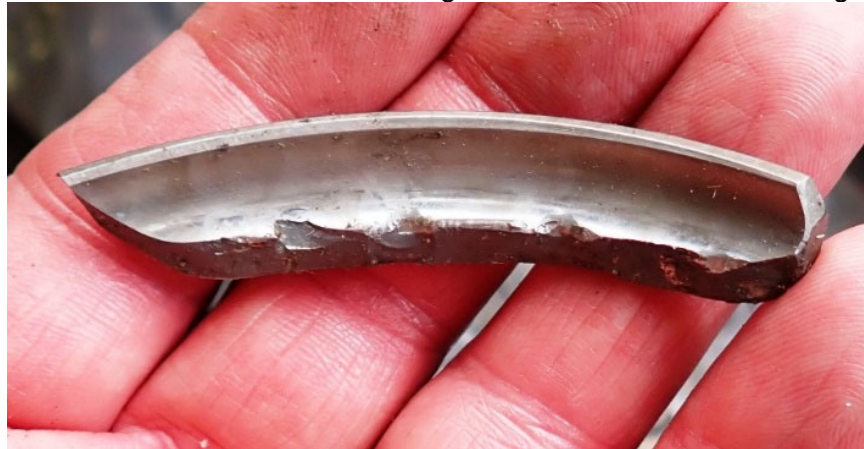
| Blade bearings | Some of the bearing races and balls separated from assembly when the blade separated. One bearing race fragment remained in the hub and exhibited a fracture with ball imprints consistent with overload. (Photo #19) |

Photo #19 - Left blade retention bearing race fracture with ball bearing marks

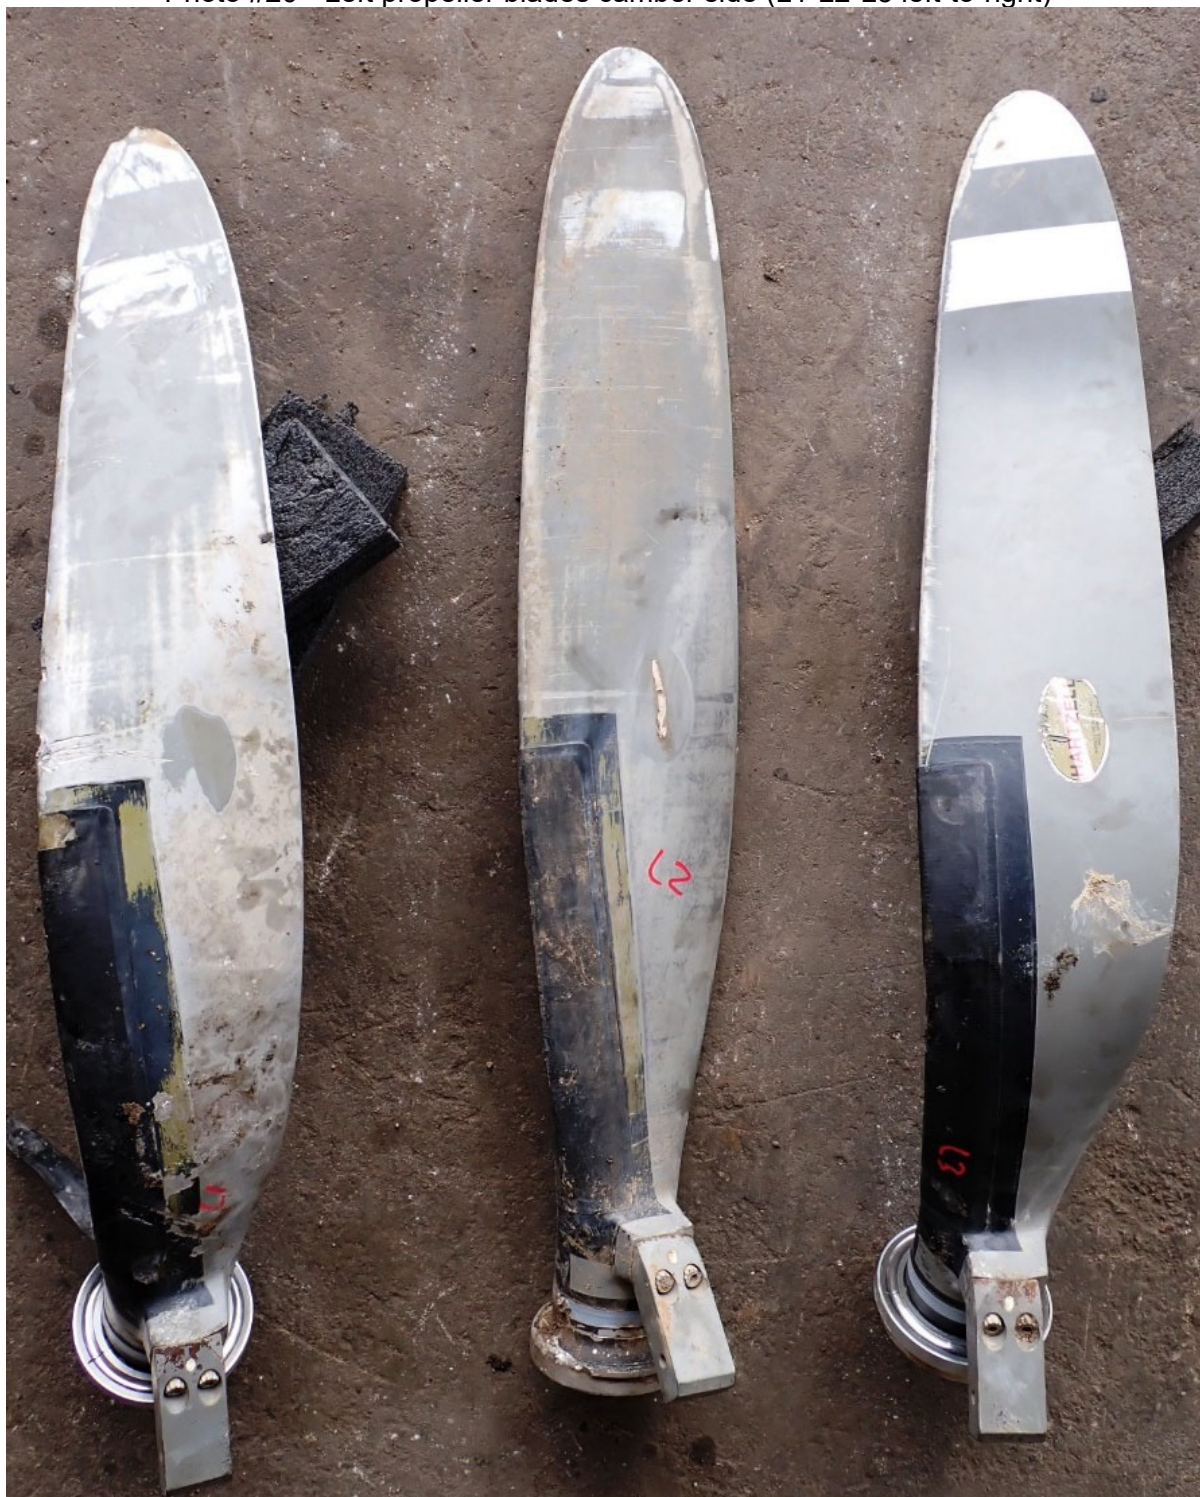
Photo #20 - Left propeller blades camber side (L1-L2-L3 left-to-right)

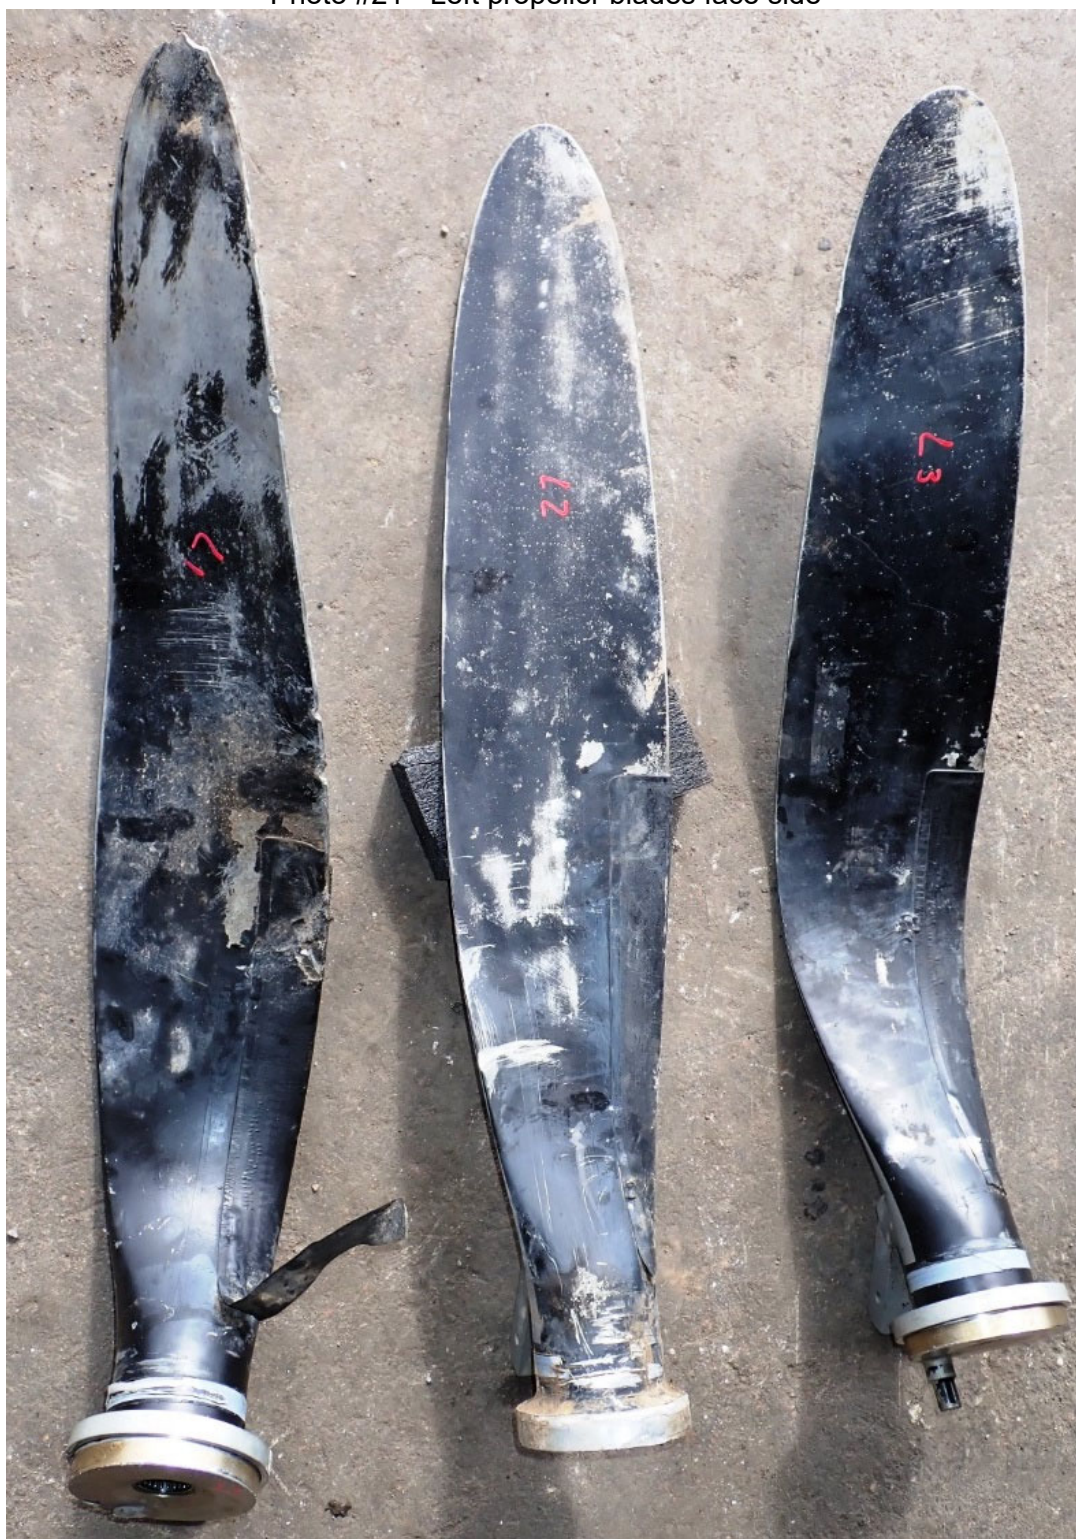
Photo #21 - Left propeller blades face side

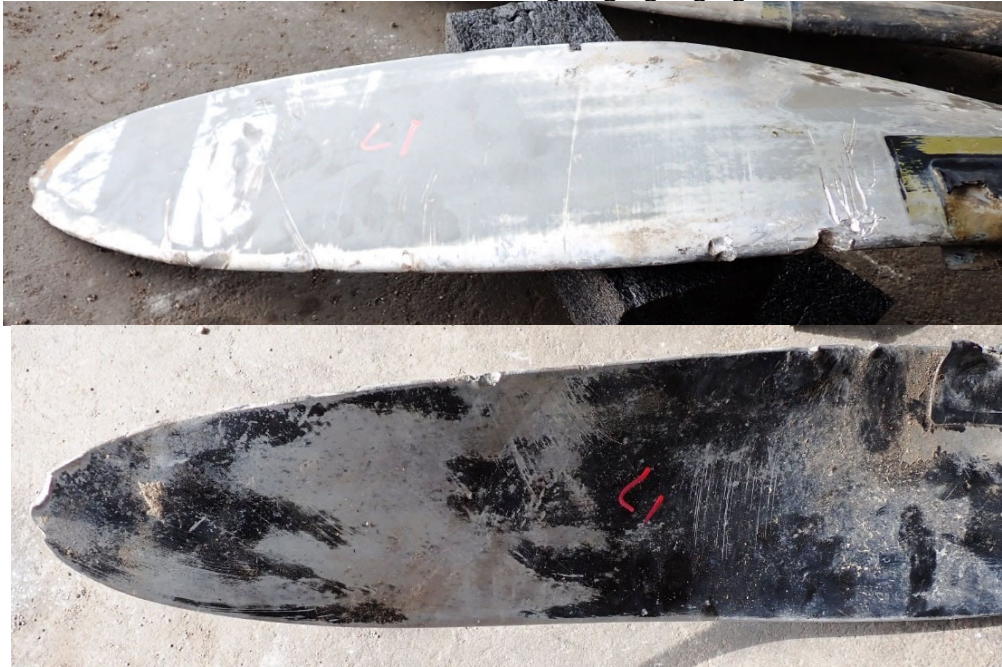
| Lead edge damage | Nicks and gouges (Photo #22) |

Photo #22 - L1 leading edge gouging

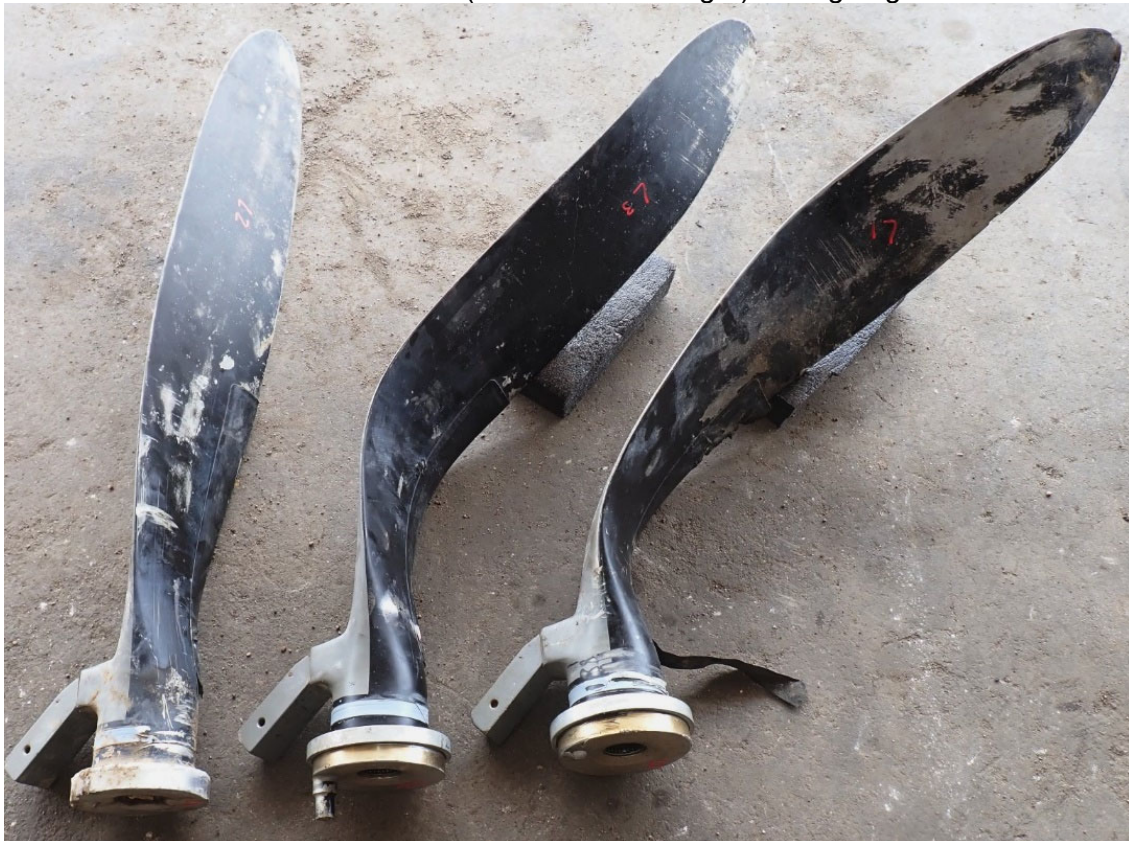
Photo #23 - Left blades (L2-L3-L1 left-to-right) trailing edge view

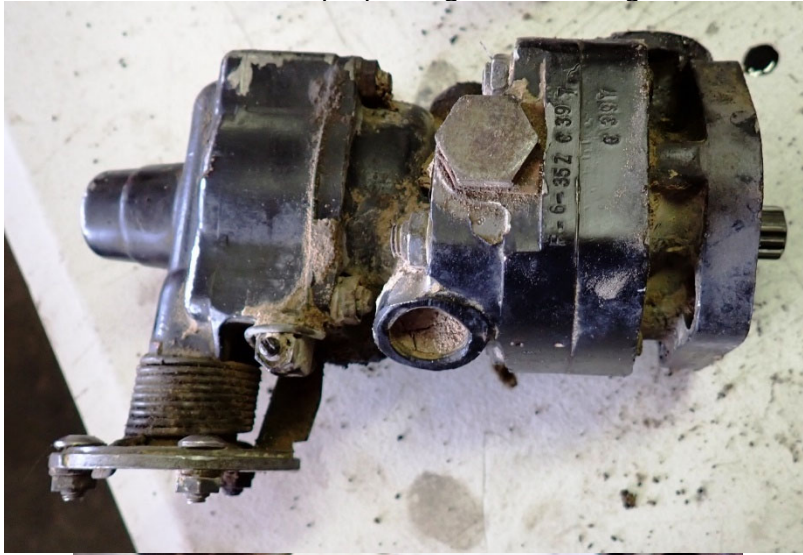
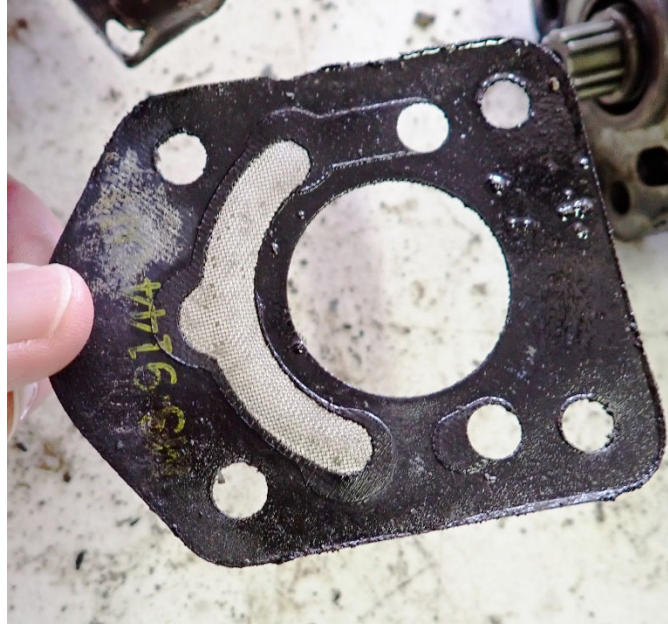
**Propeller Governor:** Model No.: F-6-35Z, Serial Number: C39T (DOM 8/1/1978)  
The left propeller governor remained attached to the engine. It was removed during this examination. The gasket/screen was clear of debris (Photo #24). The pump shaft rotated freely and smoothly. The control arm rotated from the high RPM stop to the feather stop freely and smoothly.

Photo #24 - Left propeller governor and gasket

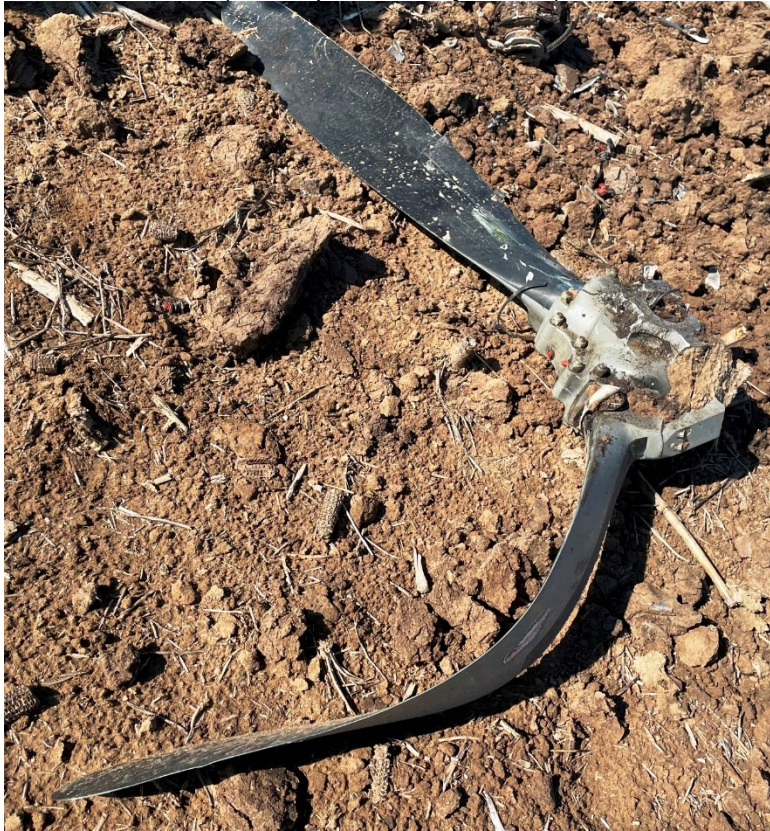
**As Received Condition:** The propeller assembly impact-separated from the engine crankshaft flange during the impact sequence and was found on top of terrain near the main impact crater (Photo #25). One blade (R1) impact-separated from the propeller hub, impaled the turbo intercooler (Photo #28) and was found near the main propeller assembly. The hydraulic unit (cylinder, piston, feathering spring and pitch stops) also impact-separated and was either not recovered or presented for examination. The spinner dome was impact-separated/torn from the assembly. Five mounting studs with nuts attached remained in the engine crankshaft flange and the sixth stud was fractured. The propeller was presented for examination as shown in Photo #26. All three blades exhibited chordwise/rotational scorning and leading edge nicks. Blades R1 and R3 were bent aft, bent opposite rotation and twisted toward low pitch. Blade R2 did not exhibit any remarkable bend or twist. The blade retention pocket for blade R1 was fractured in the aft direction. The aft hub was fractured between R2 and R1 retention pockets. The counterweight for R2 impact-separated and the counterweights for R1 and R3 remained attached to their respective blades.

Photo #25 - Right propeller in-situ  
(Photo provided by NTSB)

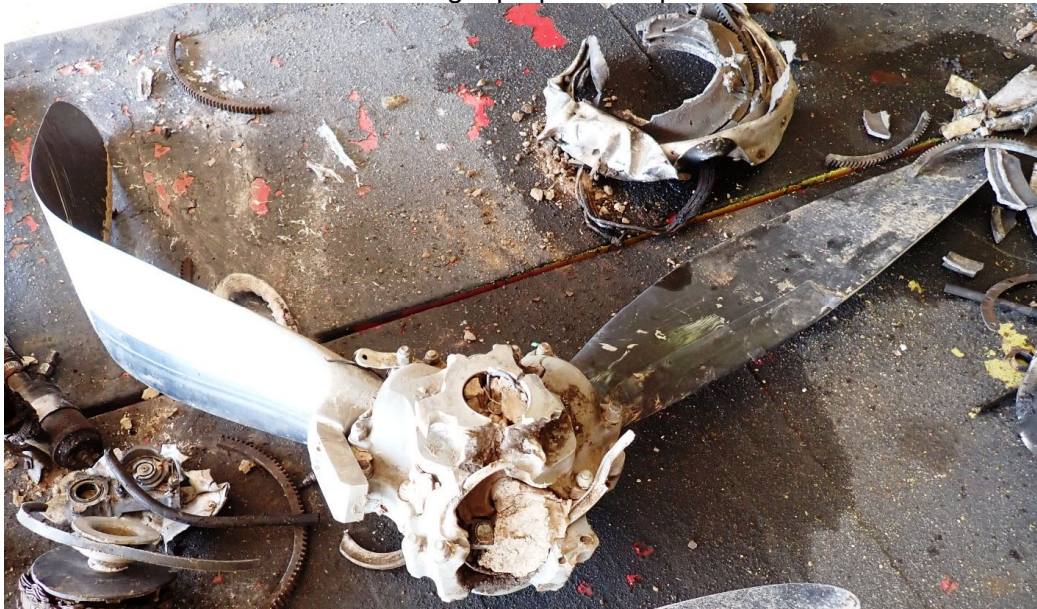
Photo #26 - Right propeller as-presented

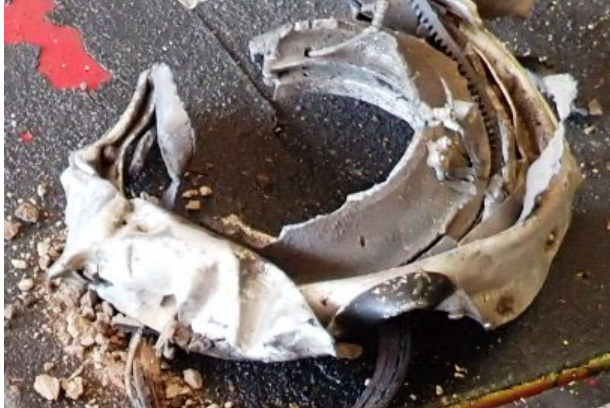
Photo #27 - Propeller spinner assembly remnants

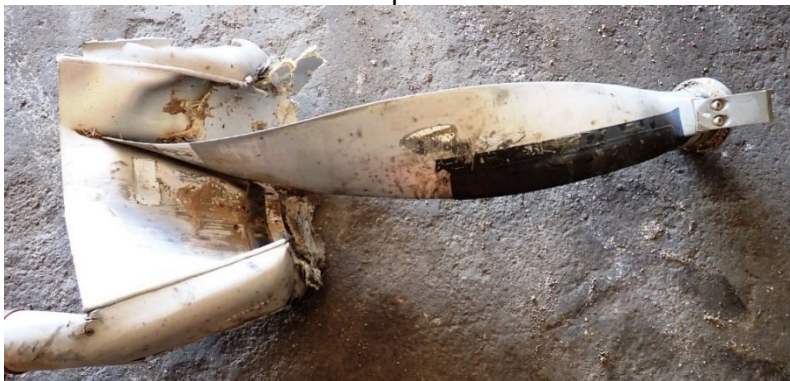
Blade # R1- Impact separated from the assembly and impaled the turbo intercooler (Photo #28)

Photo #28 - Blade R1 impaled the turbo intercooler

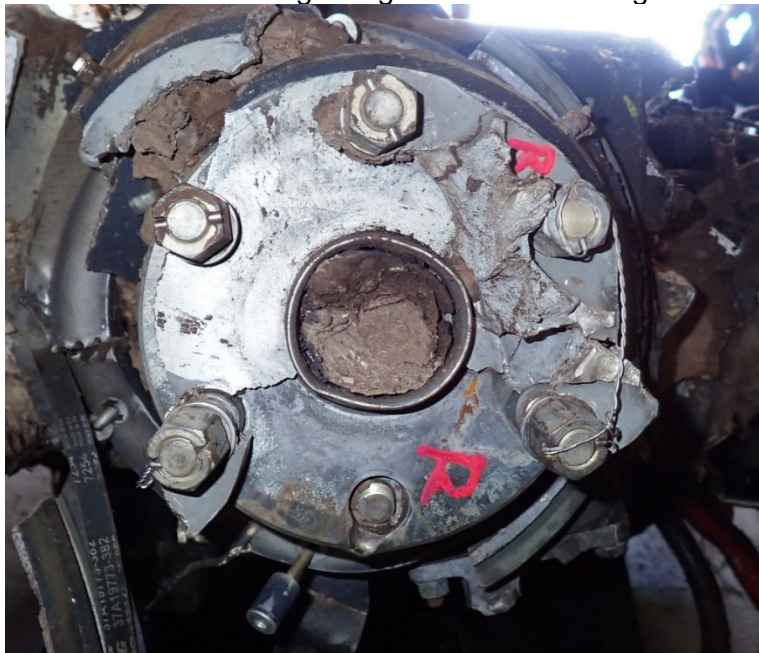
**Engine/Propeller Mounting:** The engine crankshaft flange remained attached to the crankshaft with all portions of all six propeller mounting studs attached (Photo #29). The crankshaft pilot bore lip was bent and packed with earthen debris. The propeller hub mounting flange feet were fractured from the hub (Photo #30).

Photo #29 - Right engine crankshaft flange

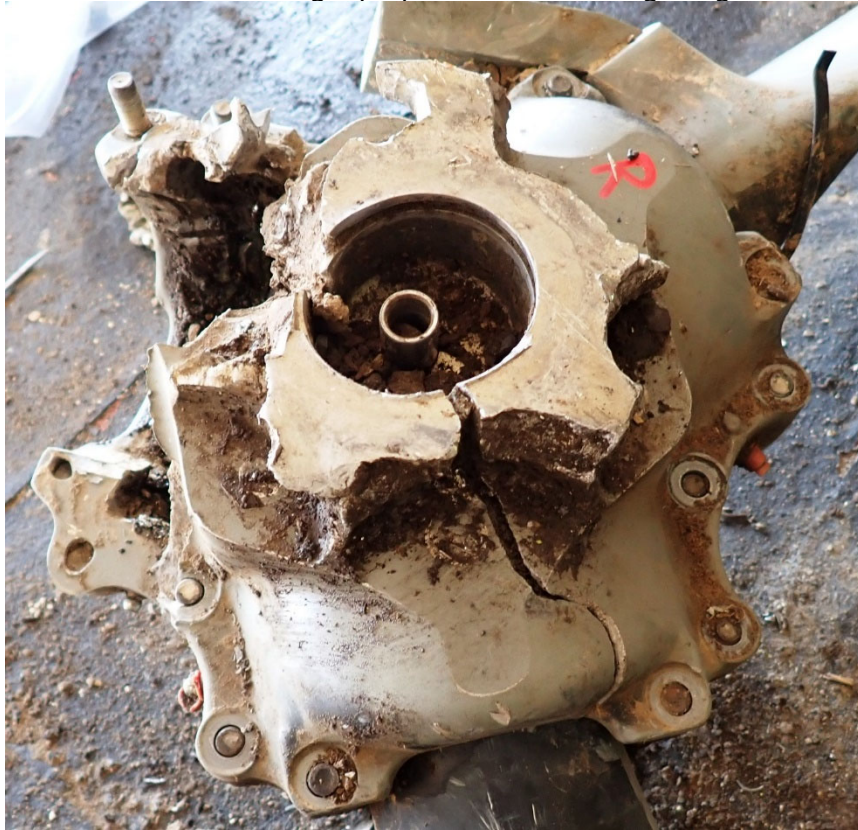
Photo #30 - Right propeller hub mounting flange
