**NTSB File No.:** CEN23FA285

**Aircraft:** Piper PA-60-601P Aerostar

## PROPELLER EXAMINATION REPORT

**Aircraft Accident/Incident report No.: 230706**

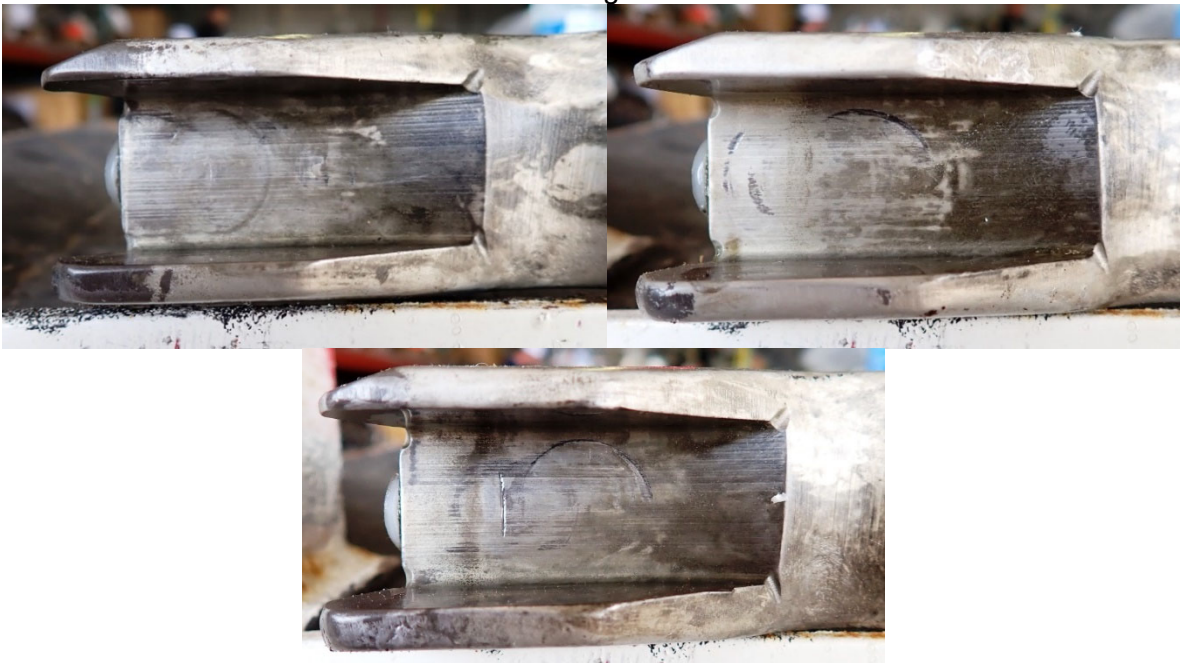
**Fork:** The fork was found loose in the hub. The pitch change rod had fractured from the fork on both the forward and aft sides. The fork was intact with no remarkable fractures seen in the slots/tangs. There were pitch change knob block marks in all three slots representative of blade angles in normal range of operation (Photo #31).

Photo #31 - Right fork slots

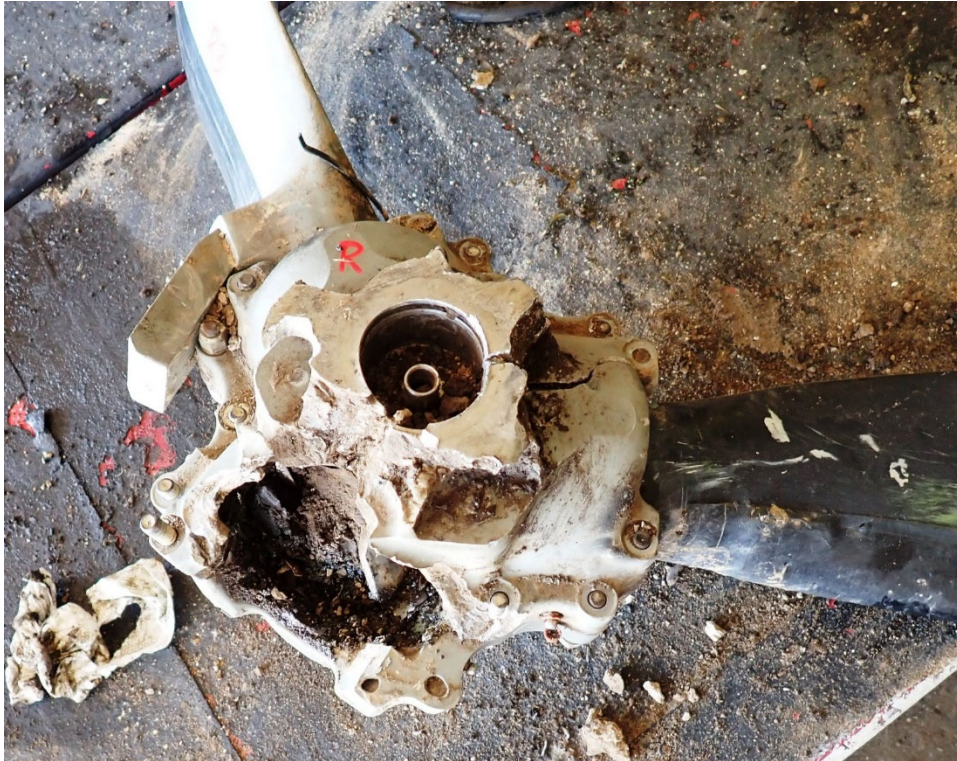
**Hub Assembly:** The hub assembly was fractured at the mounting flange. The R1 blade retention pocket and the cylinder mounting boss were fractured (Photos #32 through #35). The hub was partially packed with dirt and had evidence of being over-serviced with grease. All of the hub thru-bolts were present but those around the R1 retention arm were bent or fractured (Photos #33 and #34). The preload plate shelves and webs of all three blades were marred and/or fractured. The bearing retention radius for R1 on the forward hub was fractured. There was a fracture in the aft hub wall that spanned between the R1 and R2 blade retention pockets.

Photo #32 - R1 blade retention arm fractured

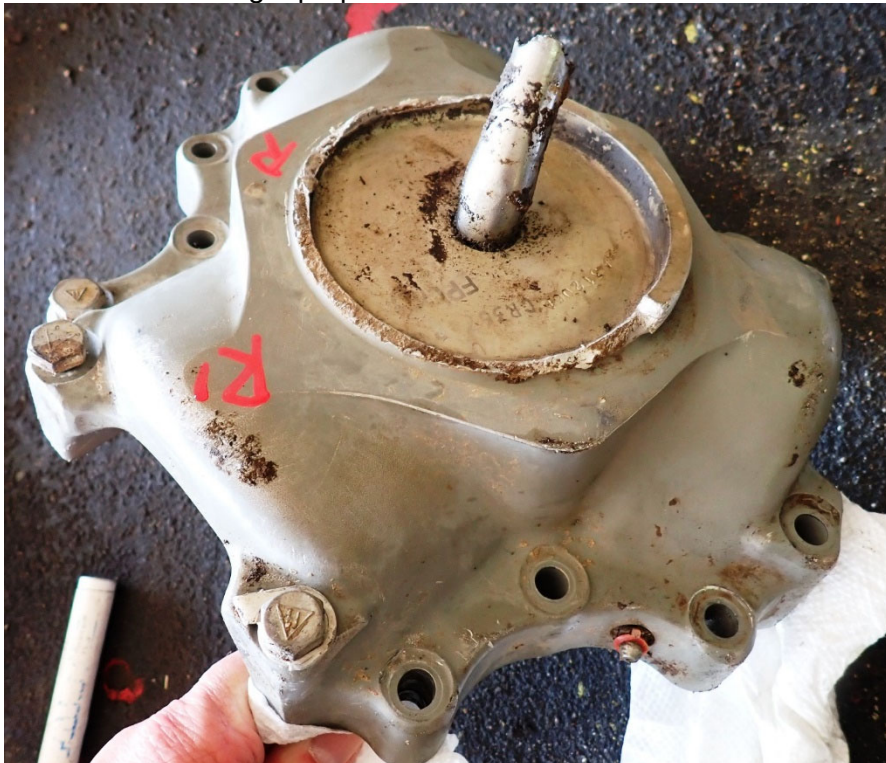
Photo #33 - Right propeller forward hub half – external view

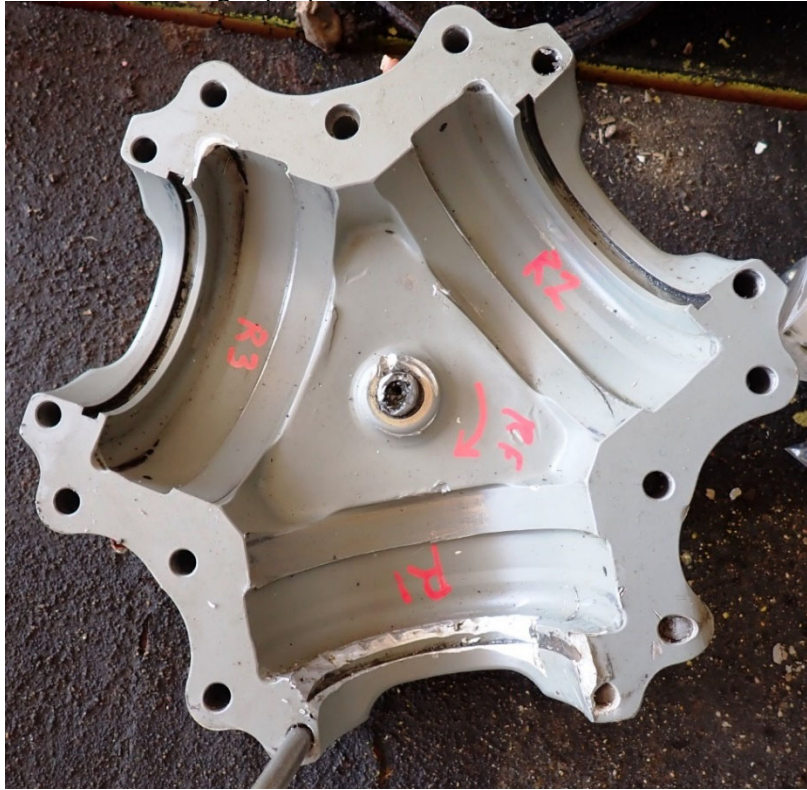
Photo #34 - Right propeller forward hub half – internal view

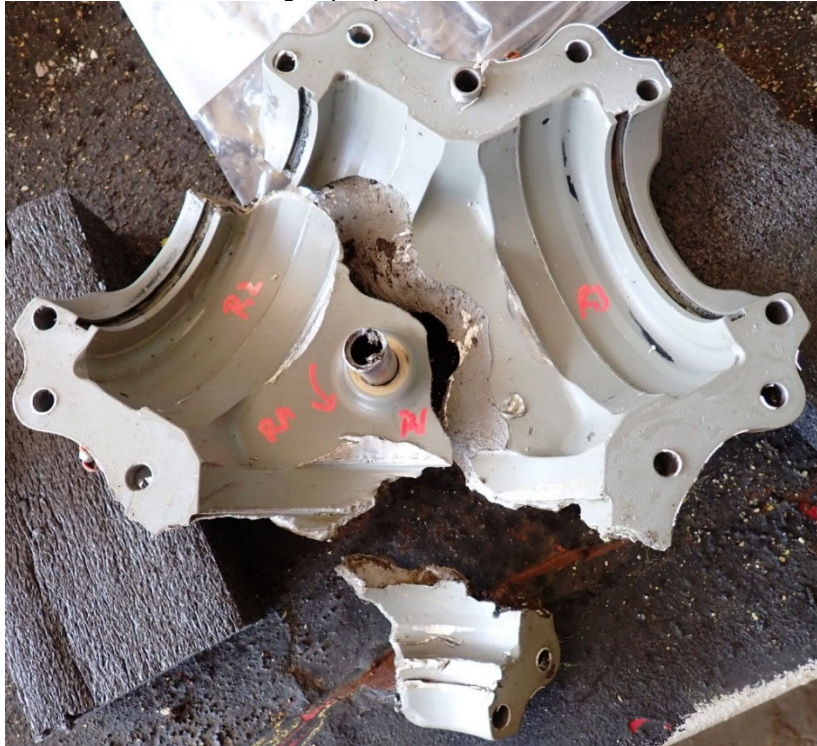
Photo #35 - Right propeller aft hub – internal view

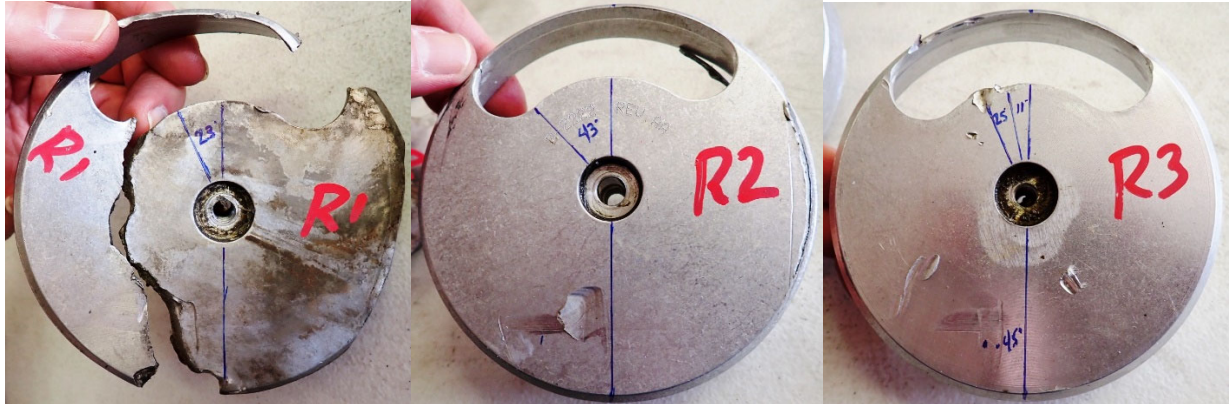
**Preload Plates:** For this propeller model, when the blade knob is aligned with the hub parting line, the blade angle at the reference station is approximately  $48.5^\circ$  (knob  $12^\circ + 36^\circ$  constant + 3-blade delta of  $0.5^\circ = 48.5^\circ$ ). All three preload plate lips were sheared and smashed and had impact damage on the aft/face side where the plate rests against the aft hub web. All three plates had fork impact marks in the lower ( $<48^\circ$ ) blade angle range of normal operation (Photo #36).

| Preload Plate | Condition |
|---|---|
| R1 | The plate was fractured into two major pieces (Photo #). There were pitch change knob marks in the slot at $23^\circ$ forward of the split line. |
| R2 | The plate was distorted and aft sidewall of the plate was fracture-separated. The forward/low pitch end of the knob slot was fractured by the remnants of the pitch change knob forcefully rotated under the plate. There was a pitch change knob mark in the slot at $43^\circ$ forward of the split line. |
| R3 | There were pitch change knob marks in the slot at $25^\circ$ and $11^\circ$ forward of the split line. There was a circular, fork bumper mark at 0.45" forward of the split line. |

Photo #36 - Right preload plates

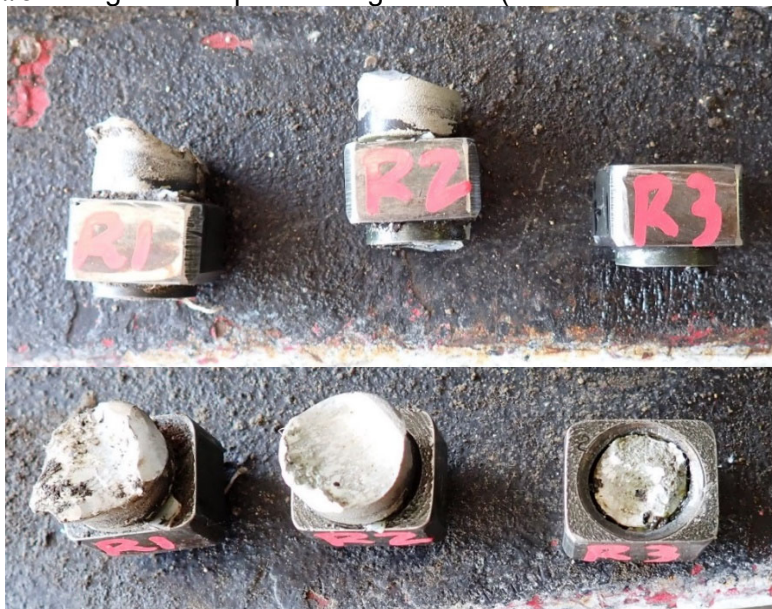
| Knob condition | Fractured (Photo #37) |

| Knob condition | Fractured (Photo #37) |

| Knob condition | Fractured (Photo #37) |

Photo #37 - Right blade pitch change blocks (R1 and R2 knobs fractured)

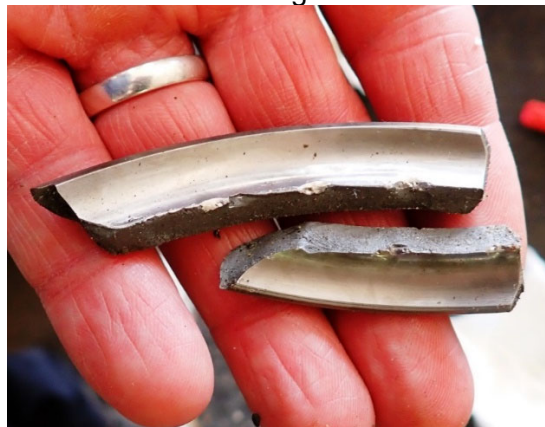
| Blade bearings | Some of the bearing races and balls separated from assembly when the blade separated. One bearing race fragment remained in the hub and exhibited a fracture with ball imprints consistent with overload. (Photo #38) |

Photo #38 - Right blade retention bearing race fracture with ball bearing marks

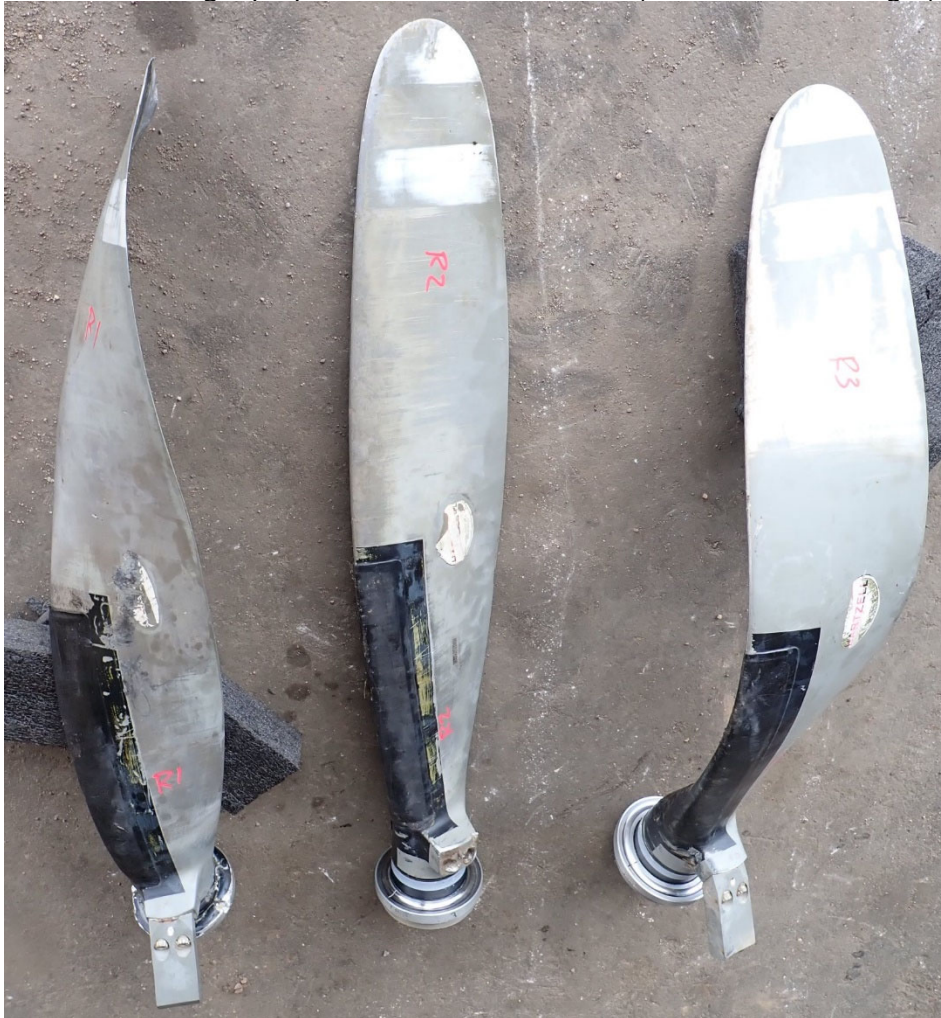
Photo #39 - Right propeller blades camber side (R1-R2-R3 left-to-right)

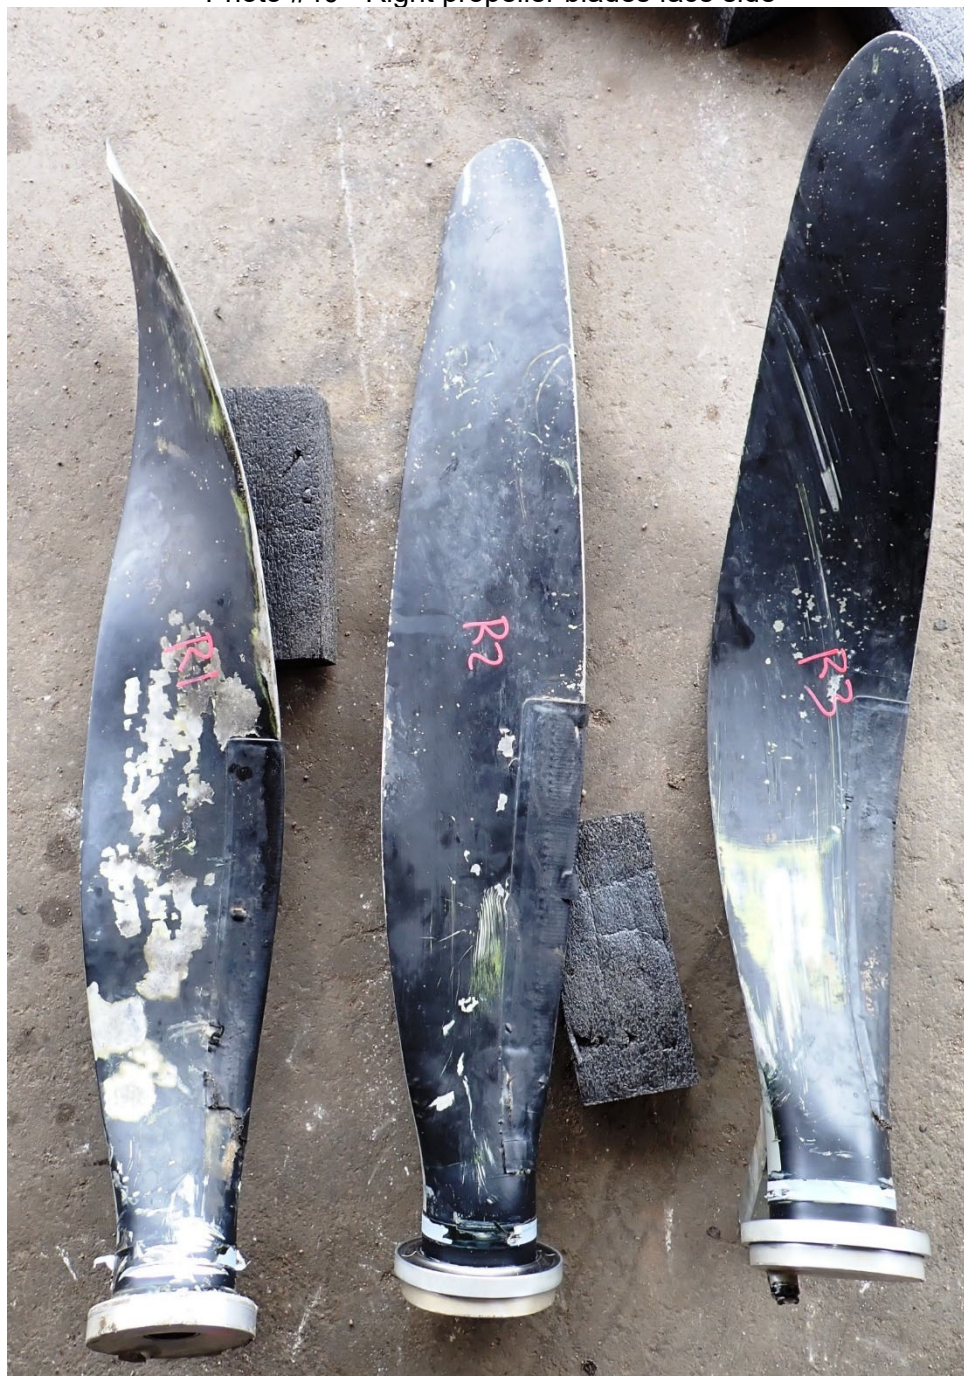
Photo #40 - Right propeller blades face side

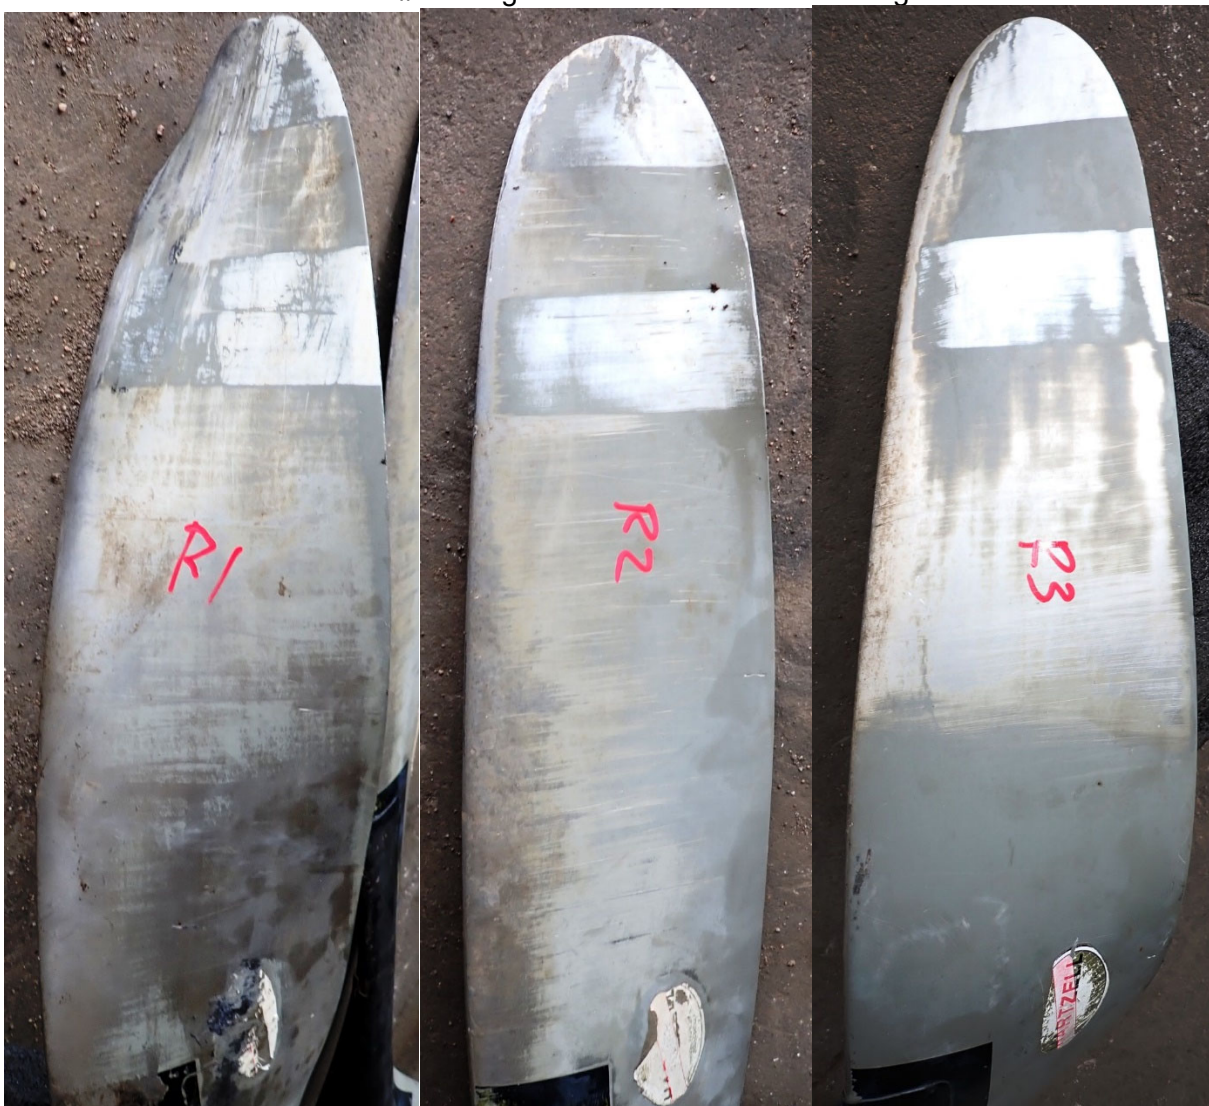
| Camber side | Chordwise/rotational scoring (Photo #41) |

| Camber side | Chordwise/rotational scoring (Photo #41) |

| Camber side | Chordwise/rotational scoring (Photo #41) |

Photo #41 - Right blades camber-side scoring

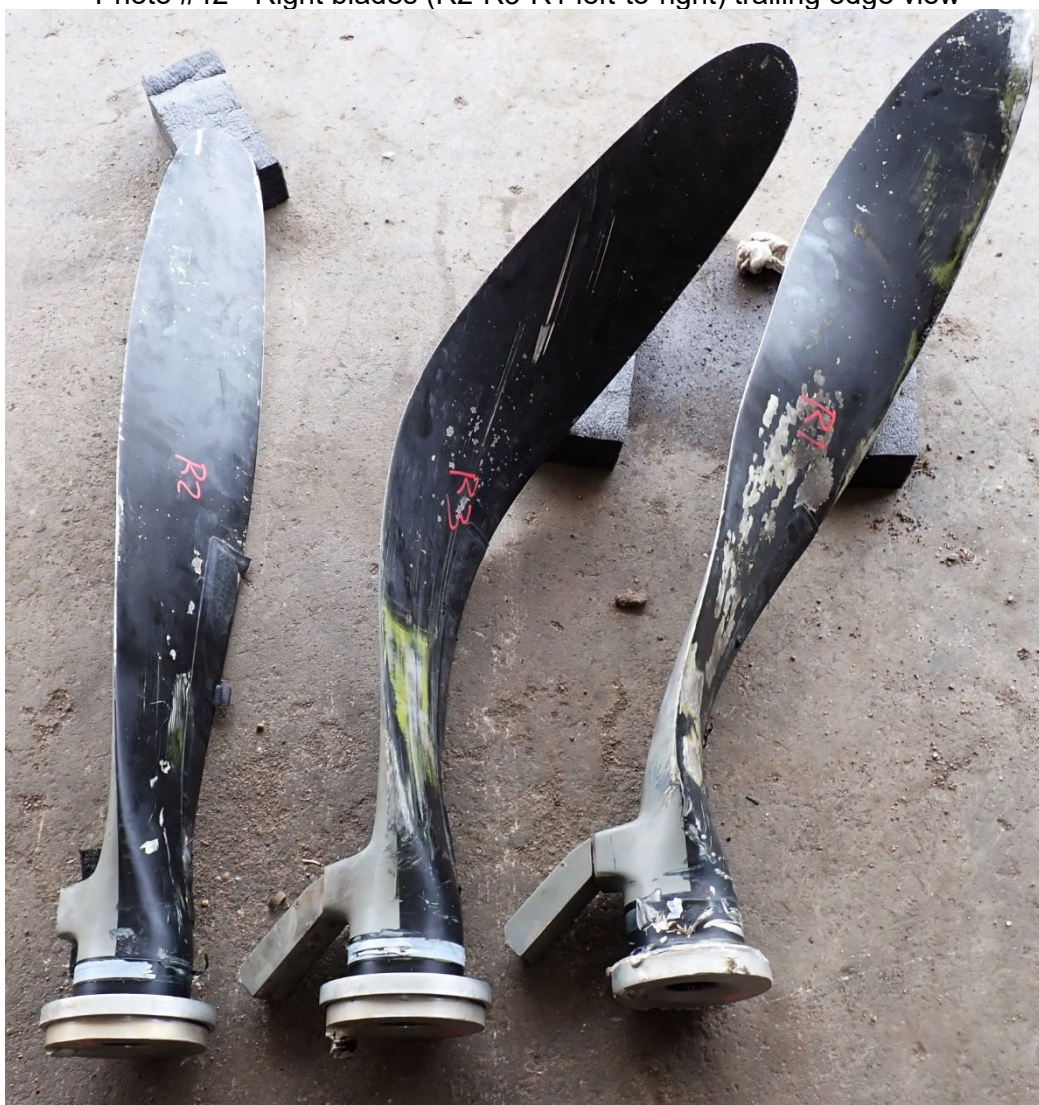
Photo #42 - Right blades (R2-R3-R1 left-to-right) trailing edge view
