# National Transportation Safety Board

CEN23FA285

## **ENGINE AND PROP EXAMINATION SUMMARY**

Location: Burlington, CO  
Date: July 6, 2023  
Time: 1330 mountain daylight time  
Airplane: Piper PA-60-601P, Registration No. N100PB

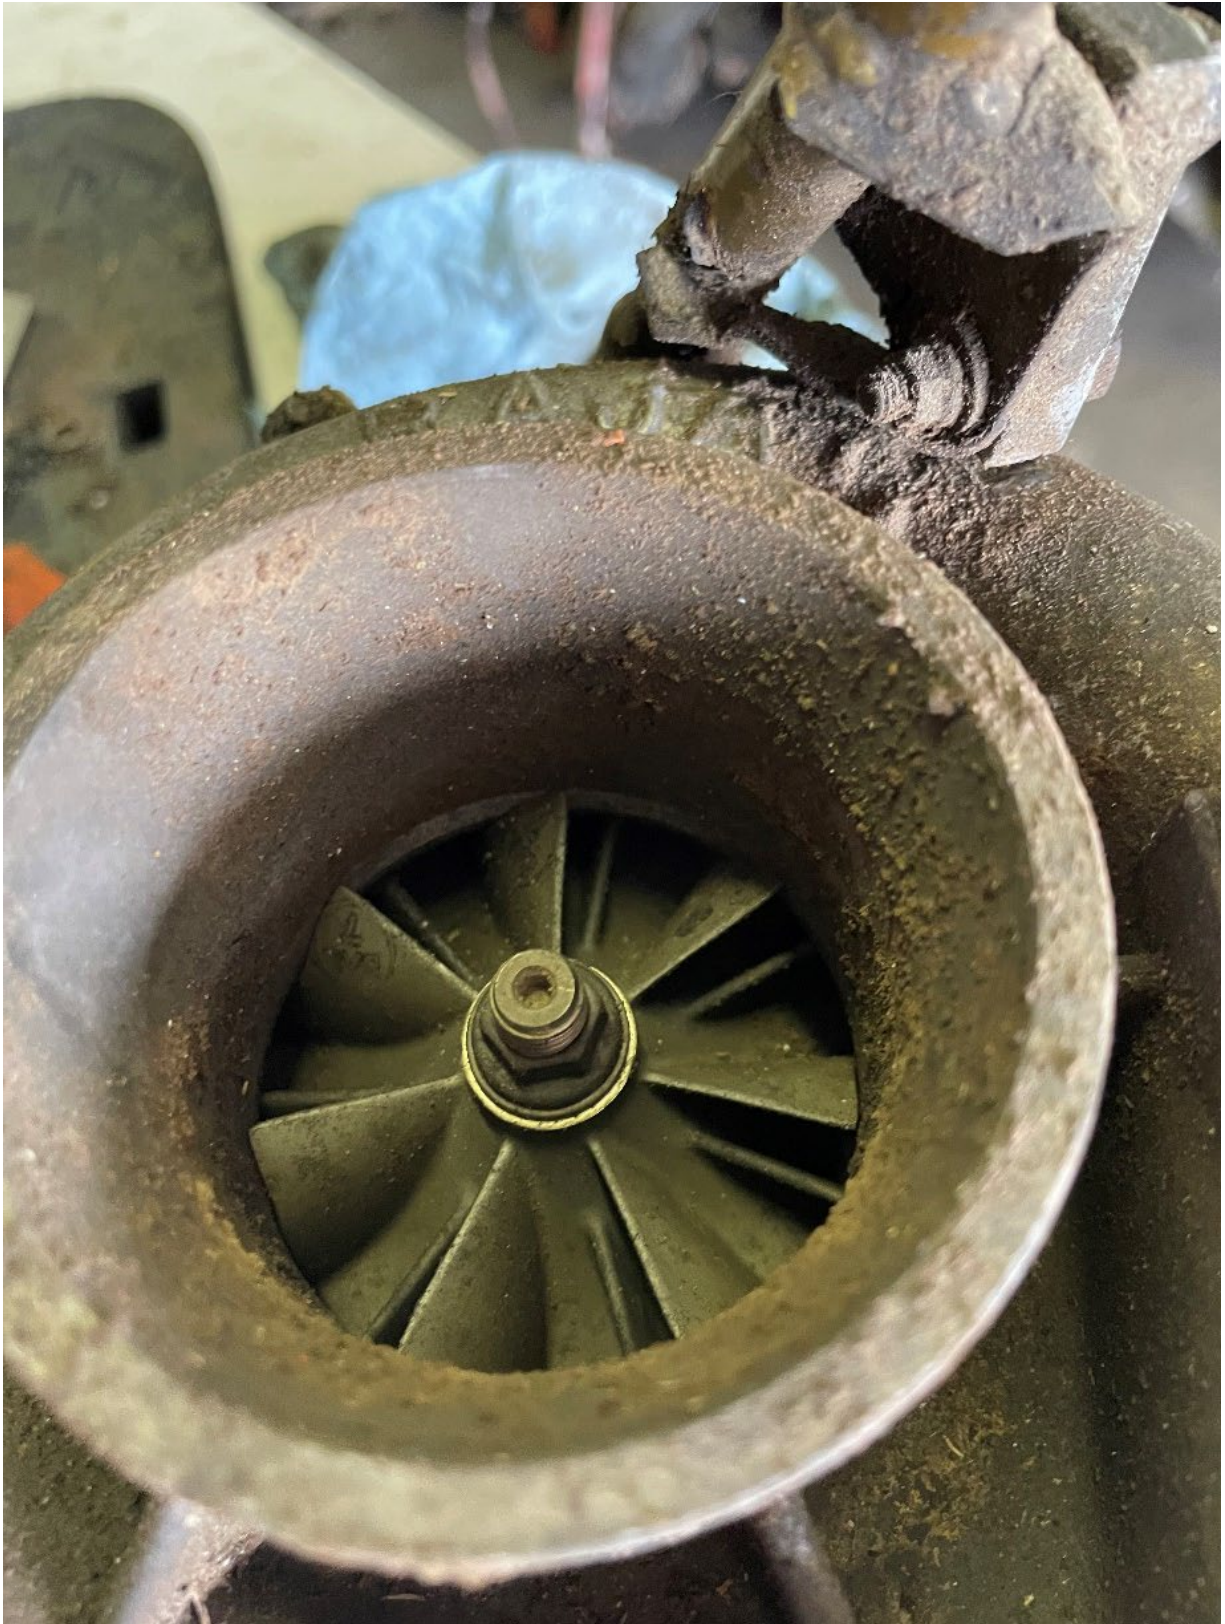
**Figure 2** - Left Engine, Left Turbo Rotational Scoring

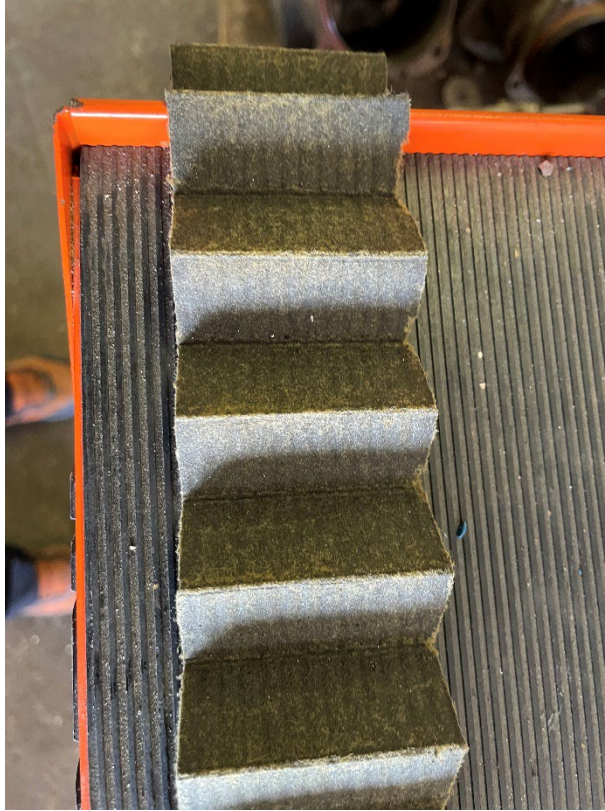
**Figure 3** - Left Engine Oil Filter Media

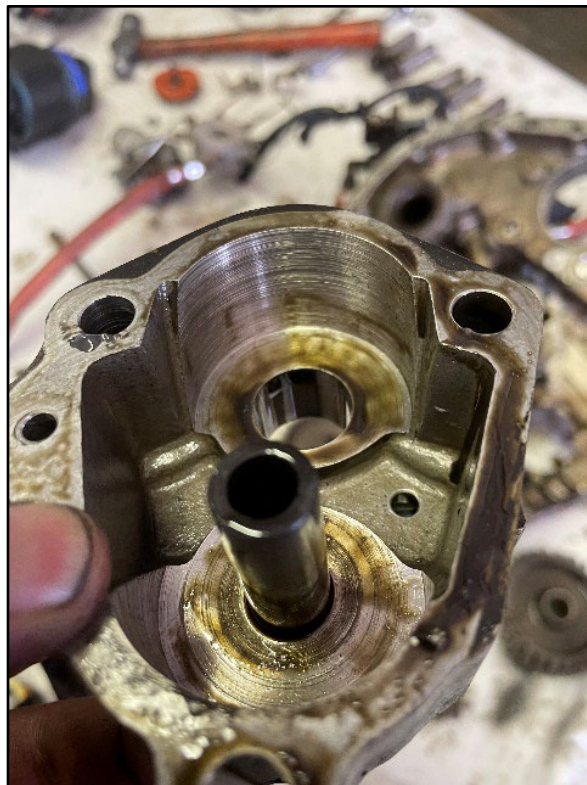
**Figure 4** - Left Engine Oil Pump Housing
