# National Transportation Safety Board

CEN23FA285

## WRECKAGE EXAMINATION SUMMARY

Location: Burlington, CO  
Date: July 6, 2023  
Time: 1330 mountain daylight time  
Airplane: Piper PA-60-601P, Registration No. N100PB

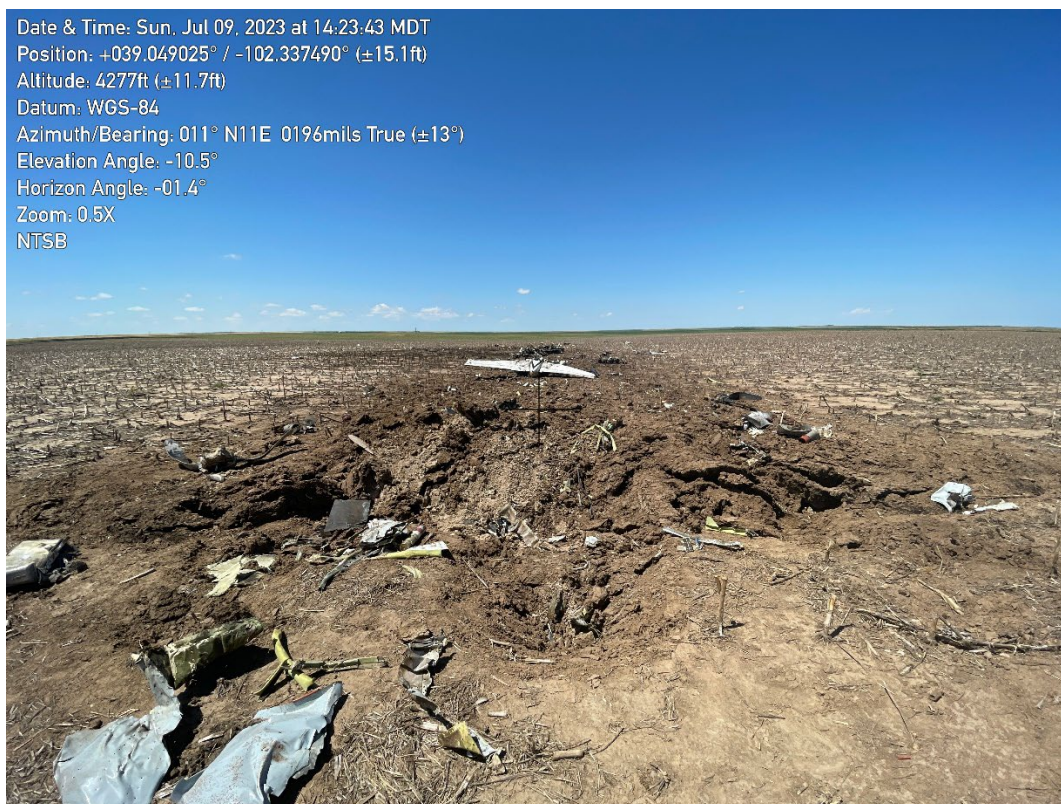
**Figure 1** - Initial Impact Point

The airplane impacted a harvested cornfield about 11.8nm southwest of the center of Kit Carson County Airport (ITR). A 350ft long debris path, oriented on a 345° magnetic heading, preceded the location of the main wreckage. The airplane impacted the ground in a near wings level nose down attitude. The nose landing gear wheel and fork were found separated from the strut about 325 ft from the initial point of impact. The wing tips were found separated from both wings along the wreckage debris path on their respective sides.

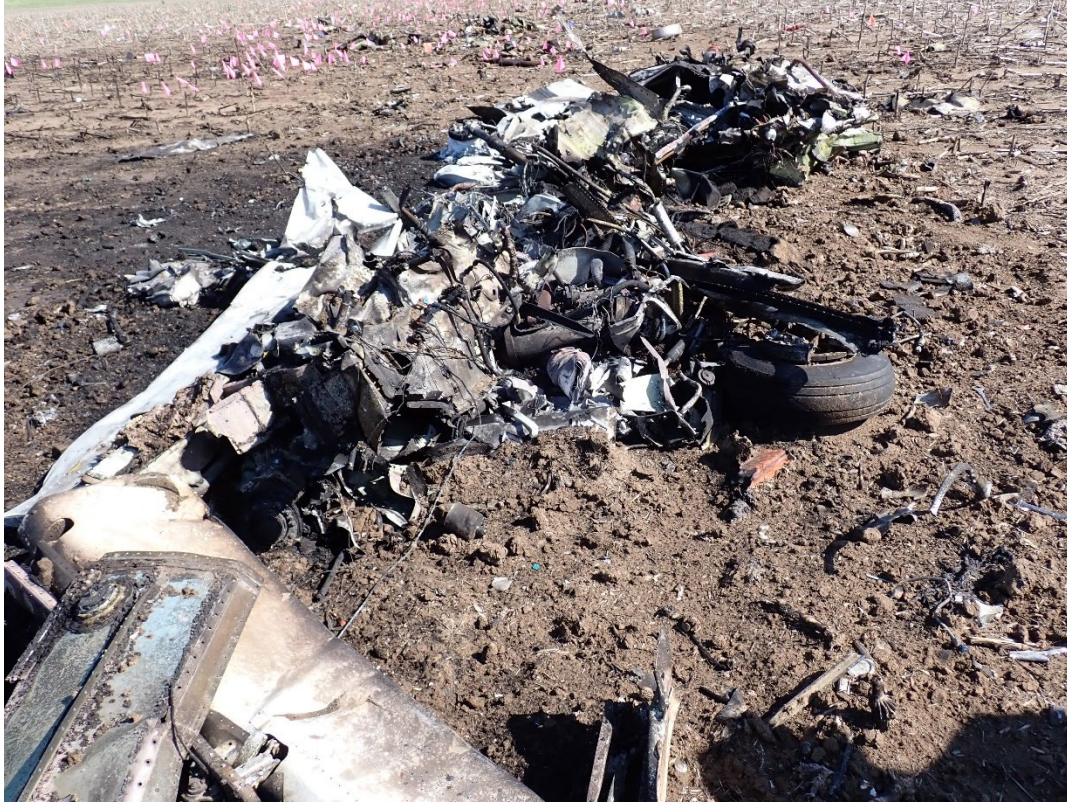
**Figure 2** - Wings and Main Landing Gear

The fuselage was fractured from the wing and the wing spars remained attached as one assembly. Flight control continuity could not be verified because the control push/pull tubes for the ailerons, elevators, and rudder exhibited extensive impact and fire damage. Both ailerons and flaps exhibited impact and fire damage. The hydraulic flap actuators were found retracted, consistent with about 0° of flap extension. The flap control handle was not located during the investigation. Both elevators remained attached to the horizontal stabilizer and exhibited impact damage. The elevator trim tabs measured about 10° tab down. The rudder was found about 125ft from the empennage, its trim tab measuring about 4° tab left. The vertical stabilizer was fractured from the empennage and crushed.

The landing gear selector handle was found to be in the up and locked position, and the landing gear was found retracted at the accident site.

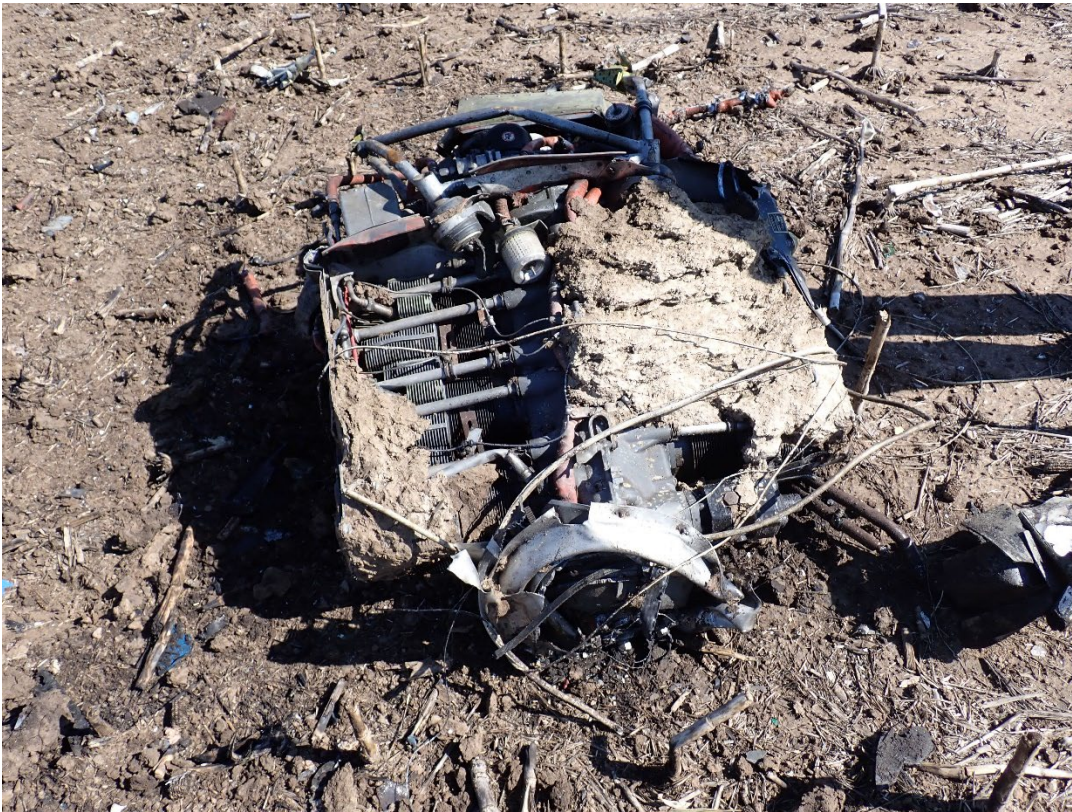
**Figure 5** - Left Engine

The right engine remained attached to its engine mounts and nacelles, and the left engine was located among the debris field attached to its mount that had fractured from its nacelle. The throttle quadrant was destroyed by impact and fire damage.

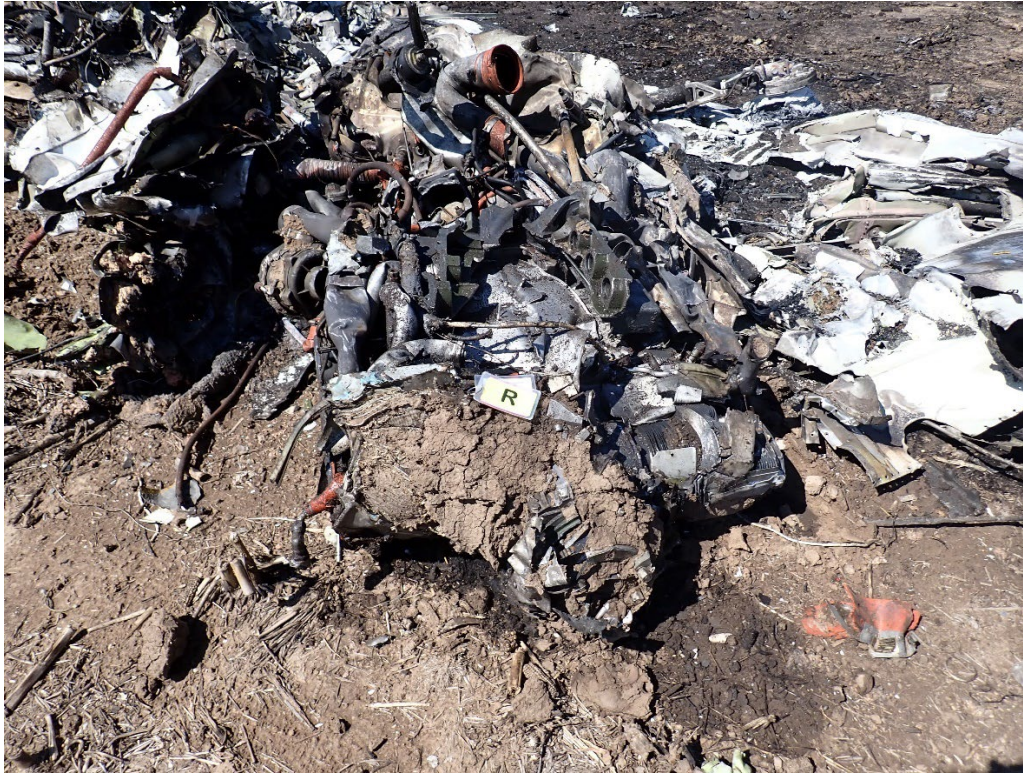
**Figure 6** - Right Engine

The right propeller was separated from the engine propeller shaft flange. One blade was separated from the hub, and its leading edge was lodged into the right engine's intercooler core. The other two blades remained in the hub but could be rotated in their housing by hand.

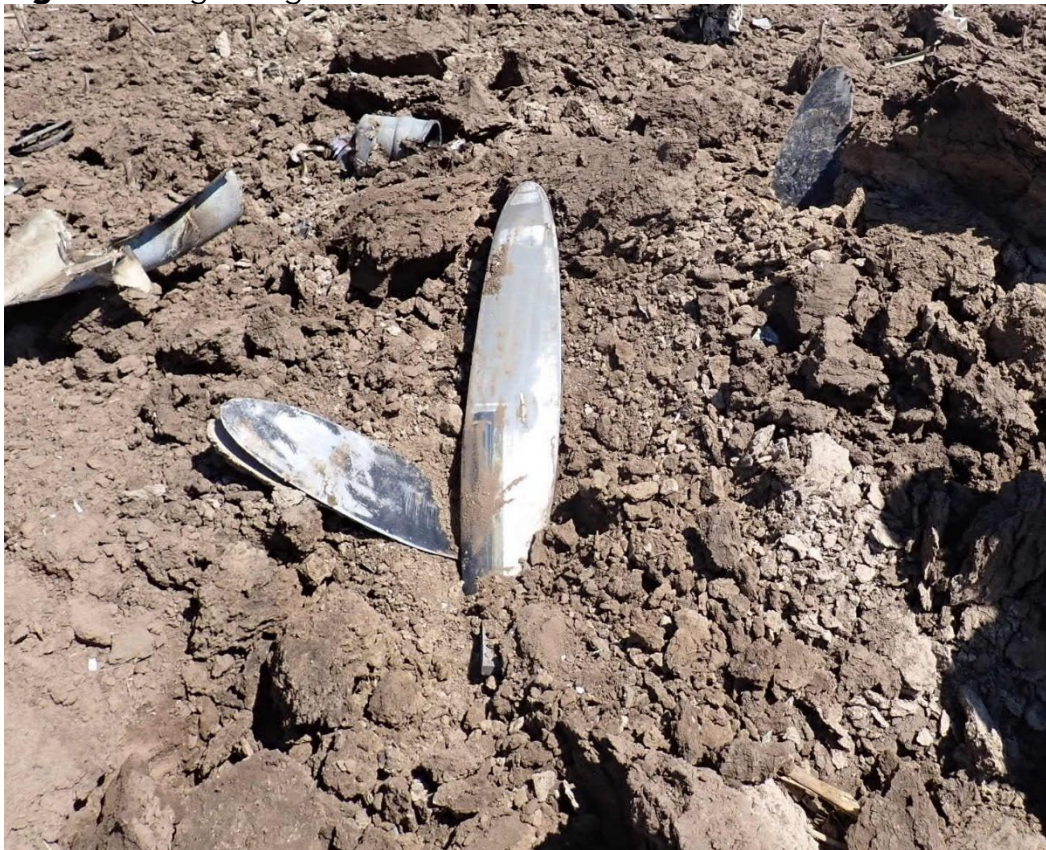
**Figure 7** - Left Propeller

The left propeller was separated from the engine propeller shaft flange. One propeller blade was separated from the hub, and the remaining two blades appeared to be in the normal range of operation. Two propeller blades were bent in the aft direction, and the remaining blade appeared to be slightly bent aft.
