CEN23FA304

## INVESTIGATION PHOTOGRAPHS

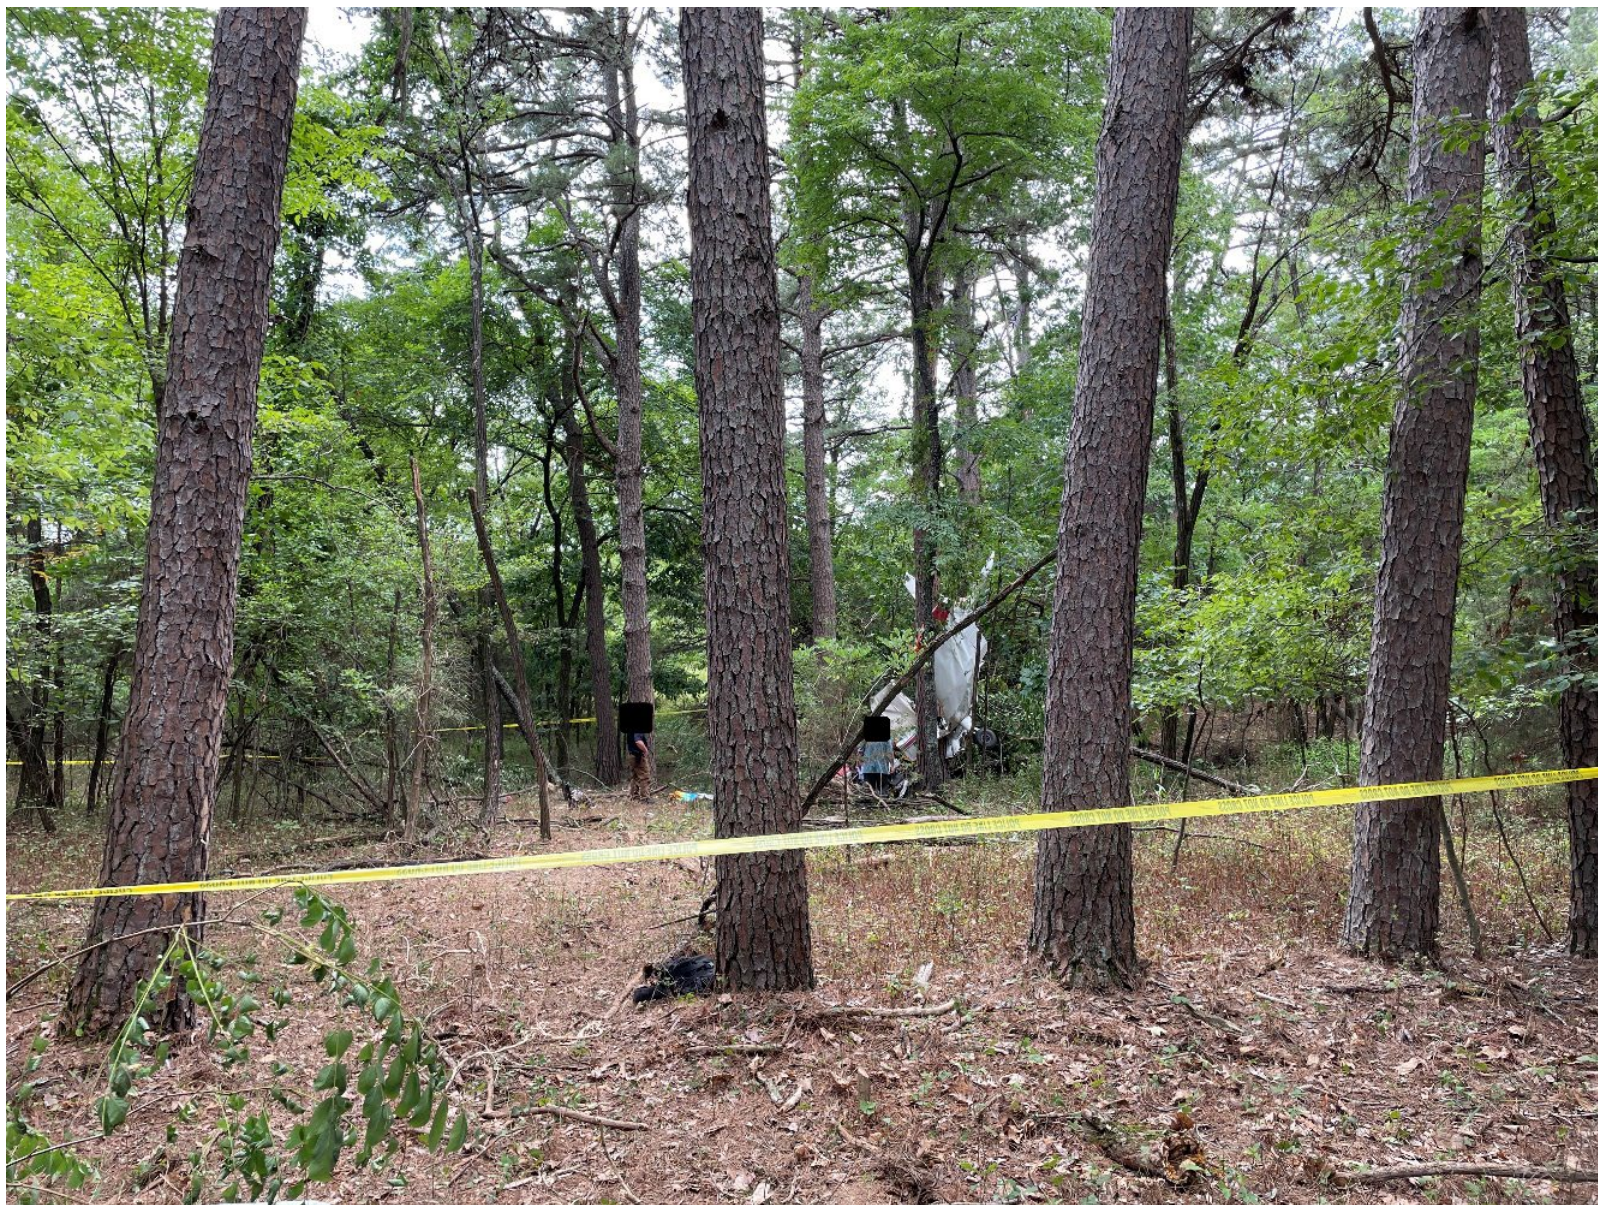
**Photograph 1 - Overview of the accident site.**

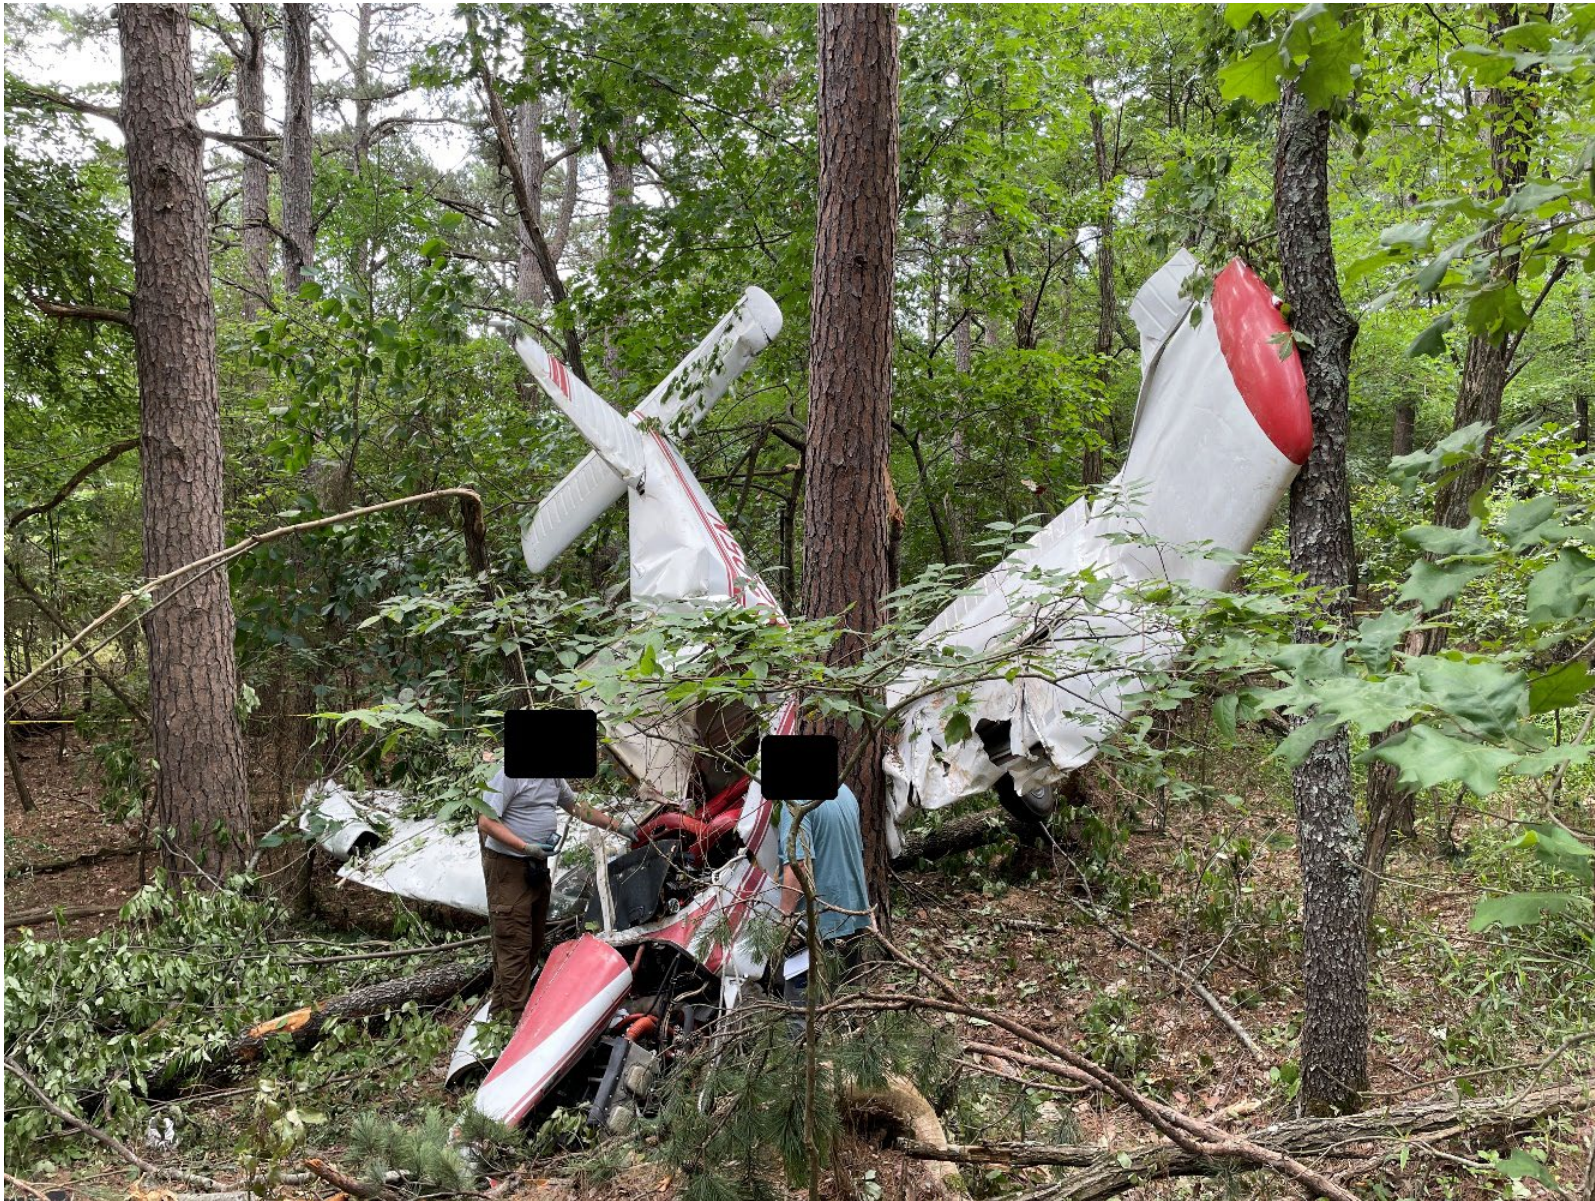
**Photograph 2 - View of the front of the airplane at the accident site.**

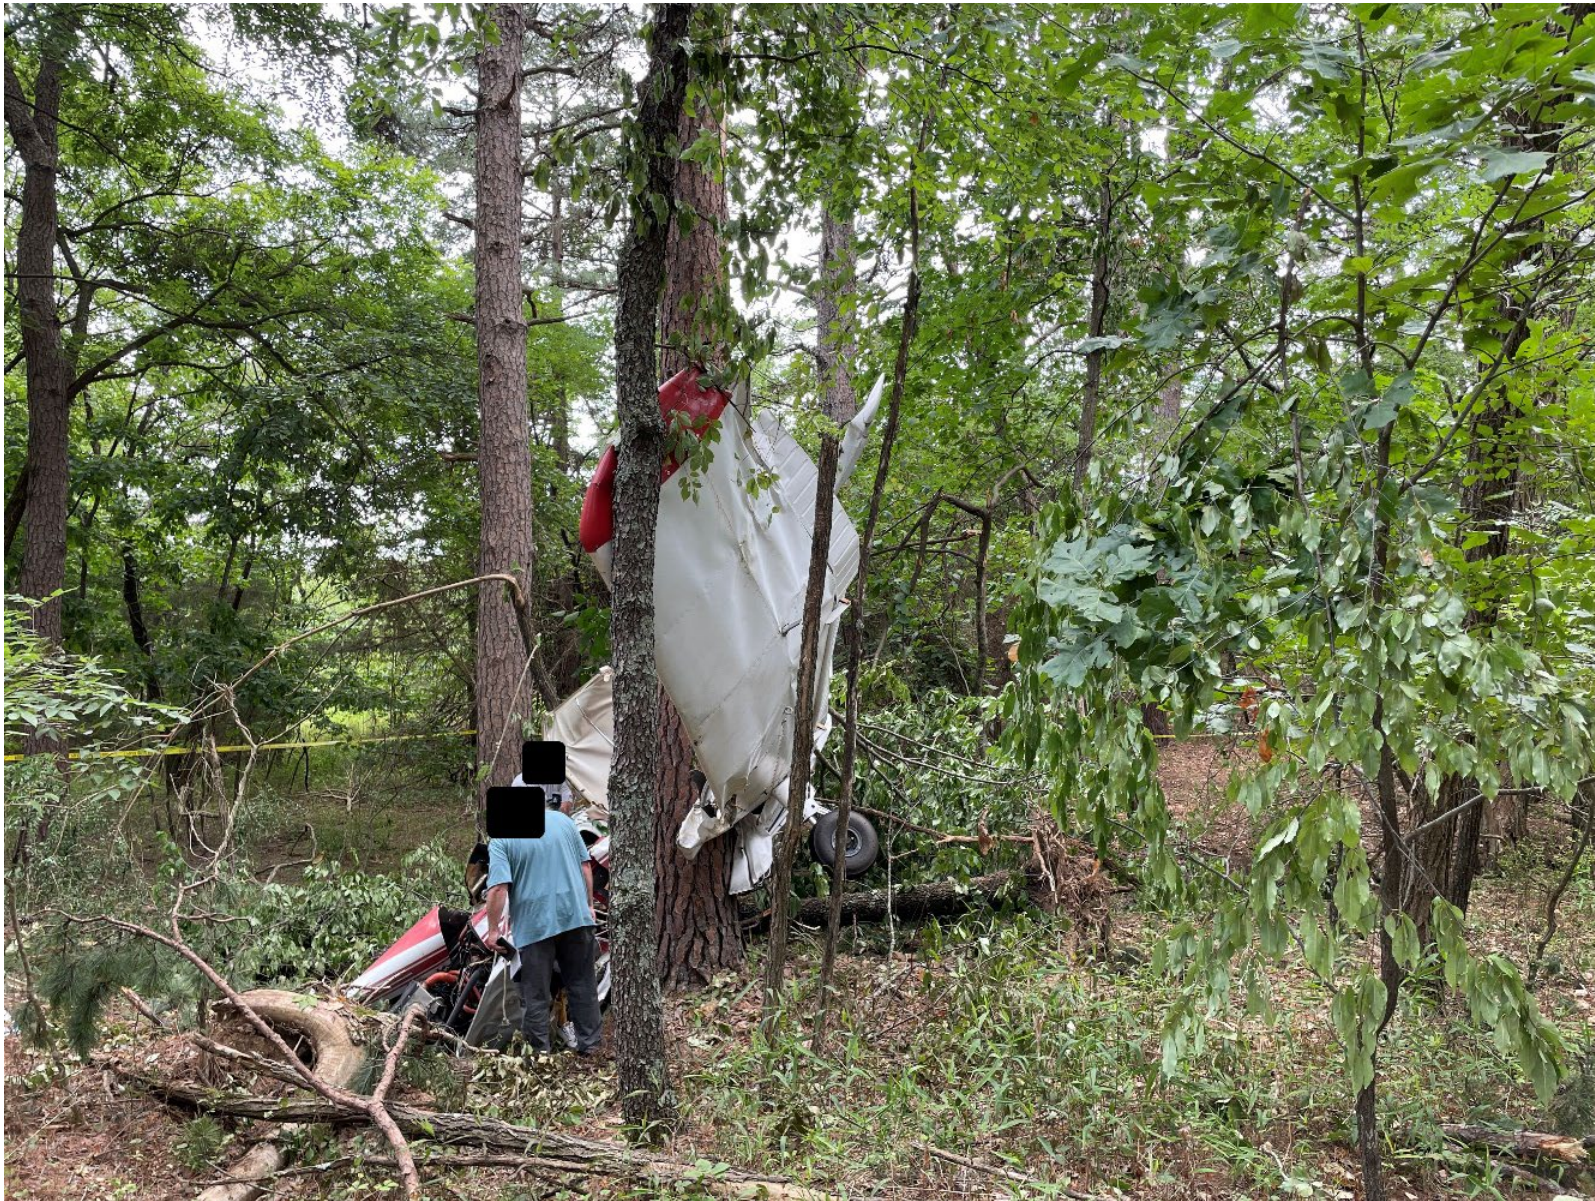
**Photograph 3 - View of the left side of the airplane at the accident site.**

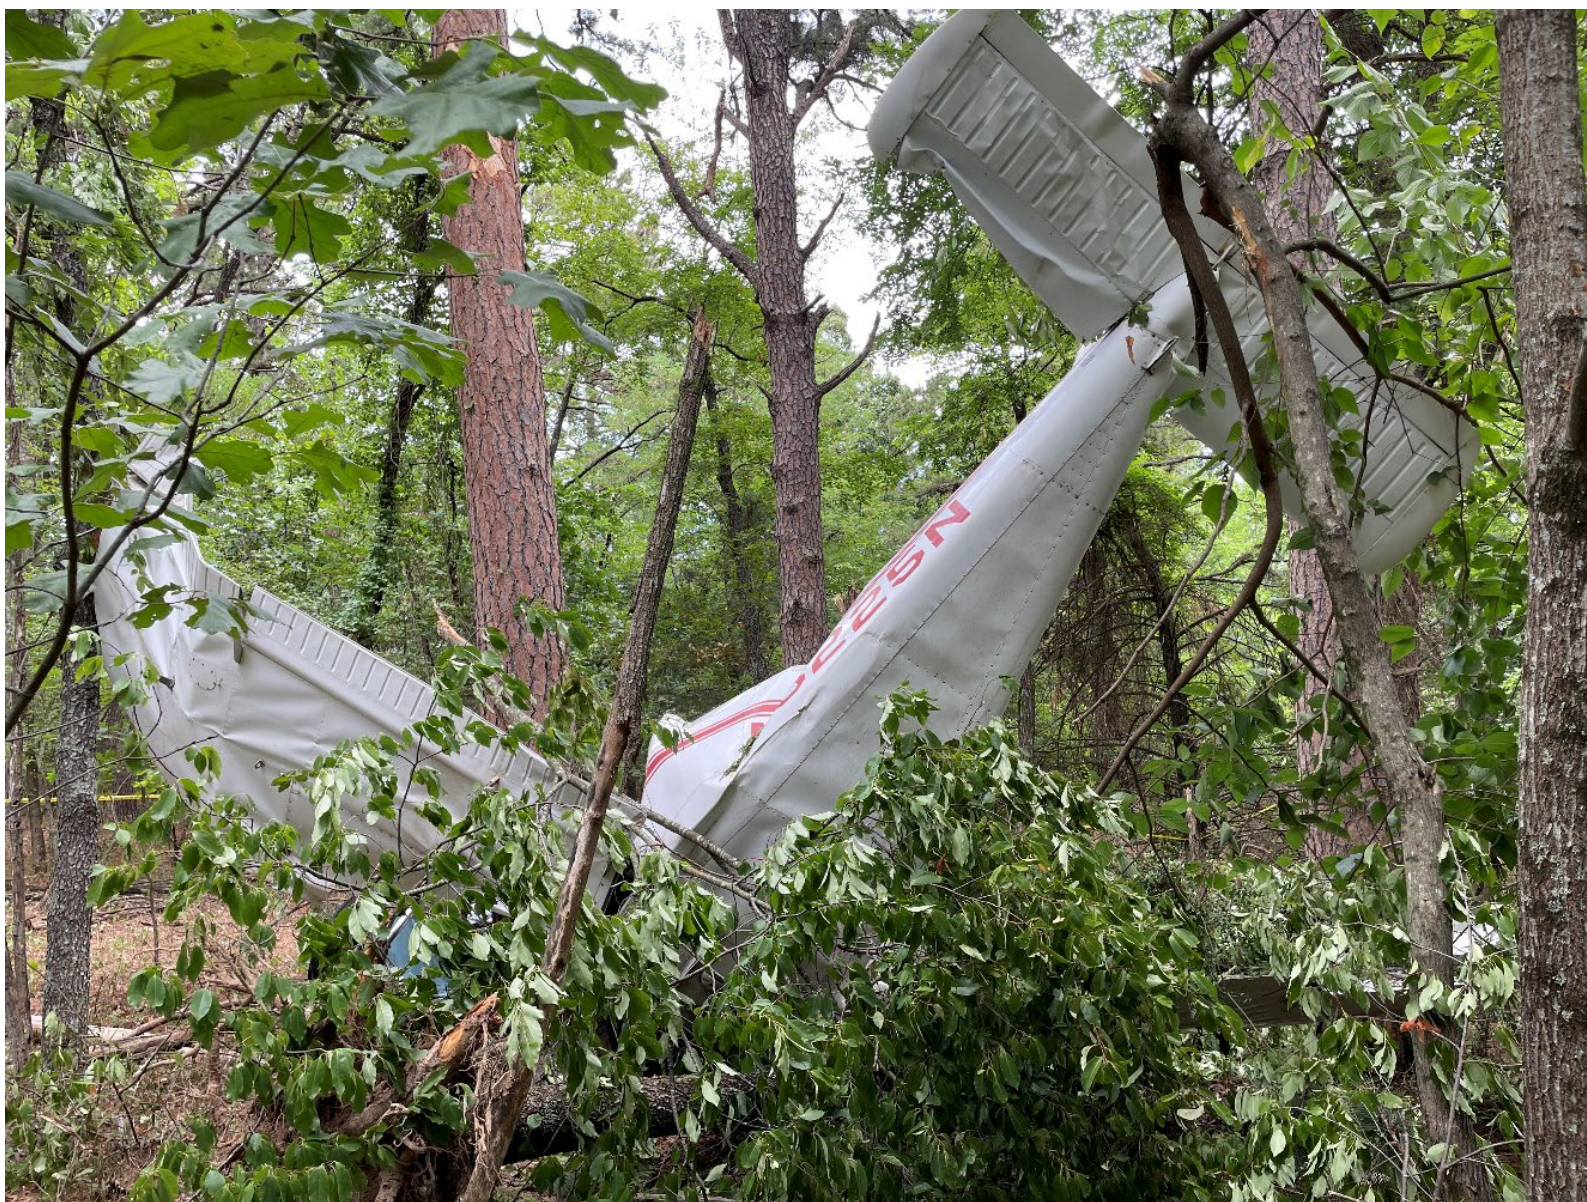
**Photograph 4 - View of the rear of the airplane at the accident site.**

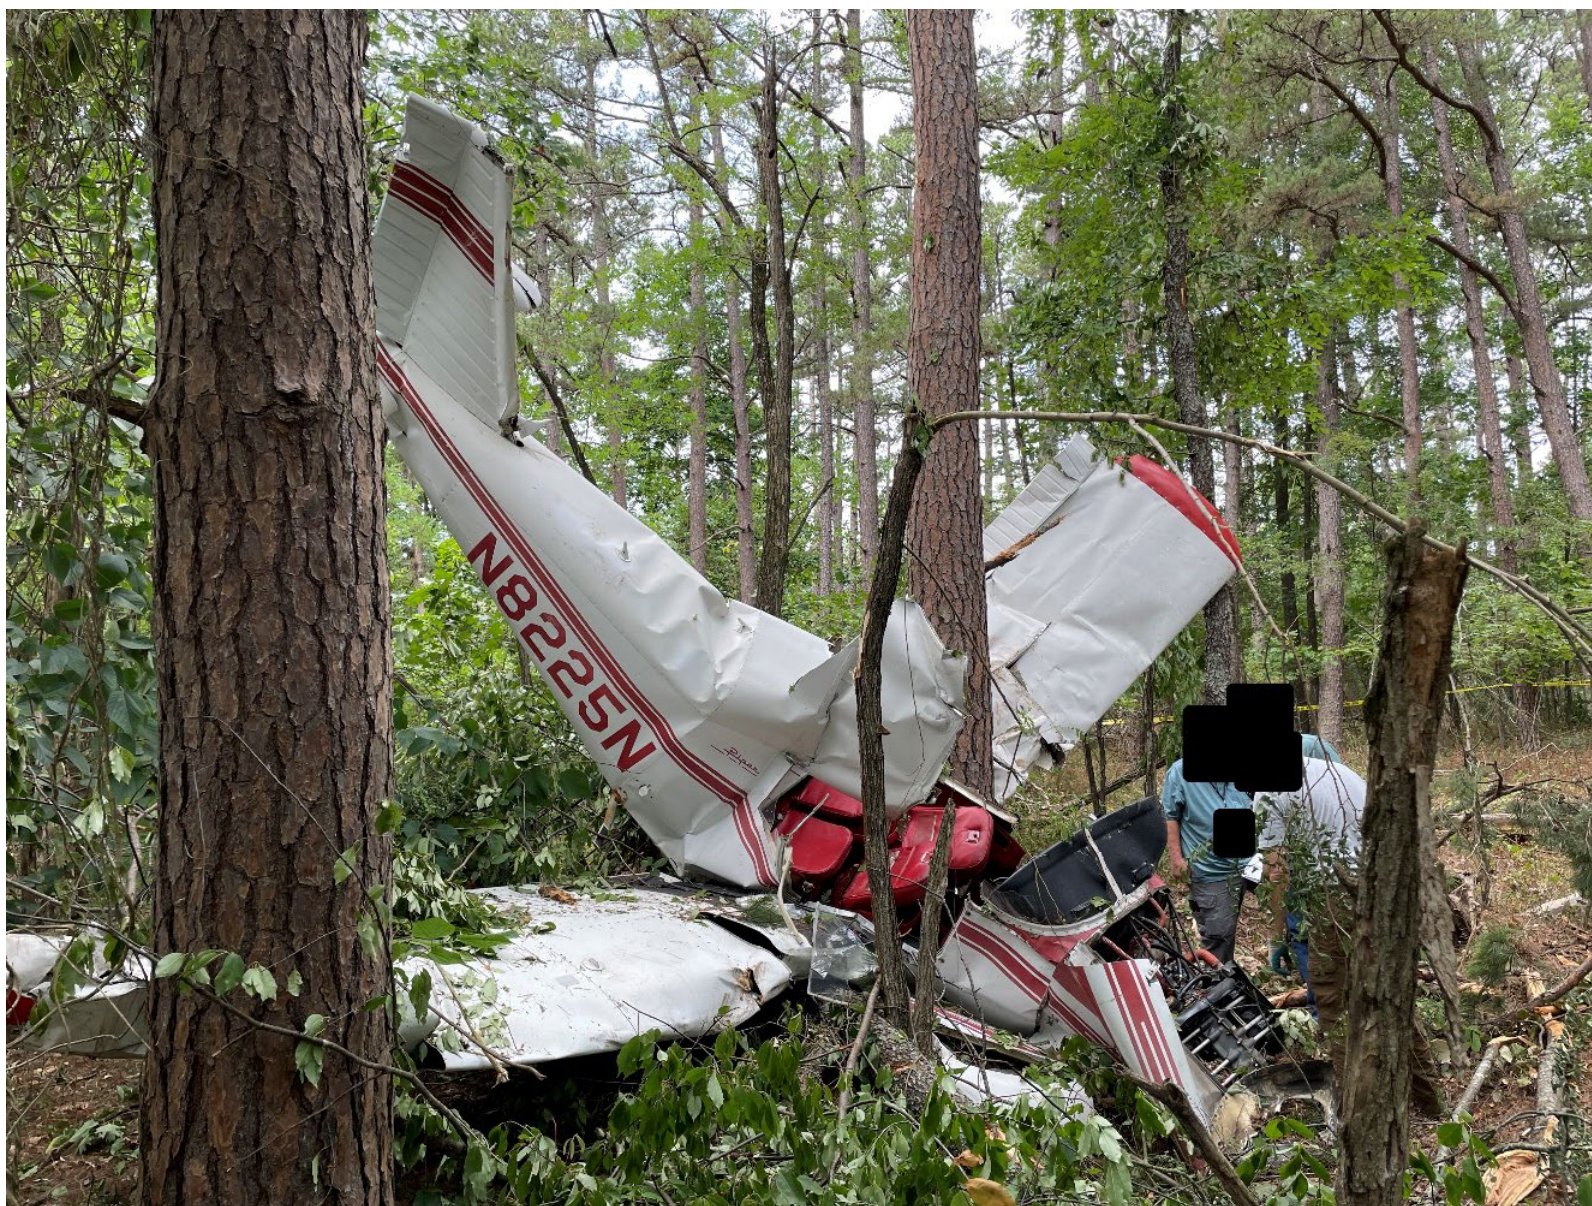
**Photograph 5 - View of the right side of the airplane at the accident site.**

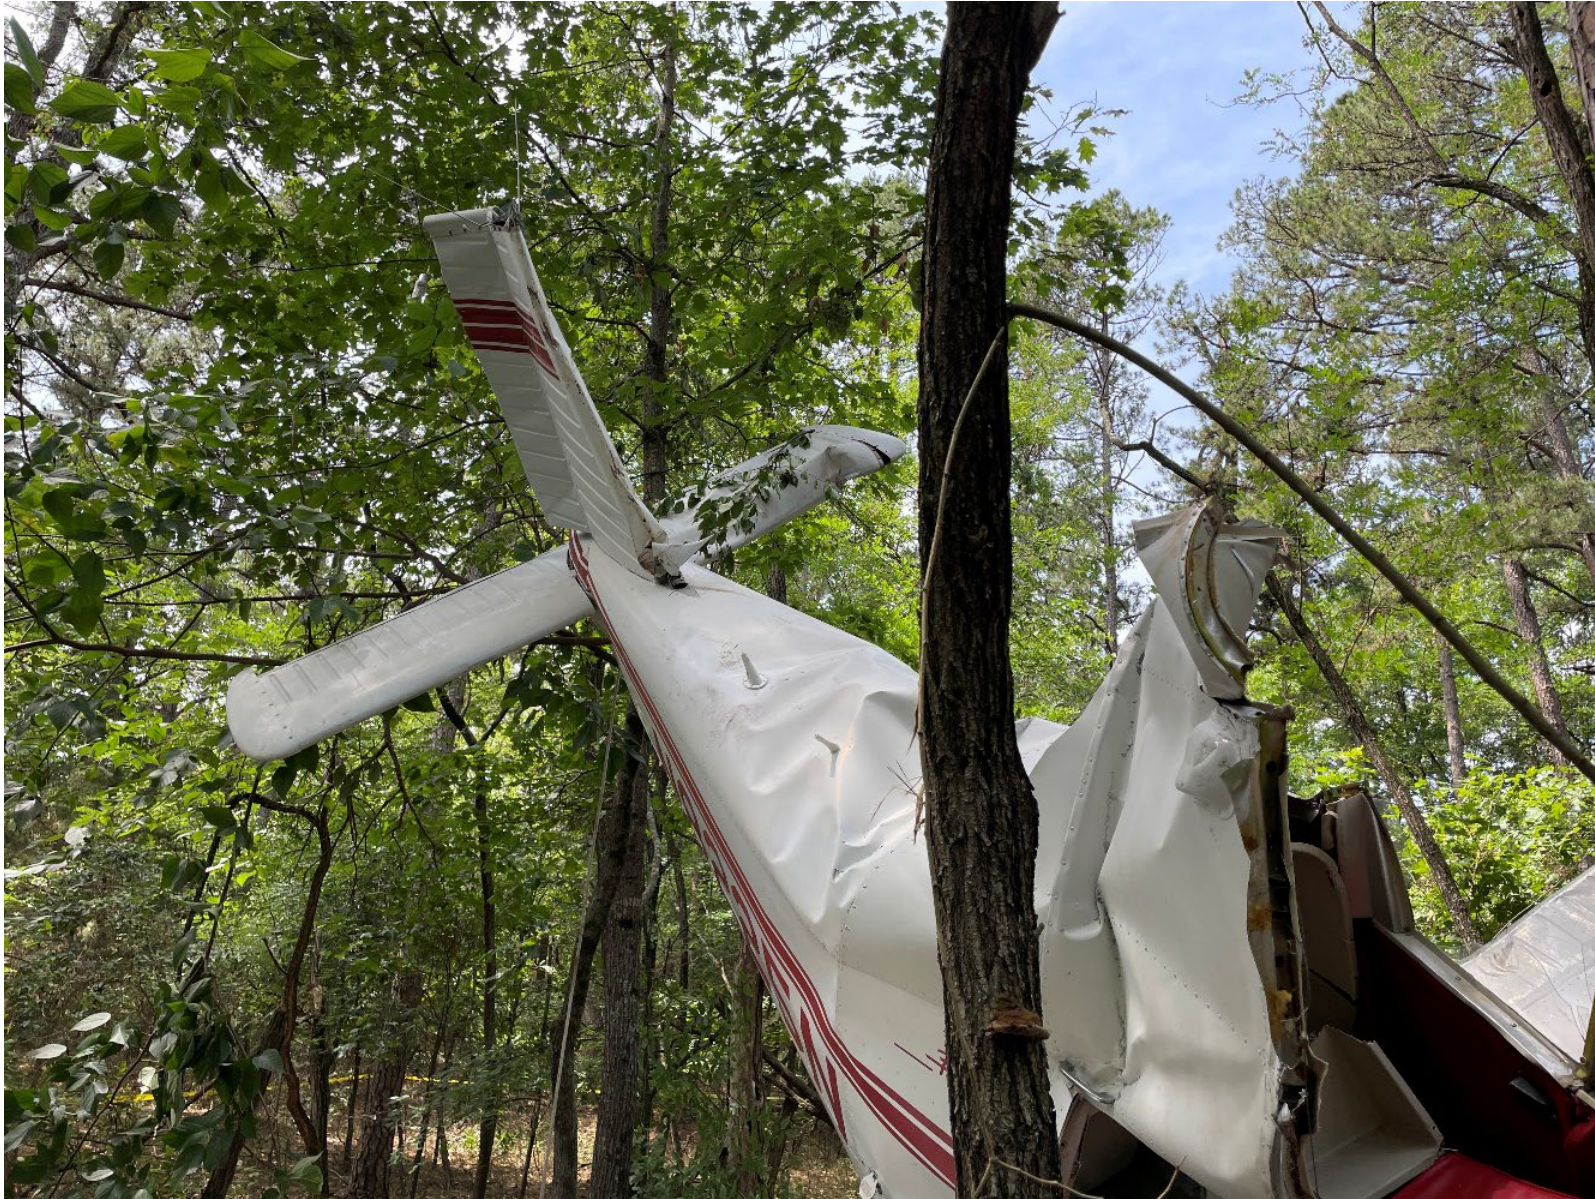
**Photograph 6 - View of the area above the accident site.**

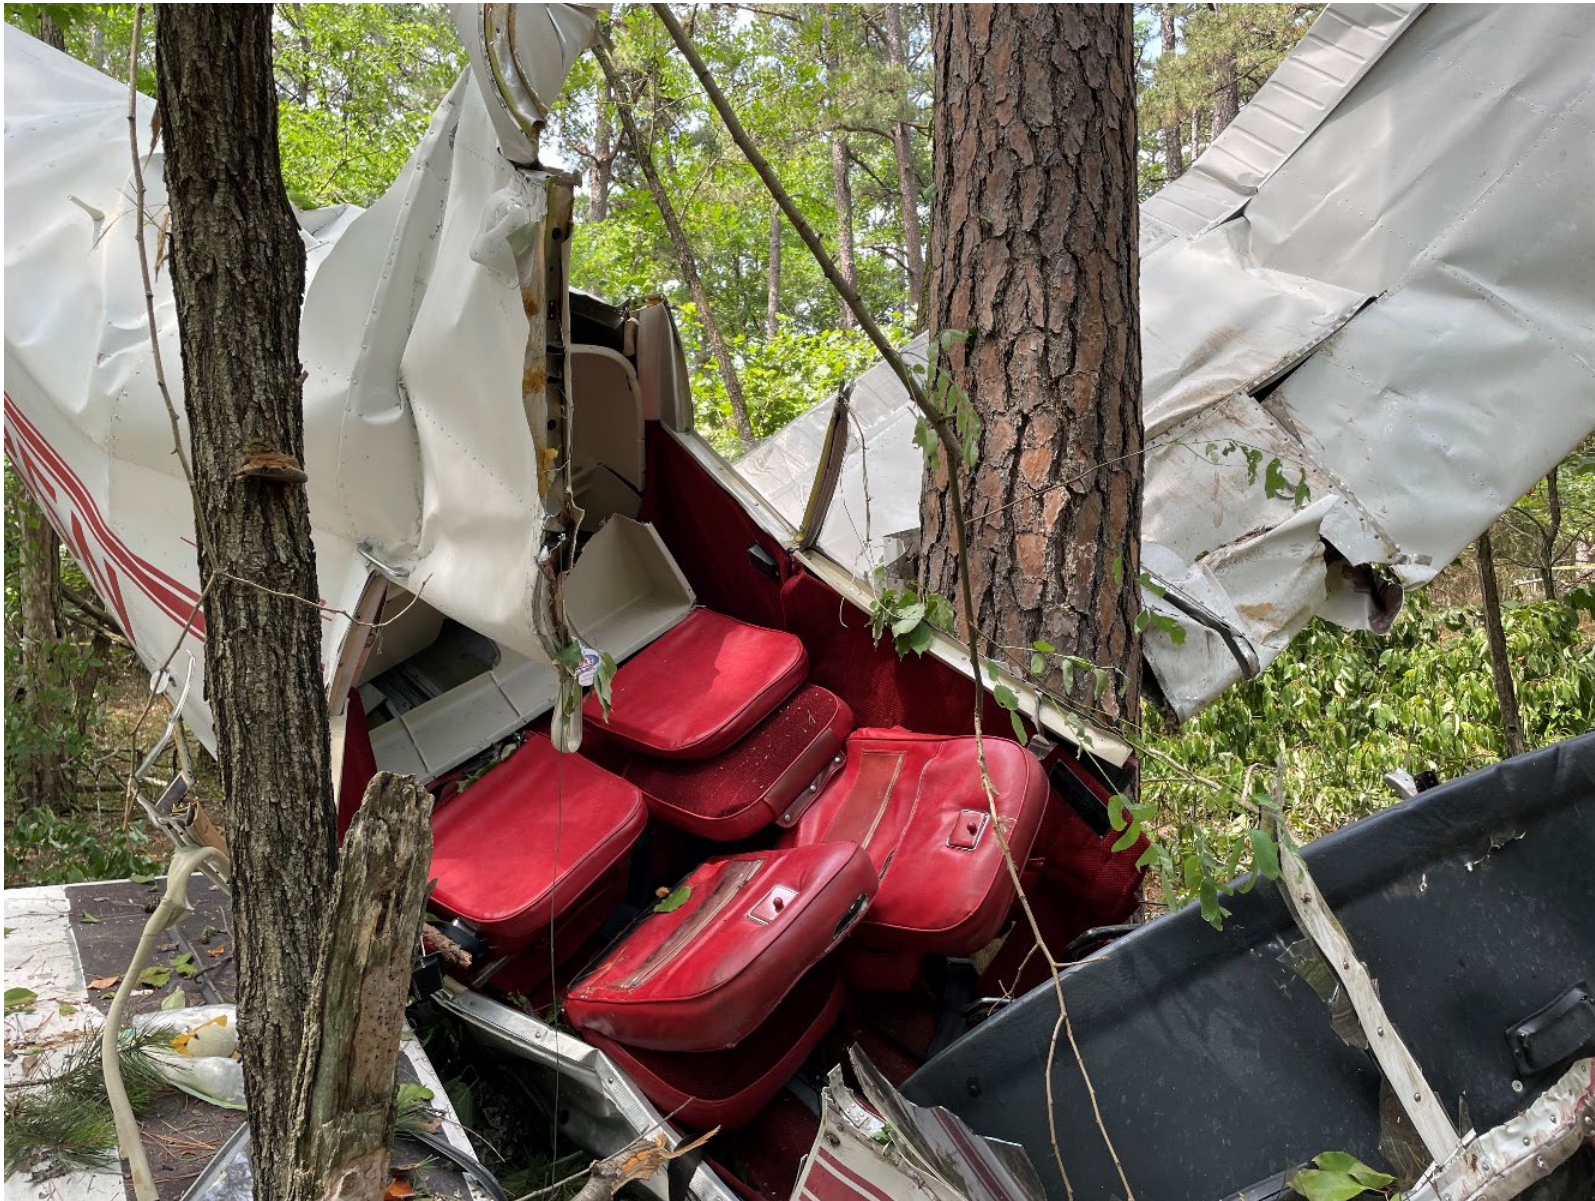
**Photograph 7 - View of the seats at the accident site.**

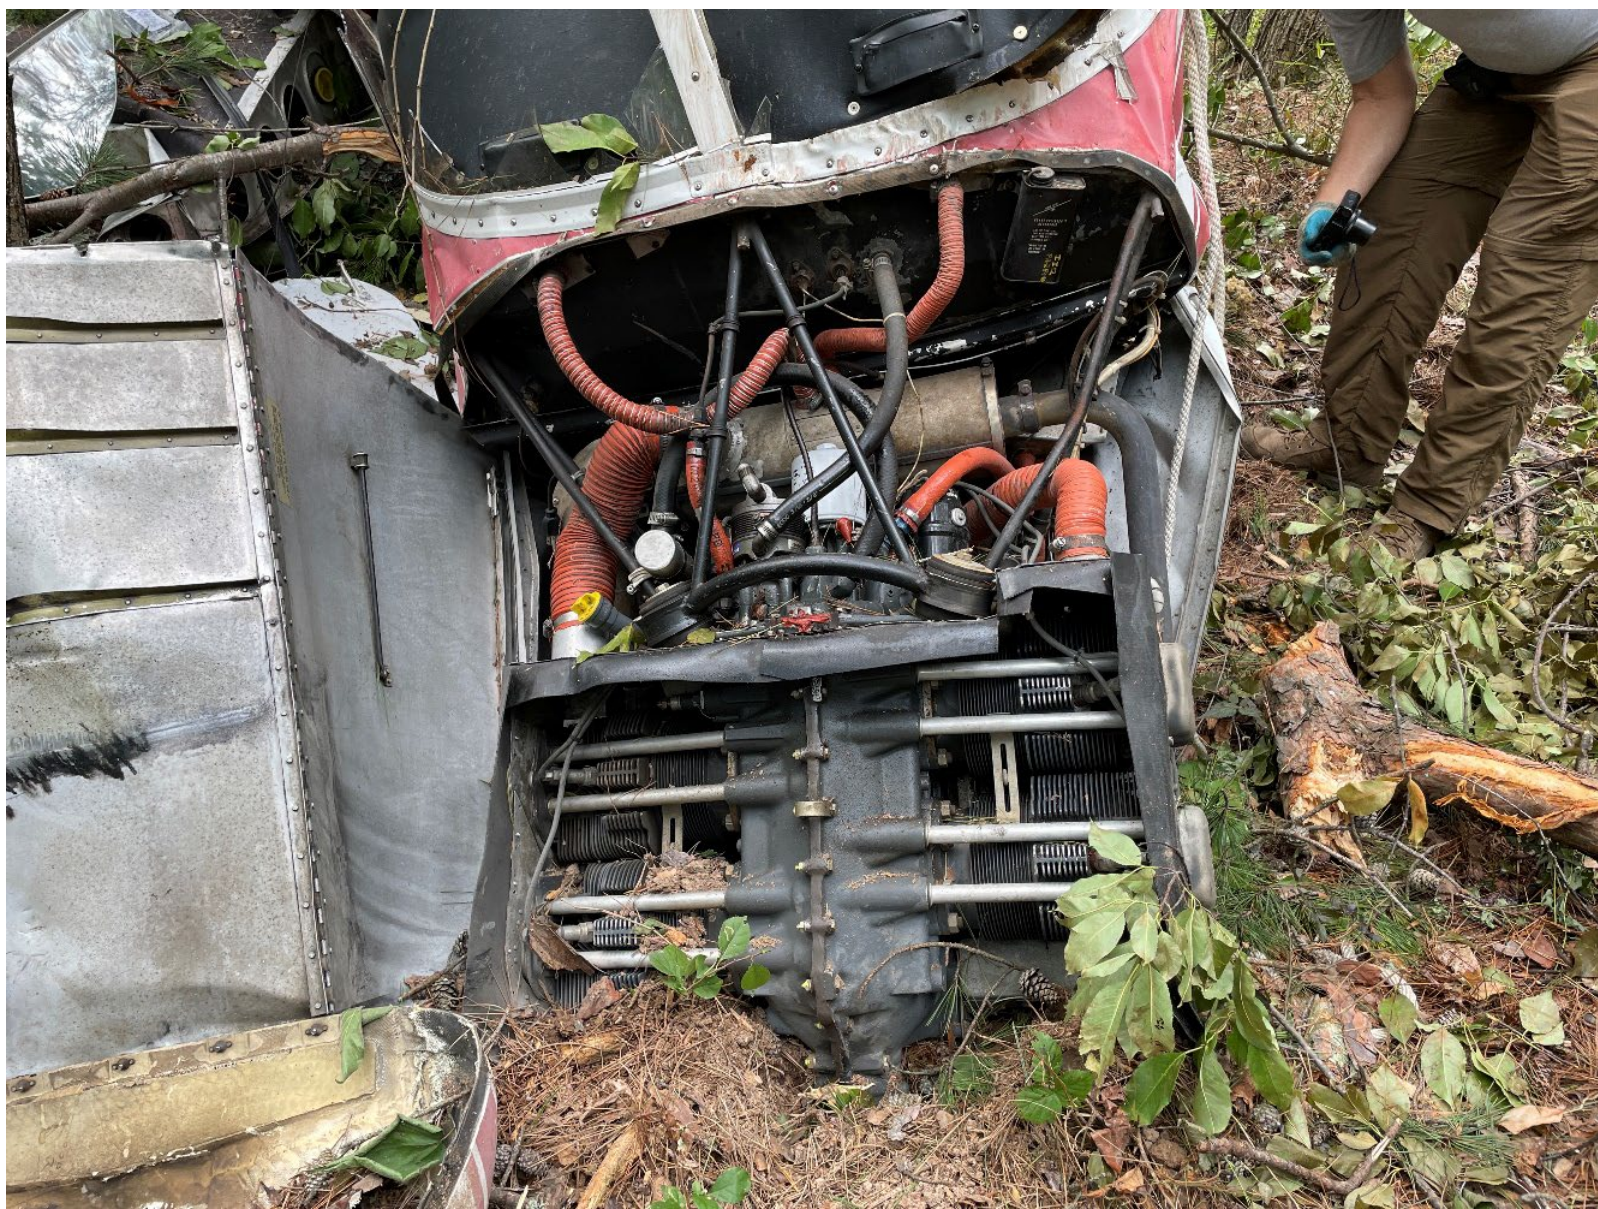
**Photograph 8 - View of the engine at the accident site.**

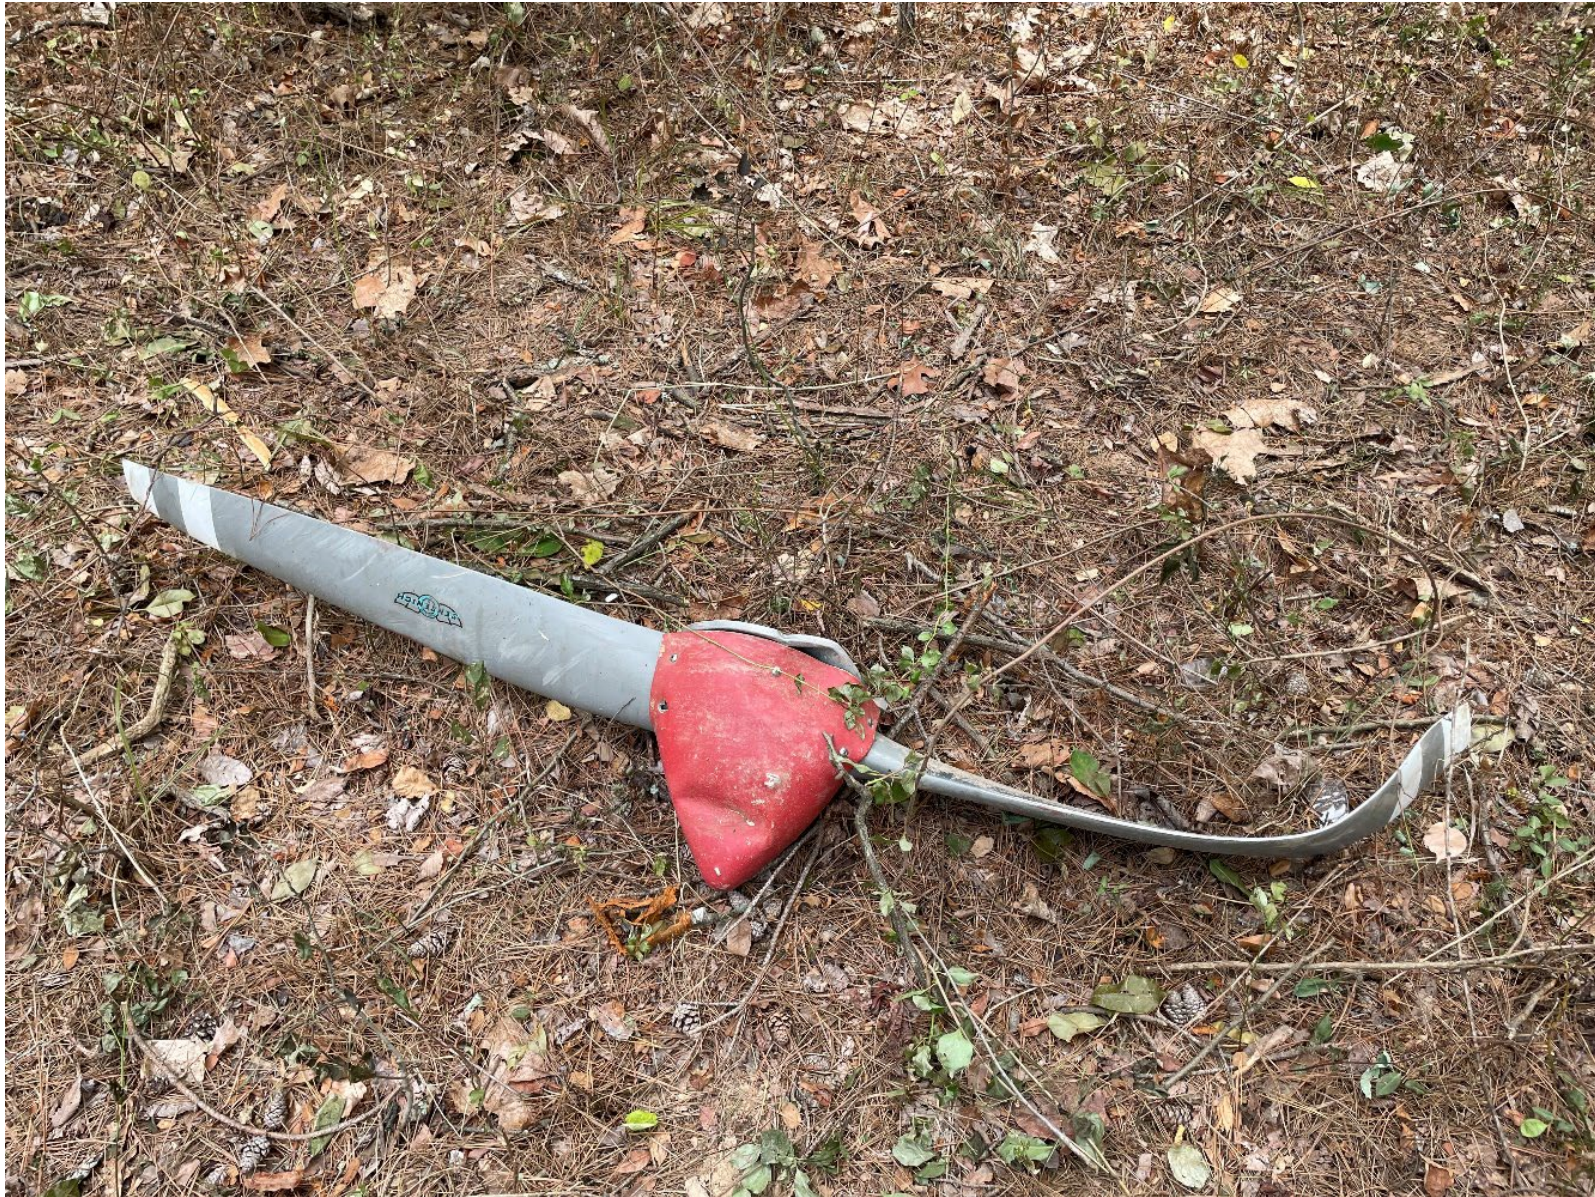
**Photograph 9 - View of the propeller at the accident site.**

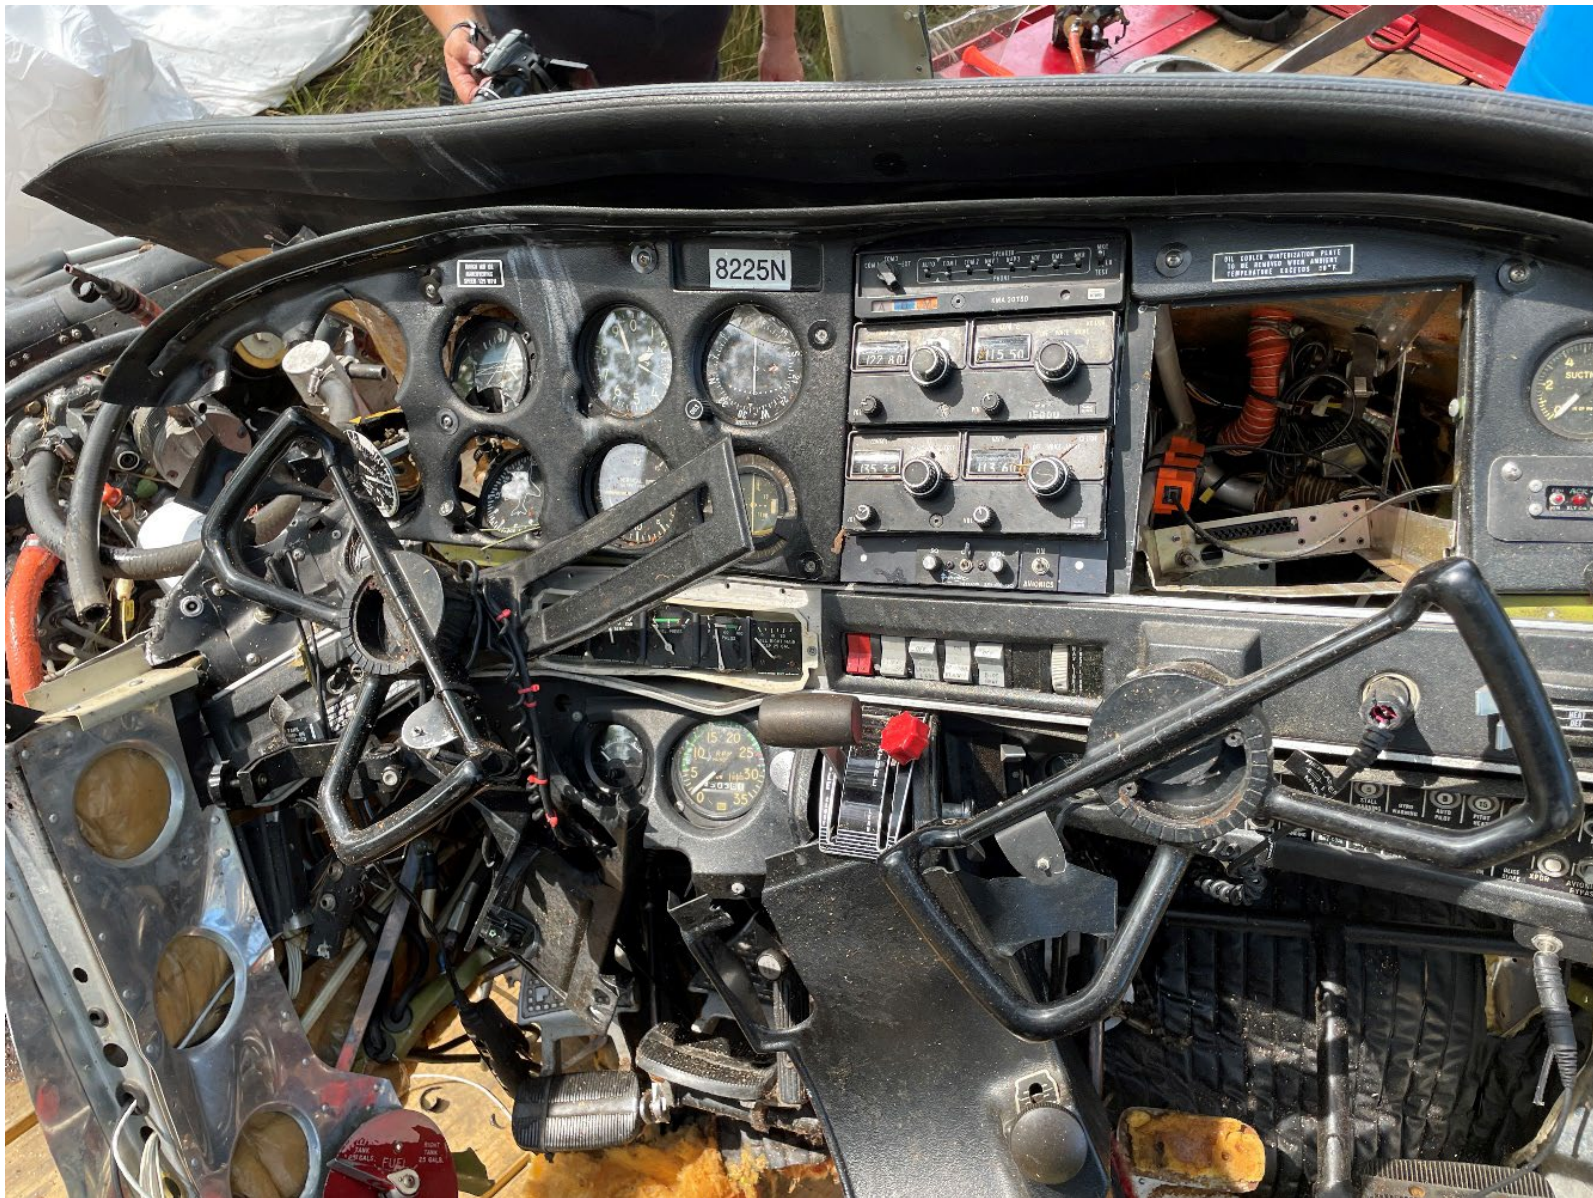
**Photograph 10 - View of the cockpit after it was recovered from the accident site.**

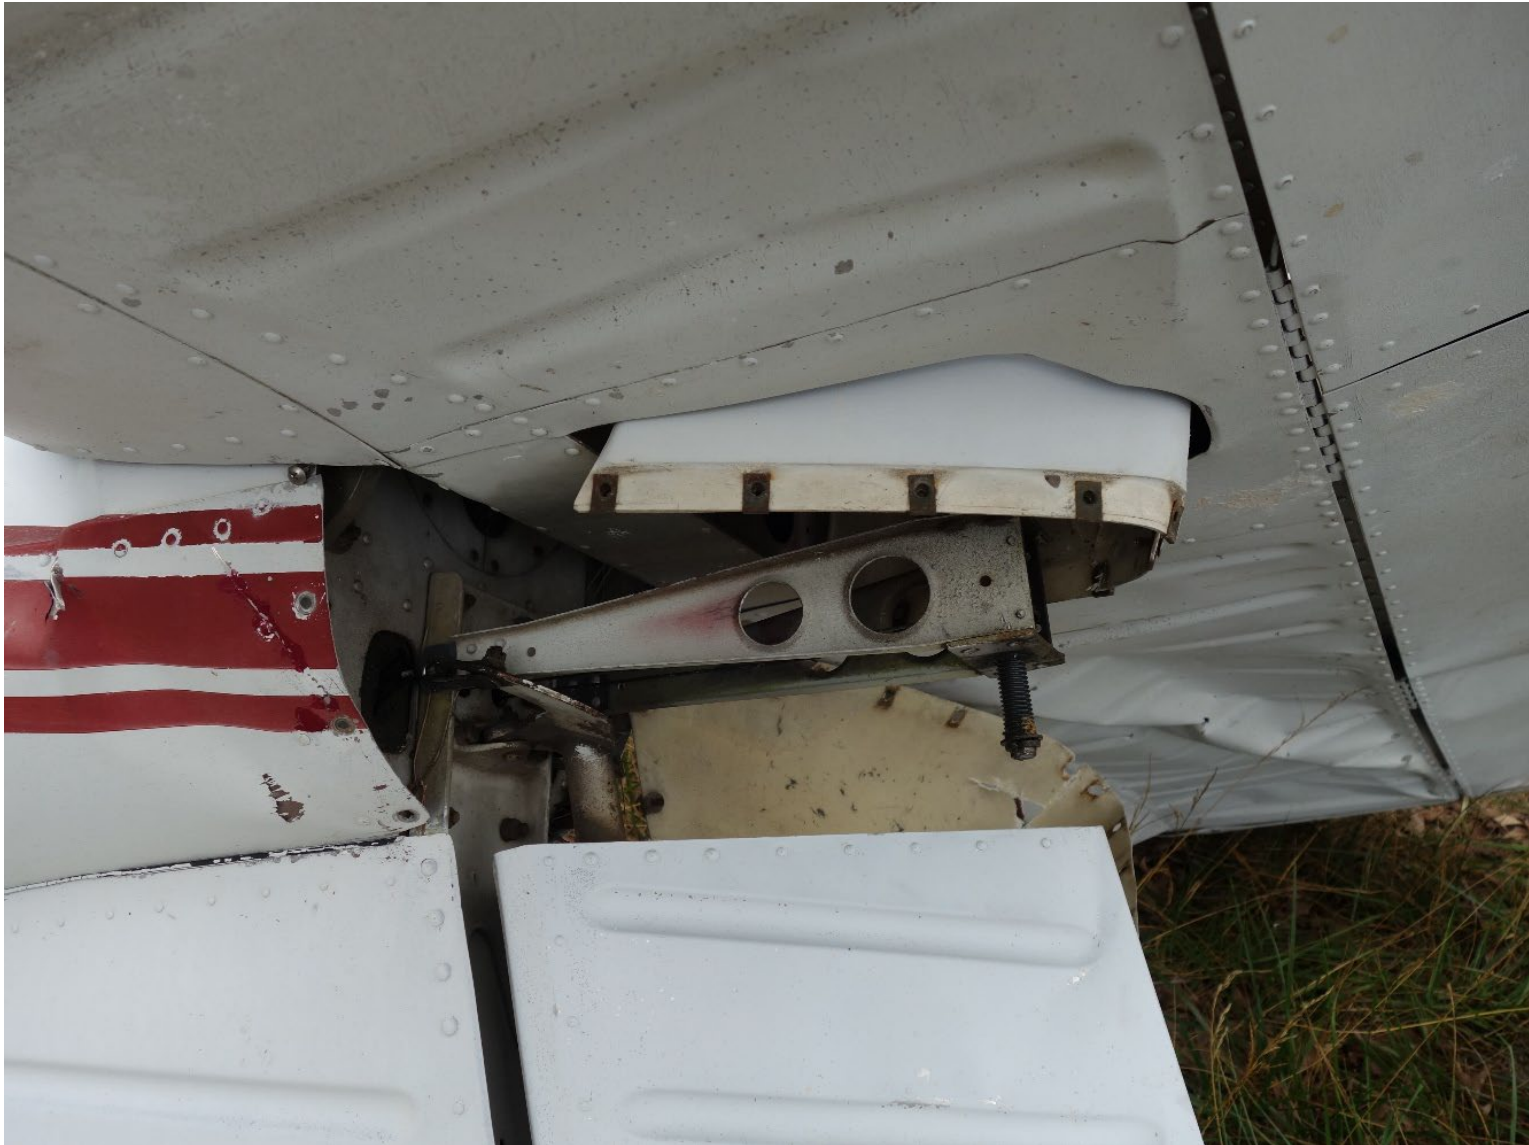
**Photograph 11 - View of the trim tab jackscrew after it was recovered from the accident site (courtesy of Piper Aircraft).**

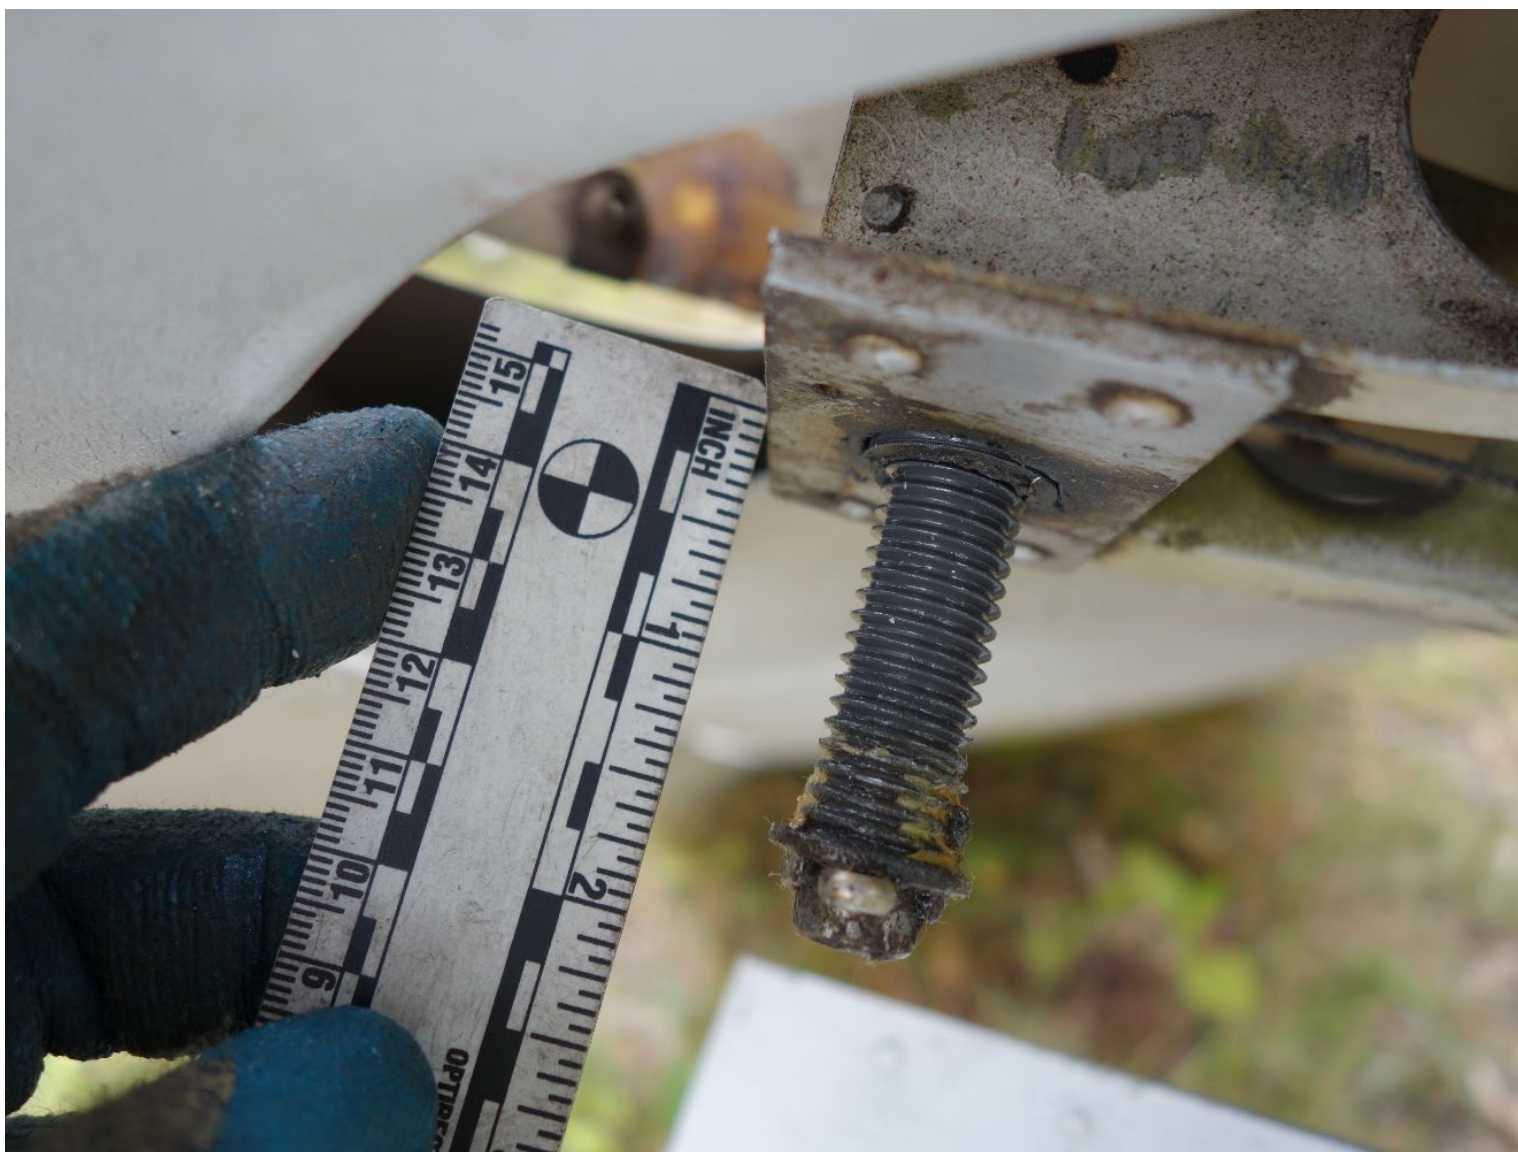
**Photograph 12 - View of the trim tab jackscrew, with a ruler for measurement purposes, after it was recovered from the accident site (courtesy of Piper Aircraft).**
