CEN23FA304

## INVESTIGATION PHOTOGRAPHS

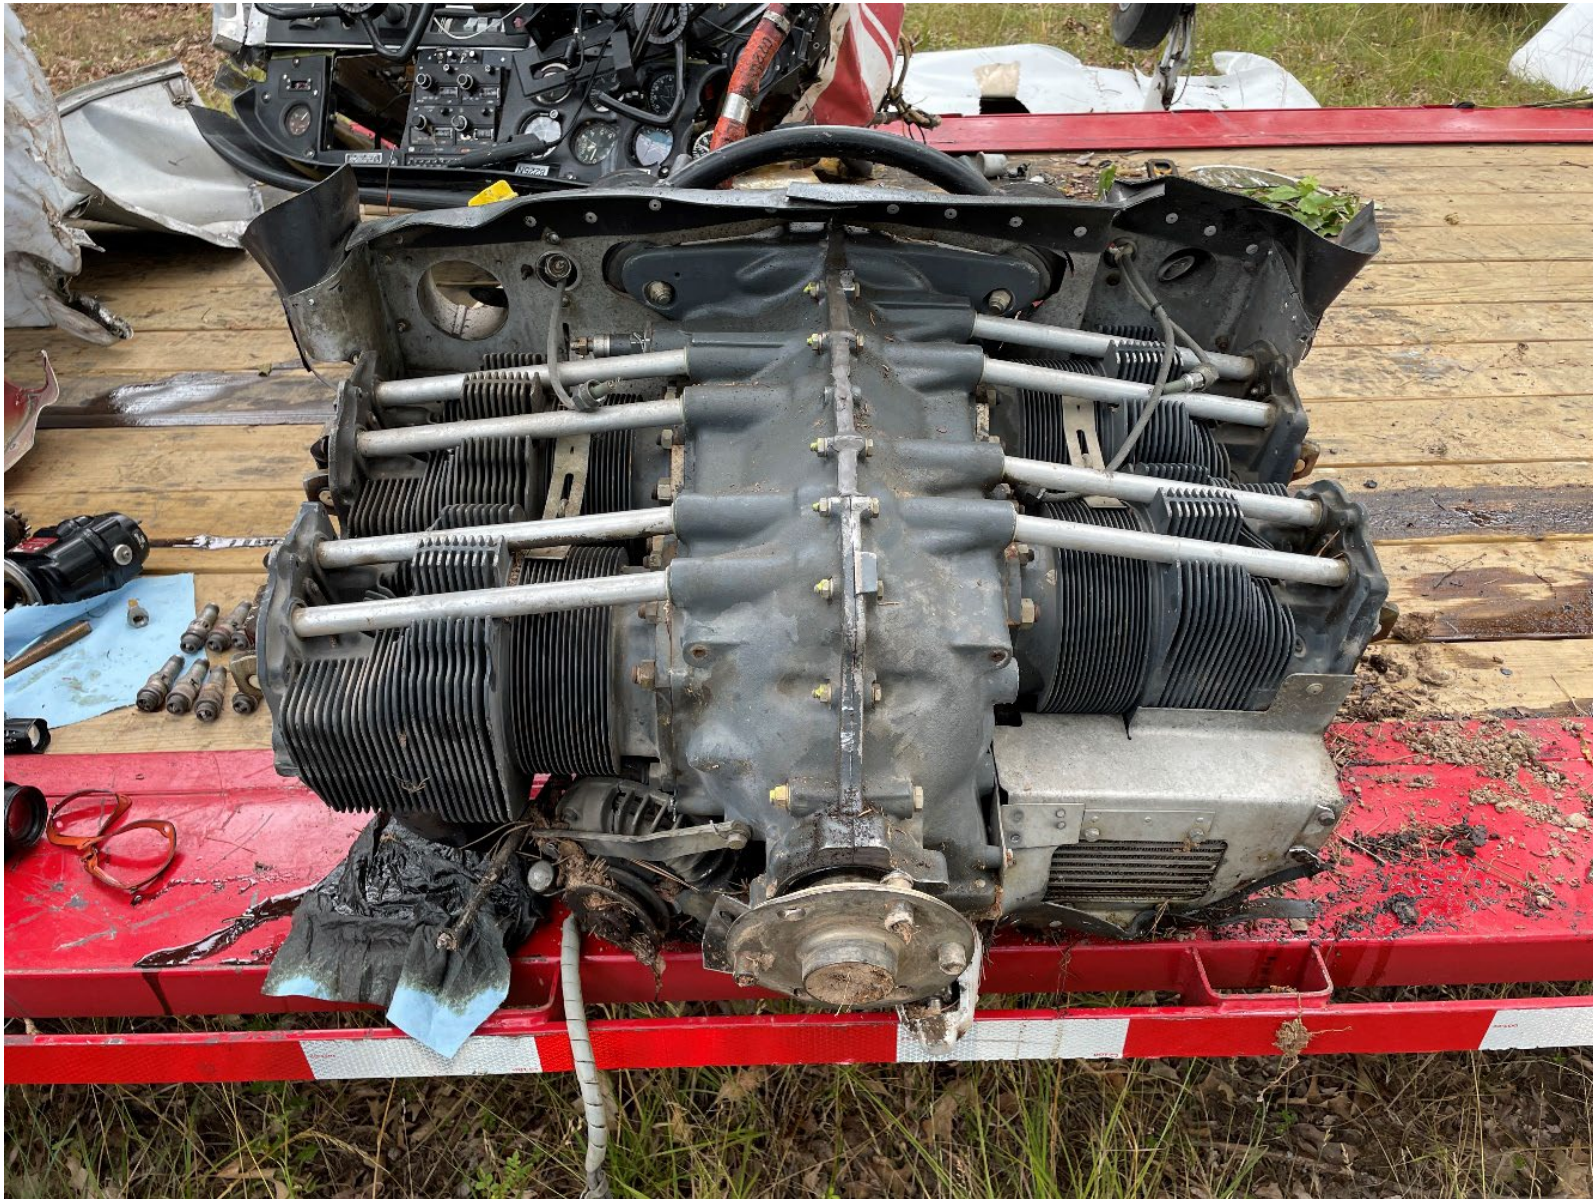
**Photograph 13 - View of the engine after it was recovered from the accident site.**

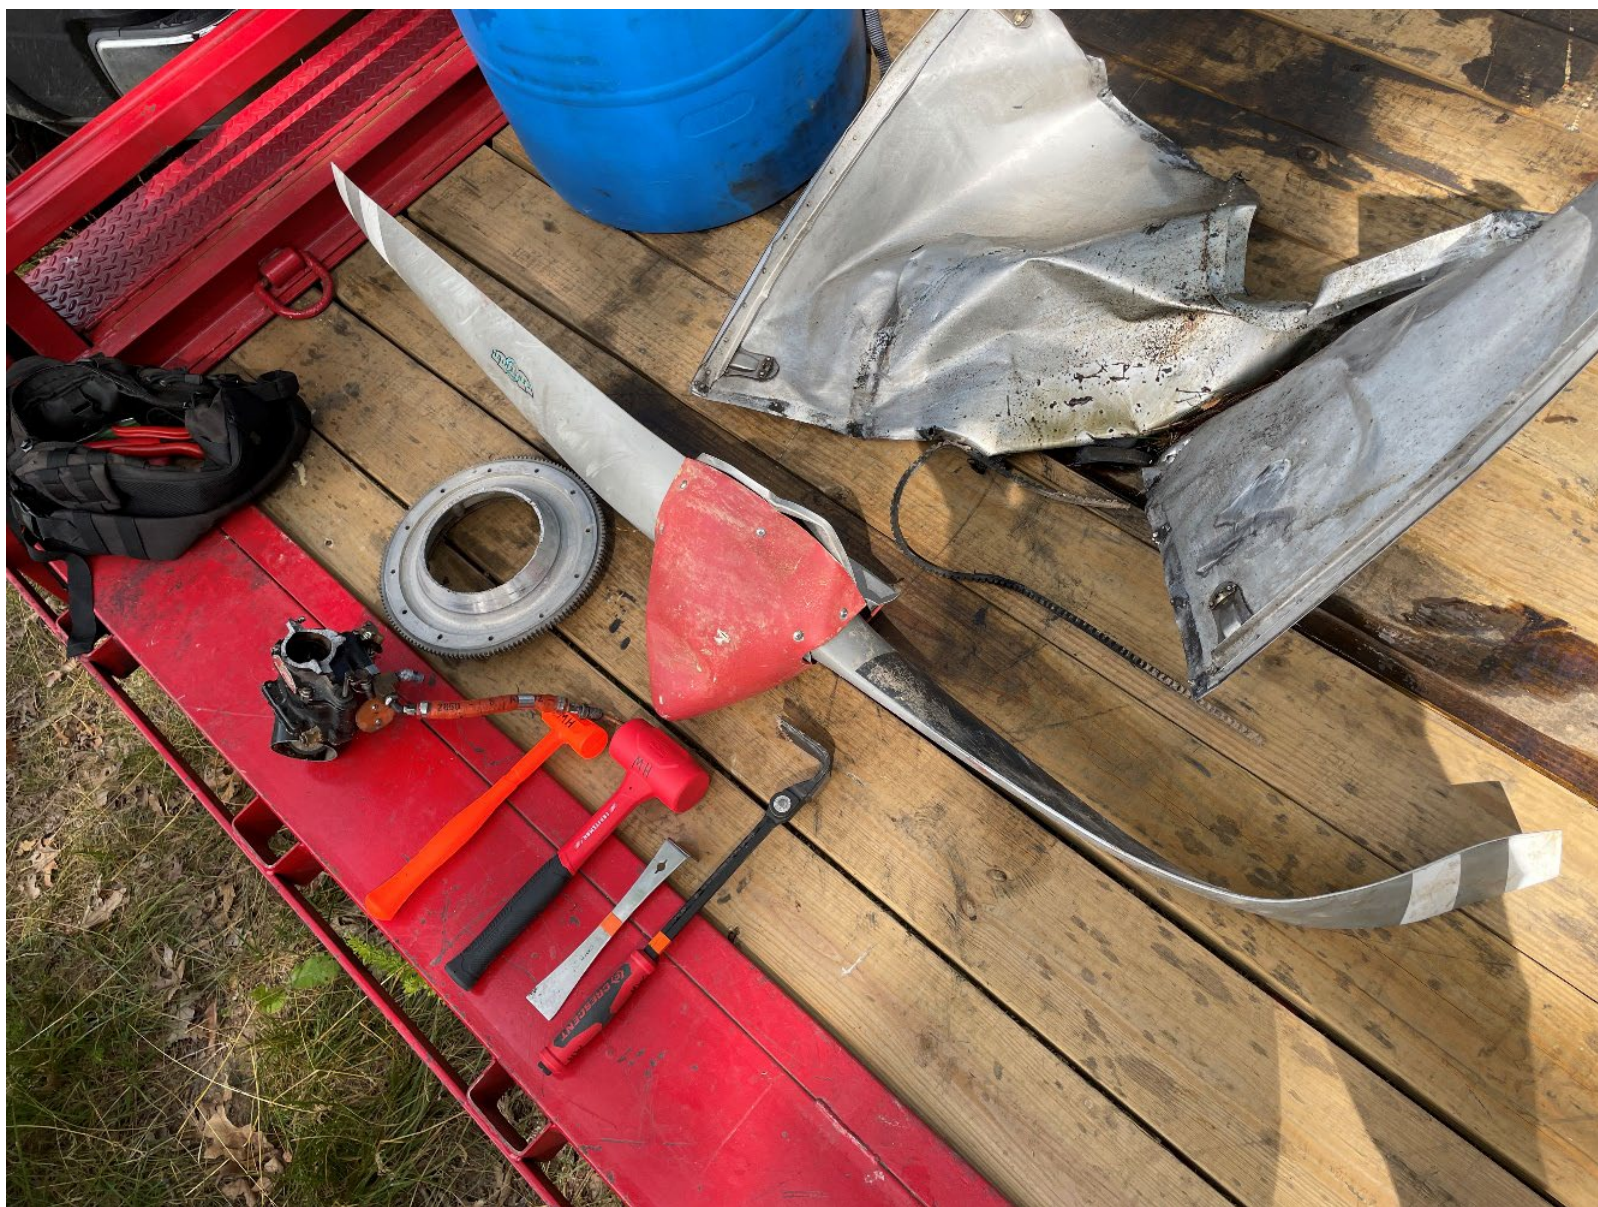
**Photograph 14 - View of the propeller after it was recovered from the accident site.**

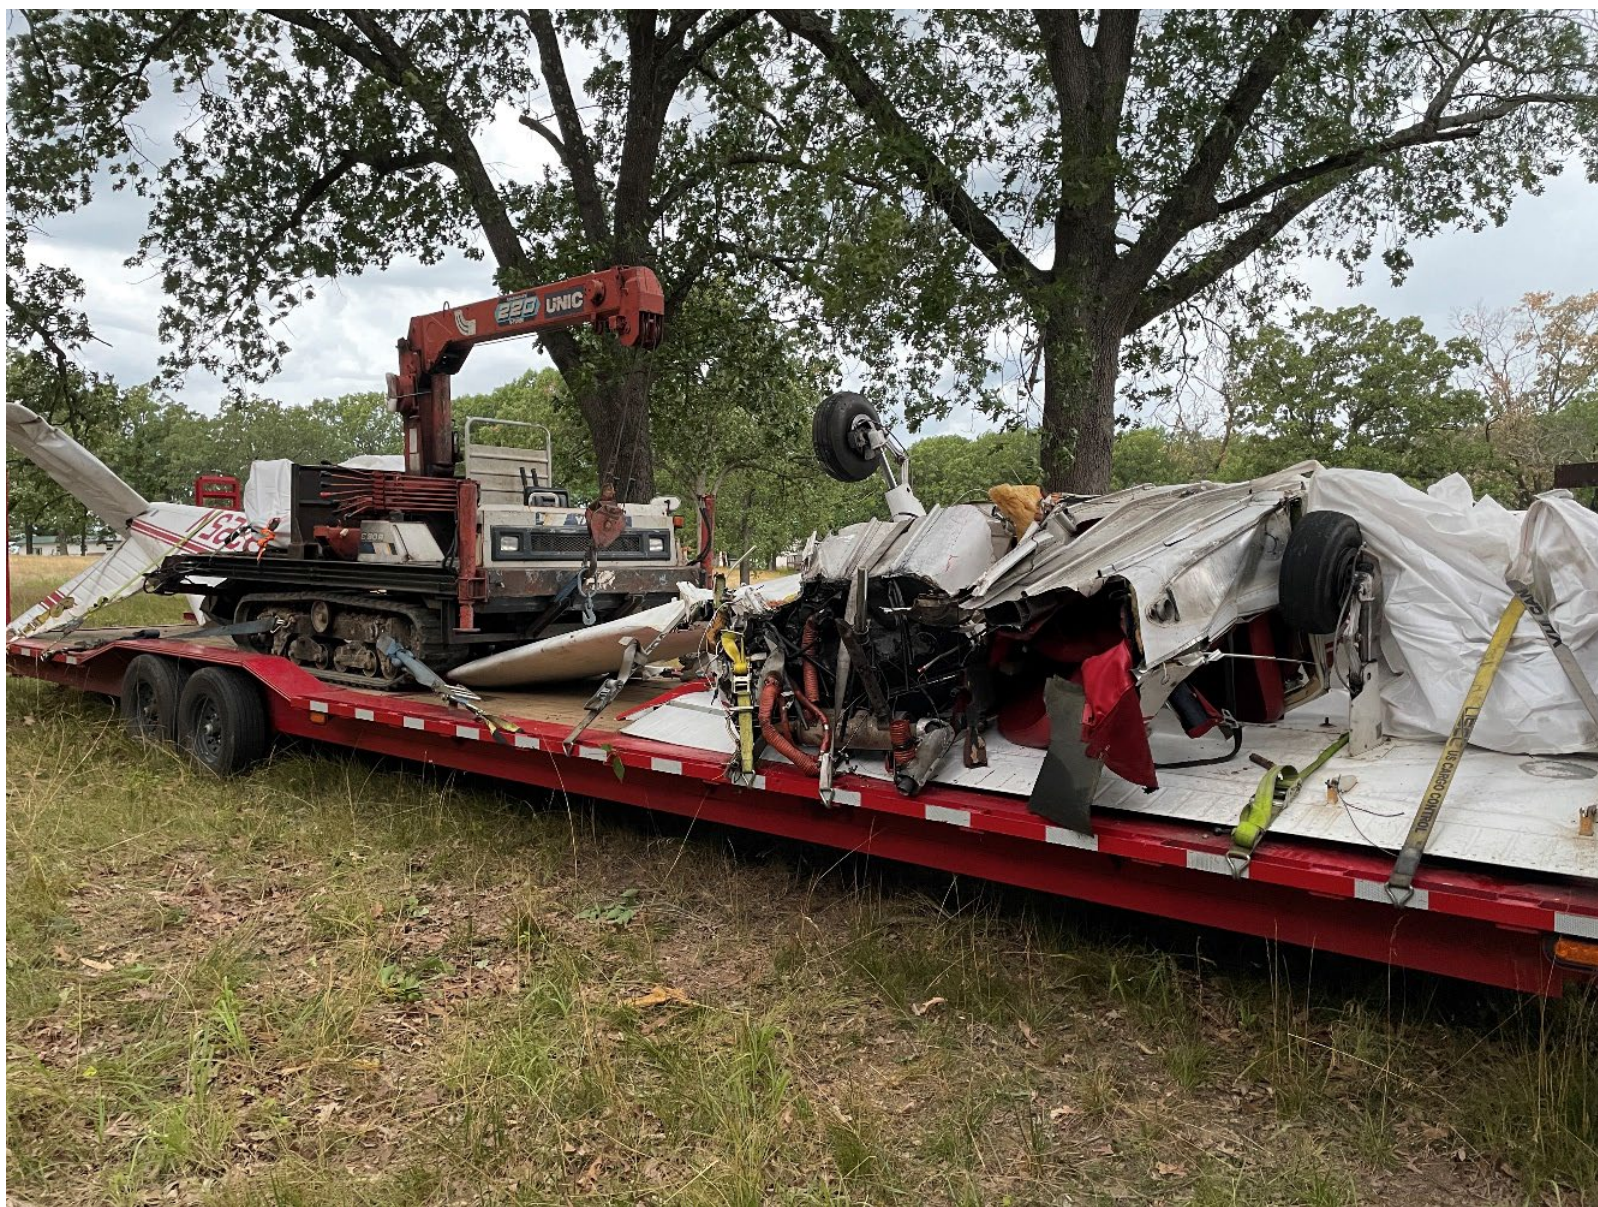
**Photograph 15 - View of the airplane after it was recovered from the accident site.**
