# National Transportation Safety Board

CEN23FA314

## EXAMINATION SUMMARY

Location: Kearney, Missouri  
Date: July 20, 2023  
Time: 0934 CDT  
Airplane: N200RA - Piper PA-31P, S/N 31P-7400198

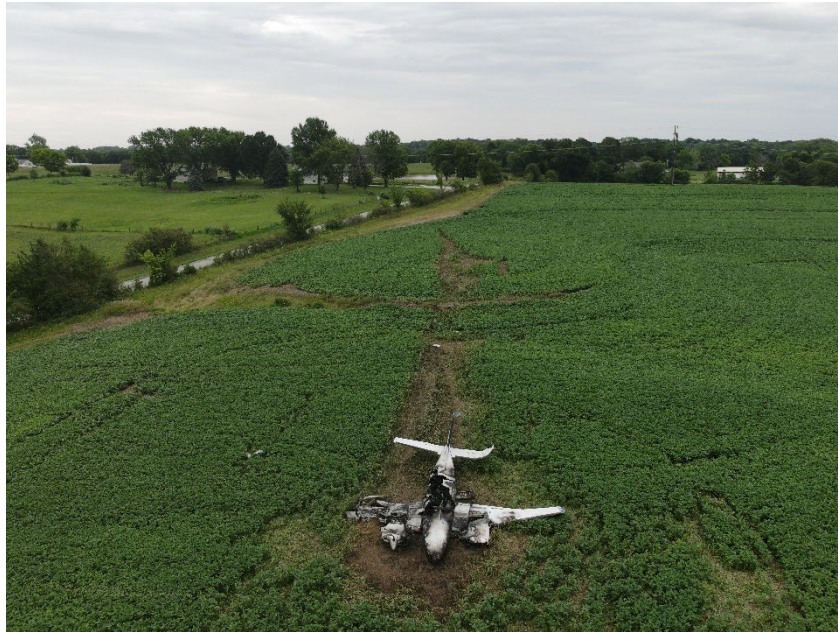
Figure 1: Accident site

- Location is +39.363823° / -094.322714°
- Location is 1.58 NM about 335° MH from the departure end of Runway 36 at GPH
- Airplane came to rest on about a 254° MH.
- Altitude is about 807 ft MSL.
- Airplane is in a flat soybean agricultural field.
- Accident site is surrounded, in the local area, by similar fields with pockets of dense trees in between the fields.
- Post impact vegetation fire was observed in and around the airplane debris field.

The fuselage, left wing, and inboard section of the right wing came to rest in the field. A post-crash fire thermally damaged the fuselage from the nose to the aft pressure bulkhead. The fire also damaged the left wing up, including the left engine and nacelle, to the midspan of the wing. The right wing had fire damage and post-crash fire damage to the right engine and right nacelle inboard to the wing root.

The debris path measured about 735 ft in length on a heading of 254°. The first impact point was two static lines on a power transmission line about 65 ft above the surrounding terrain. According to local authorities and power company personnel, the static wires were pulled and separated from the power poles and

found in a field in the direction of the airplane's path. The static wires had blue paint transfer consistent with airplane contact. A tree had a large v shaped cut on the side canopy about 60 ft above ground level and 150 ft from the transmission static wires. The right aileron counterweight was found at the base of the tree. Numerous paint and airplane skin fragments were found in-between the transmission lines and the tree. Broken fresh tree branches and tree leaves were found below the v shaped tree cut.

The ground debris path was a ground scar through agricultural plants consistent with the airplane nose structure. One pitot tube was found embedded in the ground about 25 ft from the initial ground scar. The ground scar widened to the airplane span about 150 ft past the first agricultural plant contact. A second separate ground scar through agricultural plants started about 100 ft past the first impact point and contained the outboard section of the left elevator. Numerous small vegetation burn spots located along the debris path. The outboard 4 ft of the right wing was found separated and laying upside down in the field about 210 ft from the first impact. The left propeller and gear reduction prop shaft were found separated and located on the right side of the debris path about 30 ft from the airplane. Numerous fuselage and wing fragments were found along the entire length of the path.

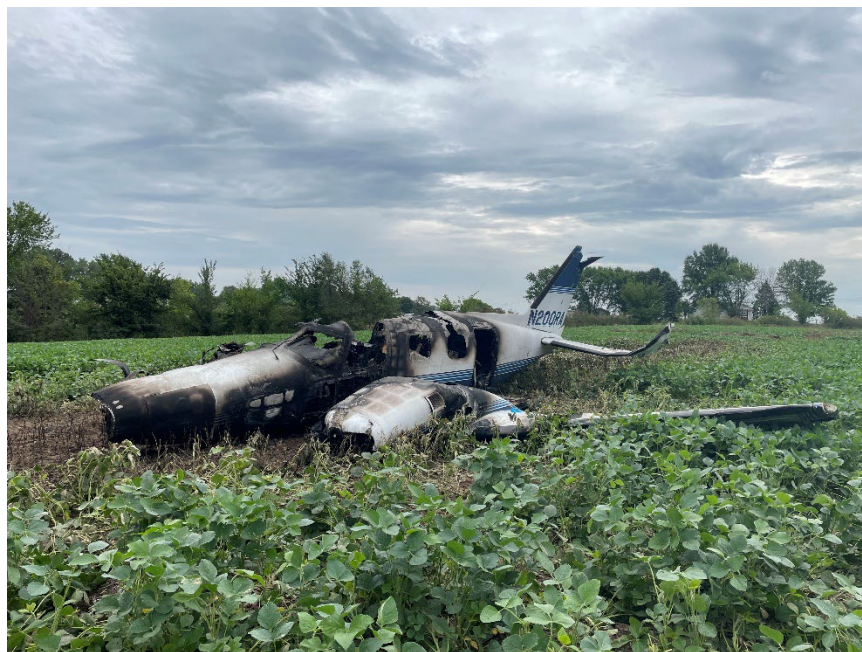
Figure 2: Accident airplane

The fuselage came to rest upright, and the left wing attached. The right wing was separated from the fuselage and laying on the ground next to the fuselage in it's normal orientation. Thermal damage occurred along the length of the fuselage to the aft pressure bulkhead. The interior, sides, and ceiling of the fuselage were consumed

by the post-crash fire. The upper nose skin surface had a large diagonal impact with witness marks and crush damage consistent with impact with a wire. The airplane records were located in the forward baggage compartment. The records were wet and damp, consistent with the fire suppression efforts.

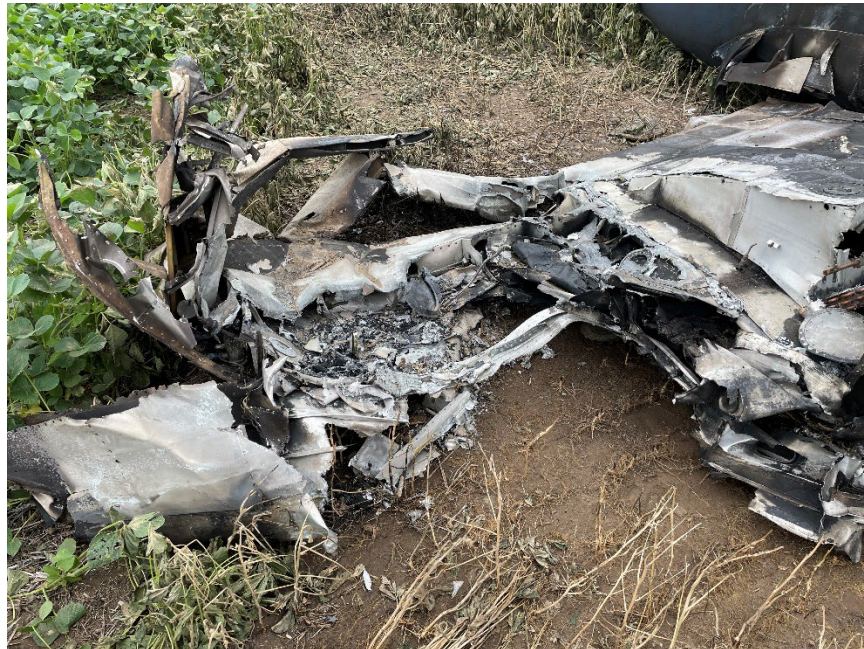
Figure 3: Right wing

- Found separated from the fuselage at the wing root with fire damage outboard to the right engine nacelle. Outboard of the nacelle the wing had fire damage, crush damage, and fragmentation of the structure. The outboard 4 ft of wing structure was found separated in the debris field.

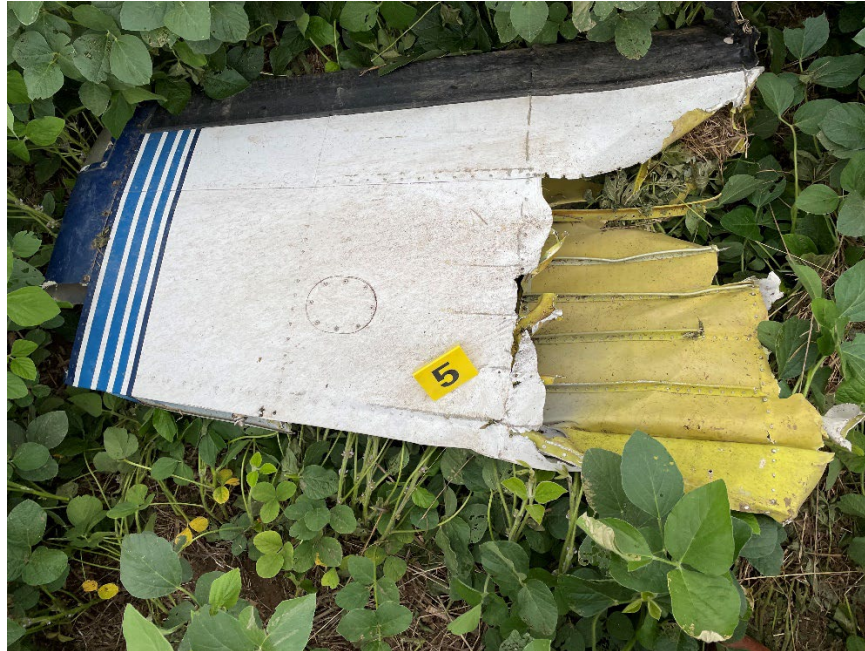
Figure 4: Separated outboard section of right wing

- The separated 4 ft section of wing had no fire damage and was found missing the right aileron. The fracture surfaces were consistent with overload failure. A large bird nest was found inside the leading edge. The upper surface had witness marks and crush damage consistent with impact of the static wire. The wire damage started at the separation point and wrapped around the leading edge of the wing. The leading edge had crush damage within the witness mark areas.

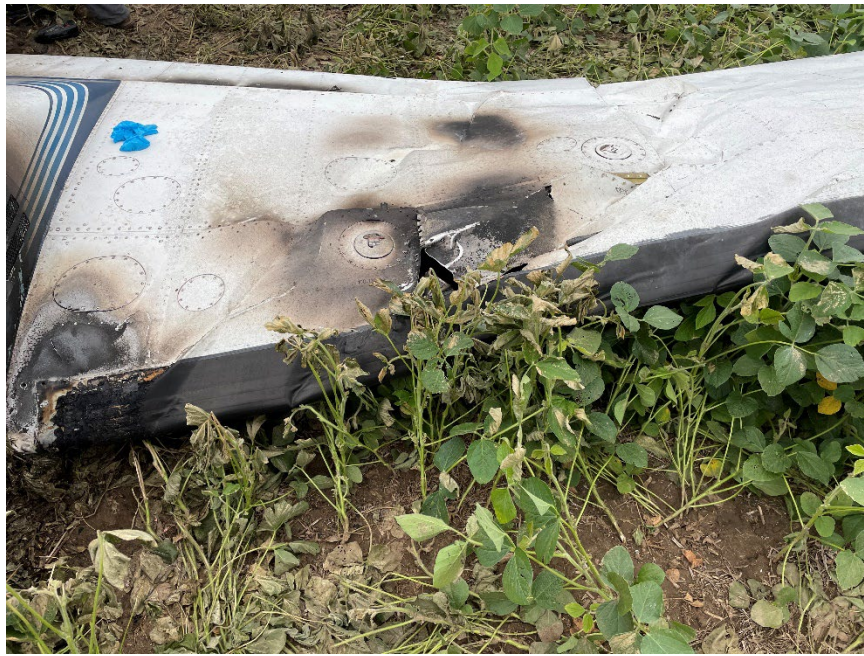
Figure 5: Outboard left wing

- Found attached to the fuselage at the wing root with fire damage to the aux tank fuel filler cap outboard of the left nacelle. Outboard of the filler cap, the wing had upward deformation with crush damage along the leading edge. The wing tip navigation light had crush damage consistent with ground impact.

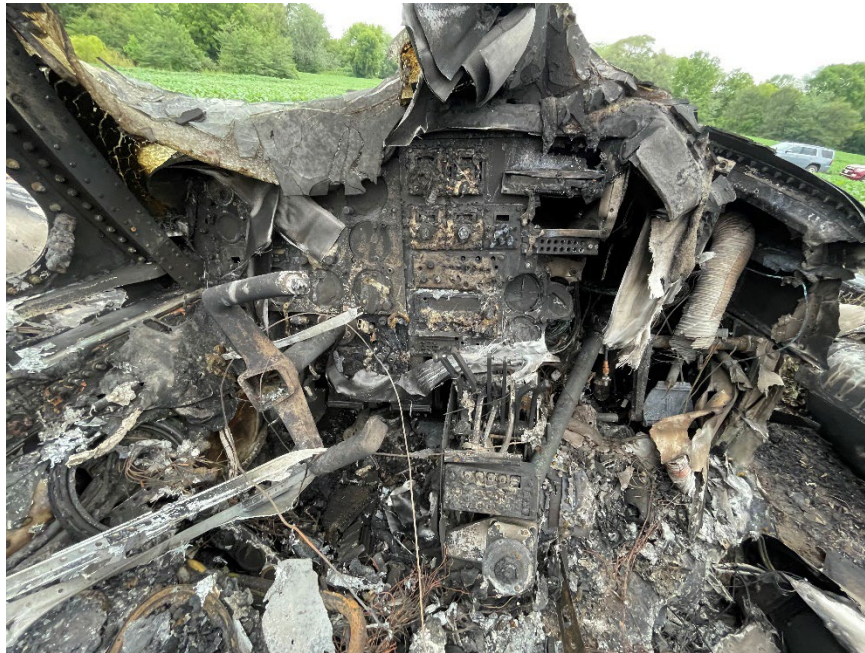
Figure 6: Cockpit

Fire damage prevented verification of the majority of the flight instruments. The manifold gauge was found intact with the right engine needle at 29 inHg and the left engine needle at 45 inHg. The vertical speed indicator needle was found at the descent limit. The throttle, prop, and mixture were found in FULL FORWARD position with fire damage. Both the right and left fuel selectors were found with the inboard tanks selected. The pilot lap belt was found unlatched with fire damage. The upper control column chain assembly was intact, and the two columns moved in unison when manually manipulated.

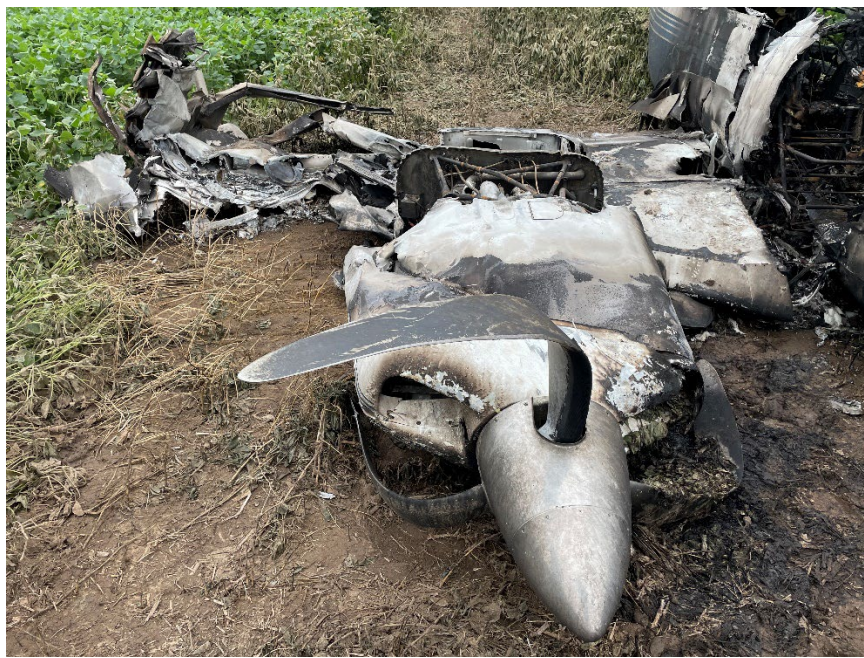
Figure 7: Right engine and propeller

Found attached to the nacelle with fire damage to the engine and accessories. The engine magnetos were unable to be tested due to being melted and partially consumed by the post-crash fire. The upper six spark plugs were removed and examined with heavy carbon fouling present. All six cylinders were borescoped with no issues noted. The crankshaft was unable to be rotated by hand due to the airplane resting on the ground. The intake system was intact, and the exhaust tailpipe

disconnected at band clamp missing. A band clamp was found in the debris path. The turbocharger rotated freely but was stiff when moved by hand. The fuel screen was clear with no fuel present in the fuel system. The oil filter was unable to be examined due to fire damage with oil present on the ground surrounding the engine. The cowling had a large diagonal impact with witness marks and crush damage consistent with impact with the static wire. The wire damage was in line with the nose and wing wire damage.

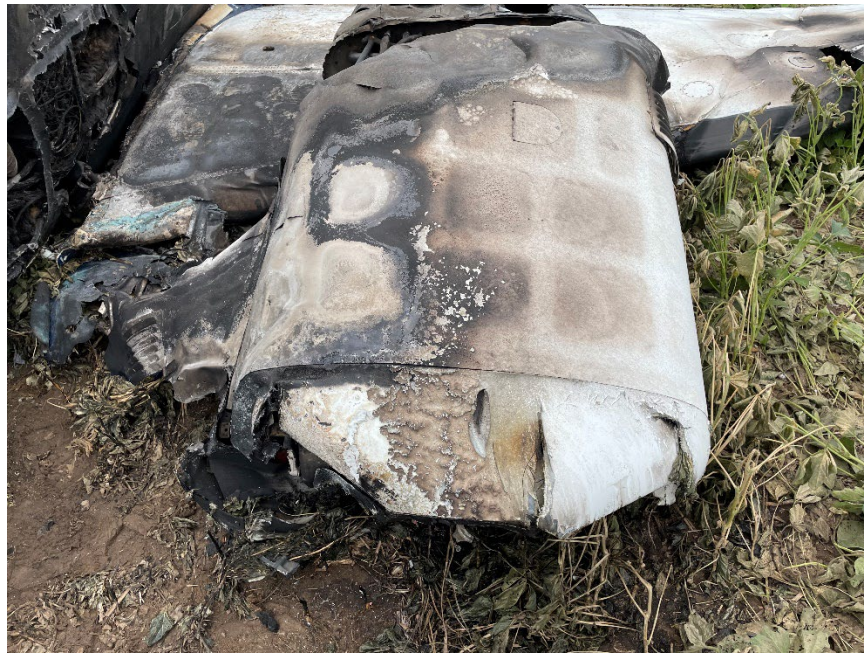
Figure 8: Left engine

Found attached to the nacelle with major fire damage to the engine and accessories. The right engine magneto was unable to be tested due to being melted and partially consumed by the post-crash fire. The left magneto was discolored due to fire but intact. However, it was unable to be tested due to the heat damage. The upper six spark plugs were removed and examined with heavy carbon fouling present. All six cylinders were borescoped with no issues noted. The crankshaft was unable to be rotated by hand due to the airplane resting on the ground. The intake system was intact, and the exhaust tailpipe contain a large crack from ground impact. The turbocharger rotated freely but was stiff when moved by hand. The fuel screen was clear with no fuel present in the fuel system due to fire exposure. The oil filter was unable to be examined due to fire damage with oil present in the sump. The gearbox was found destroyed with the propeller separated from the engine. Various forward gearbox and crankshaft fragments were found within the debris path.

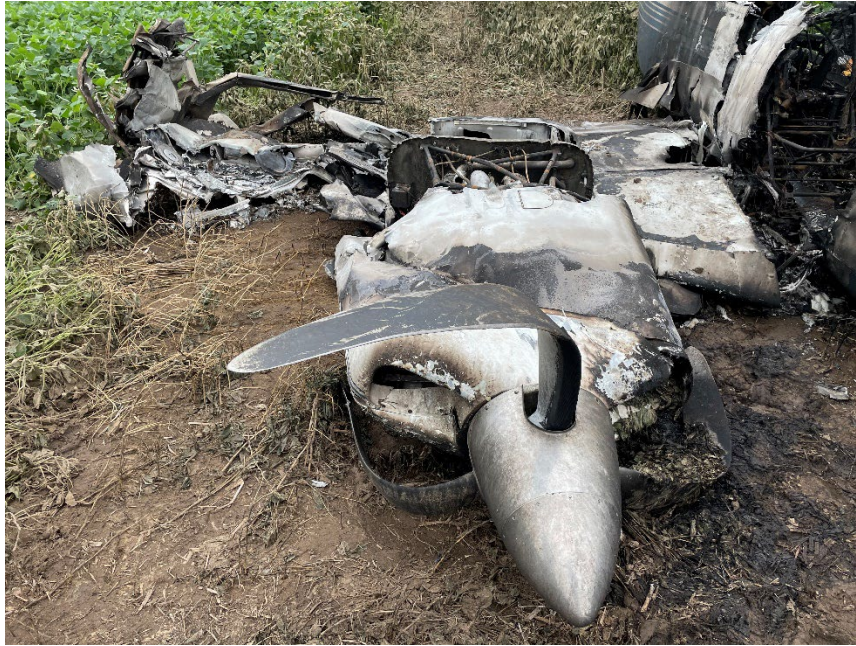
Figure 9: Right propeller

The propeller blades were identified from right to left as A, B, and C for documentation purposes. All three blades were found attached to the hubs. The propeller blades were found loose within the hub. Blade A had a leading-edge gouge consistent with impact with a wire. Blade B had filing of the leading edge and blade face witness marks consistent with wire impact. Blade A and C had no rotational bending and were bent lengthwise aft of the hub. Blade B had rotational bending.

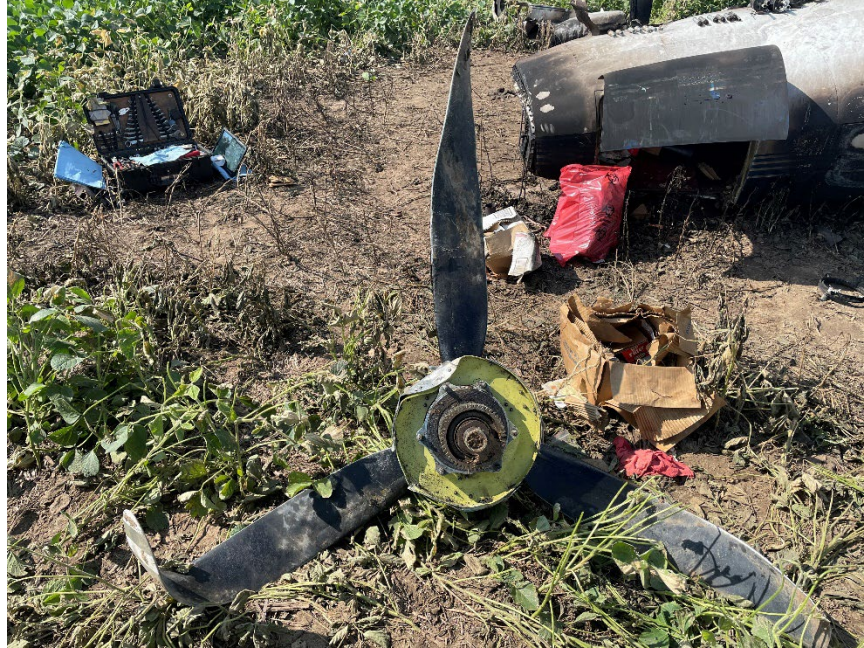
Figure 10: Left propeller

The propeller blades were identified from right to left as A, B, and C for documentation purposes. All three blades were found attached to the hubs. The propeller blades were found loose within the hub. The entire propeller was found separated from the engine gearcase with the gear reduction prop shaft still attached to the hub. All three blades had bending. Blade B had blue paint transfer on the back side of the blade consistent with impact with the airplane structure. Additionally, Blade B had a loop witness mark on the blade face consistent with impact with a wire. Blade C had about 4 inches of the tip missing. The tip was unable to be located due to the agricultural nature of the site.
