# National Transportation Safety Board

CEN23FA314

## **RIGHT ENGINE EXAMINATION SUMMARY**

Location: Kearney, Missouri  
Date: July 20, 2023  
Time: 0934 LCL  
1434 UTC  
Airplane: N200RA, Piper PA-31P, S/N 31P7400198

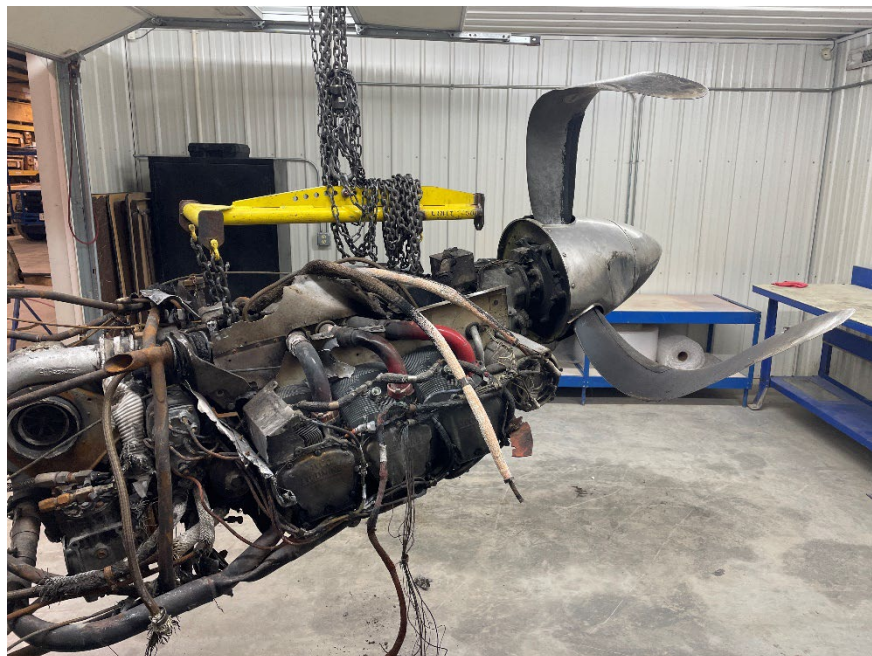
Visual examination of the engine prior to teardown showed post-impact fire damage to the entire engine with majority of the damage occurring along the accessory section. Numerous hoses and wiring had post-impact fire damage to both the fire sleeves and inner hoses or wiring. Both magnetos had post-impact fire damage with melting of the case and ignition harness. Various components along the bottom and rear of the engine had crush damage consistent with impact. The turbocharger was still attached with relatively little fire damage.

Figure 1. Engine prior to examination teardown

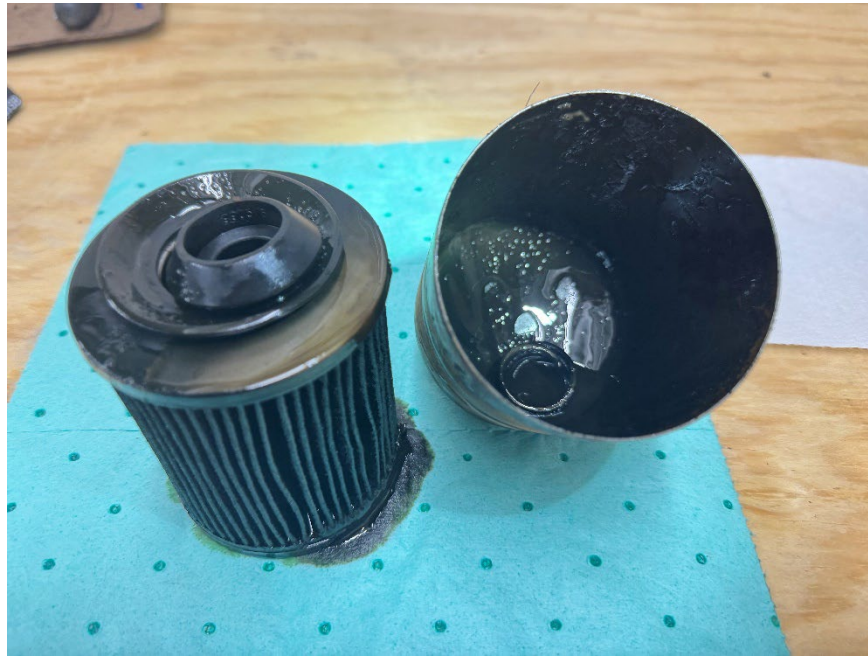
Oil dipstick was removed, and no oil level was observed. Oil filter was dated March 24 201X with a Hobbs of 1180.0 hours. An undated entry in the Right Engine Logbook #2 contains information regarding an oil filter change at 1179.9 hours before a subsequent entry on May 5, 2012. The filter was removed and examined with no metal observed in the media. The oil and filter media had a mostly black appearance with some clean oil. Additionally, oil was removed from the propeller governor and no debris was observed and the oil was dirty in appearance.

Figure 2. Oil Filter

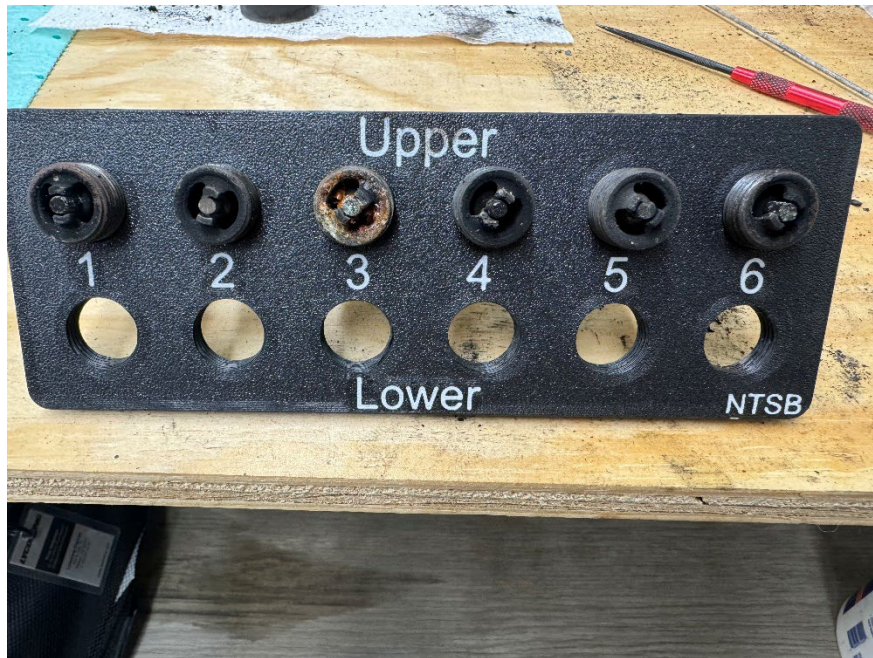
Spark plugs were removed and observed to be all black, except the upper spark plug of Cylinder #3. The upper spark plug from Cylinder #3 had debris and lead fouling consistent with combustion deposits and rust.

Figure 3. Spark Plugs

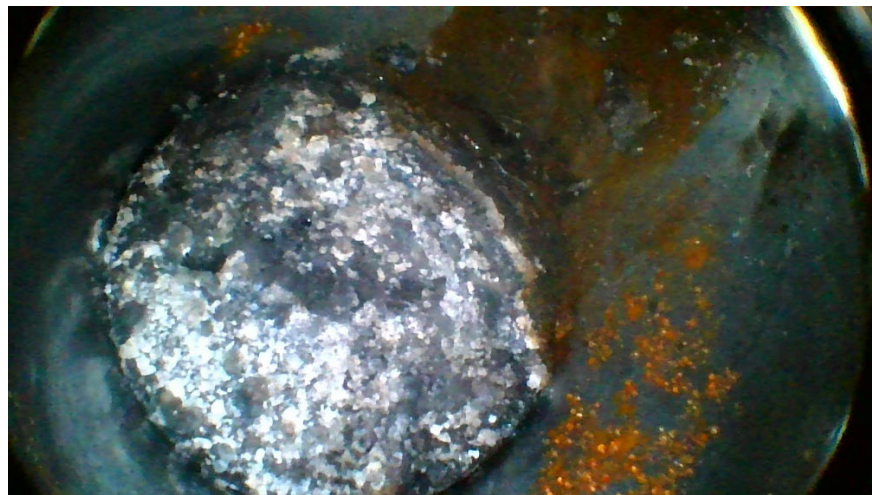
All six cylinders were borescope with no abnormality observed beyond rust on the cylinder walls and piston heads. Cylinder #3 contained the most observable rust on the cylinder walls and piston head.

Figure 4. Cylinder #3 rust along piston head and walls.

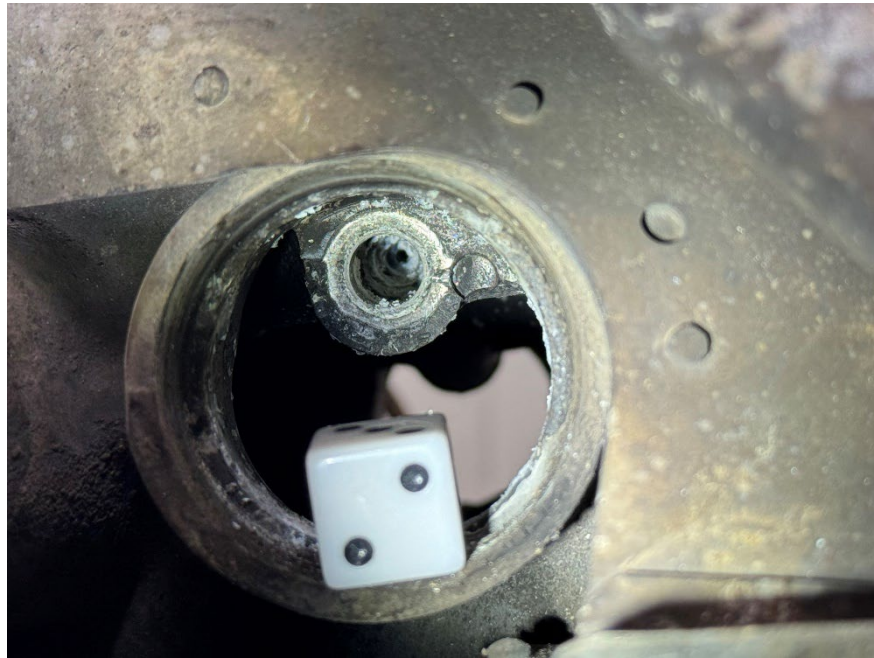
The intake tubes were removed and the fuel injectors inside the manifold housing were examined. The intake manifold housing contained foreign debris along the bottom of the housing. All the fuel injectors and manifold ports had extensive corrosion from the manifold housing.

Figure 5. Example of the corrosion in the #2 Fuel Injector port.

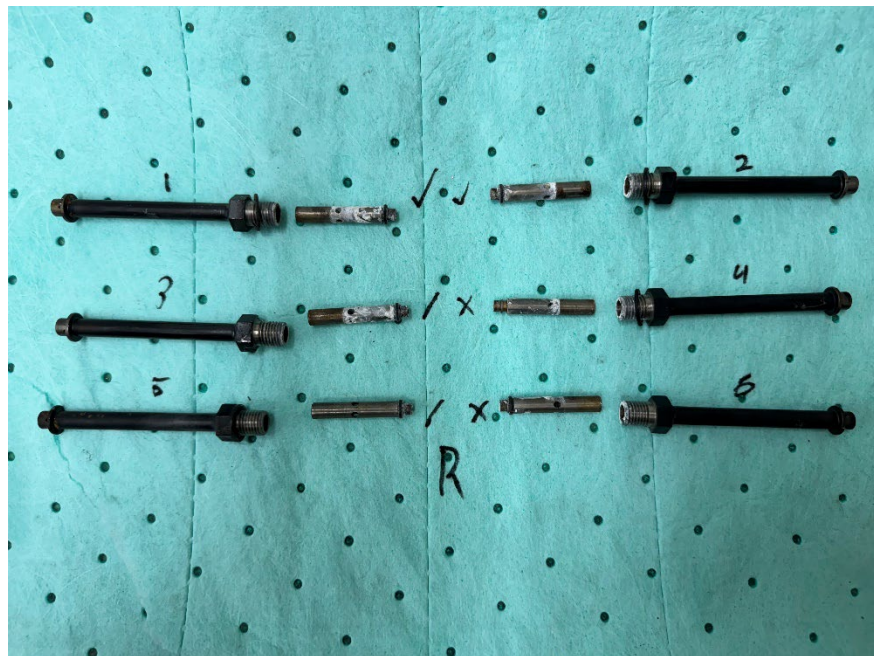
The fuel injectors were examined for blockages and general condition. All the fuel injectors had white powder from corrosion of the manifold housing and rust debris from an unknown source. The fuel injectors passage was examined by holding the injector to a flashlight. The #1 and #2 fuel injectors were clear, the #3 and #5 fuel injectors were partially blocked with debris, and the #4 and #6 fuel injectors were completely blocked with a semi-translucent foreign debris.

Figure 6. Fuel Injectors as removed from the manifold.

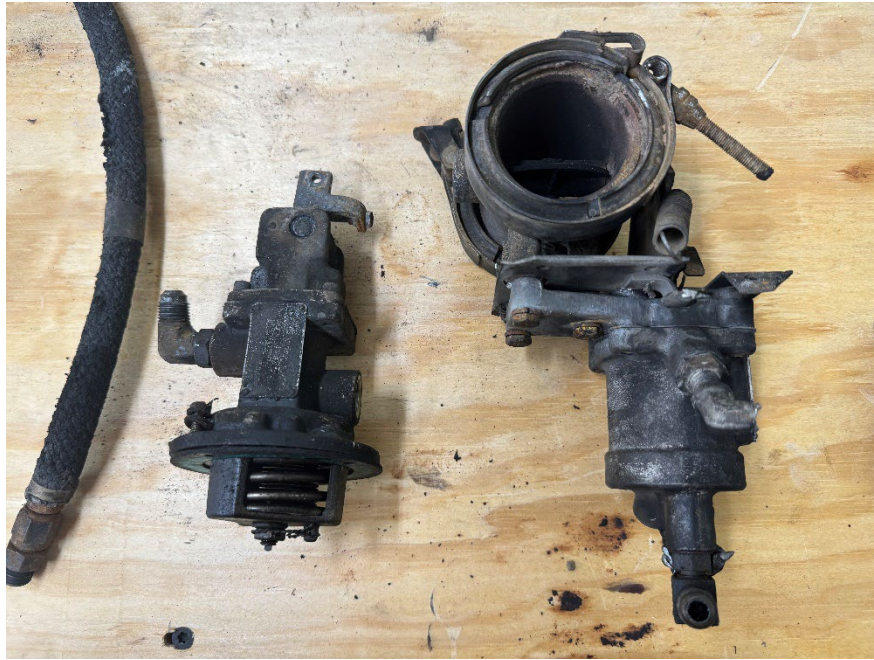
Figure 7. Turbocharger (Left) and Waste Gate (Right) Controller

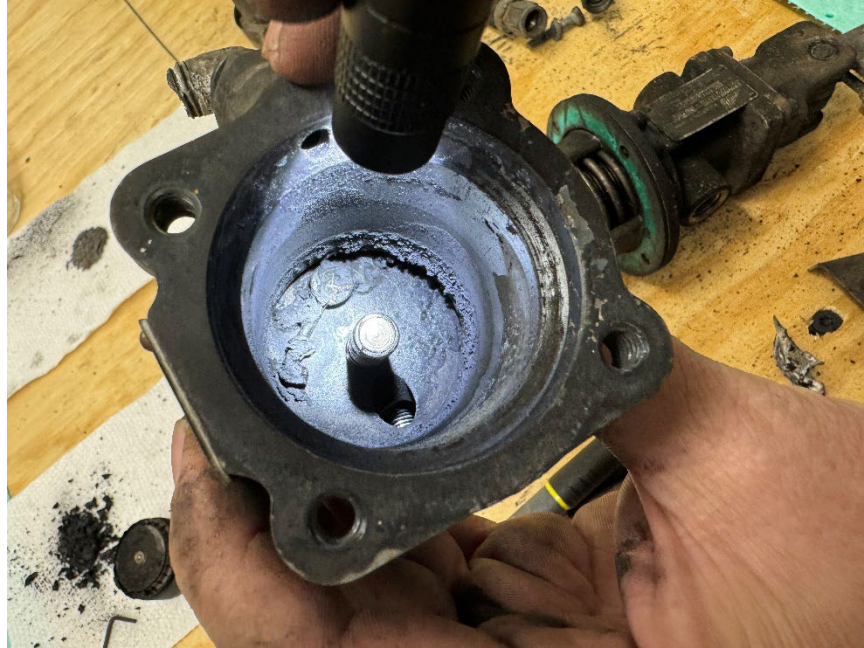
The turbocharger, oil hoses, controller, waste gate, and waste gate controller were removed and teardown inspection was performed. Both controllers had sooting on the exterior surface from the post-impact fire. The waste gate was in the fully open position with no external damage to the linkage arm. The waste gate moved freely through the entire range when actuated by hand. The waste gate controller housing was removed, and the piston was found seized in the fully open position. Black tar and ash like debris were found within the housing between the piston and spring. The piston was successfully removed by turning the adjustment screw to the fully closed position. Black tar and cinder like debris were found between the piston head and oil inlet orifice. Both oil hoses contained black tar and ash like debris when gently tapped. Additionally, one hose debris contained metal shards from an unknown source.

Figure 8. Wastegate Controller Housing (Oil Inlet Side)

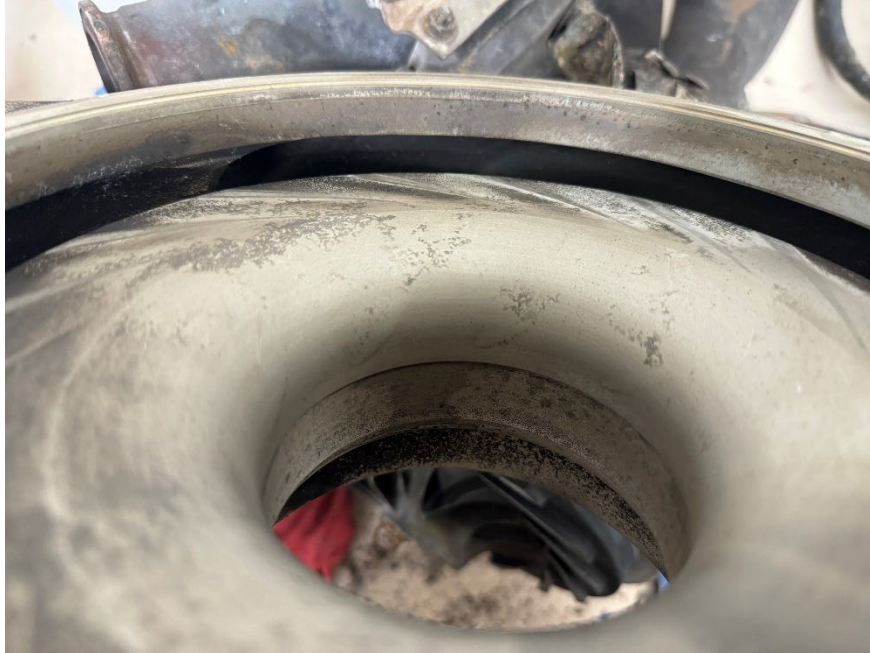
The turbocharger was visual inspected with numerous areas of rust present on the exterior surface. The turbocharger had continuity between the compressor and exhaust sections and rotated freely when turned by hand with a metallic grinding sound present. A teardown of the assembly was performed to inspect for rotational witness marks, the bearing and oil galleries. Rust was present on all internal components with no oil present. Additionally, no oil was present on the compressor side bearing or discoloration of the bearing. All oil galleries were clear of debris with no oil present. The compressor housing showed no rotational witness marks and the compressor had no burring or bending of the blades.

Figure 9. Internal side of the compressor housing.

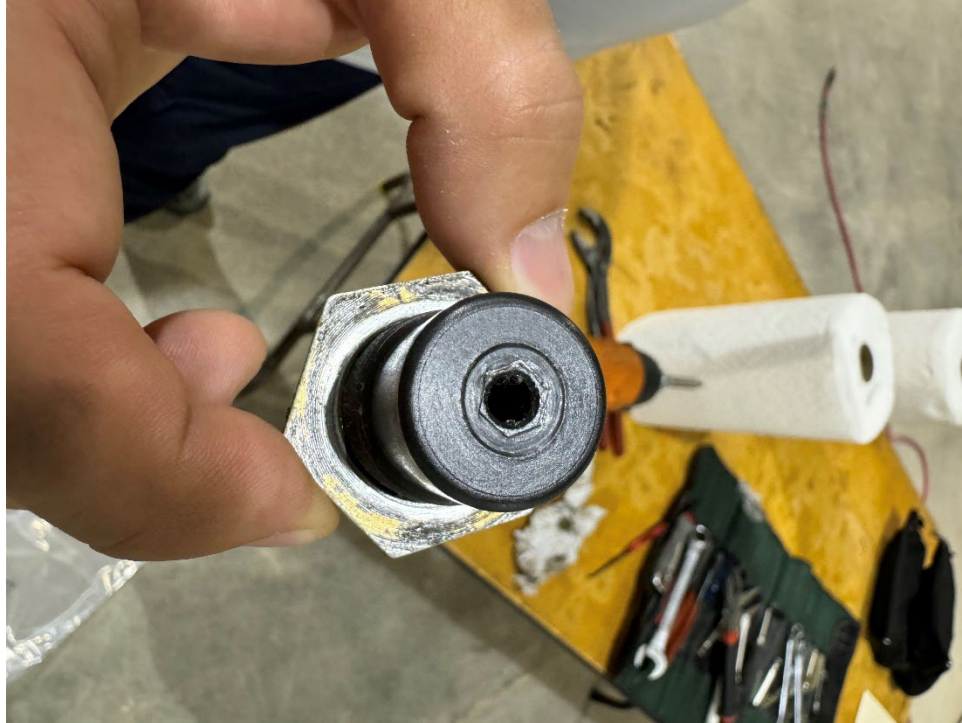
blades contained cable strike gouges along the leading edge. Blade R1 was bent forward in the thrust direction. Blade R2 and R3 were bent aft and opposite rotation. The Low Pitch Stop had impact mark indicating the propeller was operating in the low pitch range and not feathered.

Figure 11. Low Pitch Stop
