# National Transportation Safety Board

CEN23FA314

## **LEFT ENGINE EXAMINATION SUMMARY**

Location: Kearney, Missouri  
Date: July 20, 2023  
Time: 0934 LCL  
1434 UTC  
Airplane: N200RA, Piper PA-31P, S/N 31P7400198

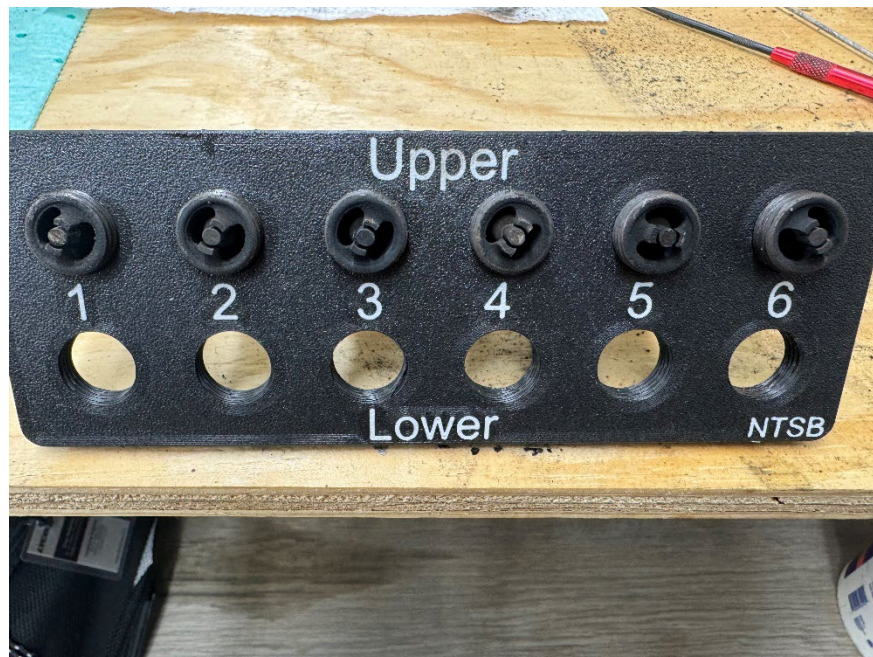
Figure 3. Spark Plugs

Spark plugs were removed and observed to be all black in appearance.

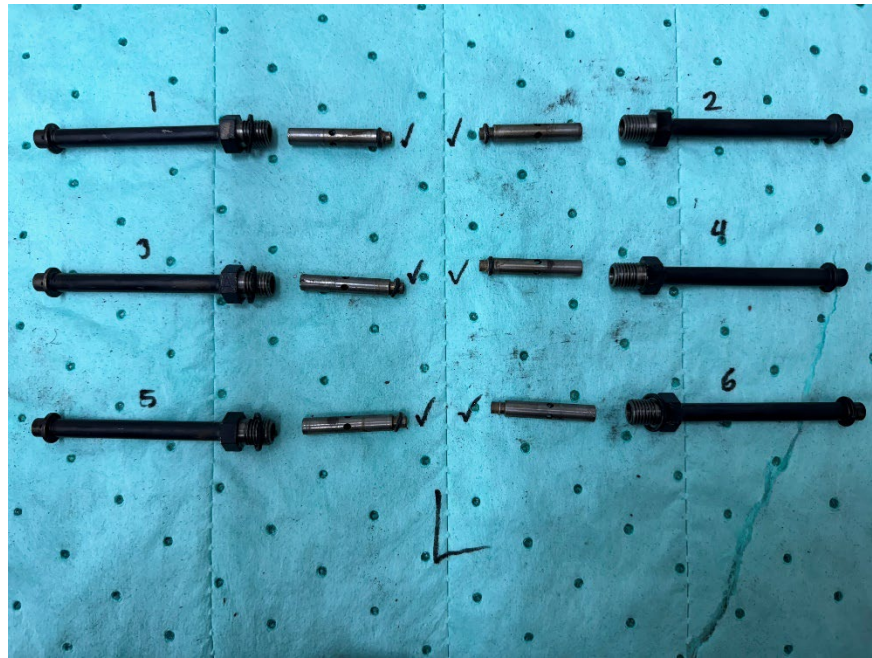
Figure 4. Fuel Injectors as removed from the manifold.

The intake tubes were removed and the fuel injectors inside the manifold housing were examined. The intake manifold housing was clean and the fuel injectors were examined for blockages and general condition. The fuel injectors passage was examined by holding the injector to a flashlight. All fuel injectors had no abnormalities observed.

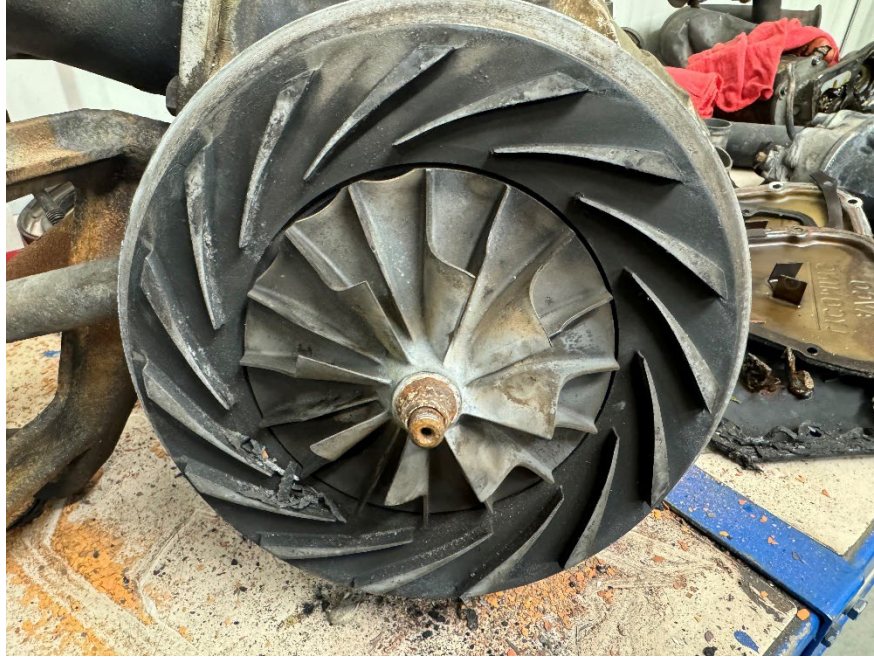
Figure 5. Turbocharger Compressor

The turbocharger, waste gate, and waste gate controller were removed and teardown inspection was performed. The waste gate controller had sooting on the exterior surface from the post-impact fire. The waste gate was in the fully closed position with external damage to the linkage arm. The waste gate moved freely through the entire range when actuated by hand. The waste gate controller housing was removed, and the piston was found seized in the fully open position. Black tar and ash like debris were found within the housing between the piston and spring. The piston was successfully removed by turning the adjustment screw to the fully closed position. Black tar and cinder like debris were found between the piston head and oil inlet orifice.

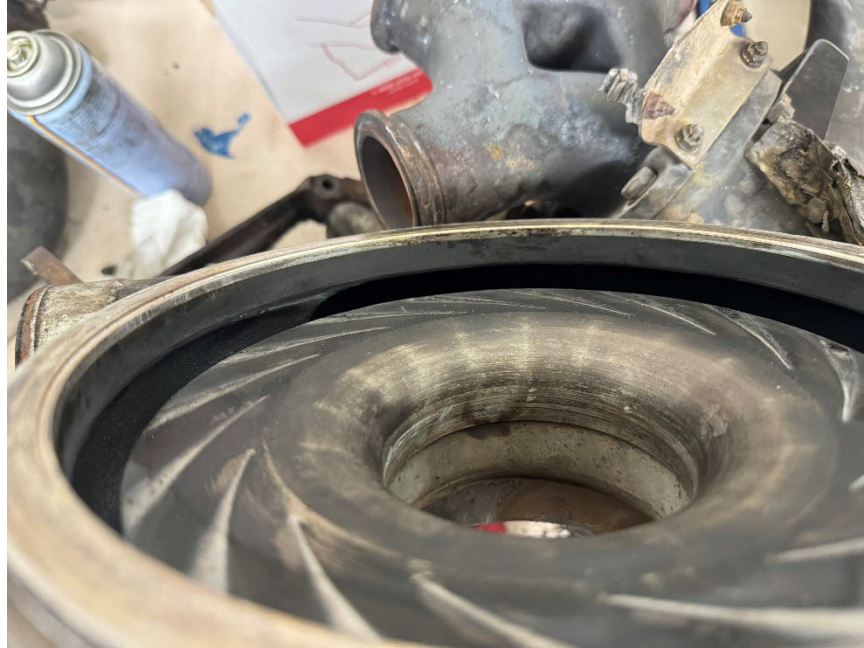
Figure 6. Compressor housing with rotational witness marks

The turbocharger was visually inspected and the turbocharger had continuity between the compressor and exhaust section. The turbocharger rotated with resistance when turned by hand with a metallic grinding sound present. A teardown of the assembly was performed to inspect for rotational witness marks. The compressor housing showed rotational witness marks and compressor burring and bending of the blades.
