**Subject:** CEN23FA314 - Witness Interview

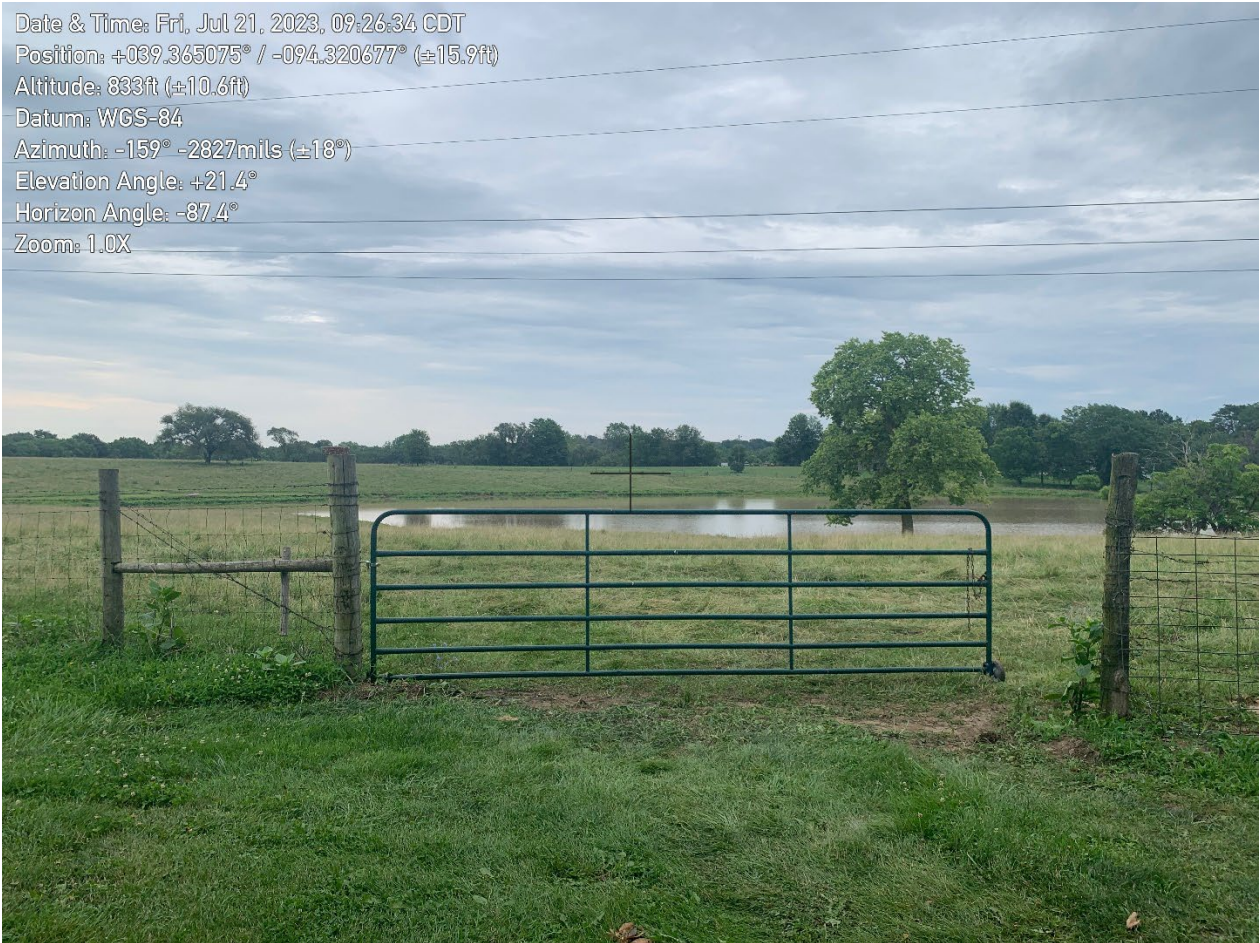
Mr. Jacot was outside in his backyard when he heard a loud low flying airplane. He looked to the east and saw an airplane appear out from behind the far tree line and pulling up higher into the sky. Mr. Jacot stated that the airplane barely cleared the tree line prior to making it into the open field between him and the tree line. He thought that the pilot was screwing around in his airplane.

The airplane continued towards him and impacted the high lines on the powerline just to the side of his house. The lines struck the middle of the airplane and the airplane continued in a straight line with a slight left bank. His wife saw the airplane impact the tree in their front yard causing multiple branches to break off. Mr. Jacot was able to get around his house prior to the airplane impacting the field. He stated that the airplane was in a left bank and impacted the field nose first while still in the left bank.

Figure 1: The Witness's Reported View
